## Condo Inspection Report

**9705 Collins Ave**

**Unit 2204N/2205N**

Inspected on Tue, Mar 29 2022 at 1:00 PM

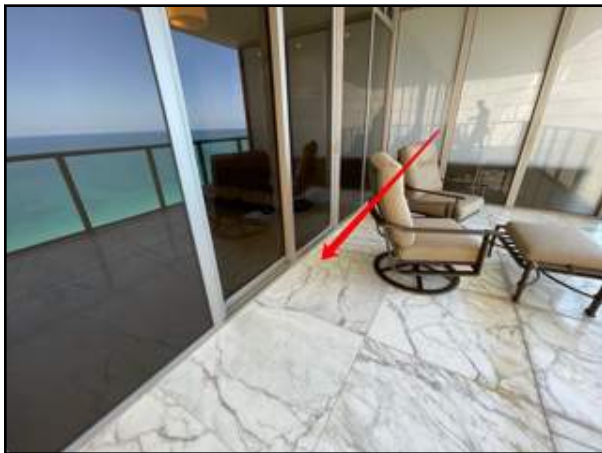
Figure 6-1

Cracked/broken flooring tile along east balcony outside of bedroom #2.  
Replace broken flooring tile along exterior balcony. (Estimate: \$200 - \$400)

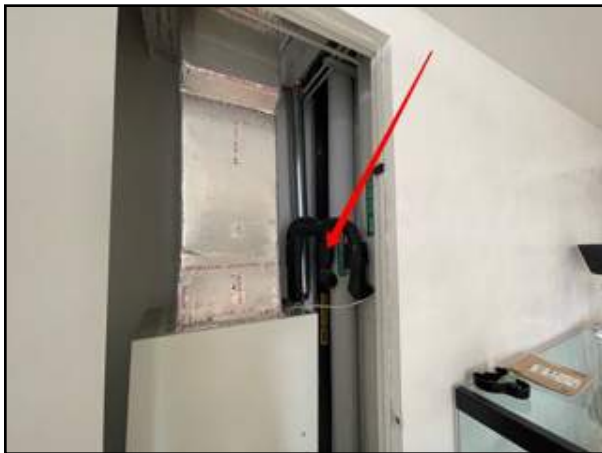
Figure 20-1

Apparent oxidation/rusting & corrosion around incoming & outgoing water valves for water source heat pump HVAC system within A/C closet.

- Apparent condensation/moisture from water valves at the time of inspection. Recommend monitoring these valves to make sure no leaking occurs in the future. If leaking from valves does happen to occur, report to building engineer to have building maintenance repair/replace valves.

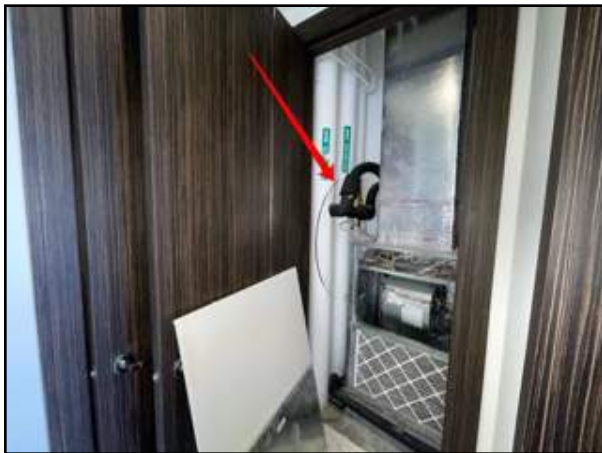
Figure 23-1

Apparent oxidation/rusting & corrosion around incoming & outgoing water valves for water source heat pump HVAC system within A/C closet.

- Apparent condensation/moisture from water valves at the time of inspection. Recommend monitoring these valves to make sure no leaking occurs in the future. If leaking from valves does happen to occur, report to building engineer to have building maintenance repair/replace valves.

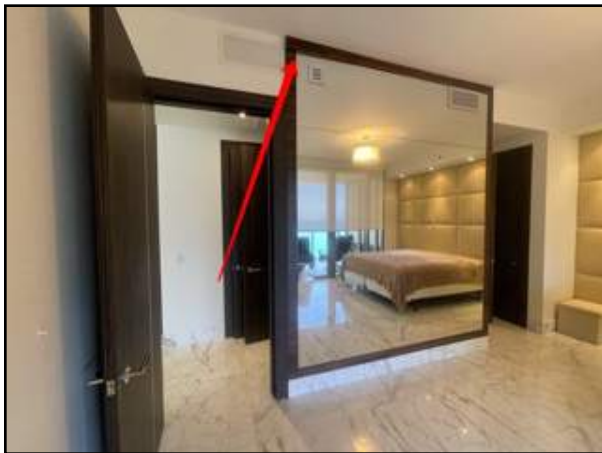
Figure 55-1

Loose wood panel along top of bedroom wall.  
Repair wood paneling. (Estimate: \$100 - \$200)

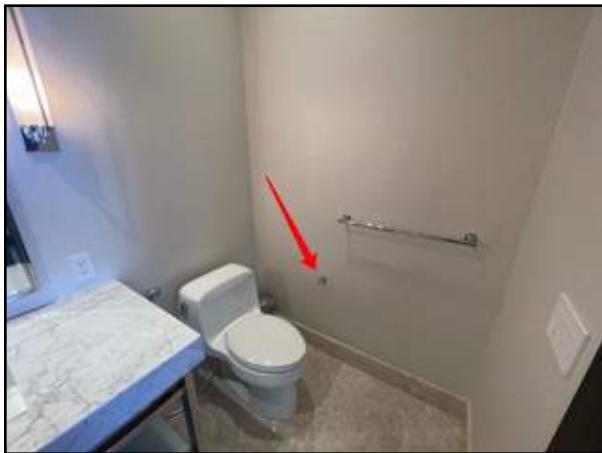
Figure 81-1

Toilet paper holder appears to have been damaged.  
Replace toilet paper holder. (Estimate: \$100 - \$200)

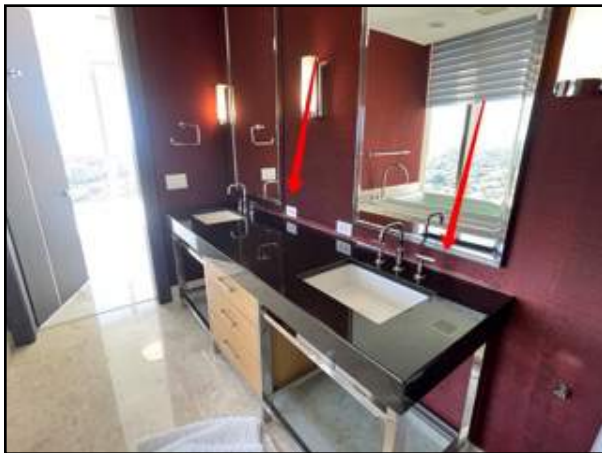
Figure 90-1

Indications of deterioration to wallpaper over vanity fixture.  
Repair/replace wallpaper. (Detailed quotation required)

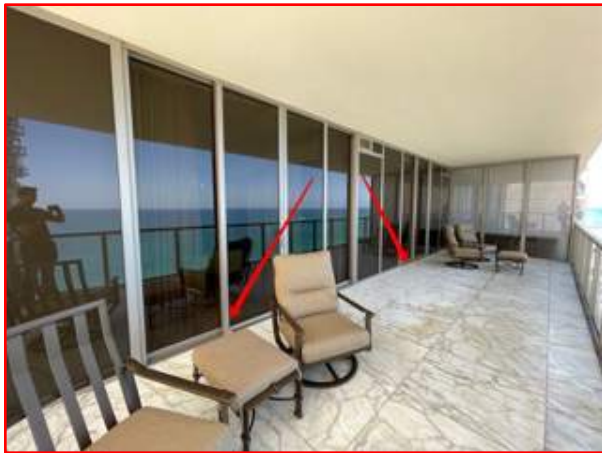
Figure 3-1

Comment 3:  
Sliding glass doors to east facing exterior balconies are stiff on tracks and difficult to open/close.  
Recommend servicing sliding-glass doors by a qualified professional, and cleaning/re-greasing tracks & rollers to sliding glass door for proper operation.  
(Estimate: \$1,500 - \$2,500)

Recommend servicing sliding-glass doors by a qualified professional, and cleaning/re-greasing tracks & rollers to sliding glass door for proper operation. (Estimate: \$1,500 - \$2,500)

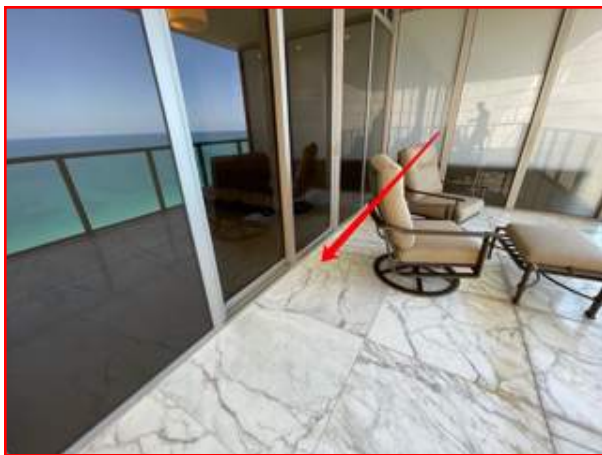
Figure 6-1

3) Comment 6: Cracked/broken flooring tile along east balcony outside of bedroom #2. Replace broken flooring tile along exterior balcony. (Estimate: \$200 - \$400)

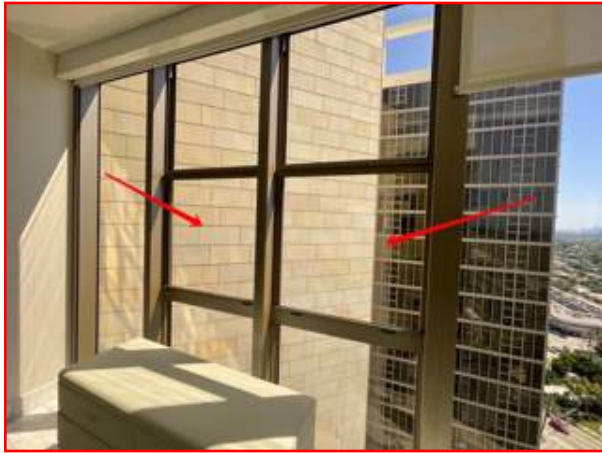
Figure 51-1

19) Comment 51: Master bedroom windows do not open/close properly due to broken spring-loaded tracks on the side of windows.

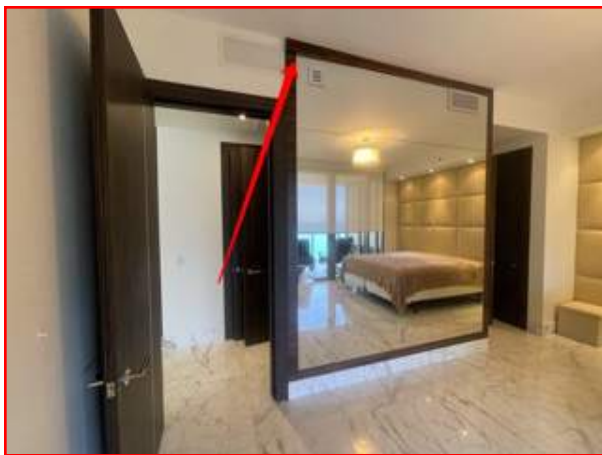
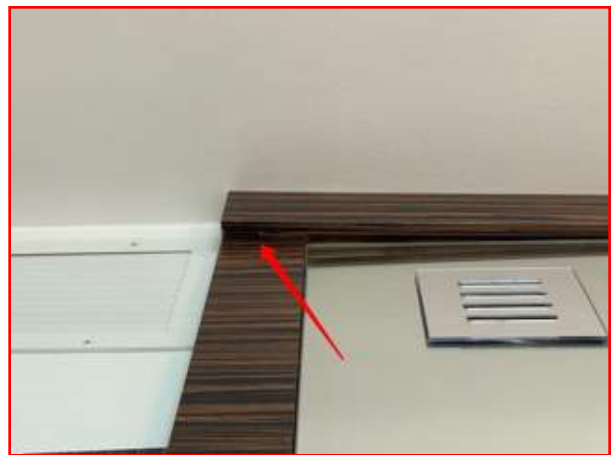
22) Comment 55: Loose wood panel along top of bedroom wall.  
Repair wood paneling. (Estimate: \$100 - \$200)

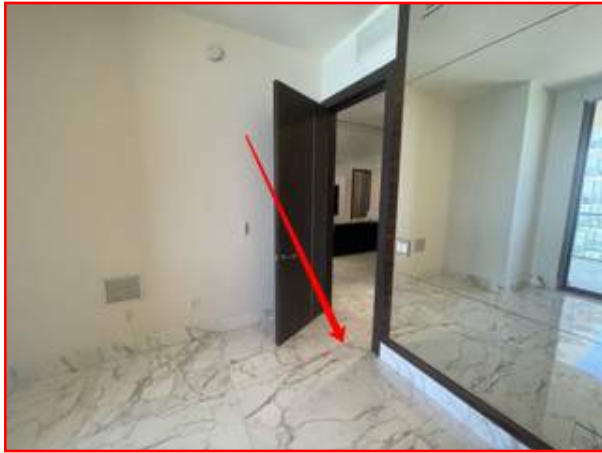
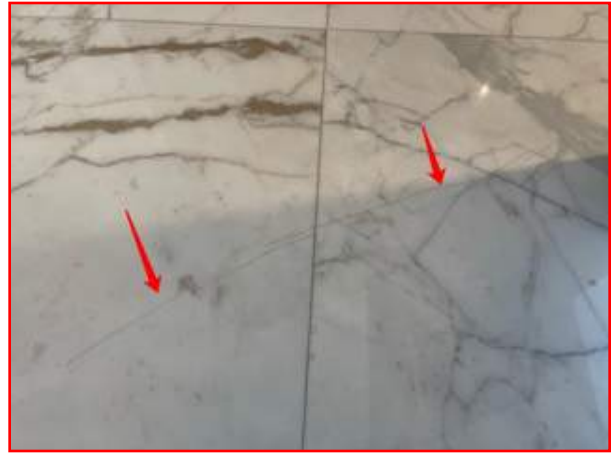
23) Comment 56: Scratched/scuffed flooring along entryway into bedroom #2.  
Recommend buffing & polishing tile flooring as necessary to remove scratching & scuffing. (Estimate: \$200 - \$300)

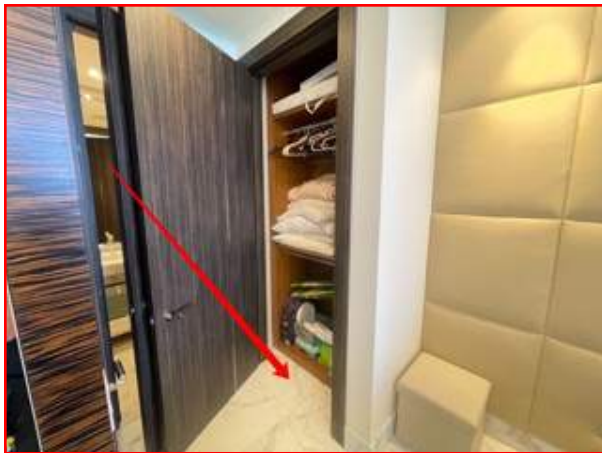
Figure 57-1

24) Comment 57: Apparent deterioration to caulking/seal along base of bedroom closet & flooring.

Recommend repairing closet door & caulking along base of closet & flooring. (Estimate: \$100 - \$250)

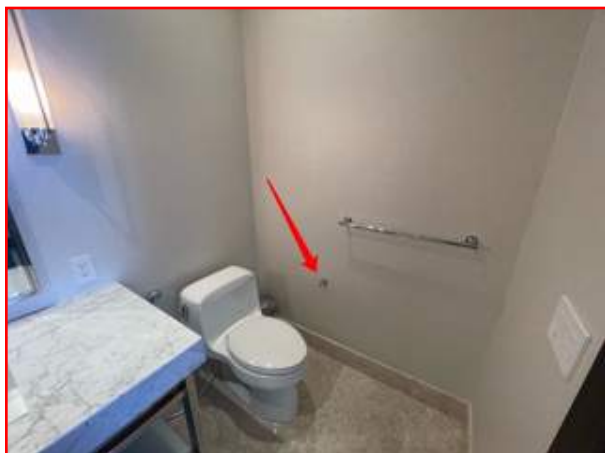
Figure 81-1

38) Comment 81: Toilet paper holder appears to have been damaged.  
Replace toilet paper holder. (Estimate: \$100 - \$200)
