Home Inspection Report

5191 Pinetree Dr
Miami Beach, FL 33141

Inspected By: Tracy Woodard

Home Pro Miami
(786) 558-5286
www.homepromiami.com
info@homepromiami.com

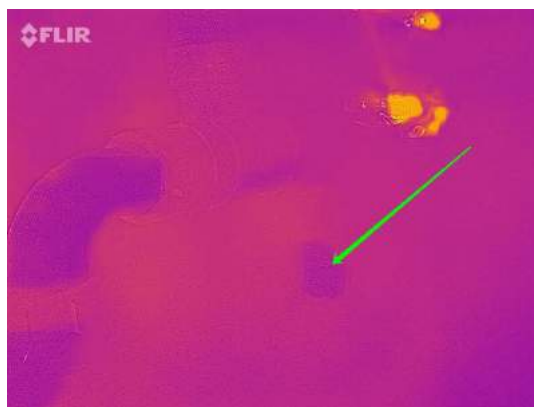
Flexible supply hose to summer kitchen sink faucet fixture appears to be leaking below sink.

Recommend repair or replacement to faucet fixture to prevent further leaking below sink & water damage. (Estimate: \$100 - \$250)

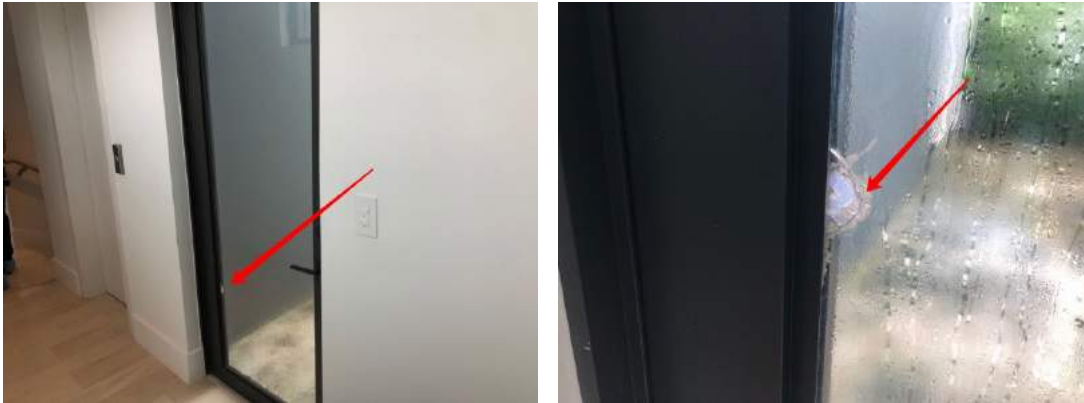
Damaged glazing to 3rd leve hallway exterior door to rooftop terrace.

Replace window pane within door or replace door. (Estimate: \$1,000 - \$3,000)

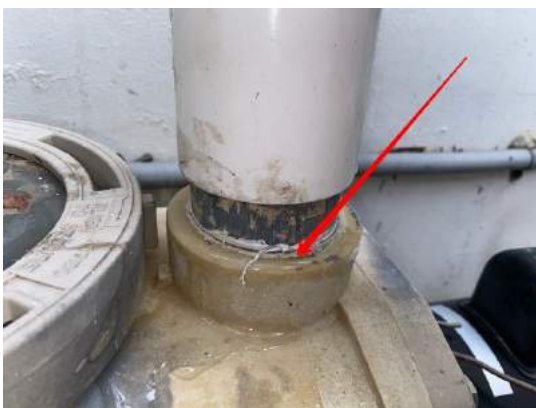
Comment 22
Deficiency

- Leaking pipe connection to pump at the time of inspection.

Recommend further evaluation by a licensed professional & repair accordingly. (Estimate: \$100 - \$250)

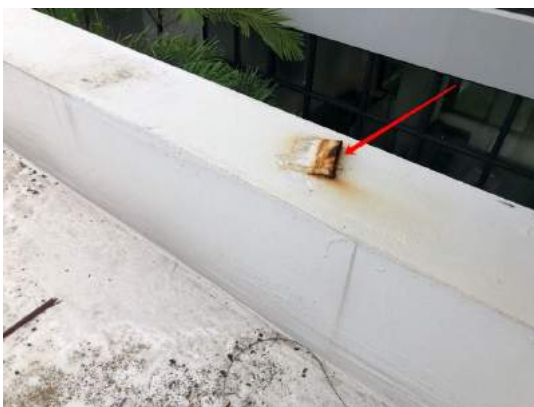
- Bubbling is an indication of moisture intrusion below liquid roof sealant around parapet wall which has expanded with heat.

- Paintbrush left along top of parapet wall from application of liquid roof sealant is currently sealed to crown of wall & oxidizing along wall.

Recommend repairing liquid roofing sealant to prevent possible leaking & water damage. (Estimate: \$1,000 - \$2,500)

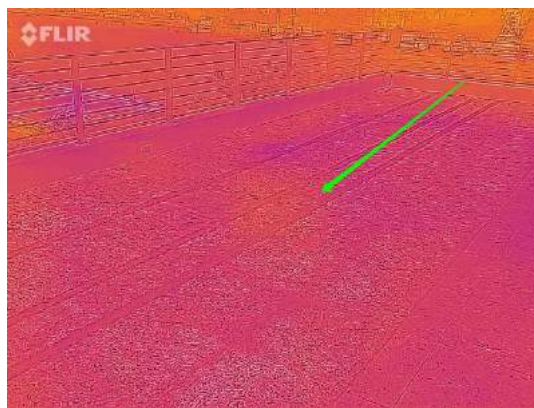
Comment 33

- South side of terrace appears to have been recently replaced.
- Terrace appears to be properly graded for adequate drainage to roof drains.
- Active leaking from roof terrace detected over 3rd level master bathroom.

Recommend further evaluation of leaking by a licensed roofing contractor & repair accordingly. (Detailed quotation required)

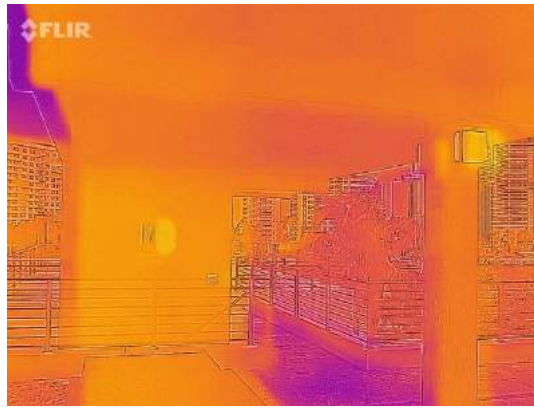
Comment 38
Deficiency

West side roof terrace.

Recommend properly repairing parapet wall to prevent potential moisture from roof. (Estimate: \$250 - \$500)

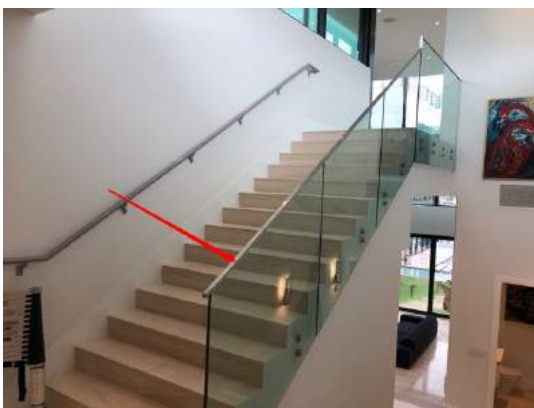
Loose handrail cap to glass staircase railing.

Properly secure cap to glass staircase railing. (Estimate: \$100 - \$200)

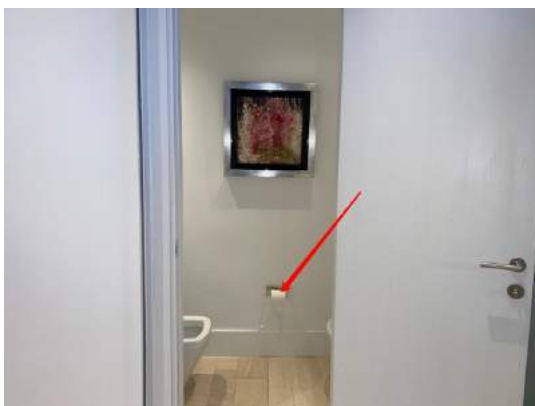
Toilet paper mount currently loose from wall.

Repair/re-secure toilet paper mount on wall. (Estimate: \$25 - \$50)

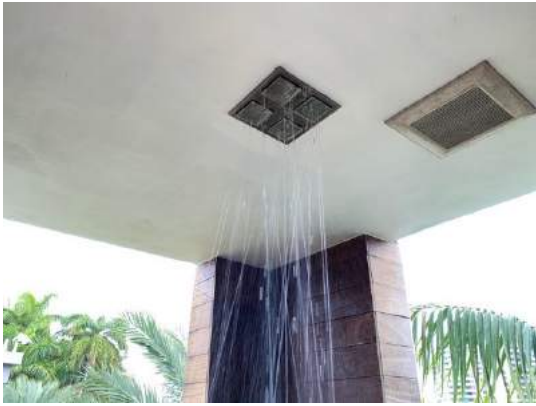
Exterior shower rain-shower shower head not functioning properly & spraying water everywhere.

Recommend repairing or replacing rain-shower shower head. (Estimate: \$50 - \$250)

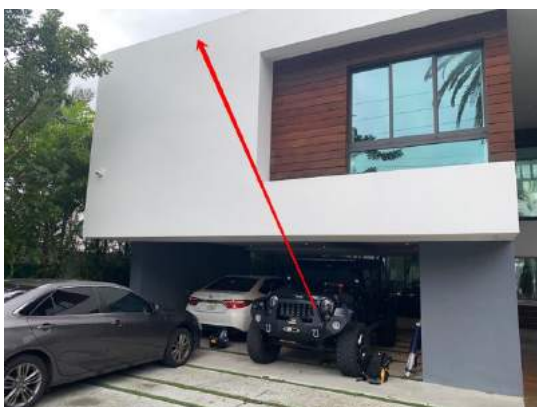
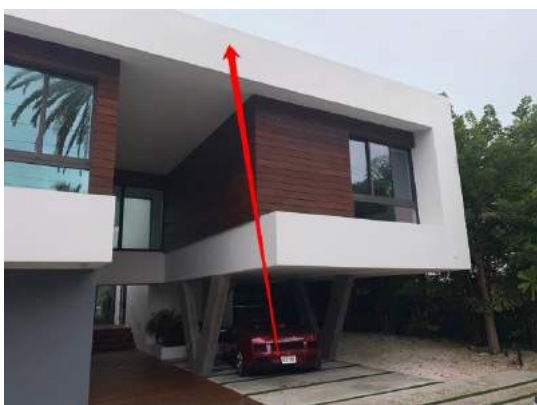
Comment 9

- Indications of moisture intrusion below paint & waterproofing.

Recommend having a licensed professional re-finish & re-paint/waterproof exterior stucco siding around exterior of property. (Estimate: \$5,000 - \$10,000)
