Condo Inspection Report

9705 Collins Ave
Unit 2204N/2205N
Bal Harbour, FL 33154

Inspected On Tue, Mar 29, 2022 at 1:00 PM

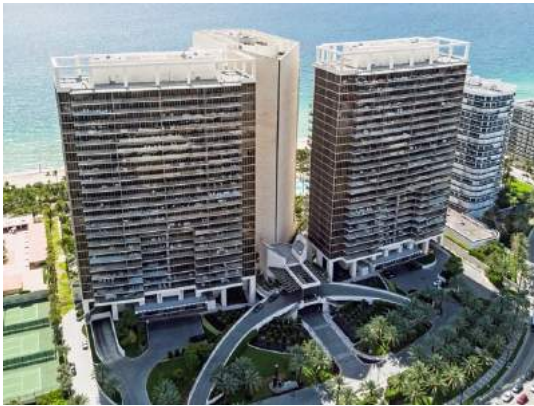
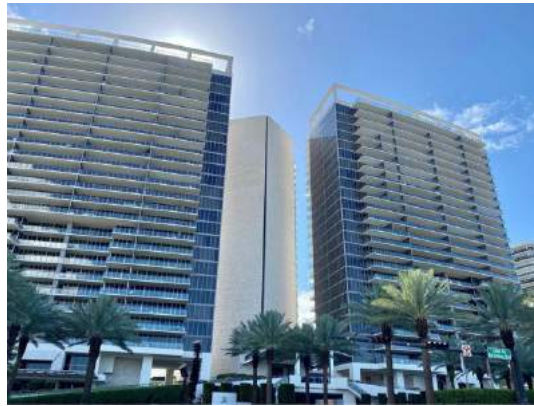
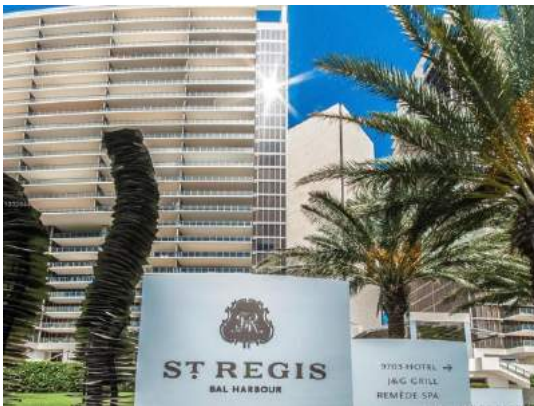
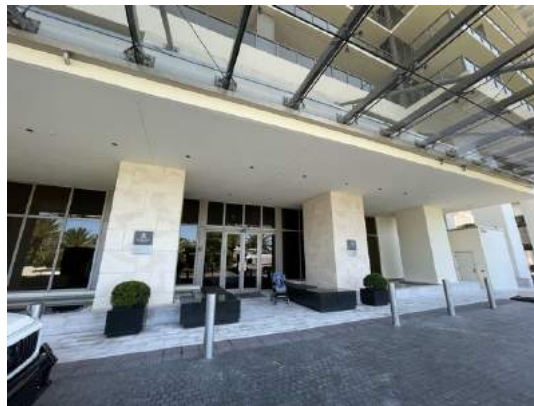
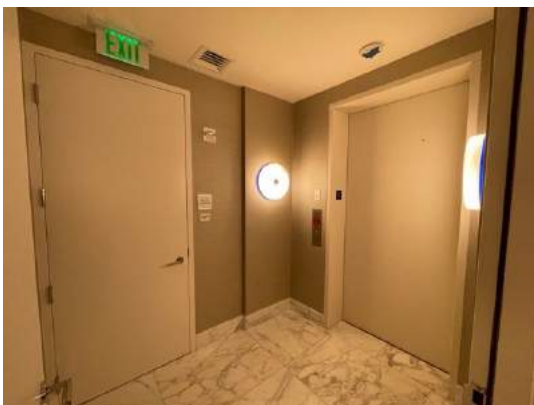
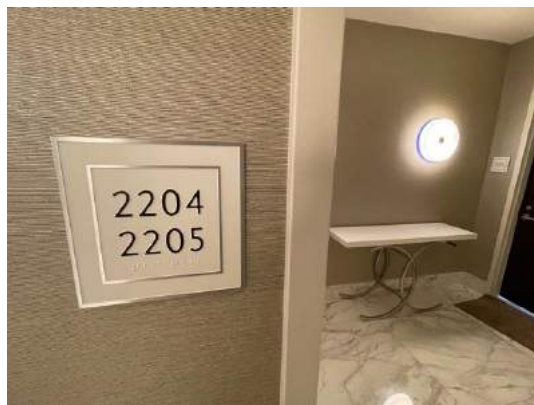
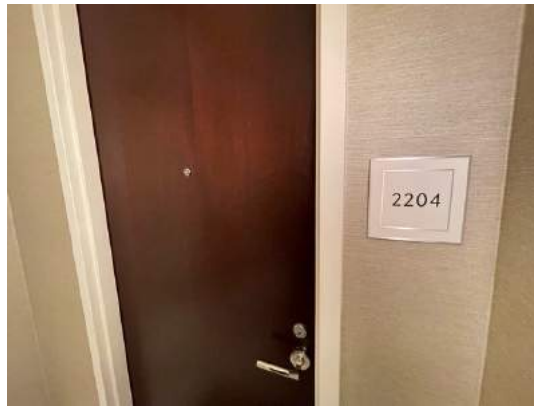
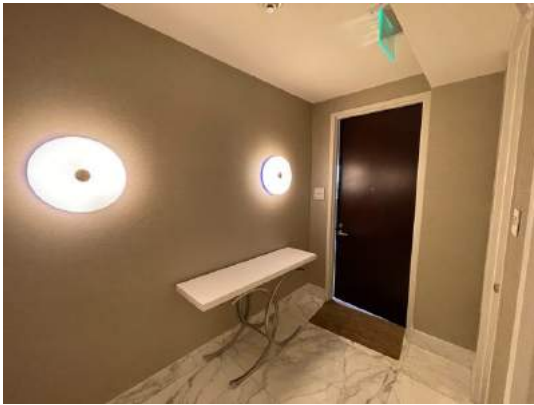
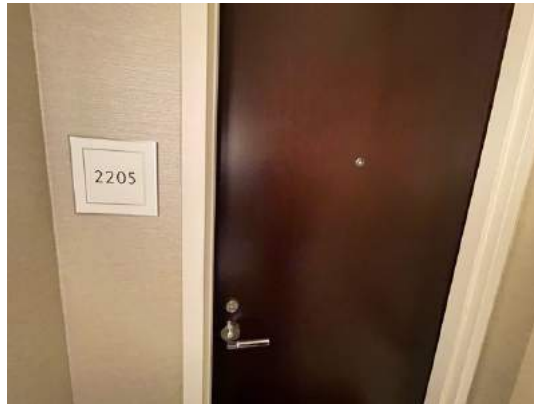
Comment 1
Information

Exterior/Site.

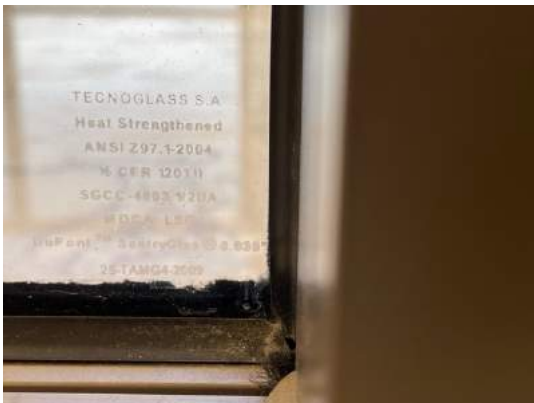
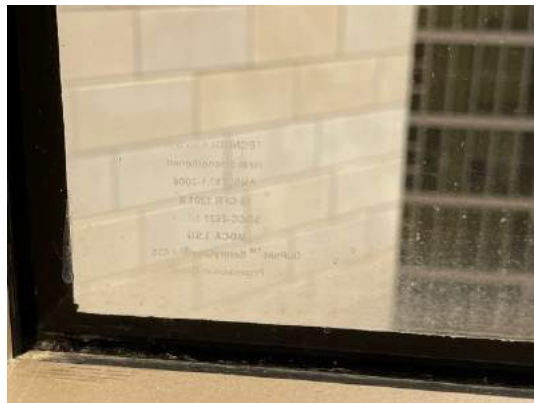
**Comment 2
Information**

Wind Mitigation / Storm Protection.

- Impact Windows & Doors

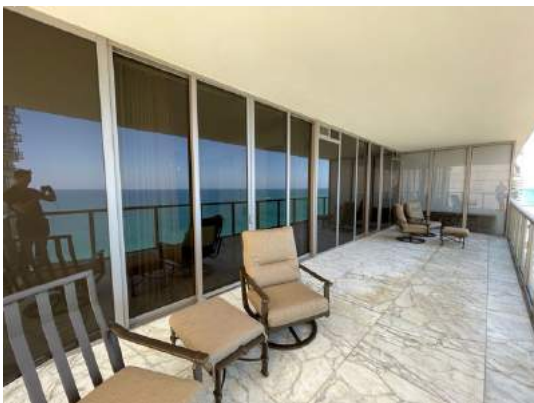
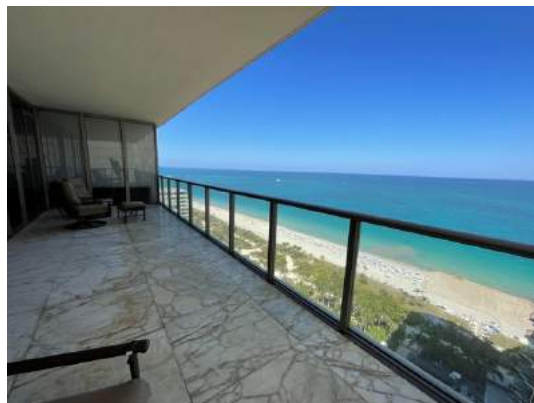
Comment 4
Information

East balcony.

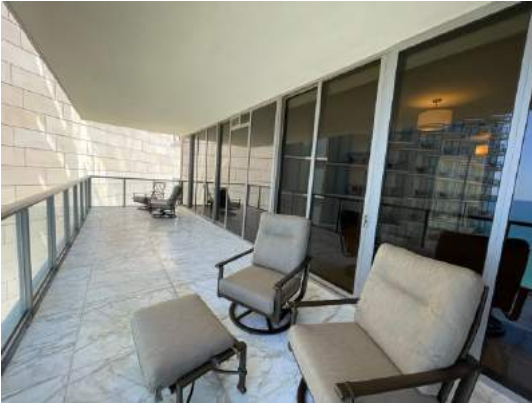
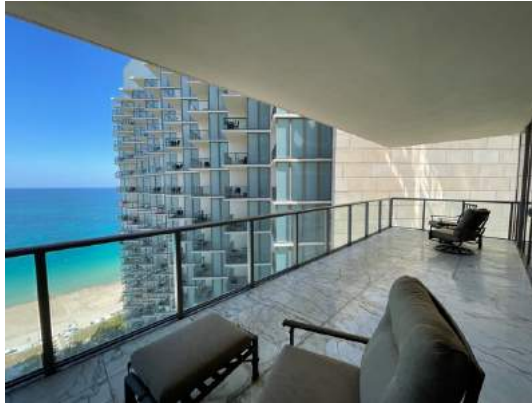
Comment 5

- Estimate discoloration may be natural texture & porous nature of marble stone tiling due to worn seal as well as moisture intrusion below tile flooring.

Repair/Replace or re-polish/re-seal damaged or discolored tile flooring along exterior balcony as desired. (Estimate: \$2,000 - \$5,000)

If tile flooring is unable to be matched, complete replacement of flooring may be necessary. (Detailed quotation required)

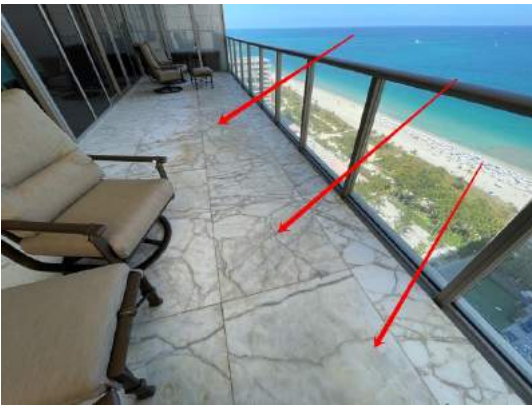
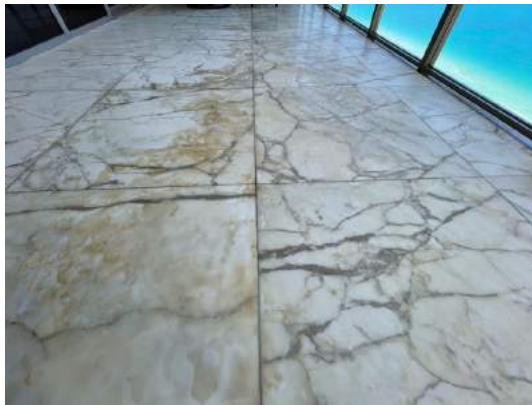
Comment 6

Cracked/broken flooring tile along east balcony outside of bedroom #2.

Replace broken flooring tile along exterior balcony. (Estimate: \$200 - \$400)

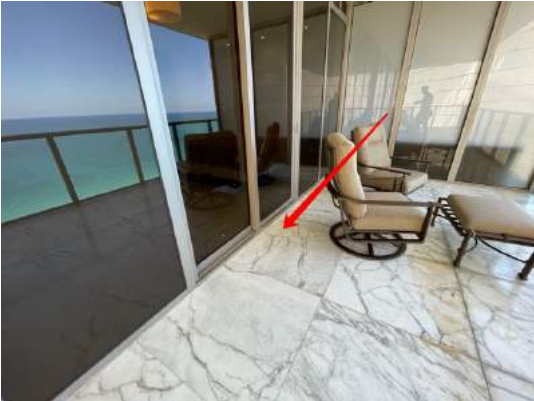
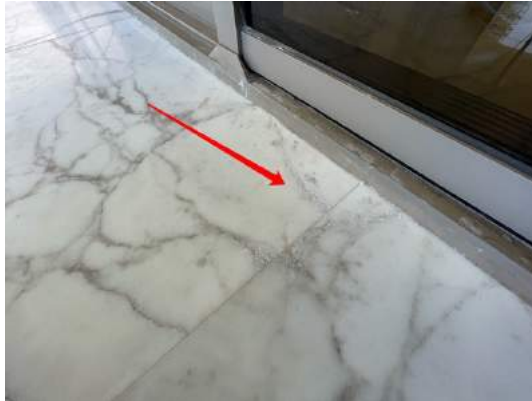
**Comment 7
Information**

Master bedroom/ dining are balcony.

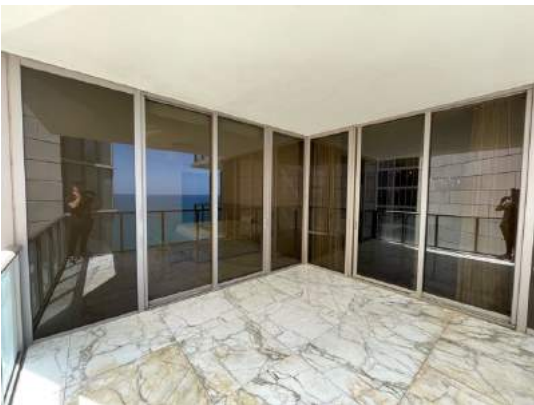
**Comment 8
Deficiency**

Exterior balcony tile flooring tiles throughout interior of unit appear to be discolored at the time of inspection.

- Estimate discoloration may be natural texture & porous nature of marble stone tiling due to worn seal as well as moisture intrusion below tile flooring.

Repair/Replace or re-polish/re-seal damaged or discolored tile flooring along exterior balcony as desired. (Estimate: \$2,000 - \$5,000)

If tile flooring is unable to be matched, complete replacement of flooring may be necessary. (Detailed quotation required)

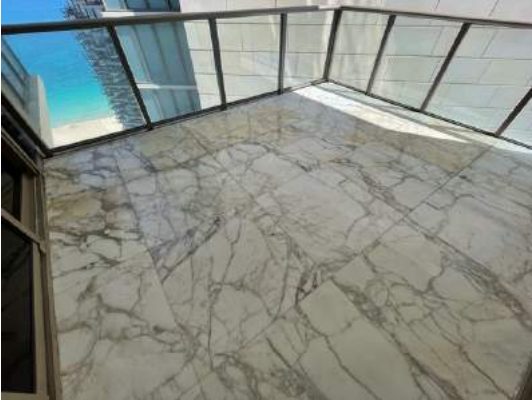
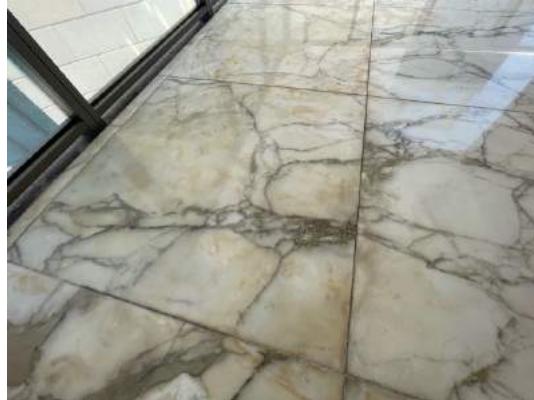
**Comment 9
Information**

West balcony.

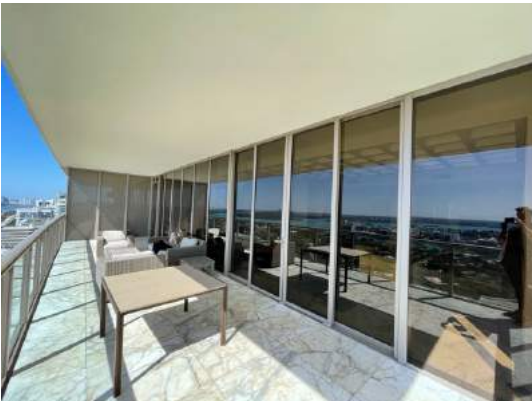
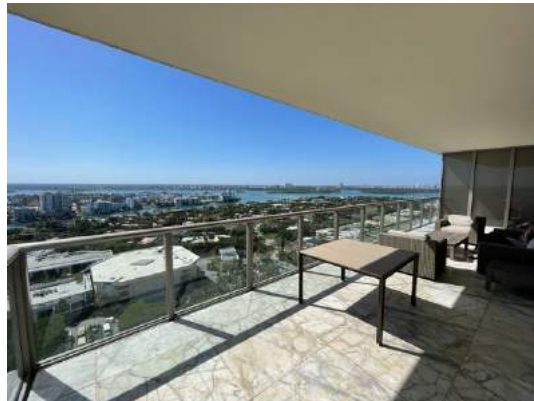
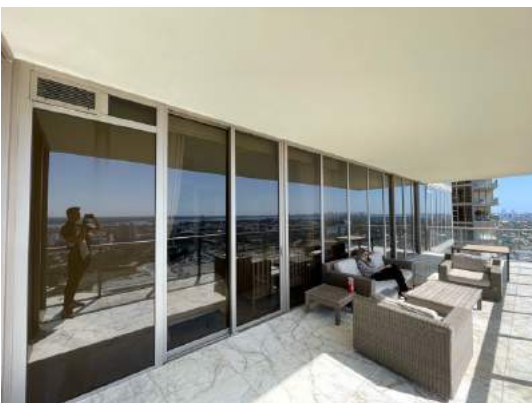
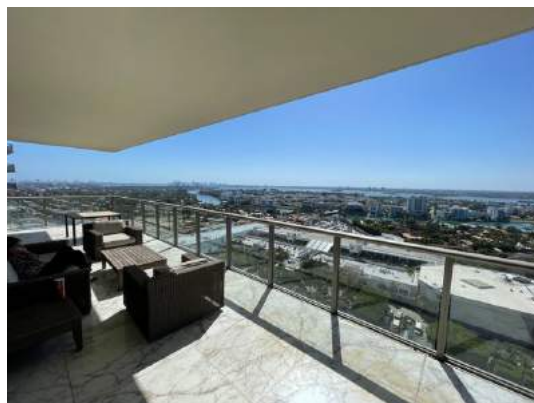
**Comment 10
Deficiency**

Exterior balcony tile flooring tiles throughout interior of unit appear to be discolored at the time of inspection.

- Estimate discoloration may be natural texture & porous nature of marble stone tiling due to worn seal as well as moisture intrusion below tile flooring.

Repair/Replace or re-polish/re-seal damaged or discolored tile flooring along exterior balcony as desired. (Estimate: \$2,000 - \$5,000)

If tile flooring is unable to be matched, complete replacement of flooring may be necessary. (Detailed quotation required)

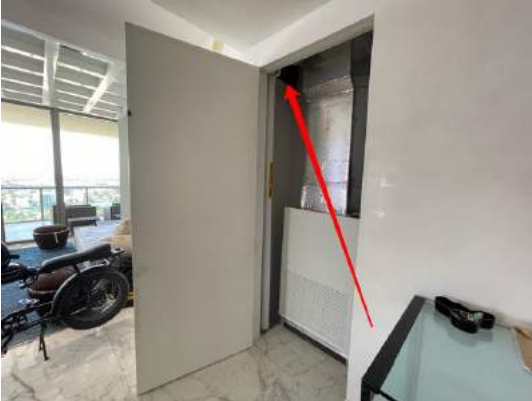
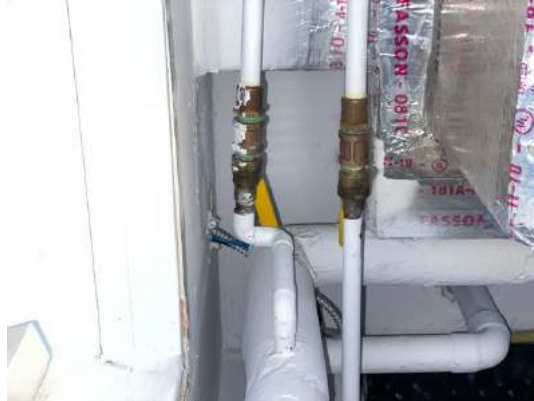
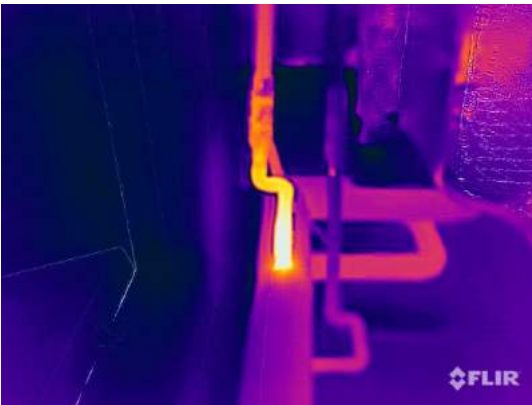
Comment 11
Information

Main water shut-off valves (hot & cold water lines) for west side of unit are located in west side of property within A/C closet above to air handler unit.

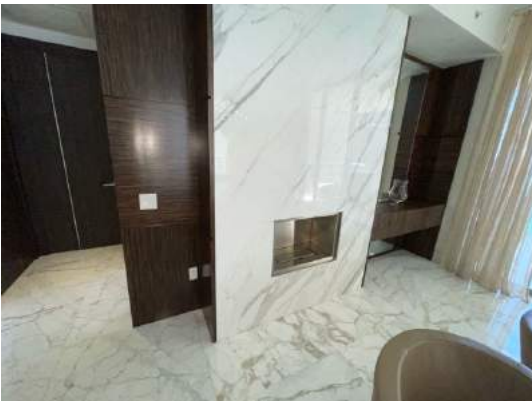
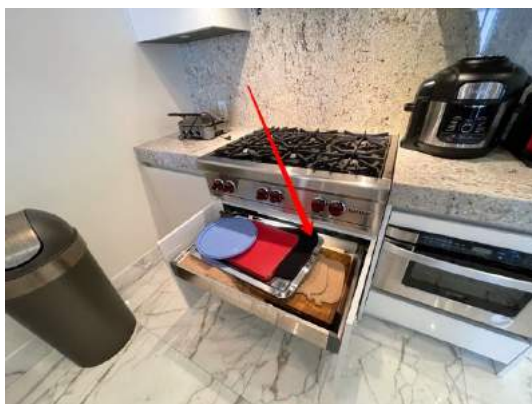
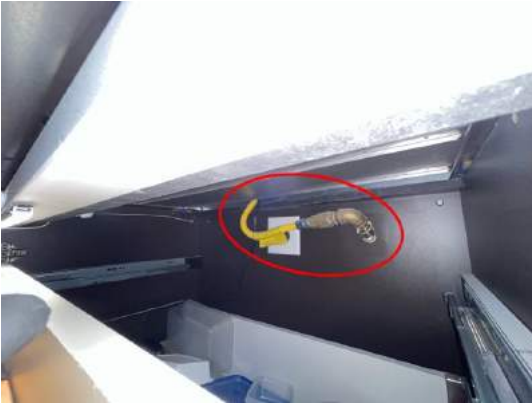
Deficiency

- Individual gas shut-off valves located below each applicable appliance.
- No shut-off valve appears to be installed below cooktop.

Recommend having a licensed professional properly install fuel shut-off valve to gas supply line below cooktop.
(Estimate: \$200 - \$400)

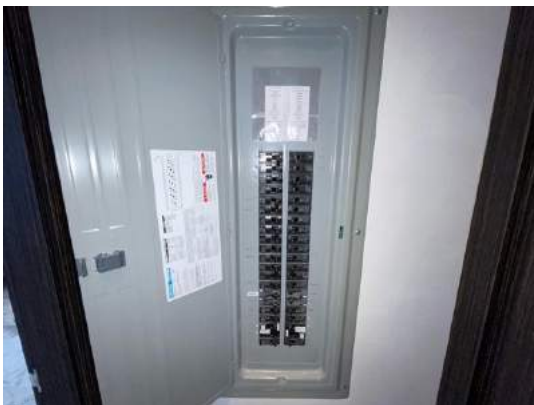
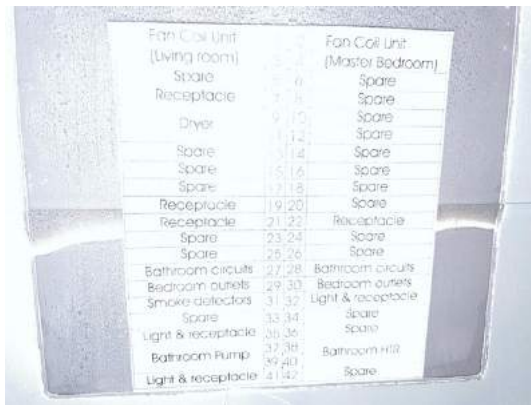
Main distribution panel A (110 AMPs) located within west bedroom hallway.

- Distribution panel, circuit breakers, and branch wiring appear in good & working condition at the time of inspection.

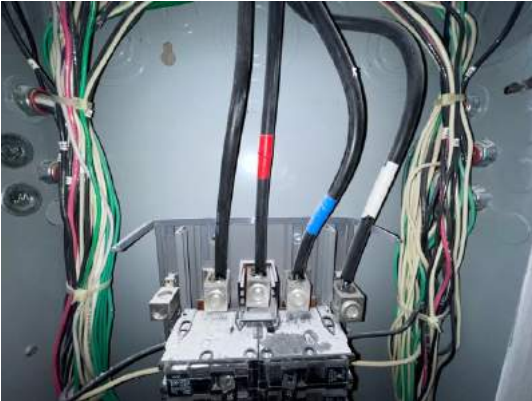
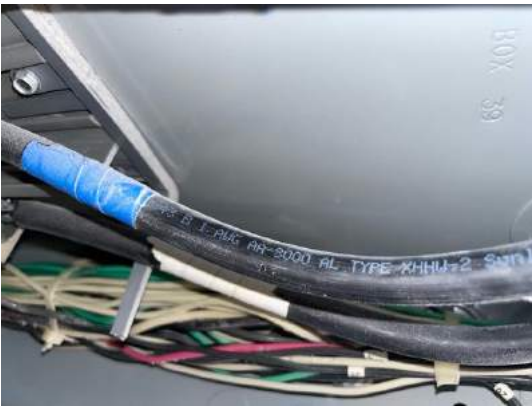
Electrical service entrance conductors (3 Phase) are in good & working condition within main distribution panel A.

- Electrical service is properly grounded in main distribution panel.

- Main service conductors are currently #1 AWG aluminum lines adequate for service up to 110 AMPs.

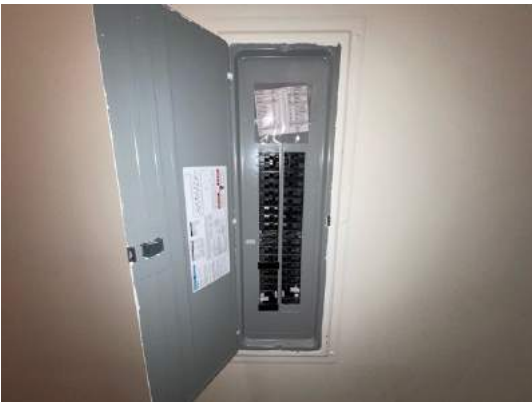
**Comment 17
Information**

Main distribution panel B (110 AMPs) located within master bedroom closet.

- Distribution panel, circuit breakers, and branch wiring appear in good & working condition at the time of inspection.

Electrical service entrance conductors (3 Phase) are in good & working condition within main distribution panel B.

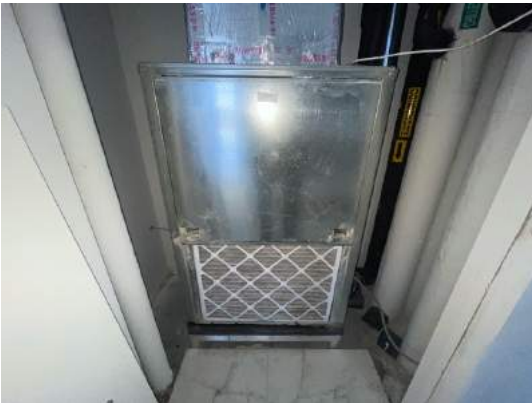
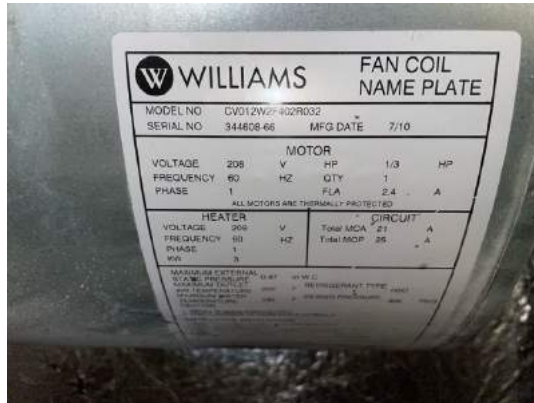
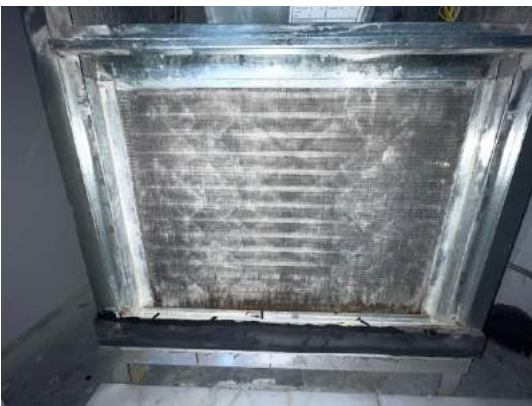
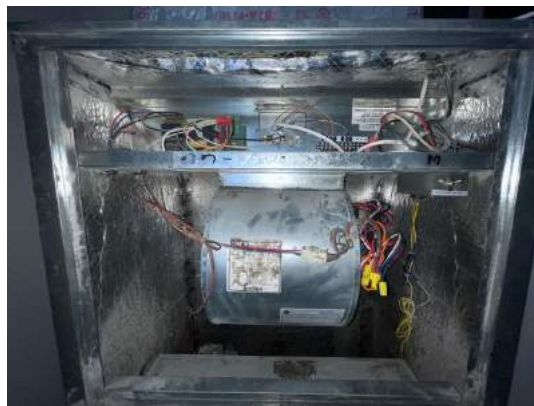
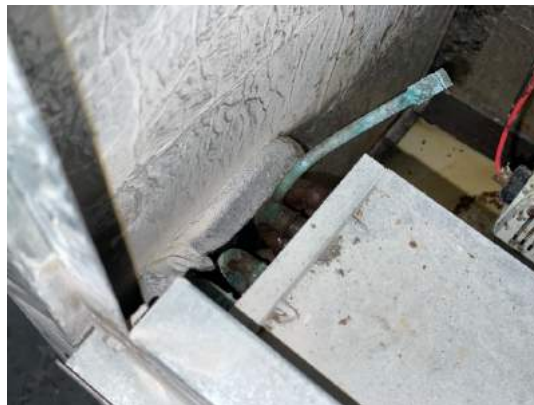
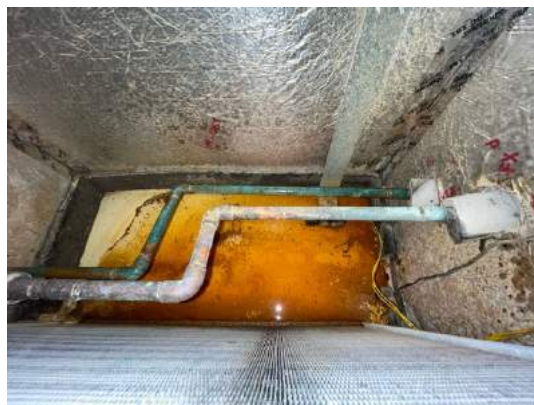
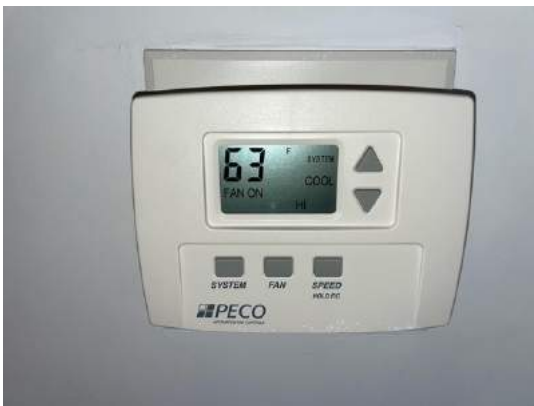
- HVAC system appears in good & working condition at the time of inspection.
- A/C radiator & coils appear in good condition at the time of inspection.
- Minor debris build up along exterior of radiator.

Recommend having HVAC system serviced/cleaned periodically by a licensed HVAC technician for better maintenance.

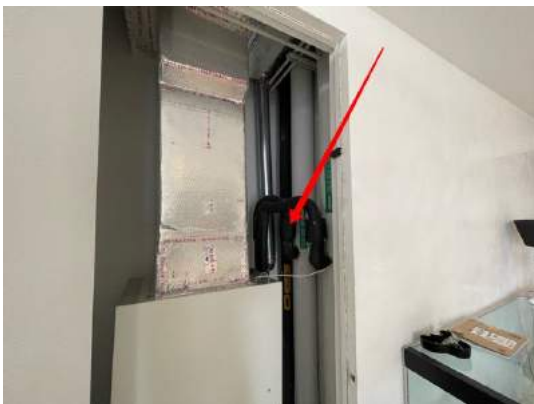
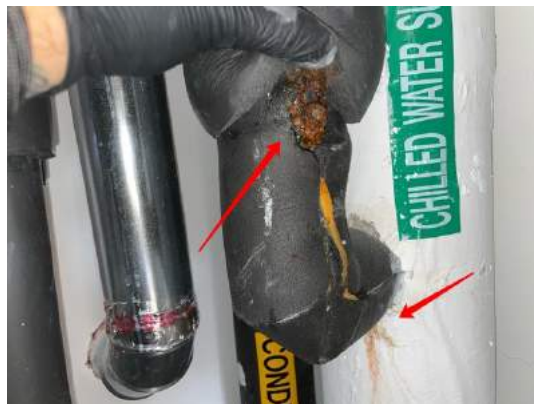
Comment 20
Deficiency

Apparent oxidation/rusting & corrosion around incoming & outgoing water valves for water source heat pump HVAC system within A/C closet.

- Apparent condensation/moisture from water valves at the time of inspection.

Recommend monitoring these valves to make sure no leaking occurs in the future. If leaking from valves does happen to occur, report to building engineer to have building maintenance repair/replace valves.

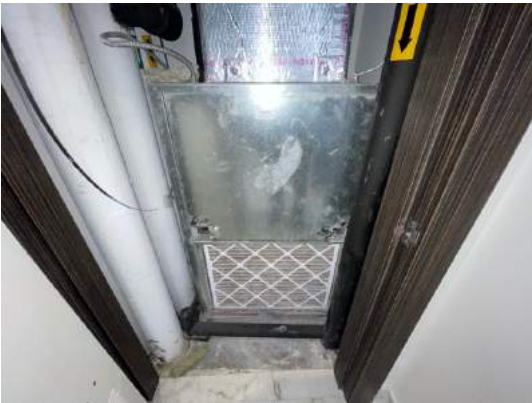
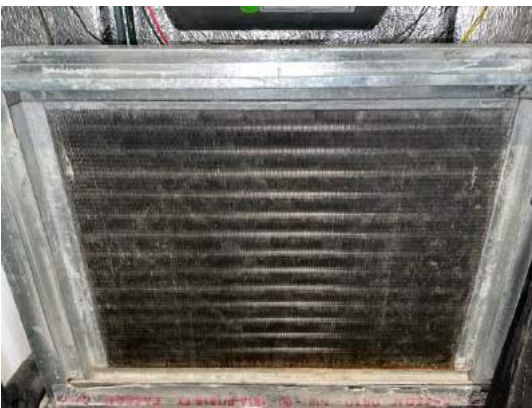
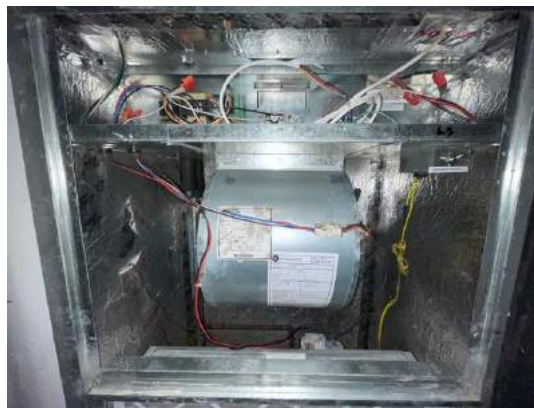
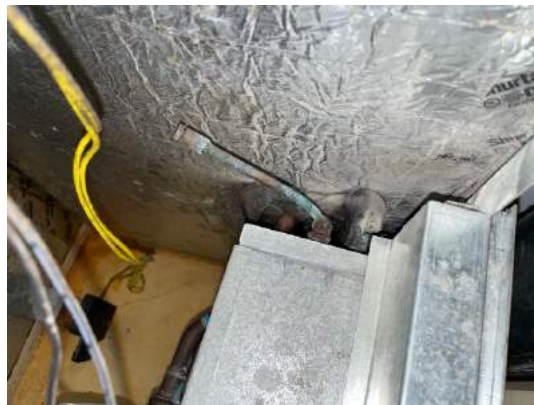
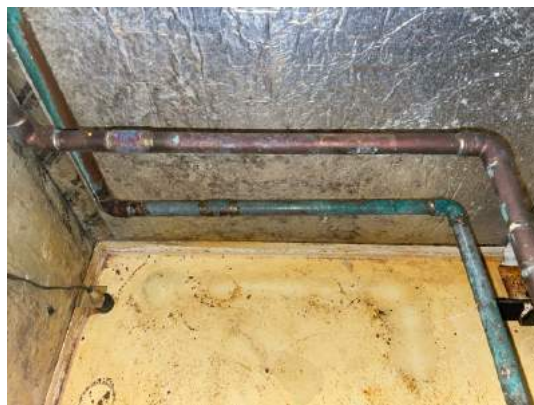
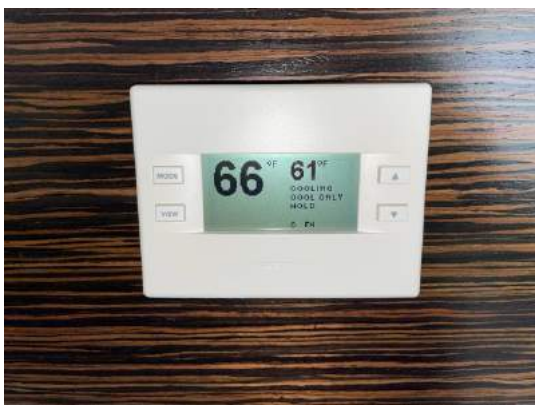
- HVAC system appears in good & working condition at the time of inspection.
- A/C radiator & coils appear in good condition at the time of inspection.
- Minor debris build up along exterior of radiator.

Recommend having HVAC system serviced/cleaned periodically by a licensed HVAC technician for better maintenance.

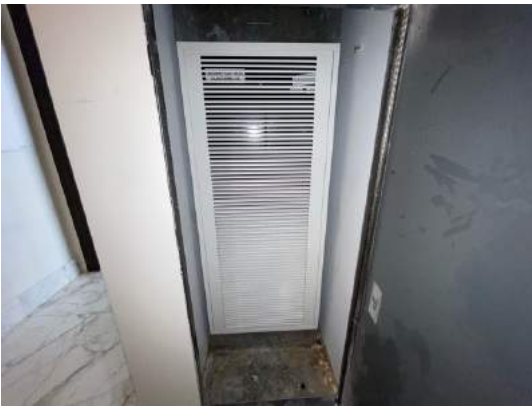
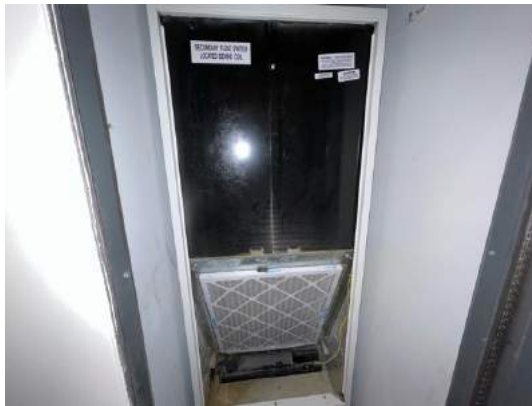
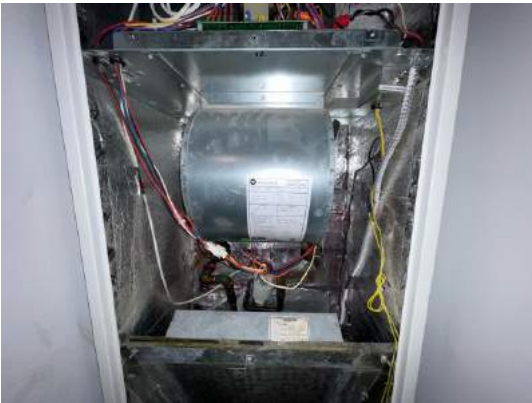
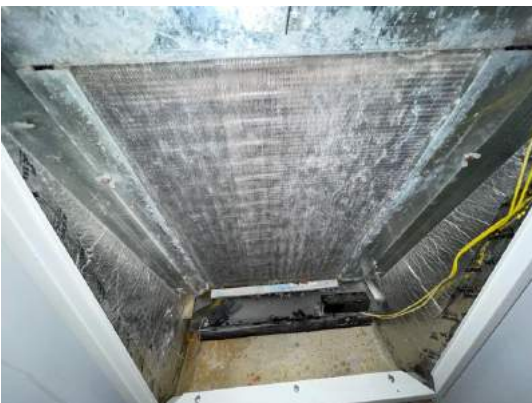
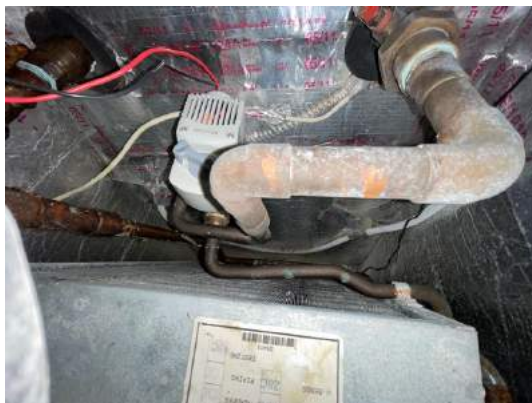
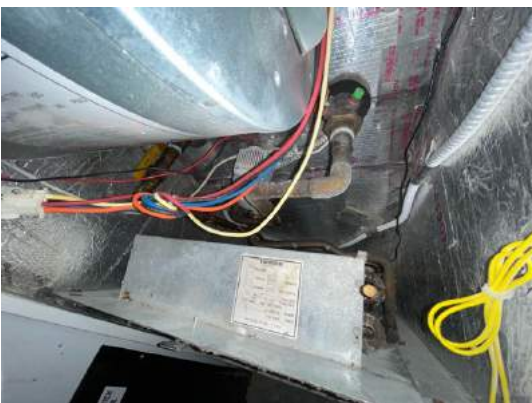
- HVAC system appears in good & working condition at the time of inspection.
- A/C radiator & coils appear in good condition at the time of inspection.
- Minor debris build up along exterior of radiator.

Recommend having HVAC system serviced/cleaned periodically by a licensed HVAC technician for better maintenance.

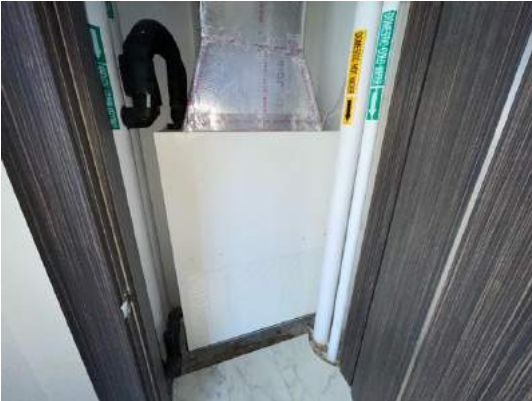
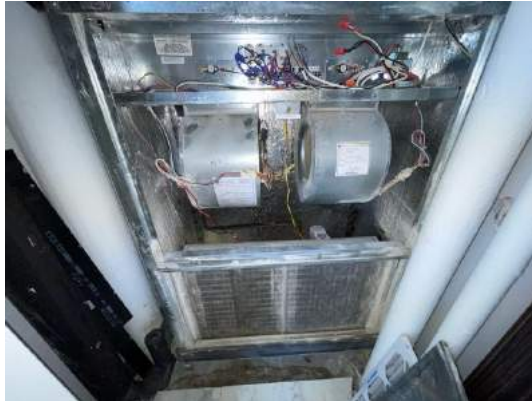
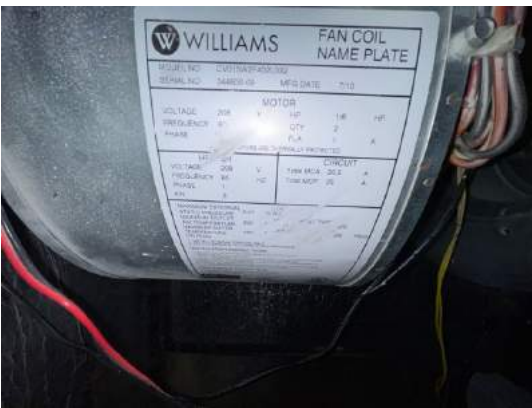
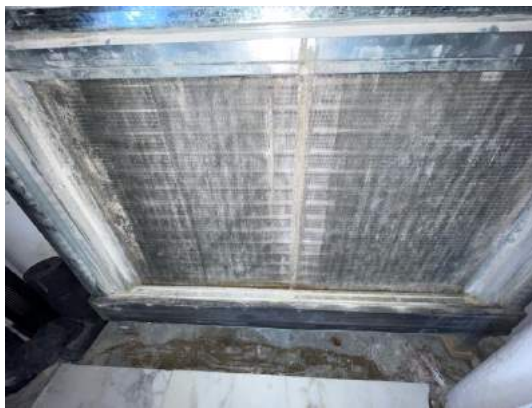
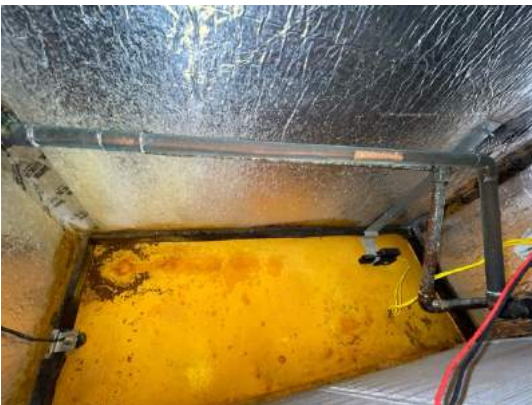
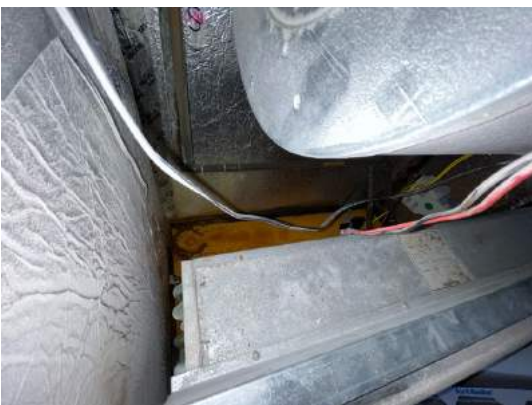
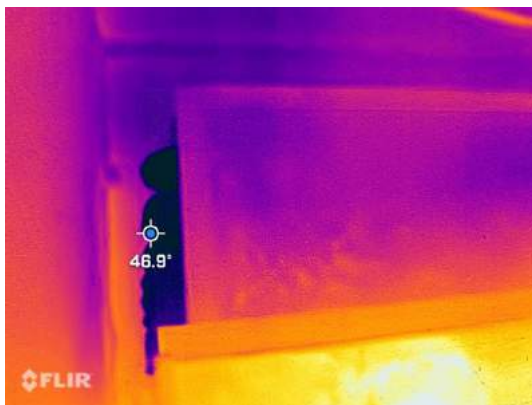
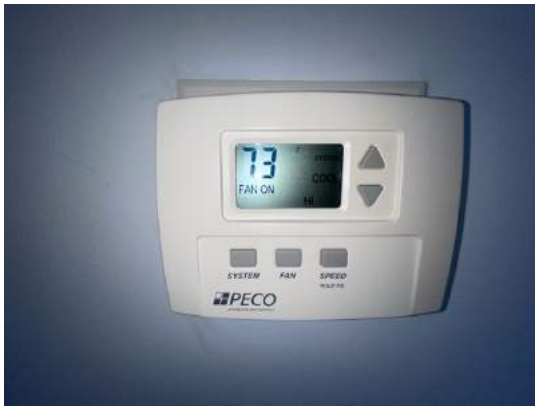
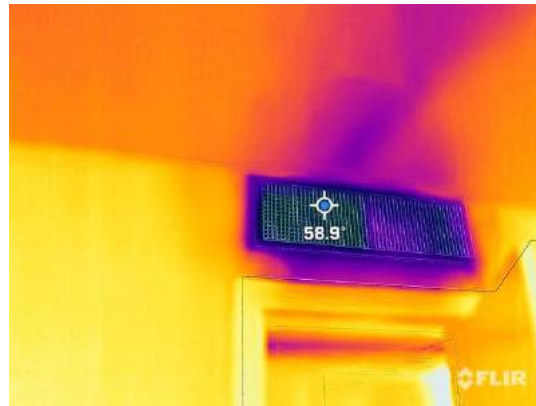
- HVAC system appears in good & working condition at the time of inspection.
- A/C radiator & coils appear in good condition at the time of inspection.
- Minor debris build up along exterior of radiator.

Recommend having HVAC systems serviced/cleaned periodically by a licensed HVAC technician for better maintenance.

HVAC systems over 10 years old should be checked, cleaned and serviced yearly by a licensed HVAC technician.

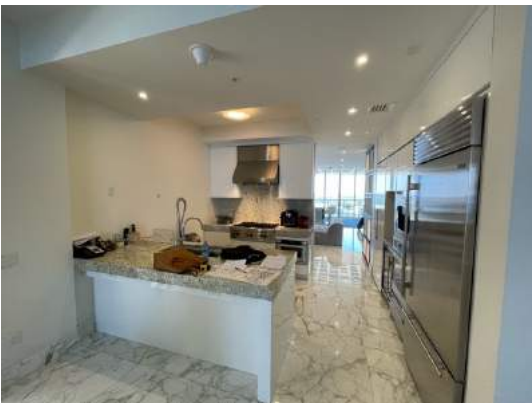
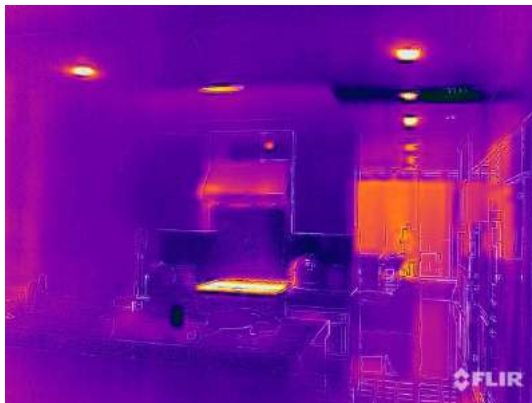
Comment 27 Information

Kitchen.

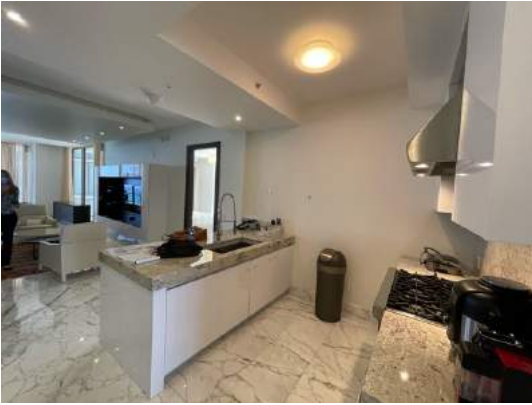
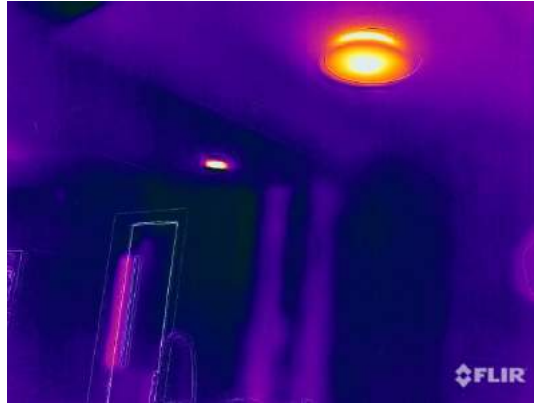
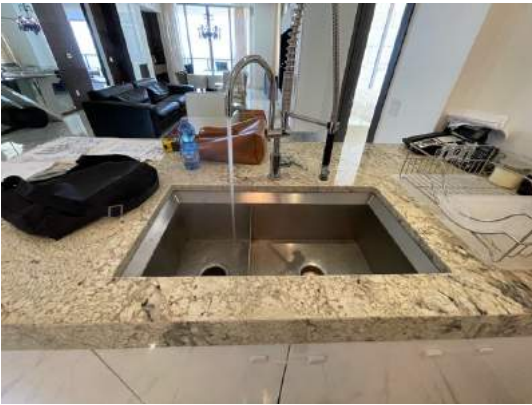
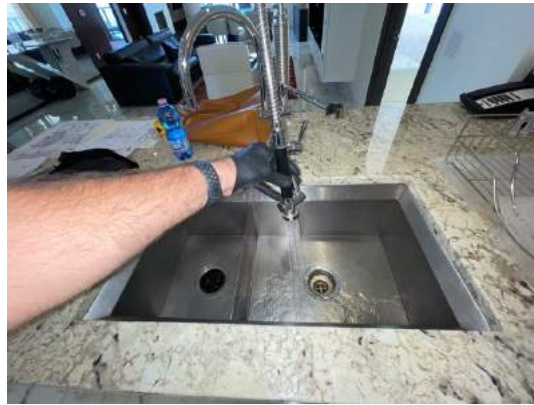
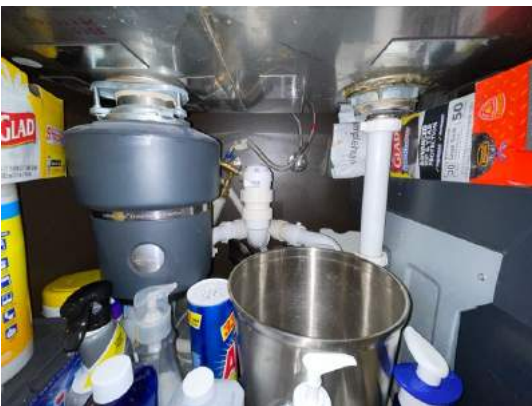
Comment 28

Deficiency

- Circuit is live when tested.
- Estimate light bulbs are burnt out.

Replace light bulbs to kitchen lights fixtures. (Estimate: \$10 - \$25)

If lighting fixture(s) continue not to function, recommend having a licensed electrician further evaluate fixtures & circuit.
(Estimate: \$200 - \$500)

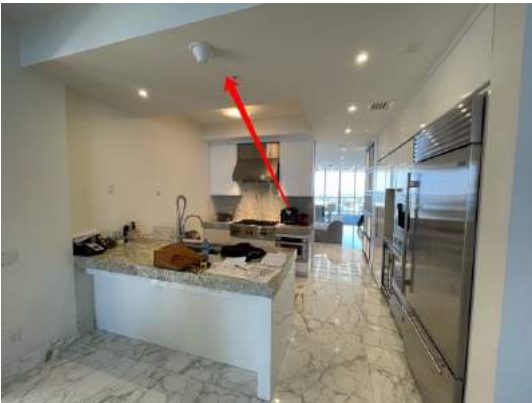
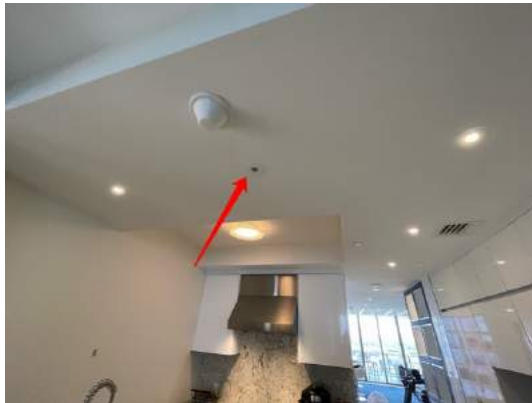
Comment 29
Deficiency

Recessed light below kitchen cabinetry not functioning at the time of inspection.

- Circuit is live when tested.
- Estimate light bulbs are burnt out.

Replace light bulb to cabinetry light fixtures. (Estimate: \$25 - \$50)

If lighting fixture(s) continue not to function, recommend having a licensed electrician further evaluate fixtures & circuit.
(Estimate: \$200 - \$500)

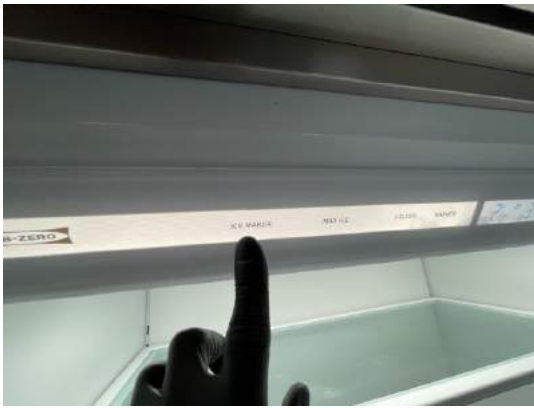
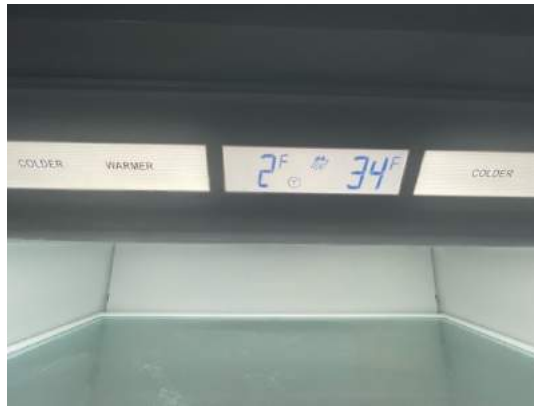
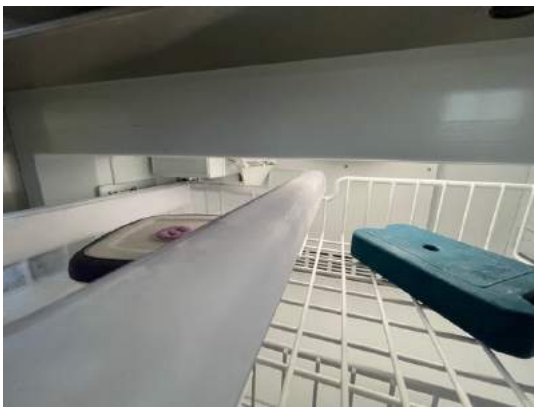
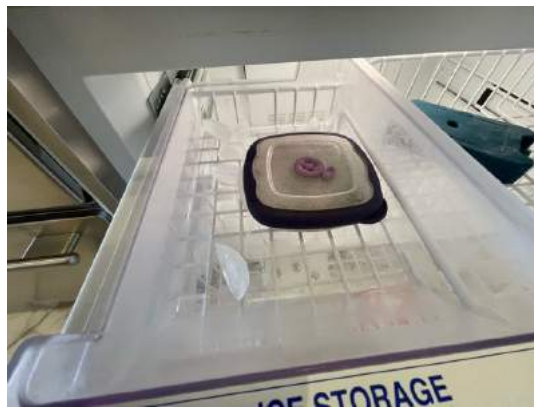
Comment 32
Information

Range cooktop functioning properly.

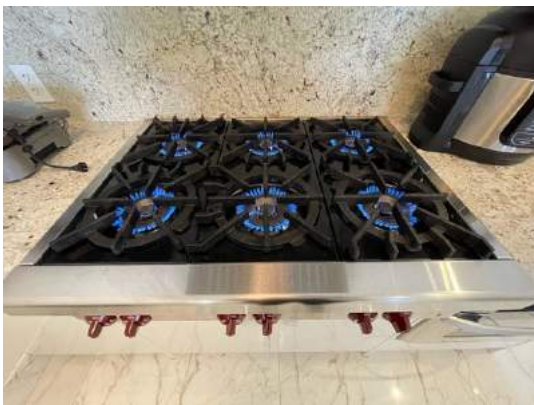
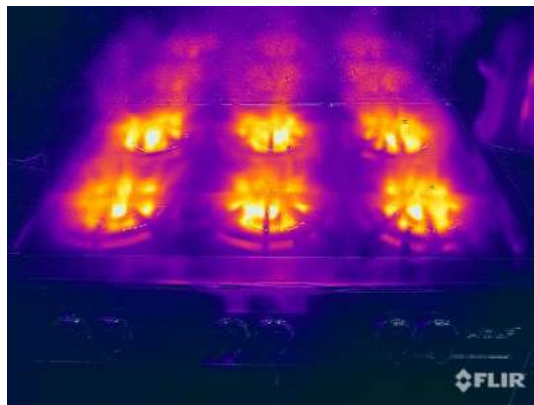
Comment 33
Deficiency

Range hood over cooktop functioning properly at the time of inspection.

- Fan knob damaged.

Repair/replace hood fan knob. (Estimate: \$25 - \$50)

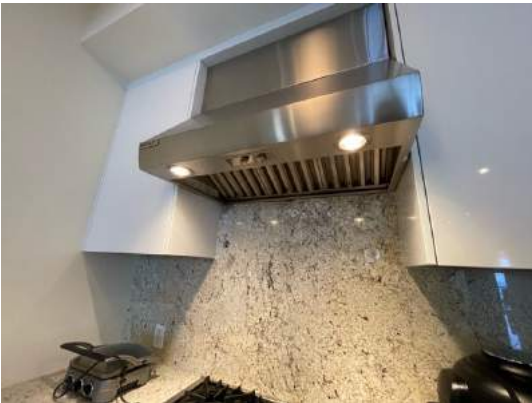
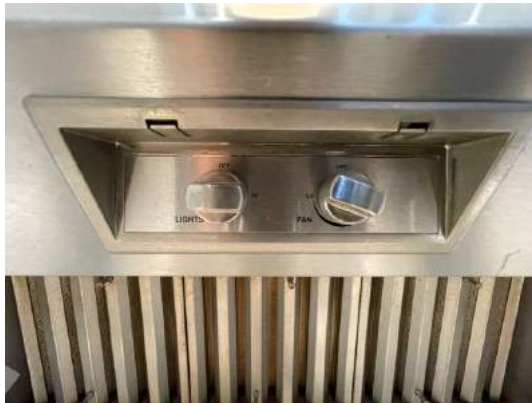
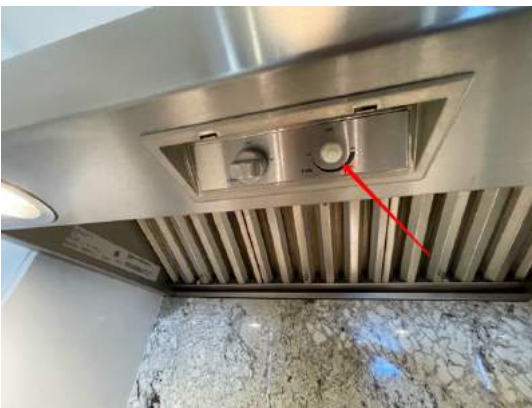
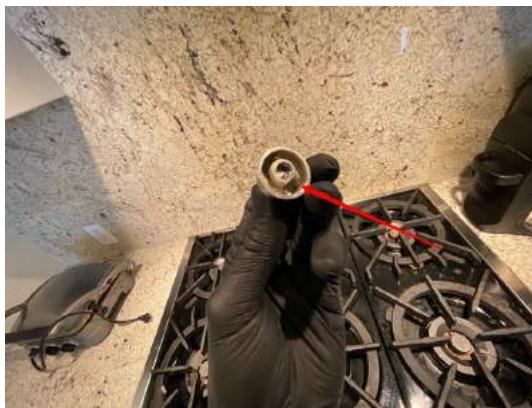
**Comment 34
Information**

Built-in coffee/espresso maker appears to be functional, and in good condition.

- Not tested

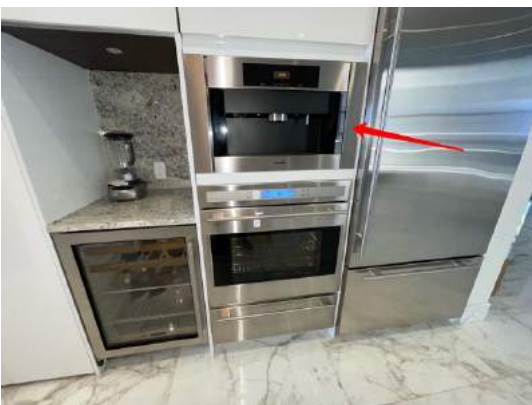
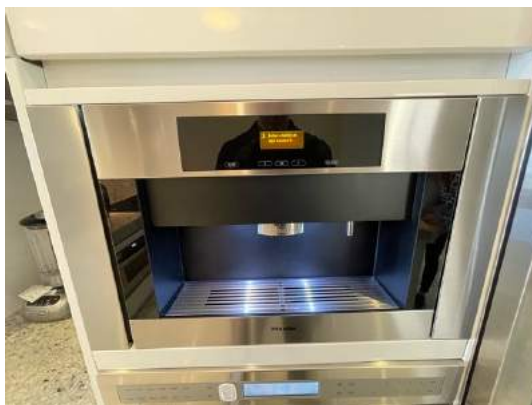
Comment 35
Information

Built-in oven functioning properly.

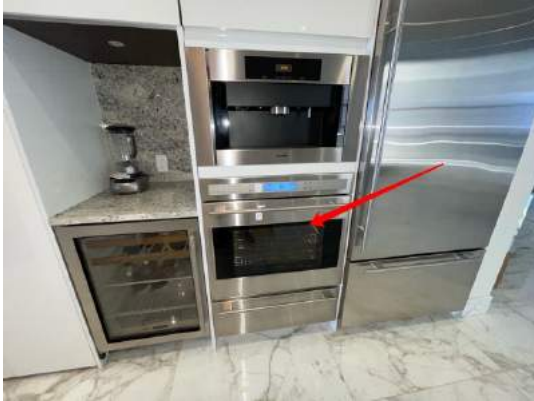
Comment 36
Information

Built-in warming drawer appears to be functioning properly at the time of inspection.

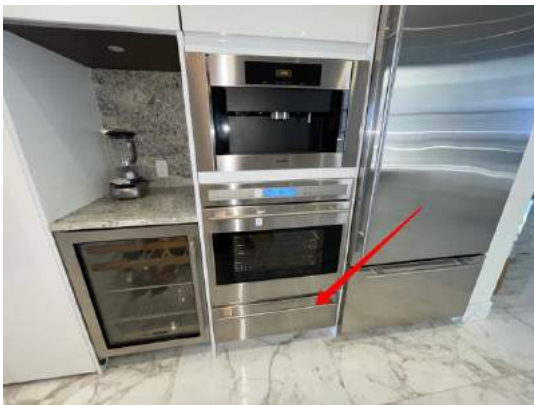
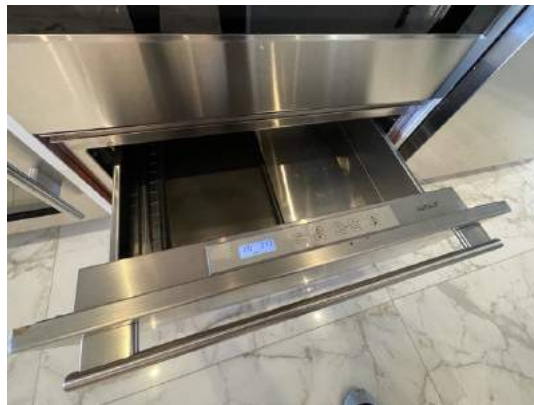
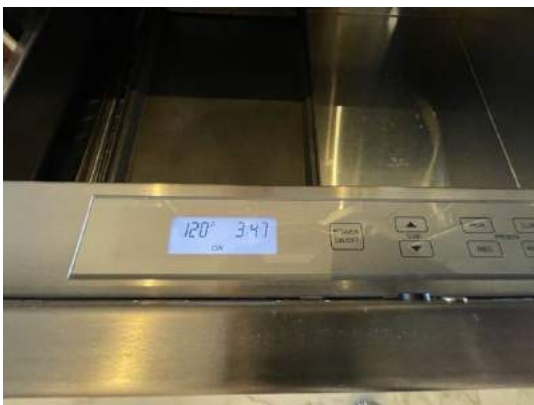
Comment 37
Information

Microwave functioning properly at the time of inspection.

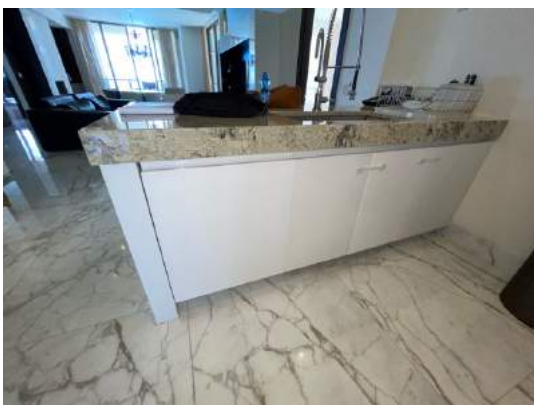
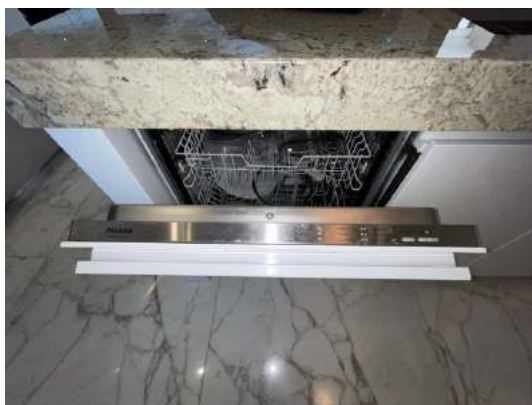
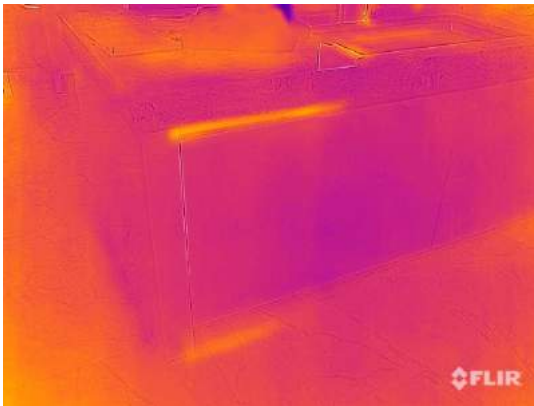
Comment 38
Information

Dishwasher functioning properly.

- No indications of leaking from or around dishwasher at the time of inspection.

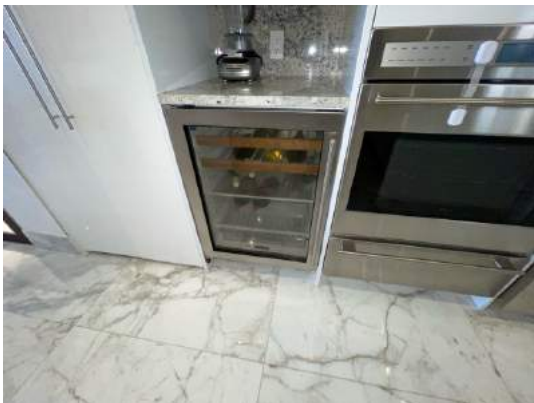
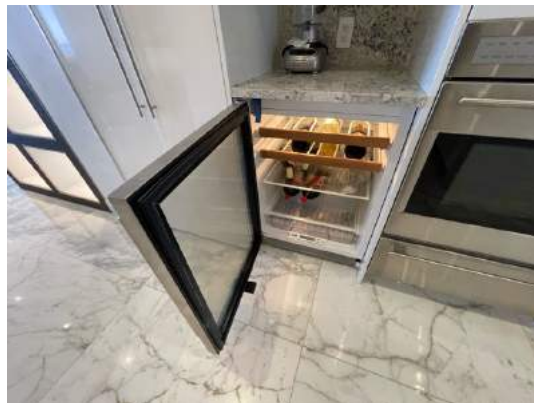
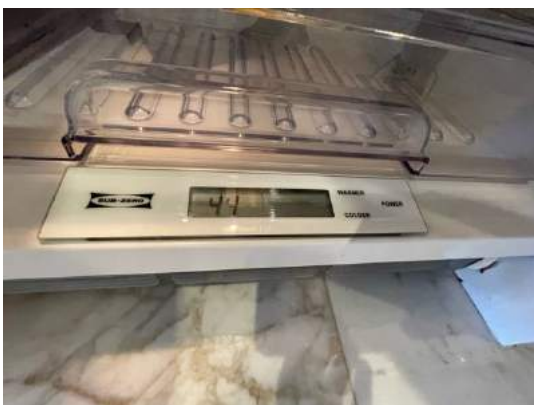
Comment 39
Information

Mini wine refrigerator functioning properly.
