Condo Inspection Report

9705 Collins Ave
Unit 2204N/2205N
Bal Harbour, FL 33154

Inspected On Tue, Mar 29, 2022 at 1:00 PM

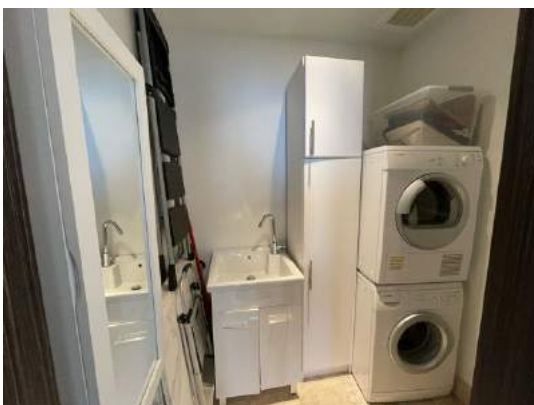
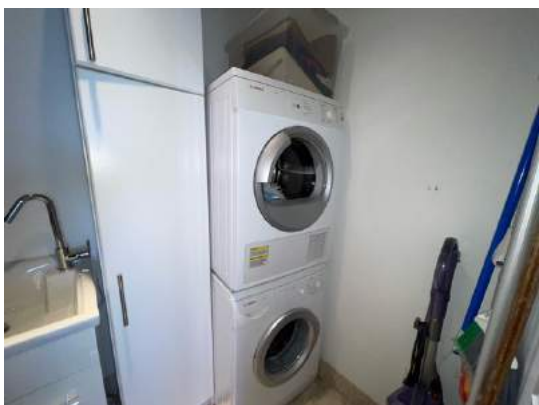
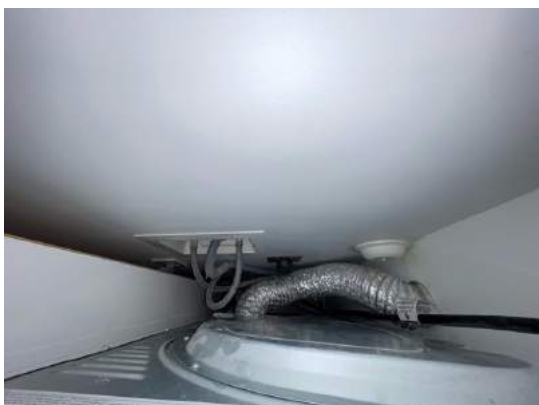
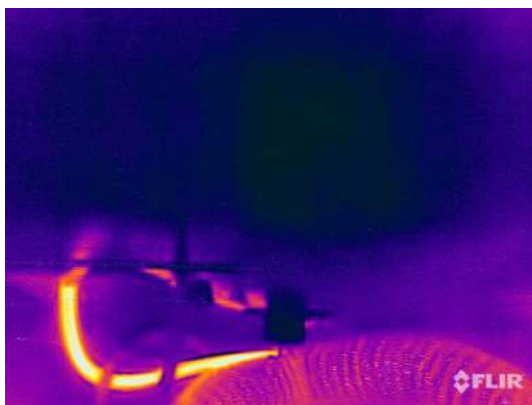
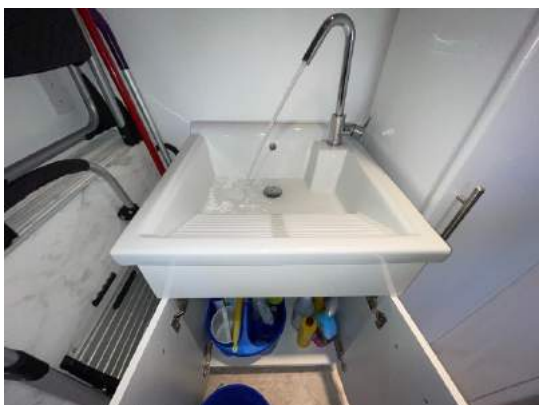
Laundry Room Photos.

- Washer & dryer functioning properly at the time of inspection.
- No indications of water damage or leaking at the time of inspection.

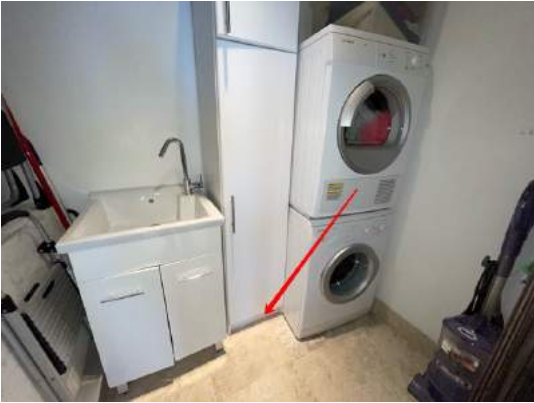
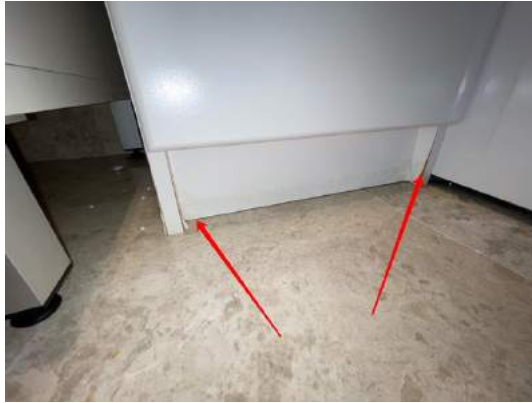
Comment 41
Deficiency

Minor water damage to base of cabinetry adjacent to washer & dryer.
- No active water damage detected at the time of inspection.

Recommend repair or replace damaged cabinetry within laundry room. (Estimate: \$200 - \$500)

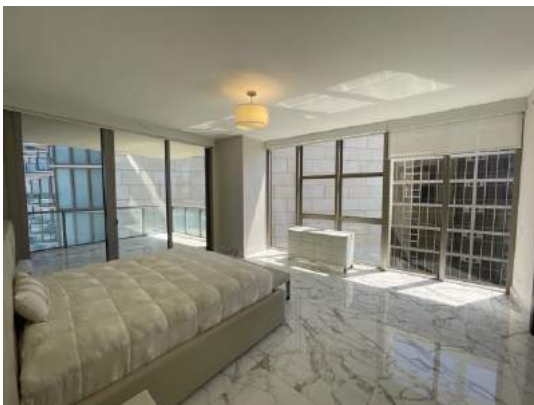
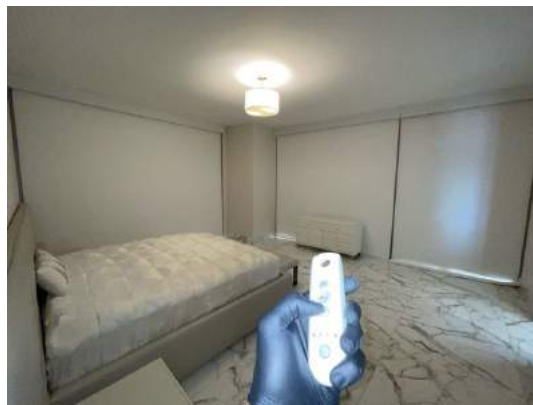
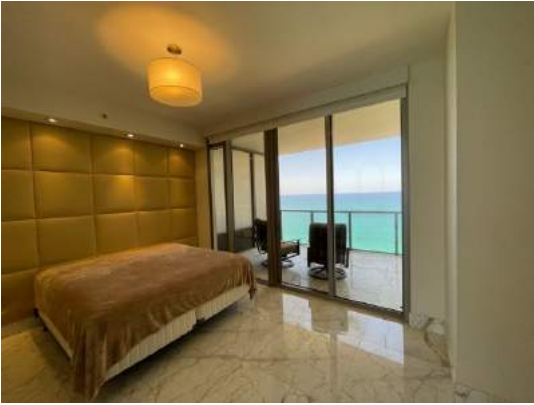
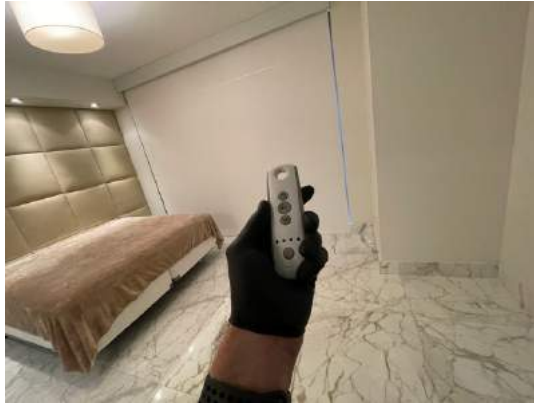
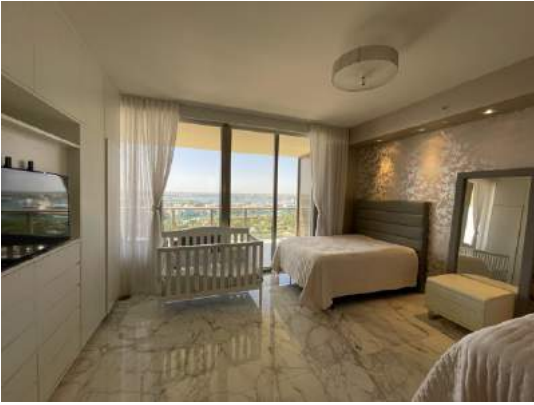
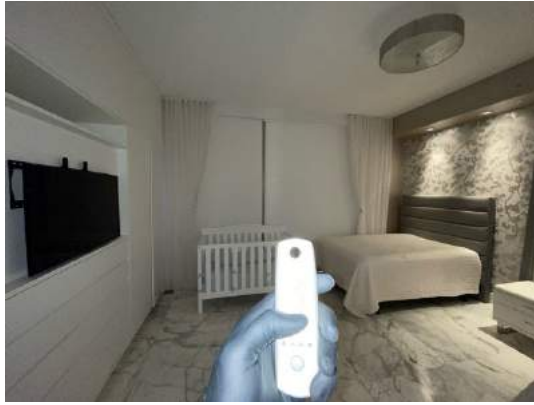
Comment 42 Information

AV roll-down shade system throughout unit appears to be functioning properly at the time of inspection.

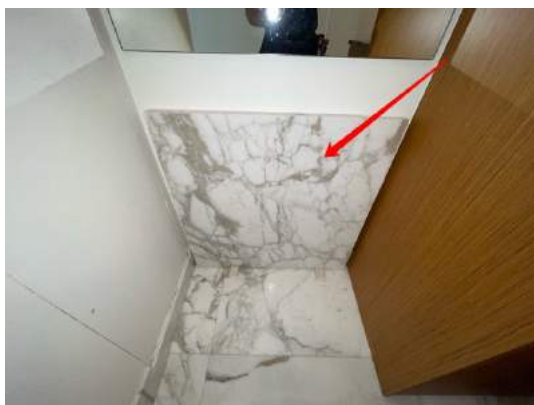
Comment 43
Information

Additional flooring tiles currently stored within master bedroom closet concealed behind mobile island.

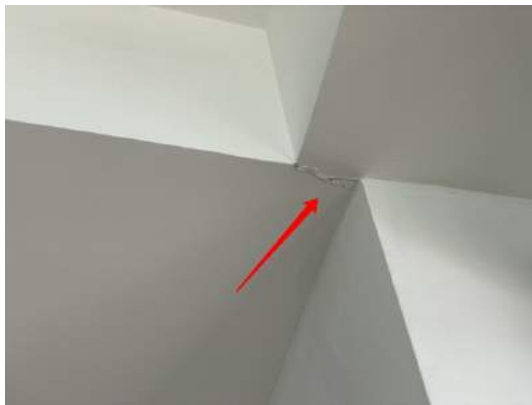
Comment 45

Minor cracking observed along living room ceiling drywall.

Recommend re-finishing surface of ceiling drywall to conceal cracking. (Estimate: \$150 - \$200)

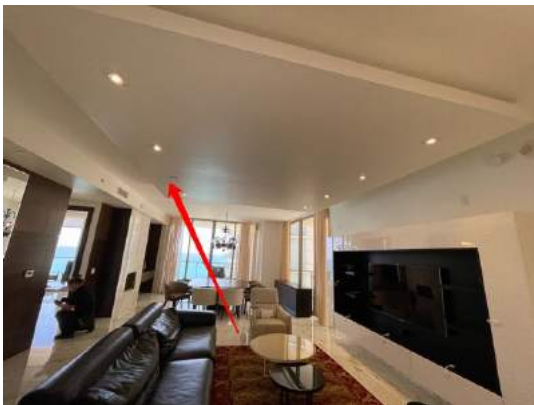
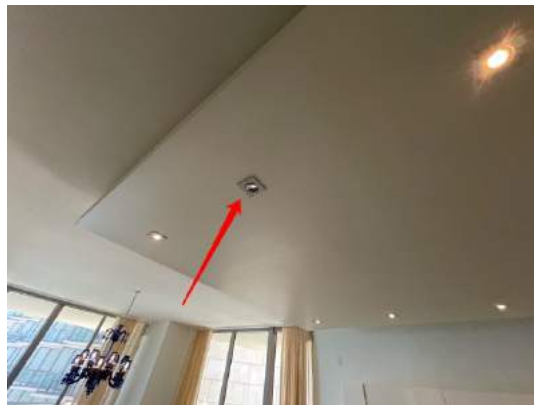
- Circuit is live when tested.
- Estimate light bulbs are burnt out.

Replace light bulbs to family room lights fixtures. (Estimate: \$10 - \$25)

If lighting fixture(s) continue not to function, recommend having a licensed electrician further evaluate fixtures & circuit. (Estimate: \$200 - \$500)

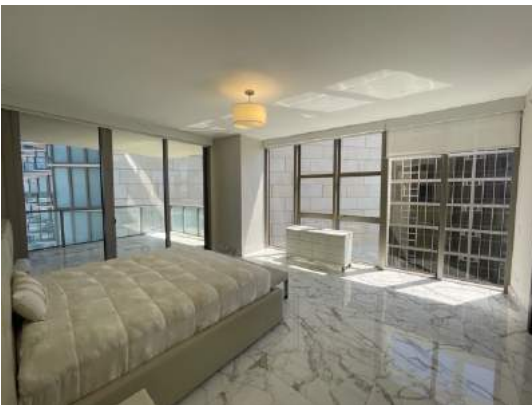
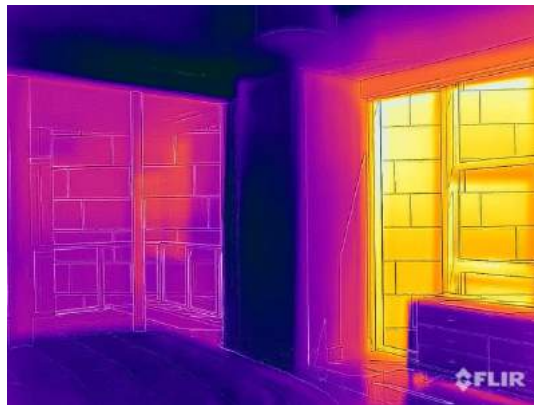
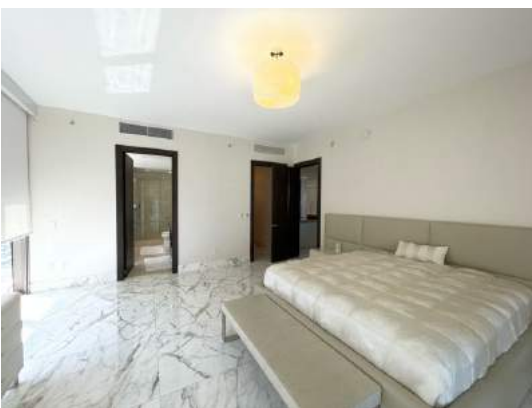
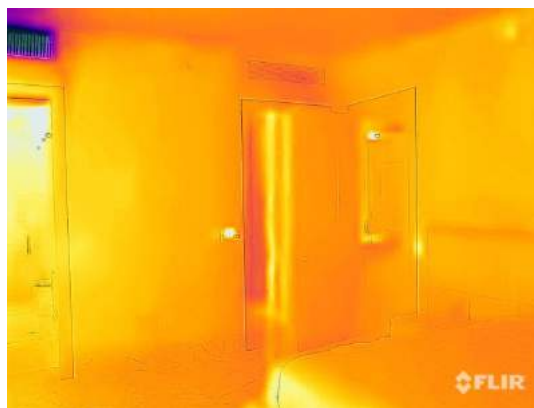
Master Bedroom.

Roll down shade (sun screen) not properly calibrated within master bedroom.

Recommend further evaluation by a qualified professional and repair roll down shade accordingly. (Estimate: \$100 - \$250)

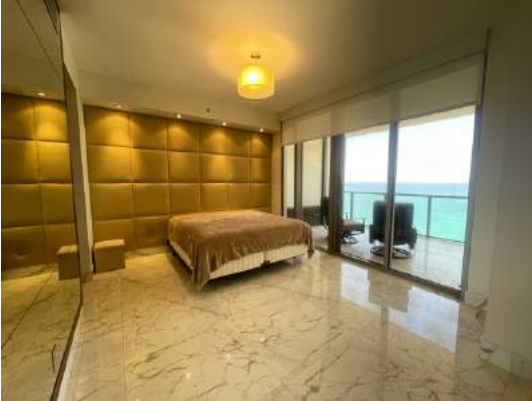
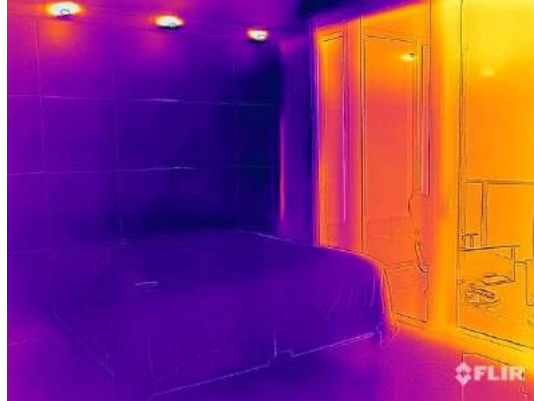
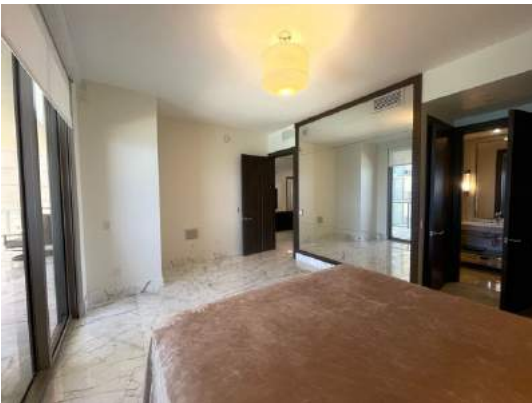
Comment 53
Deficiency

Bedroom #2 sliding glass doors are currently stuck on track within door frame, and does not open.

Recommend further evaluation by a licensed professional & repair/replace sliding-glass door tracks & rollers as necessary. (Estimate: \$500 - \$1,000)

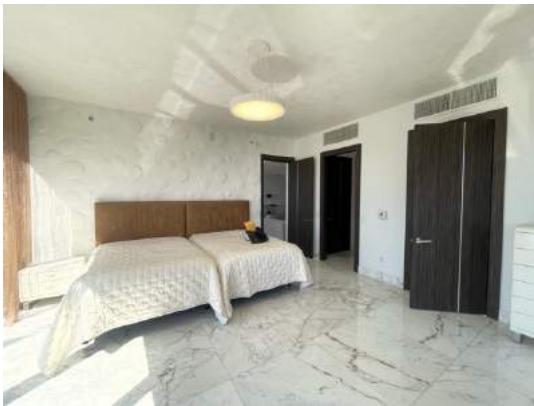
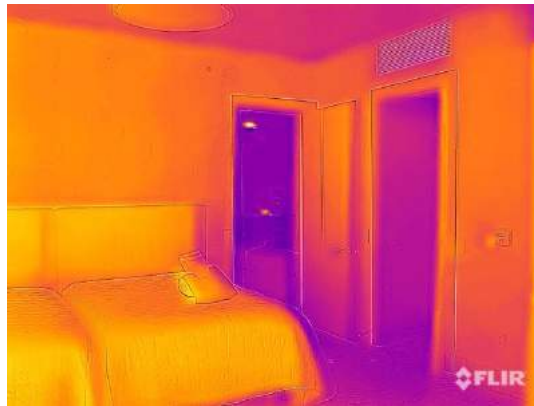
Comment 59

Bedroom windows do not open/close properly due to broken spring-loaded tracks on the side of windows.

Repair/adjust spring-loaded tracks to bedroom windows. (Estimate: \$150 - \$250)

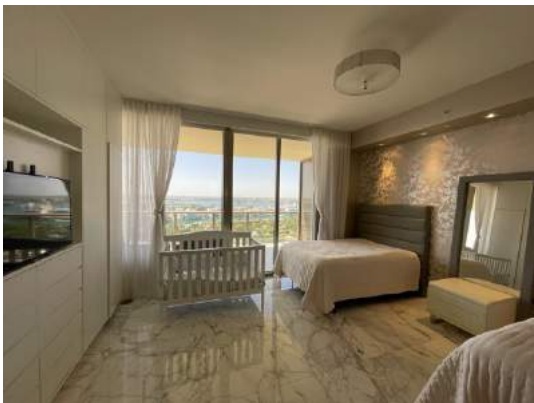
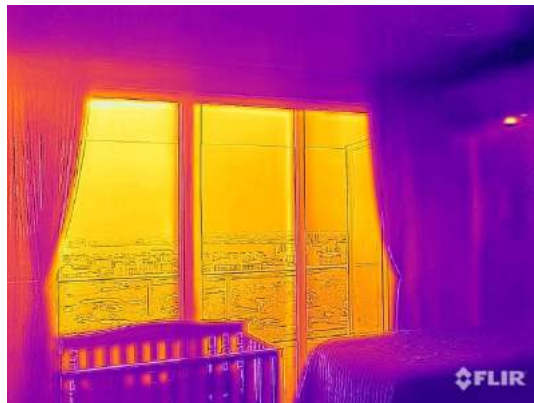
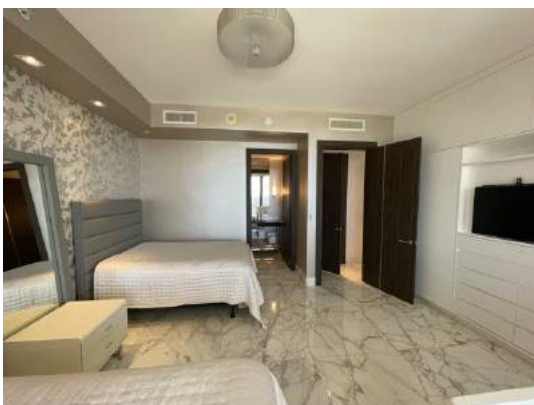
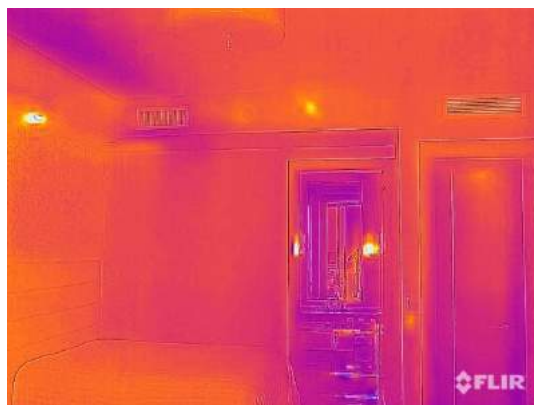
Comment 62
Deficiency

Roll down shade (sun screen) not properly calibrated and stuck in framing within bedroom #4.

Recommend further evaluation by a qualified professional and repair roll down shade accordingly. (Estimate: \$100 - \$250)

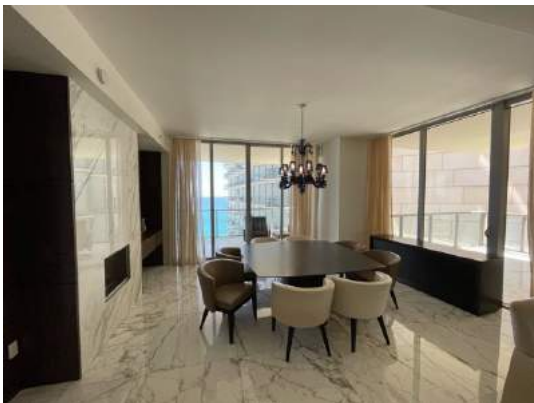
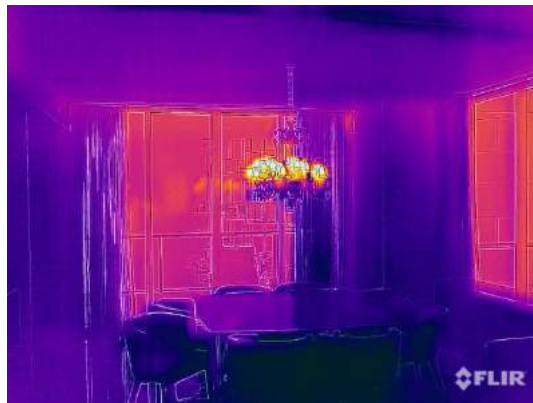
Comment 65 Deficiency

Gas ventless fire place located within dining room appears to be in good condition, but not functioning at the time of inspection as remote controls are not currently functional.

Repair remote activation controls for proper use of ventless fireplace within dining room. (Estimate: \$25 - \$150)

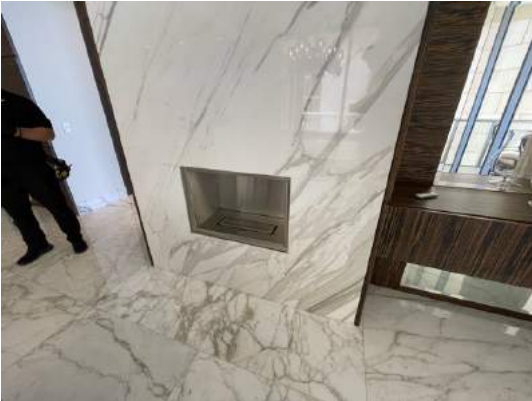
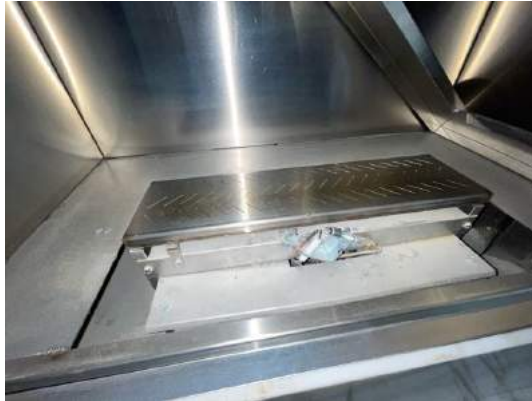
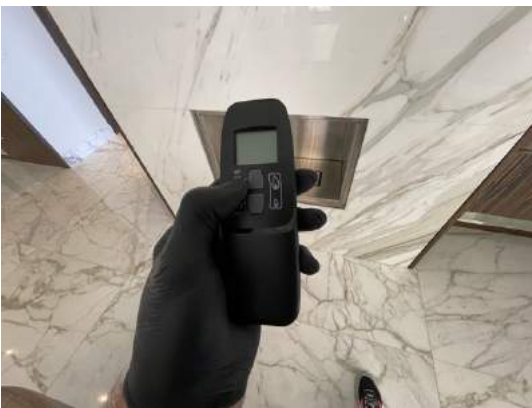
- Gas valve located within adjacent bedroom behind fireplace.

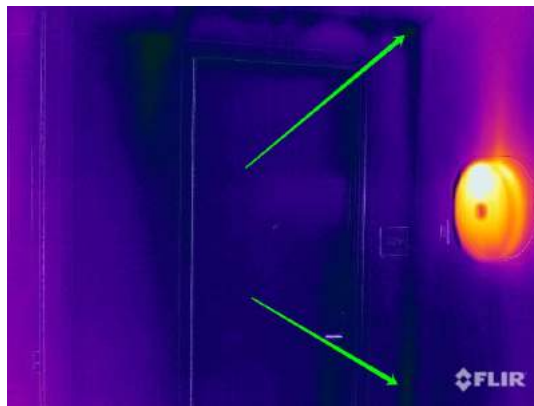
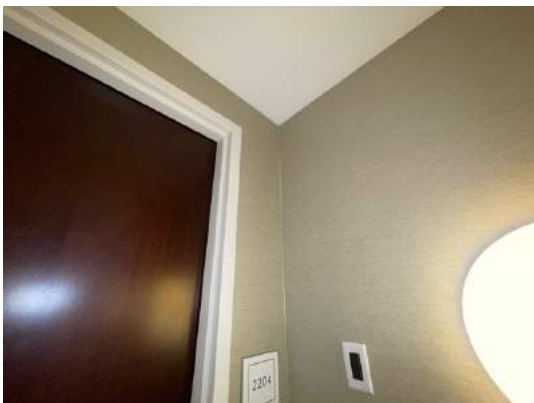
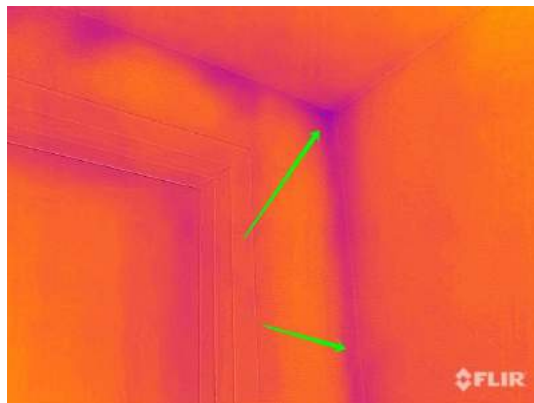
Comment 67

Concern for potential moisture intrusion over elevator entrance/foyer.

- Minor moisture detected via thermal imaging as well as moisture meters along top corner of wall & base of floor.
- Indications of discoloration to tile flooring along base of floor due to extended exposure to moisture.
- Estimate potential active leaking from unit above.

Recommend reporting to building for further investigation into potential leaking from unit above & repair accordingly.

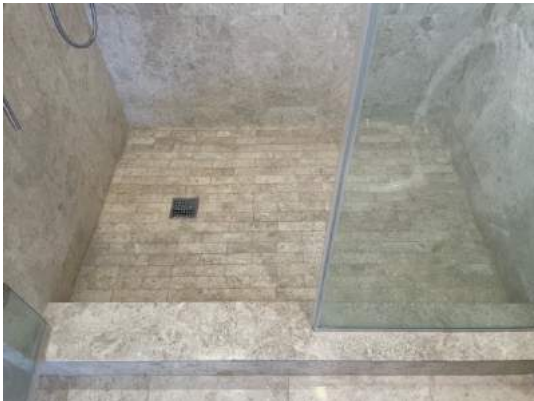
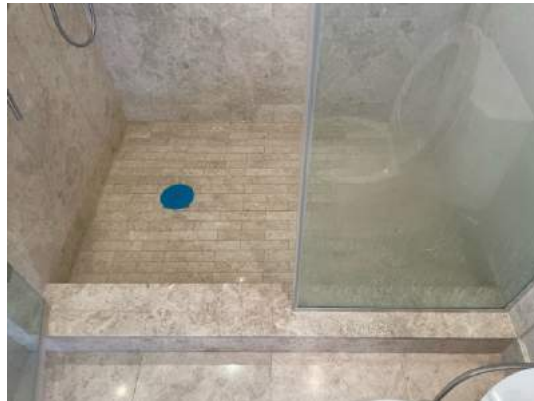
Shower pan tested.

- No indications of leaking from shower pan at the time of inspection.

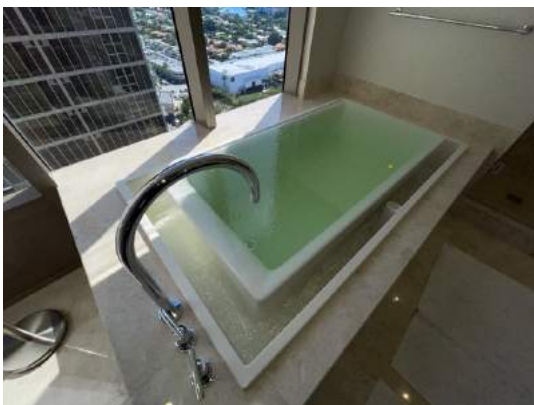
Comment 74
Information

Jacuzzi tub functioning properly.

- No indications of leaking from around jacuzzi tub at the time of inspection.
- No access panel available to access jacuzzi motor or shut-off valves to tub fixture.

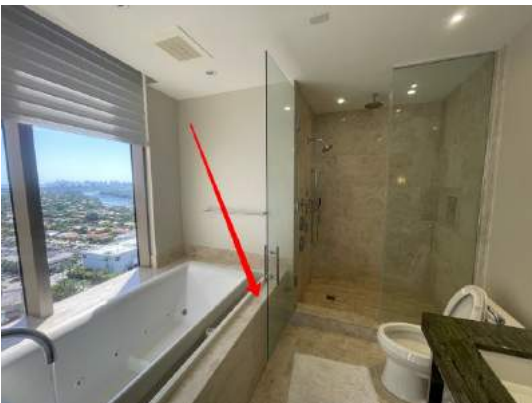
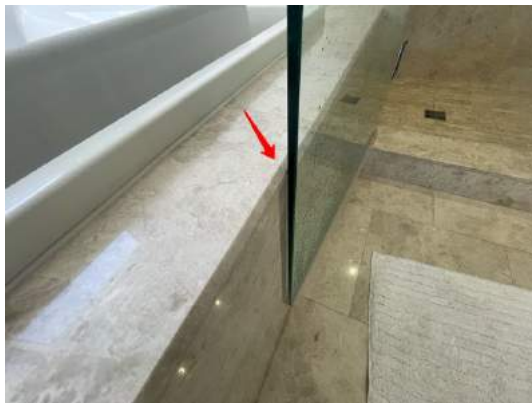
Comment 75
Deficiency

Frameless glass shower door within bathroom conflicting with adjacent tub wall when opening. Recommend installing a door stopper or bumper prevent damaging wall. (Estimate: \$25 - \$50)

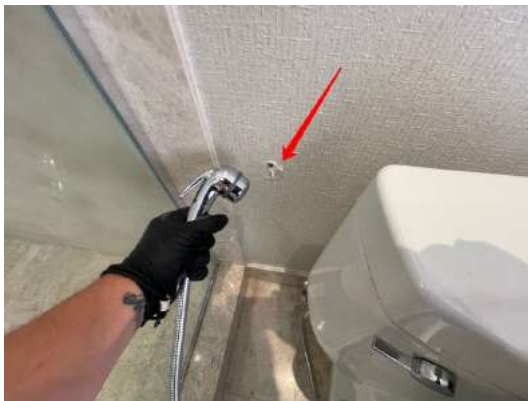
Comment 76
Deficiency

Hand held fixture to toilet functional, but wall mount appears to have been removed leaving damage to wall adjacent to toilet fixture.

Recommend repairing wall & re-mounting wall mount/bracket to hold hand held fixture. (Estimate: \$200 - \$300)

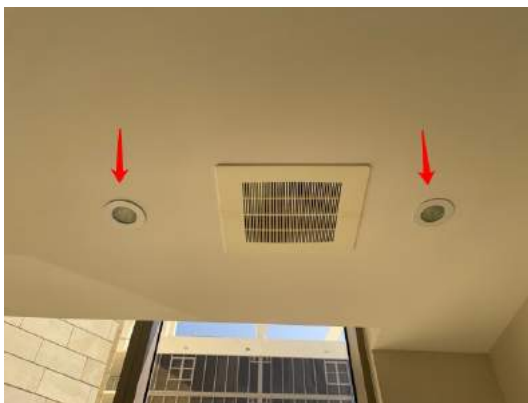
Comment 77
Deficiency

Bathroom lights over tub fixture not functioning at the time of inspection.

- Estimate light bulbs are burnt out.

Replace light bulbs to bathroom lighting fixtures. (Estimate: \$10 - \$25)

If lighting fixture(s) continue not to function, recommend having a licensed electrician further evaluate circuit. (Estimate: \$200 - \$500)

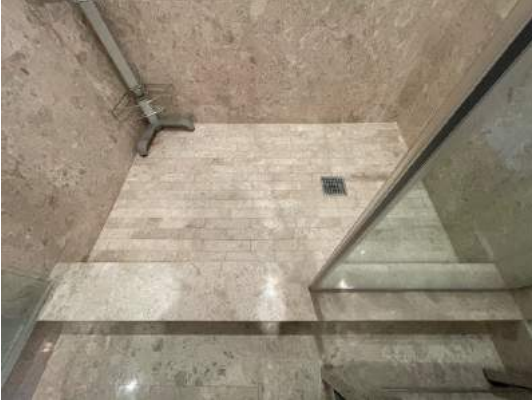
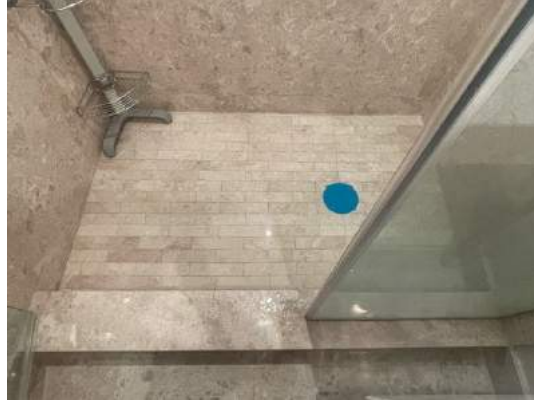
Comment 79
Information

No indications of leaking from around base of shower or shower pan within unit at the time of inspection.

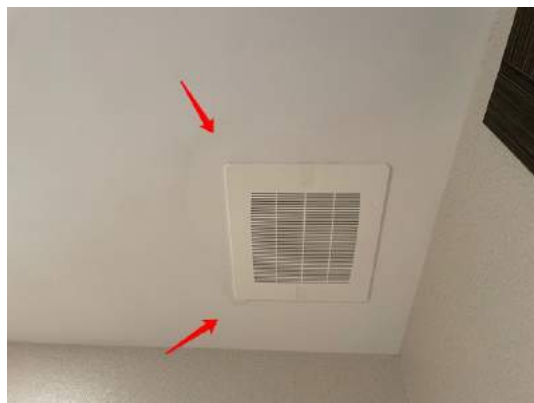
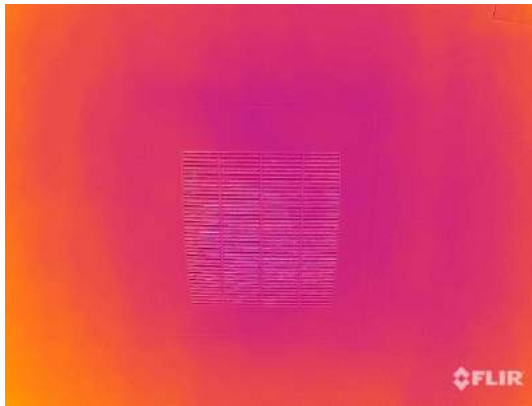
Comment 80
Deficiency

Ventilation exhaust fan not functioning at the time of inspection.

- Indications of dry water staining around exhaust fan at the time of inspection. No active moisture detected at the time of inspection.

Repair/replace ventilation exhaust fan. (Estimate: \$250 - \$500)

Repair/refinish surrounding in drywall to conceal previous dry water staining. (Estimate: \$100 - \$200)

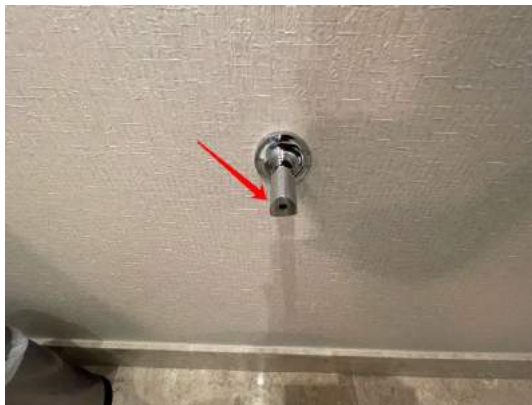
Comment 81

Deficiency

Toilet paper holder appears to have been damaged.

Replace toilet paper holder. (Estimate: \$100 - \$200)

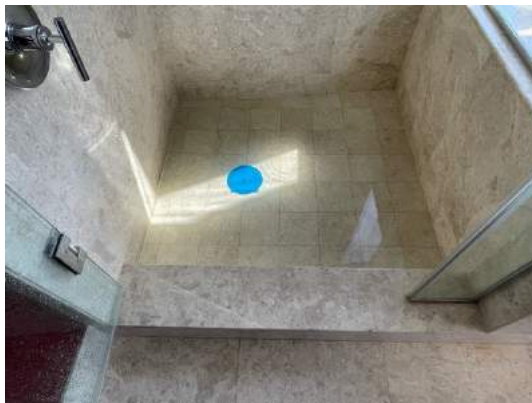
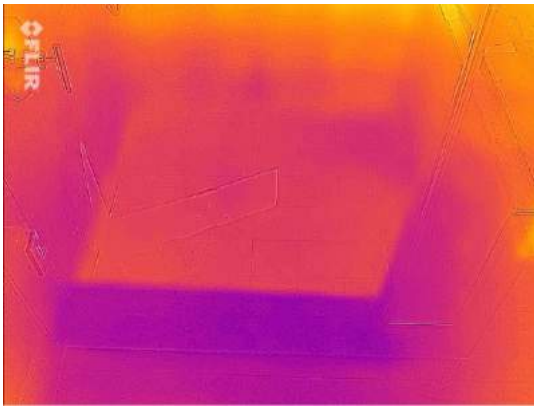
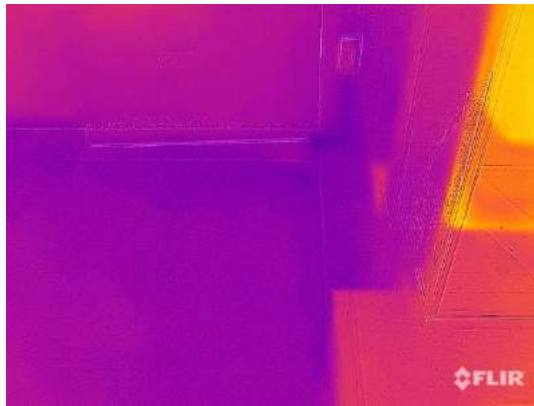
Comment 83
Information

Shower pan tested.

- No indications of leaking from shower pan at the time of inspection.

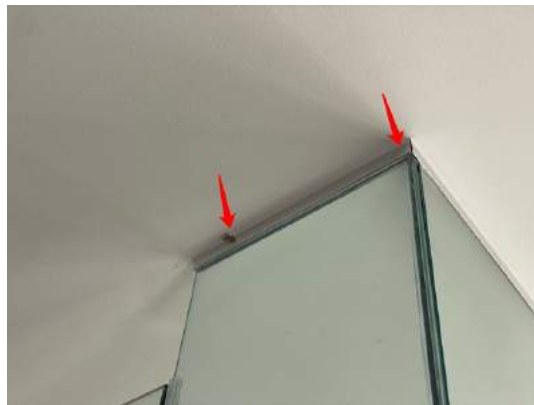
Comment 85

Loose trim along top of glass shower enclosure.

Recommend properly securing glass panel & trim along ceiling. (Estimate: \$100 - \$200)

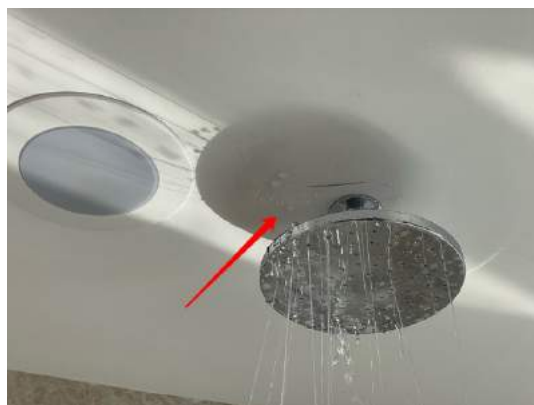
Comment 86

Broken rain shower head fixture causing water to spray towards ceiling.

- Active water damage caused to ceiling drywall due to broken shower fixture.

Replace rain shower head fixture to prevent further water damage to ceiling over shower. (Estimate: \$200 - \$300)

Repair water damage ceiling drywall over shower fixture. (Estimate: \$150 - \$250)

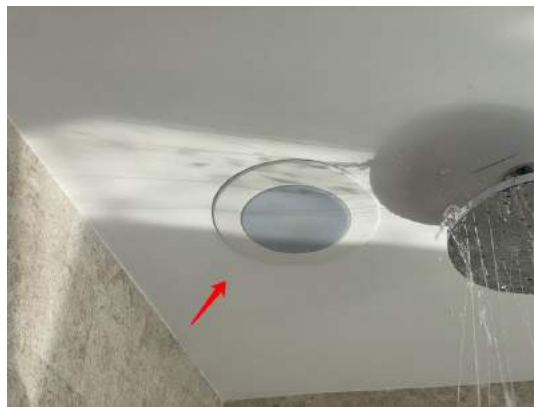
Comment 87

- Estimate light bulb is burnt out.

Replace light bulb to bathroom light fixture. (Estimate: \$10 - \$25)

If lighting fixture(s) continue not to function, recommend having a licensed electrician further evaluate circuit. (Estimate: \$200 - \$500)

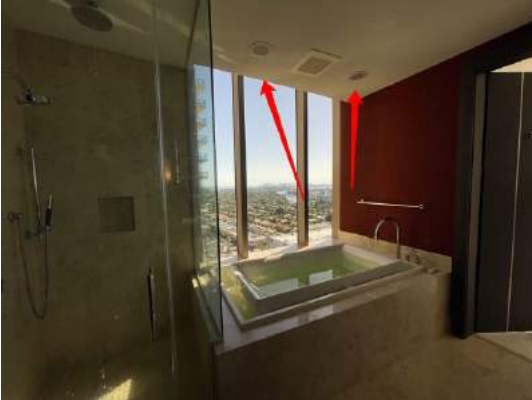
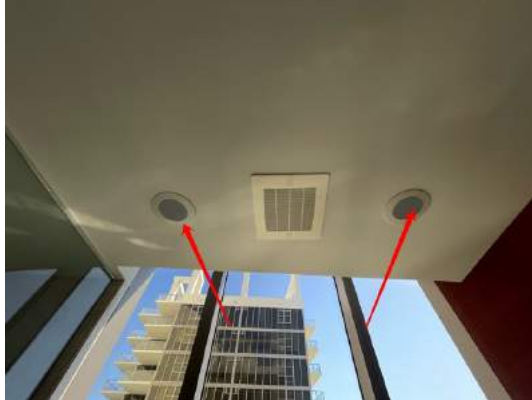
Comment 88

- Estimate light bulbs are burnt out.

Replace light bulbs to bathroom lighting fixtures. (Estimate: \$10 - \$25)

If lighting fixture(s) continue not to function, recommend having a licensed electrician further evaluate circuit. (Estimate: \$200 - \$500)

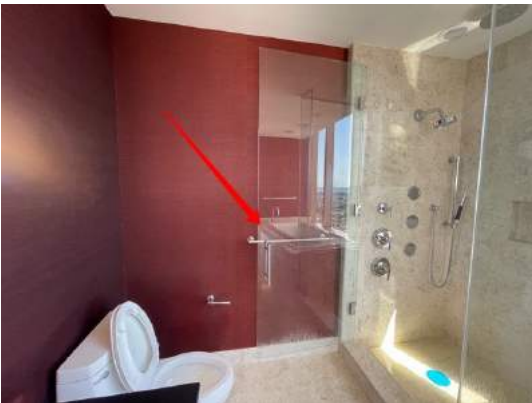
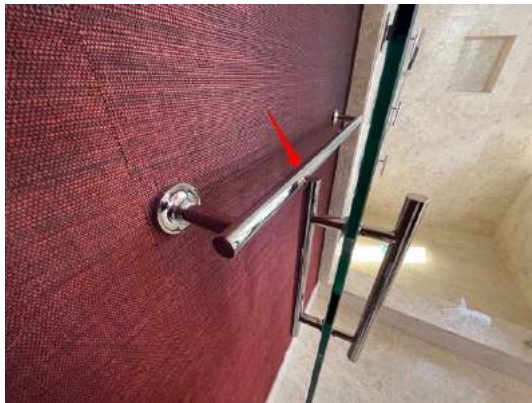
Comment 89

Frameless glass shower door within bathroom conflicting with adjacent wall & towel rack when opening. Recommend installing a door stopper or bumper prevent damaging wall. (Estimate: \$25 - \$50)

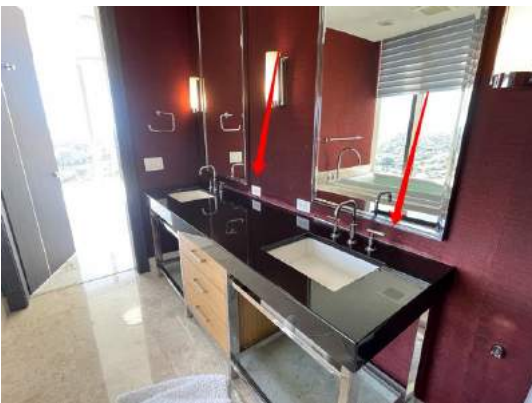
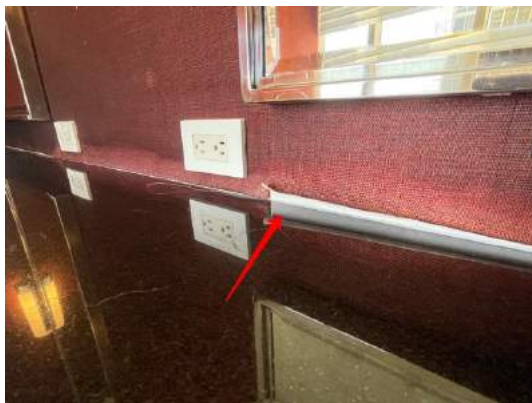
Comment 90

Indications of deterioration to wallpaper over vanity fixture. Repair/replace wallpaper. (Detailed quotation required)

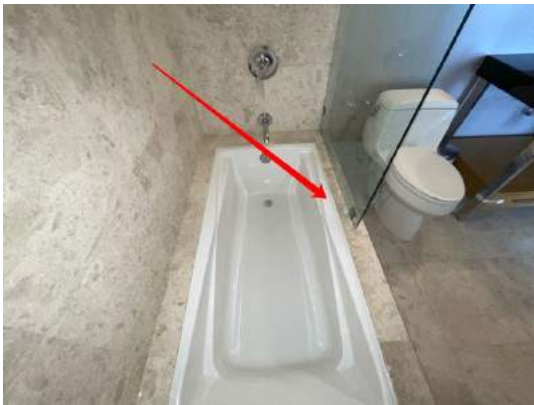
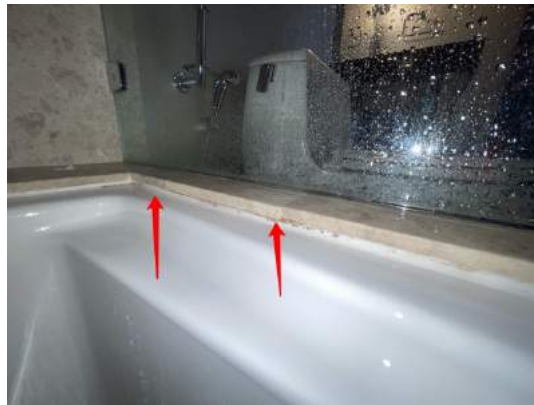
Comment 93

Apparent deterioration to caulking around tub fixture.

Recommend re-caulking/re-sealing around tub fixture. (Estimate: \$100 - \$200)

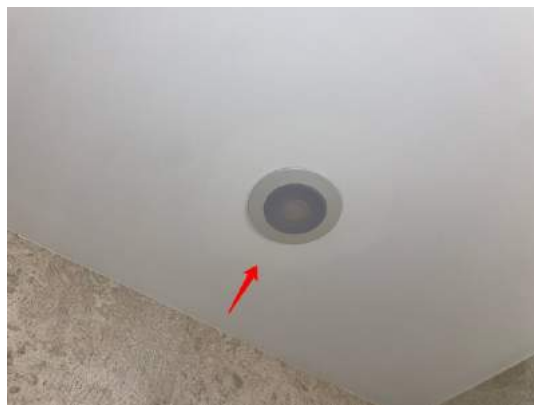
Comment 94

- Estimate light bulb is burnt out.

Replace light bulb to bathroom light fixture. (Estimate: \$10 - \$25)

If lighting fixture(s) continue not to function, recommend having a licensed electrician further evaluate circuit. (Estimate: \$200 - \$500)

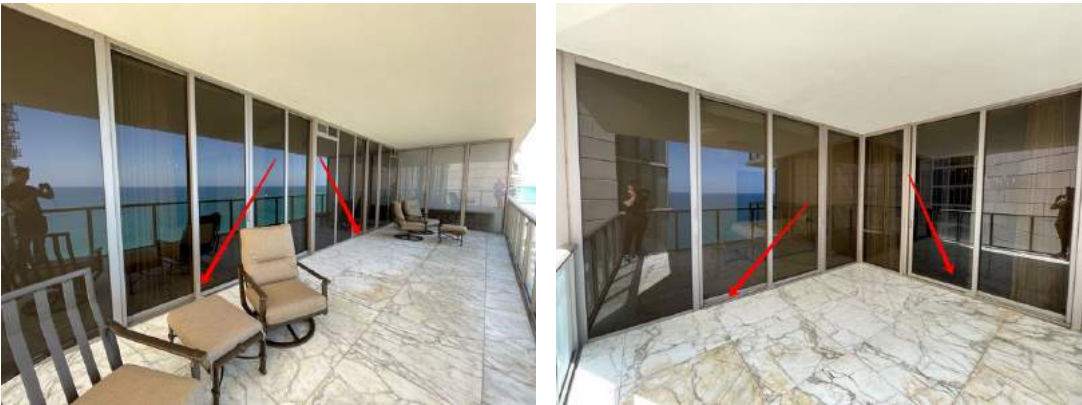
Sliding glass doors to east facing exterior balconies are stiff on tracks and difficult to open/close.

Recommend servicing sliding-glass doors by a qualified professional, and cleaning/re-greasing tracks & rollers to sliding glass door for proper operation. (Estimate: \$1,500 - \$2,500)

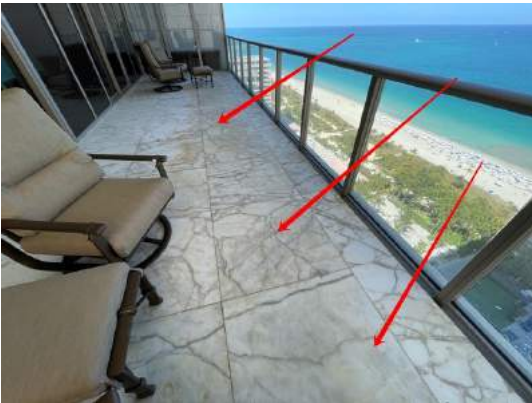
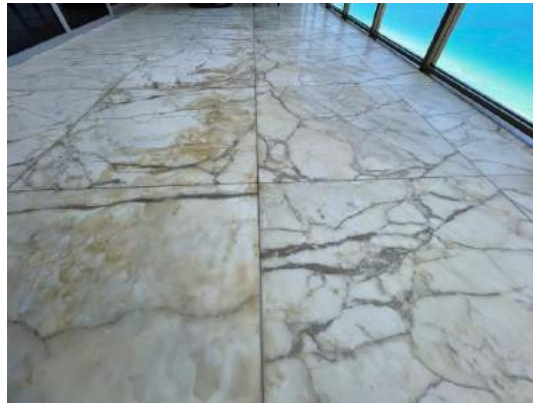
Comment 5

- Estimate discoloration may be natural texture & porous nature of marble stone tiling due to worn seal as well as moisture intrusion below tile flooring.

Repair/Replace or re-polish/re-seal damaged or discolored tile flooring along exterior balcony as desired. (Estimate: \$2,000 - \$5,000)

If tile flooring is unable to be matched, complete replacement of flooring may be necessary. (Detailed quotation required)

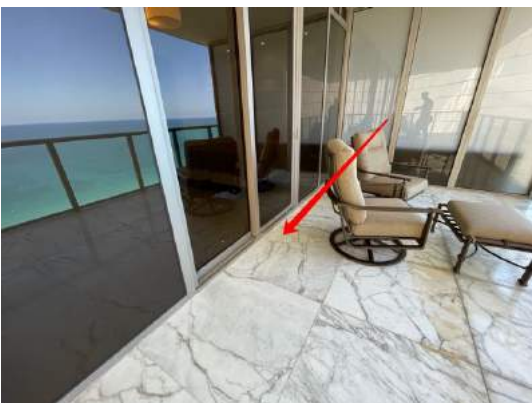
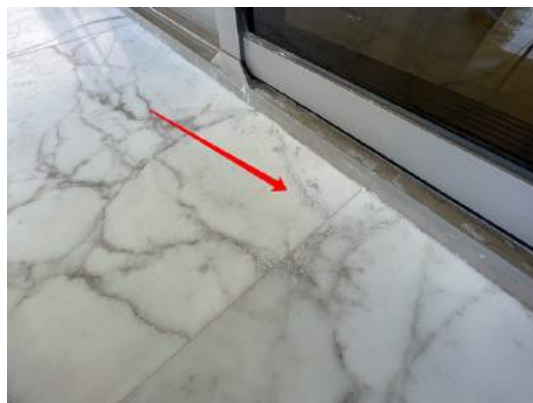
Comment 6

Cracked/broken flooring tile along east balcony outside of bedroom #2.

Replace broken flooring tile along exterior balcony. (Estimate: \$200 - \$400)

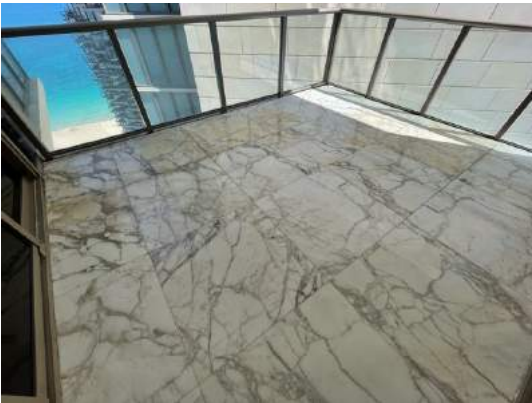
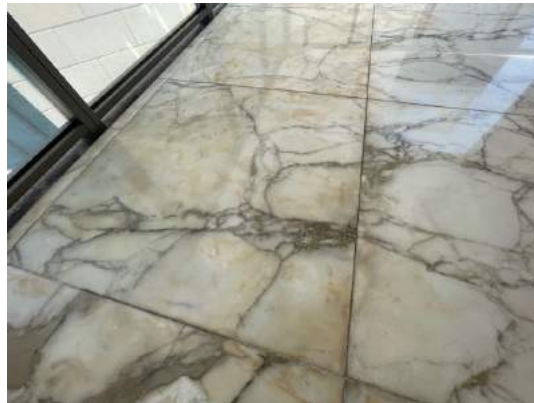
Comment 8

- Estimate discoloration may be natural texture & porous nature of marble stone tiling due to worn seal as well as moisture intrusion below tile flooring.

Repair/Replace or re-polish/re-seal damaged or discolored tile flooring along exterior balcony as desired. (Estimate: \$2,000 - \$5,000)

If tile flooring is unable to be matched, complete replacement of flooring may be necessary. (Detailed quotation required)

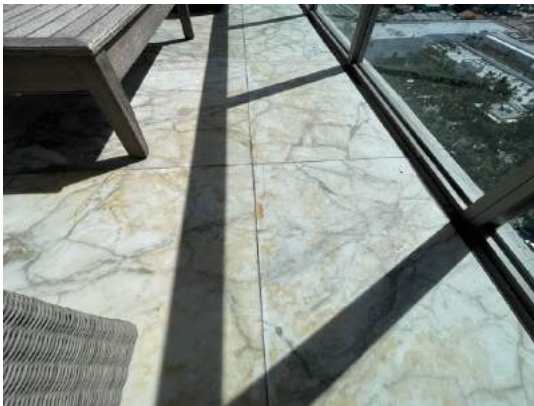
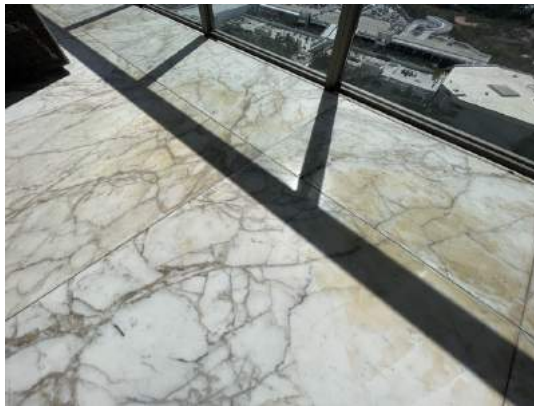
Comment 10

- Estimate discoloration may be natural texture & porous nature of marble stone tiling due to worn seal as well as moisture intrusion below tile flooring.

Repair/Replace or re-polish/re-seal damaged or discolored tile flooring along exterior balcony as desired. (Estimate: \$2,000 - \$5,000)

If tile flooring is unable to be matched, complete replacement of flooring may be necessary. (Detailed quotation required)

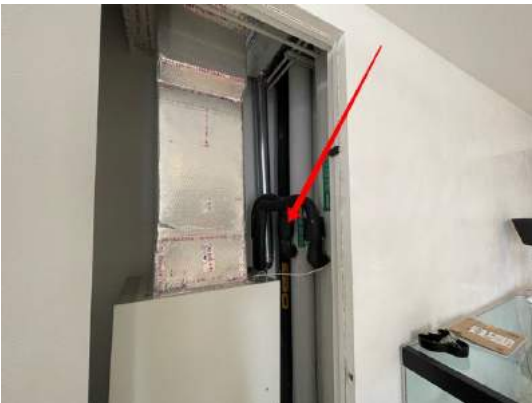
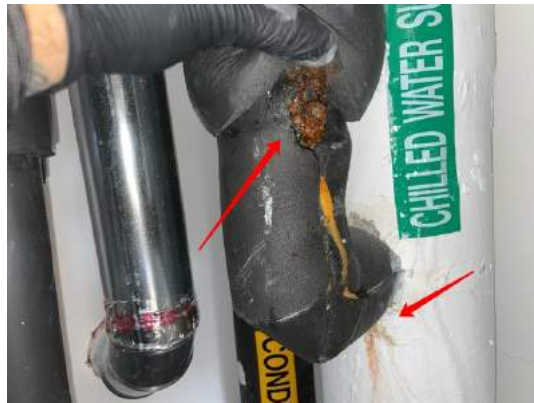
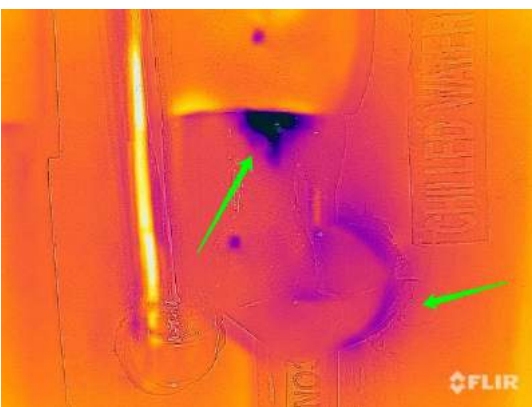
Comment 20

Apparent oxidation/rusting & corrosion around incoming & outgoing water valves for water source heat pump HVAC system within A/C closet.

- Apparent condensation/moisture from water valves at the time of inspection.

Recommend monitoring these valves to make sure no leaking occurs in the future. If leaking from valves does happen to occur, report to building engineer to have building maintenance repair/replace valves.

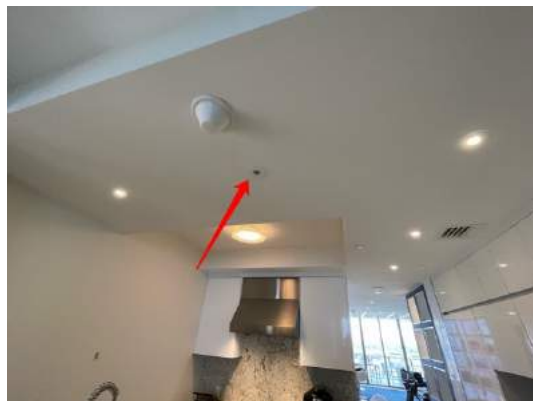
Comment 29

- Estimate light bulbs are burnt out.

Replace light bulb to cabinetry light fixtures. (Estimate: \$25 - \$50)

If lighting fixture(s) continue not to function, recommend having a licensed electrician further evaluate fixtures & circuit. (Estimate: \$200 - \$500)

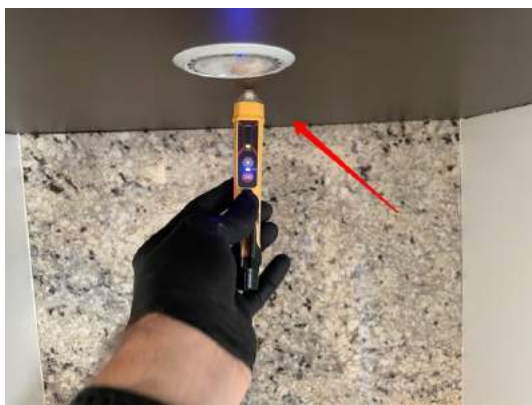
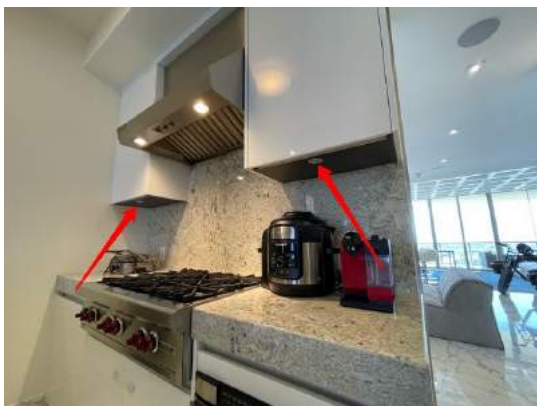
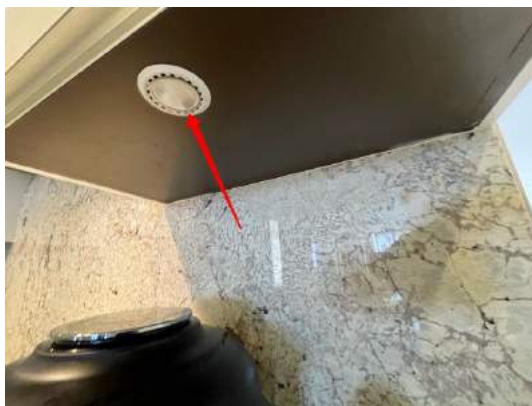
Comment 33

- Fan knob damaged.

Repair/replace hood fan knob. (Estimate: \$25 - \$50)

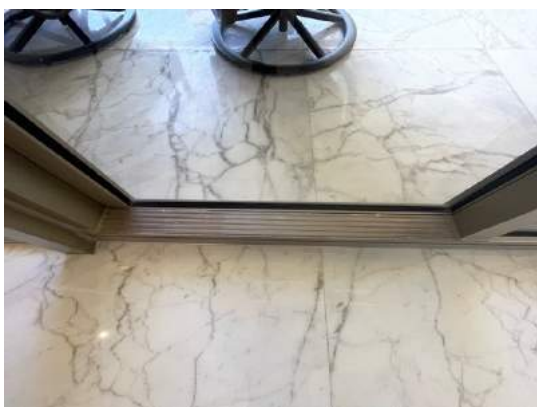
Bedroom #2 sliding glass doors are currently stuck on track within door frame, and does not open.

Recommend further evaluation by a licensed professional & repair/replace sliding-glass door tracks & rollers as necessary. (Estimate: \$500 - \$1,000)

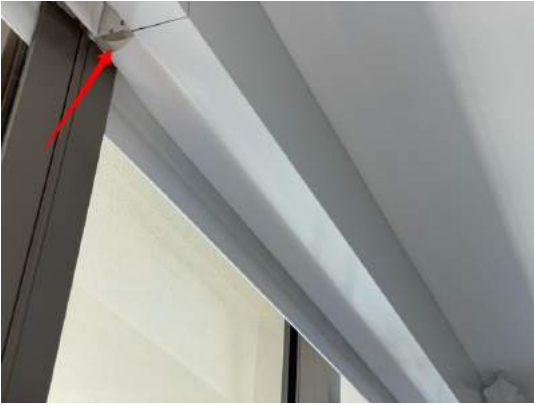
Comment 63

- Estimate light bulb is burnt out.

Replace light bulb to bedroom light fixture. (Estimate: \$10 - \$25)

If lighting fixture(s) continue not to function, recommend having a licensed electrician further evaluate circuit. (Estimate: \$200 - \$500)

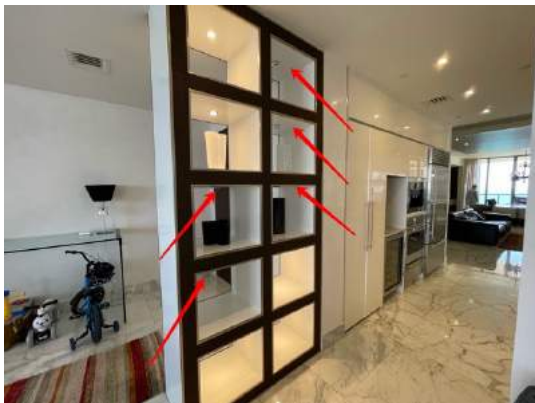
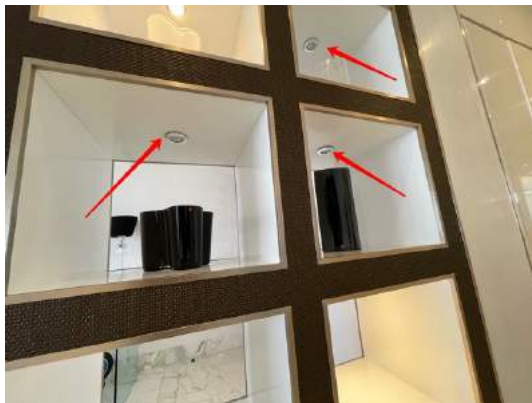
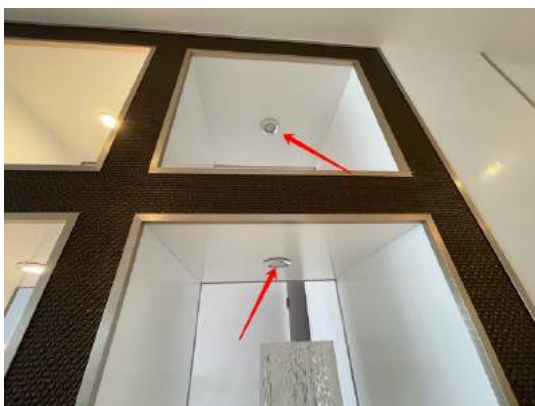
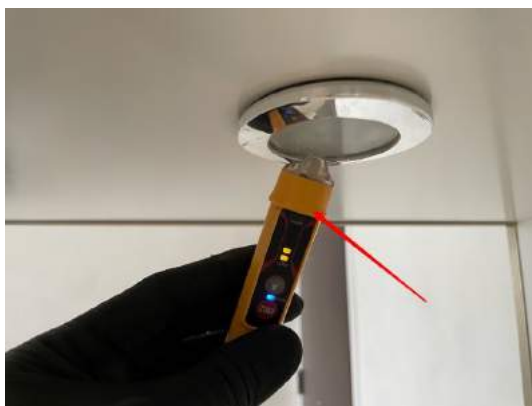
Comment 68

- Circuit is live when tested.
- Estimate light bulbs are burnt out.

Replace light bulbs to shelving light fixtures. (Estimate: \$10 - \$25)

If lighting fixture(s) continue not to function, recommend having a licensed electrician further evaluate fixtures & circuit. (Estimate: \$200 - \$500)

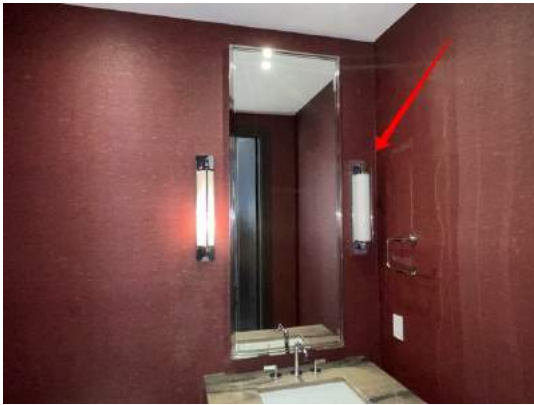
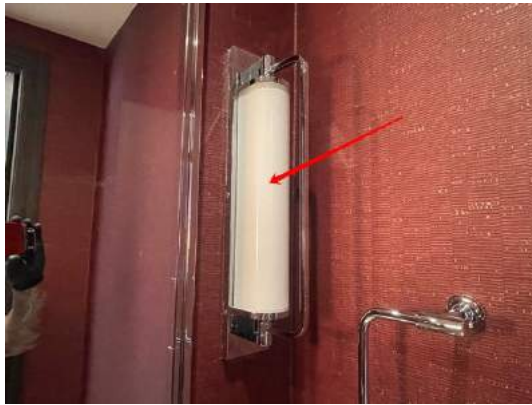
Comment 70

- Estimate light bulb is burnt out.

Replace light bulb to bathroom light fixture. (Estimate: \$10 - \$25)

If lighting fixture(s) continue not to function, recommend having a licensed electrician further evaluate circuit. (Estimate: \$200 - \$500)

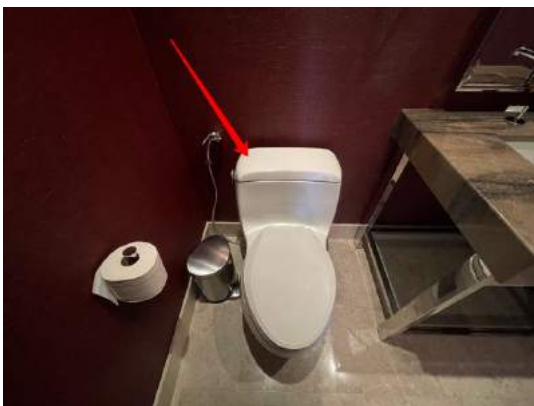
Comment 71

Flushing mechanism within toilet tank is broken preventing toilet from flushing and causing water to constantly run.

- Water turned off to toilet fixture following inspection to prevent water from continuously running.

Replace flushing mechanism within tank of toilet. (Estimate: \$50 - \$100)

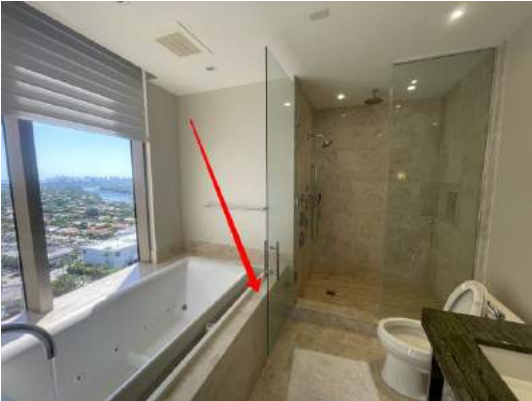
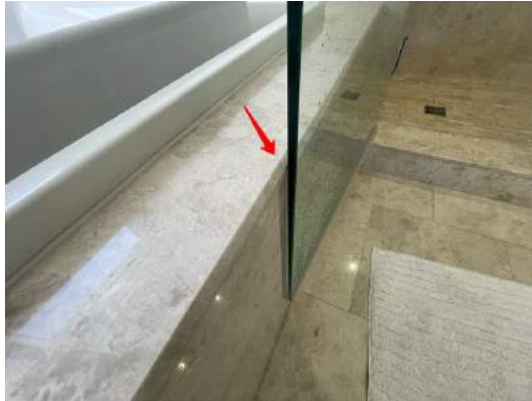
Comment 75

Frameless glass shower door within bathroom conflicting with adjacent tub wall when opening.

Recommend installing a door stopper or bumper prevent damaging wall. (Estimate: \$25 - \$50)
