Condo Inspection Report

9705 Collins Ave
Unit 2204N/2205N
Bal Harbour, FL 33154

Inspected On Tue, Mar 29, 2022 at 1:00 PM

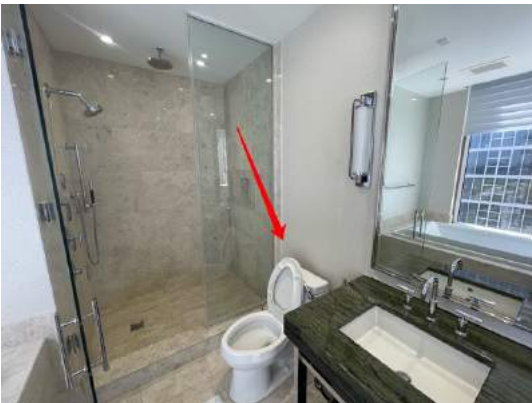
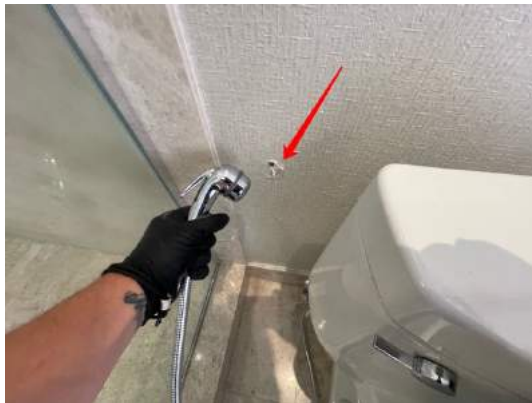
Comment 76

Hand held fixture to toilet functional, but wall mount appears to have been removed leaving damage to wall adjacent to toilet fixture.

Recommend repairing wall & re-mounting wall mount/bracket to hold hand held fixture. (Estimate: \$200 - \$300)

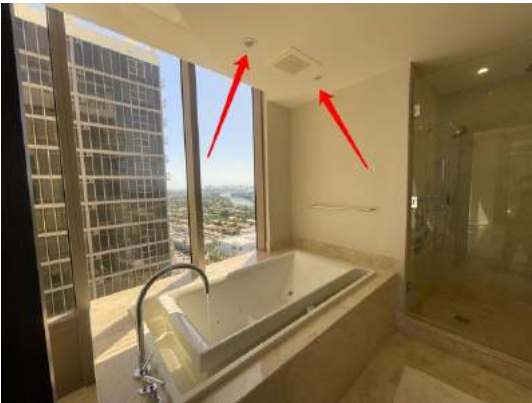
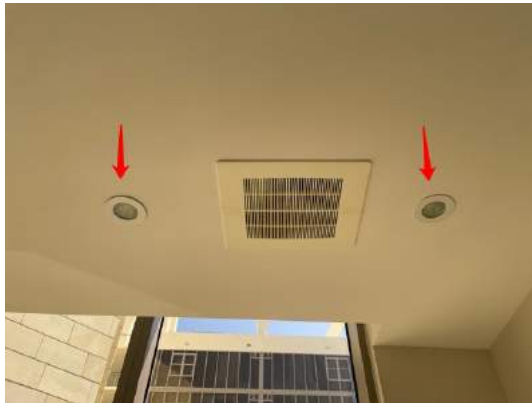
Comment 77

- Estimate light bulbs are burnt out.

Replace light bulbs to bathroom lighting fixtures. (Estimate: \$10 - \$25)

If lighting fixture(s) continue not to function, recommend having a licensed electrician further evaluate circuit. (Estimate: \$200 - \$500)

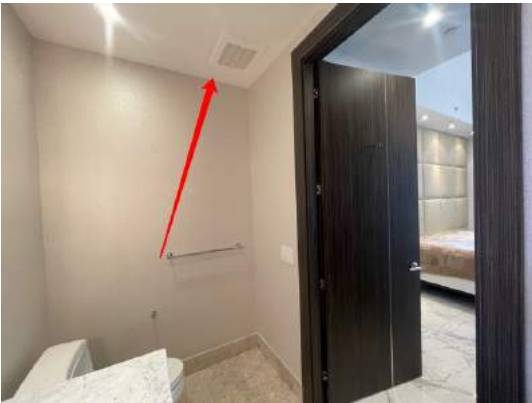
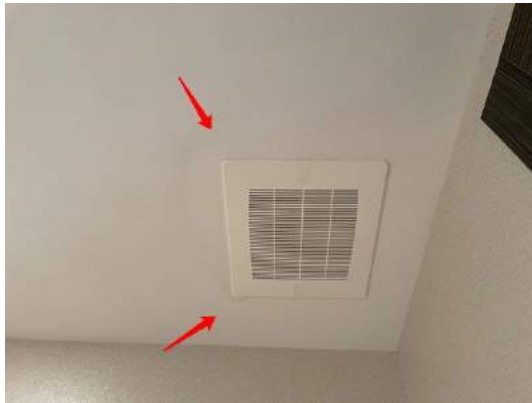
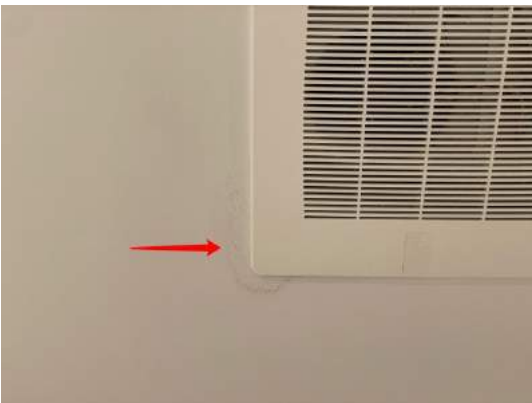
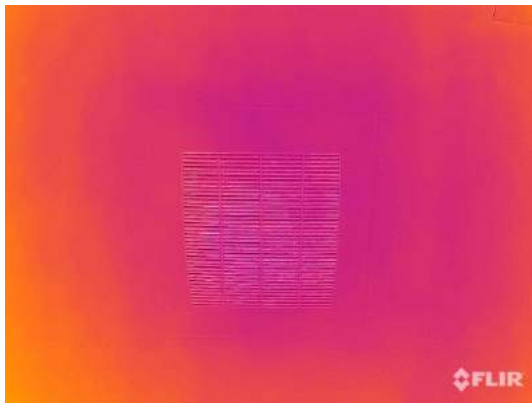
Comment 80

- Indications of dry water staining around exhaust fan at the time of inspection. No active moisture detected at the time of inspection.

Repair/replace ventilation exhaust fan. (Estimate: \$250 - \$500)

Repair/refinish surrounding in drywall to conceal previous dry water staining. (Estimate: \$100 - \$200)

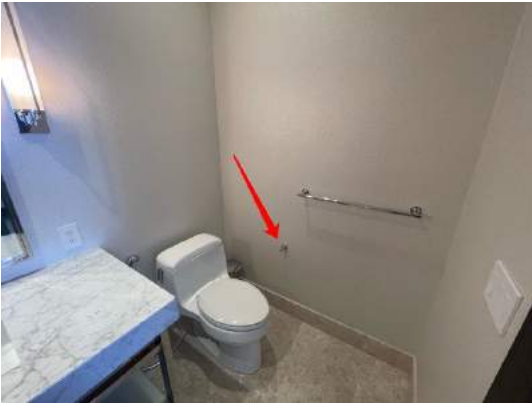
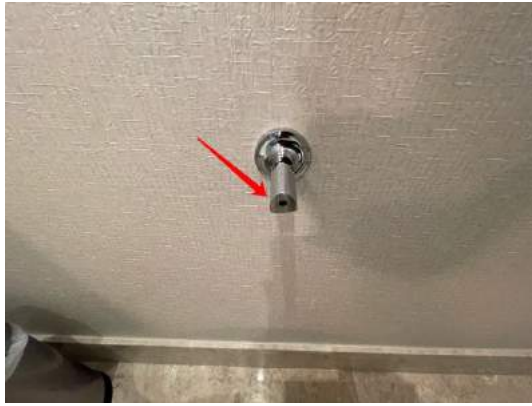
Comment 81

Toilet paper holder appears to have been damaged.

Replace toilet paper holder. (Estimate: \$100 - \$200)

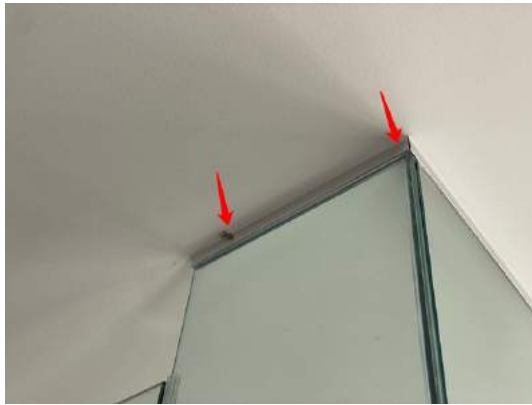
Comment 85

Loose trim along top of glass shower enclosure.

Recommend properly securing glass panel & trim along ceiling. (Estimate: \$100 - \$200)

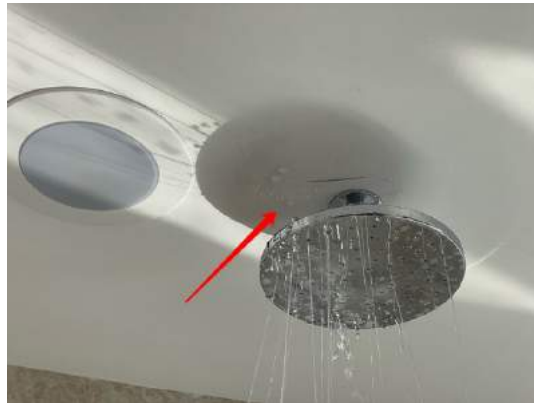
Comment 86

Broken rain shower head fixture causing water to spray towards ceiling.

- Active water damage caused to ceiling drywall due to broken shower fixture.

Replace rain shower head fixture to prevent further water damage to ceiling over shower. (Estimate: \$200 - \$300)

Repair water damage ceiling drywall over shower fixture. (Estimate: \$150 - \$250)

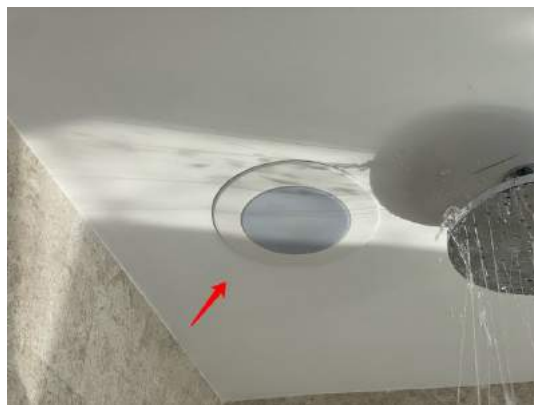
Comment 87

- Estimate light bulb is burnt out.

Replace light bulb to bathroom light fixture. (Estimate: \$10 - \$25)

If lighting fixture(s) continue not to function, recommend having a licensed electrician further evaluate circuit. (Estimate: \$200 - \$500)

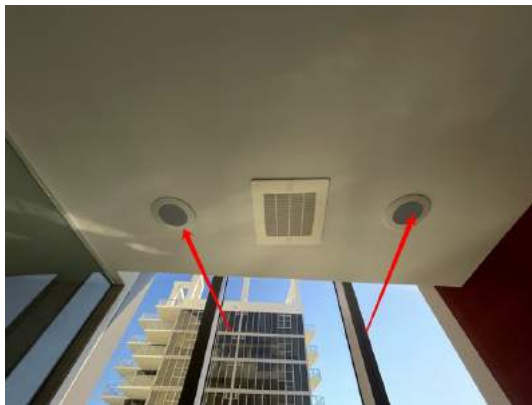
Comment 88

- Estimate light bulbs are burnt out.

Replace light bulbs to bathroom lighting fixtures. (Estimate: \$10 - \$25)

If lighting fixture(s) continue not to function, recommend having a licensed electrician further evaluate circuit. (Estimate: \$200 - \$500)

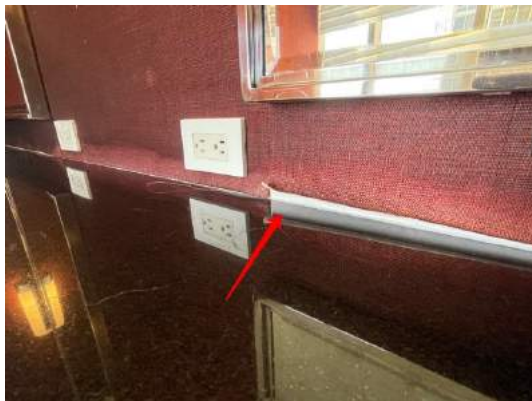
Indications of deterioration to wallpaper over vanity fixture.

Repair/replace wallpaper. (Detailed quotation required)

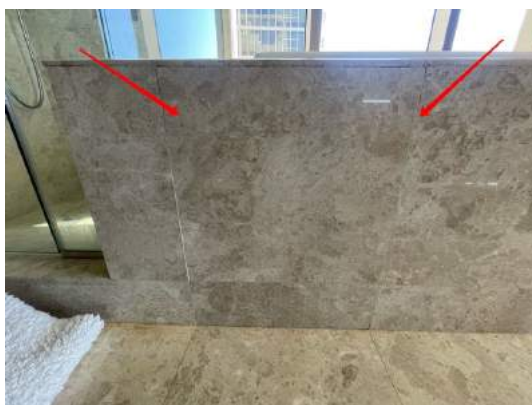
Comment 91

Loos tile around tub fixture within bathroom.

Recommend securing & re-grouting tile around tub fixture. (Estimate: \$100 - \$250)

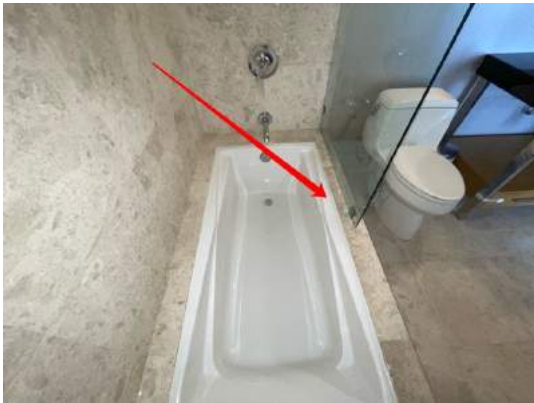
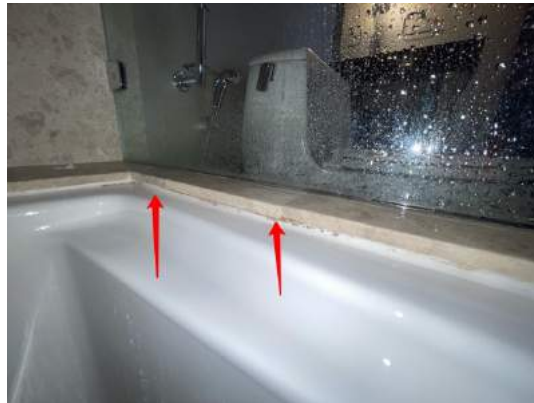
Comment 93

Apparent deterioration to caulking around tub fixture.

Recommend re-caulking/re-sealing around tub fixture. (Estimate: \$100 - \$200)

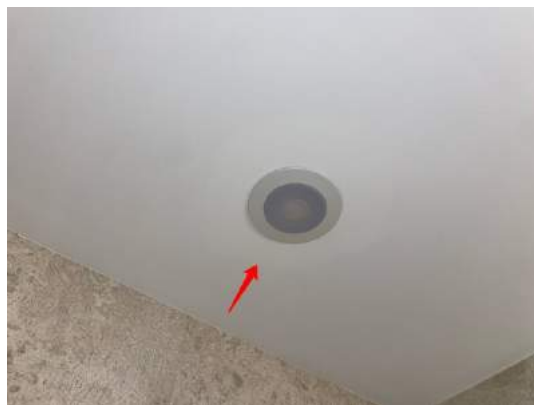
Comment 94

- Estimate light bulb is burnt out.

Replace light bulb to bathroom light fixture. (Estimate: \$10 - \$25)

If lighting fixture(s) continue not to function, recommend having a licensed electrician further evaluate circuit. (Estimate: \$200 - \$500)
