## Condo Inspection Report

**9705 Collins Ave**

**Unit 2204N/2205N**

Inspected on Tue, Mar 29 2022 at 1:00 PM

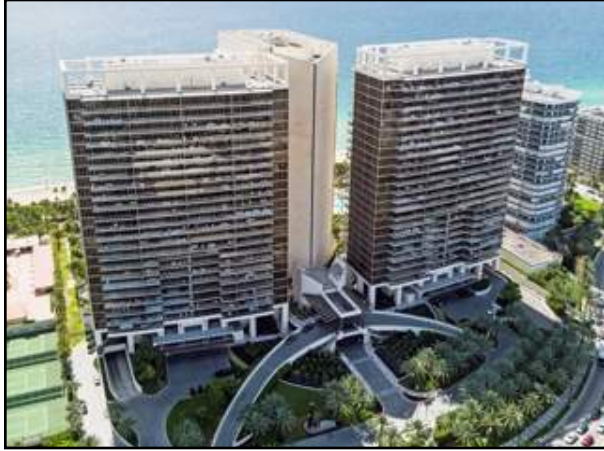
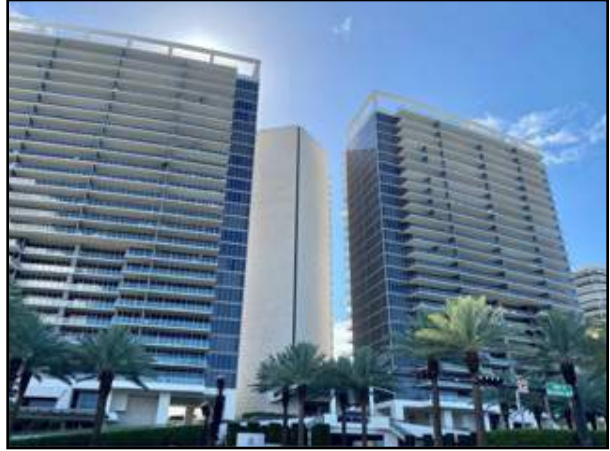
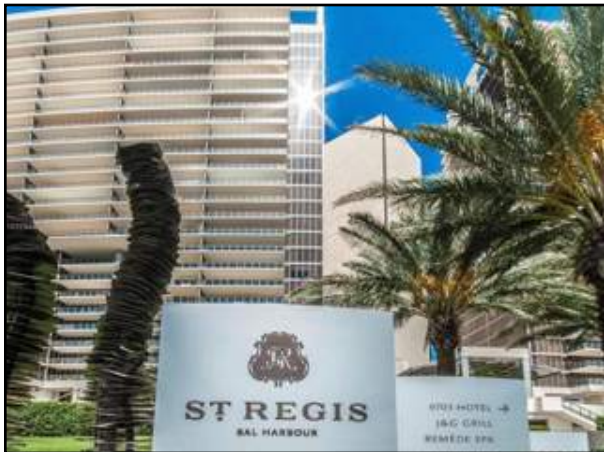
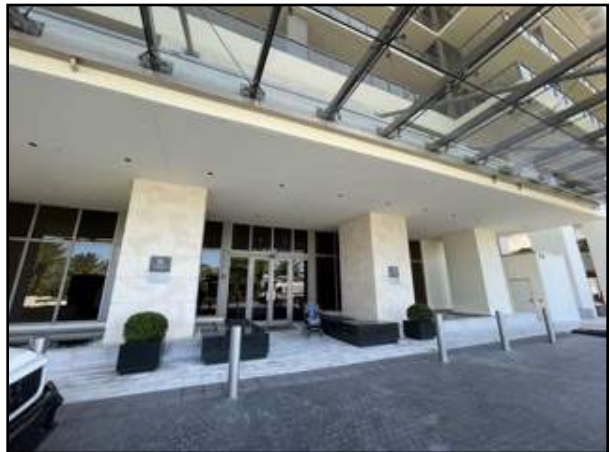
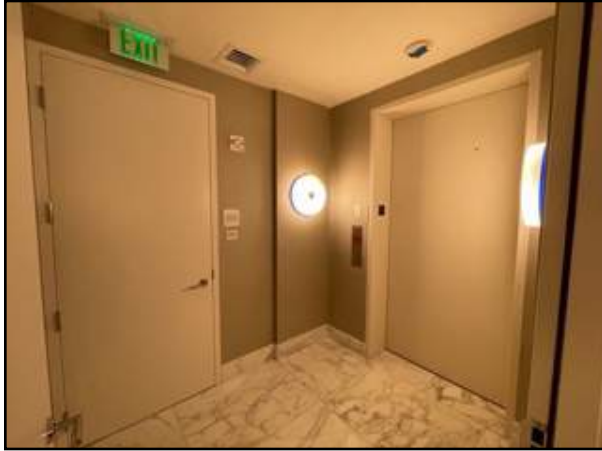
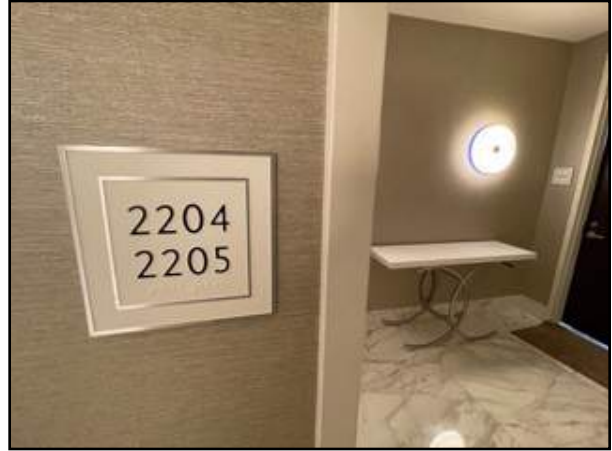
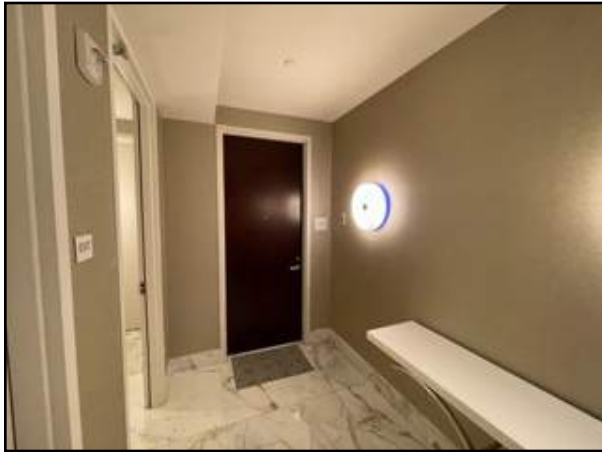
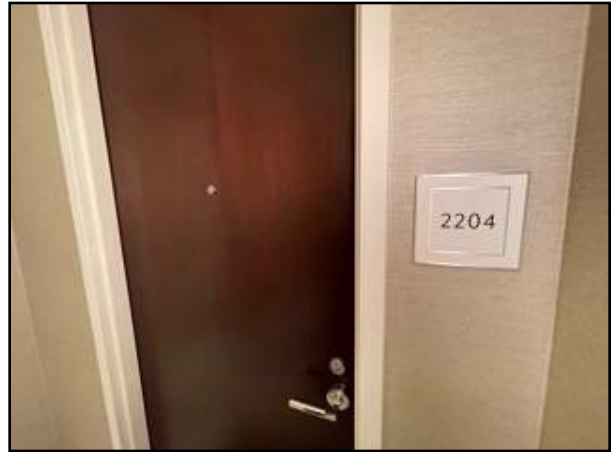
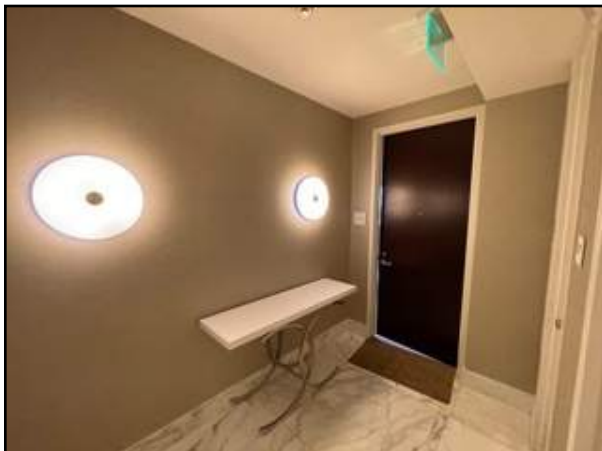
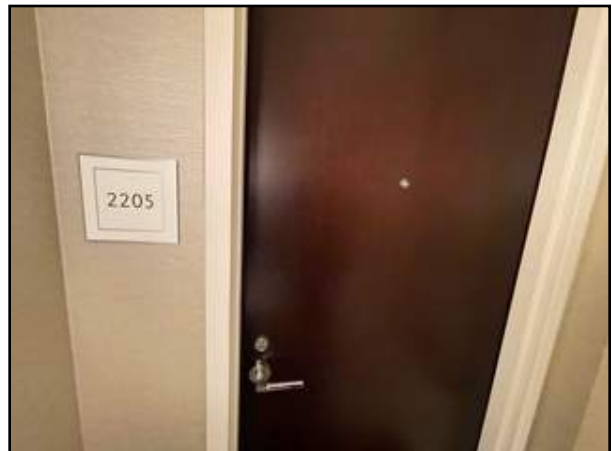
Comment 1:  
Exterior/Site.

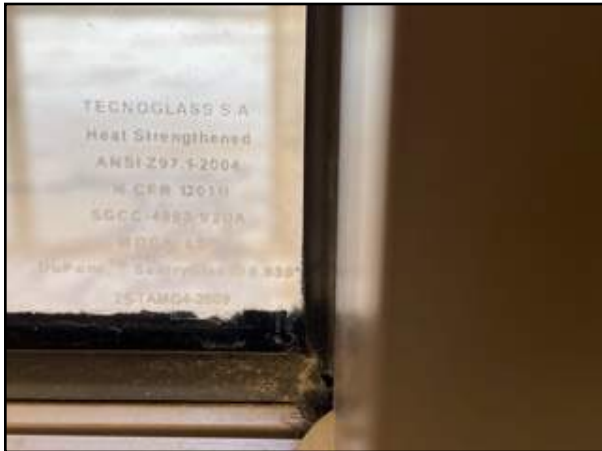
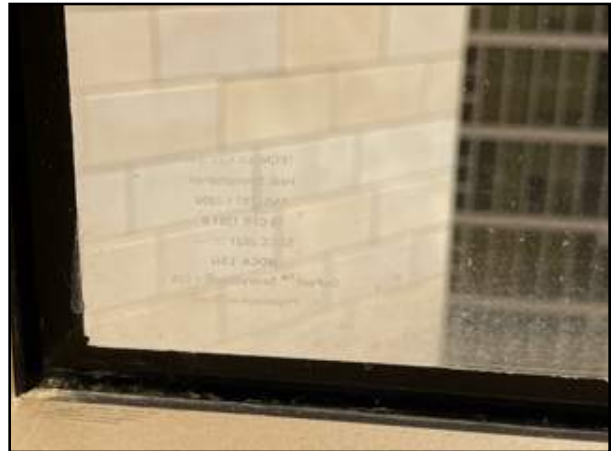
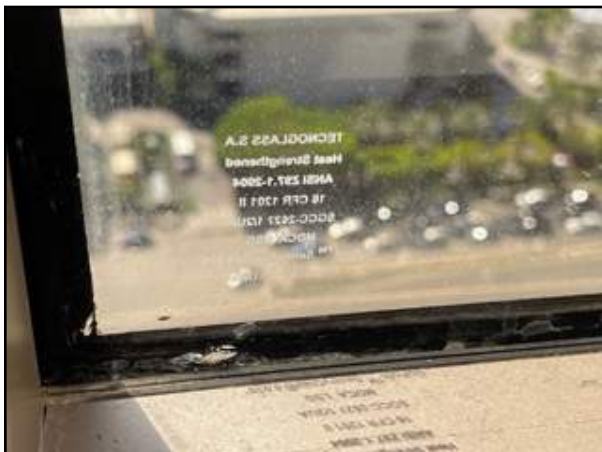
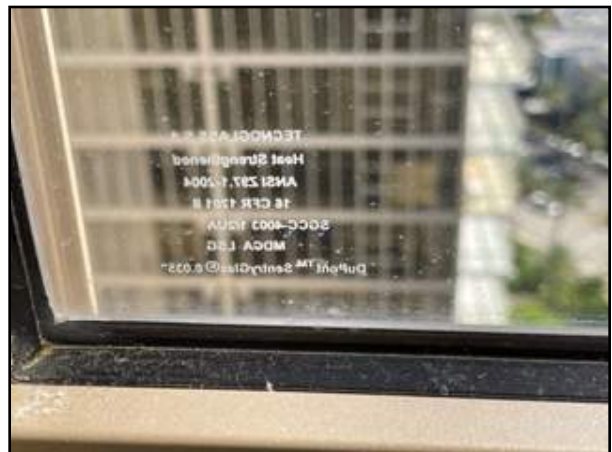
Comment 2:  
Wind Mitigation / Storm Protection.  
- Impact Windows & Doors

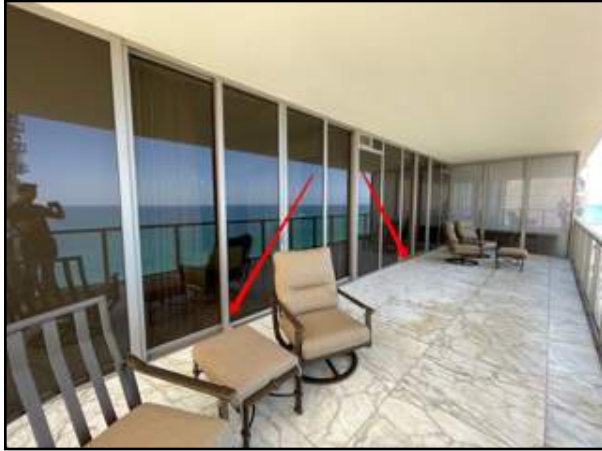
Figure 3-1

Comment 3:  
Sliding glass doors to east facing exterior balconies are stiff on tracks and difficult to open/close.  
Recommend servicing sliding-glass doors by a qualified professional, and cleaning/re-greasing tracks & rollers to sliding glass door for proper operation.  
(Estimate: \$1,500 - \$2,500)

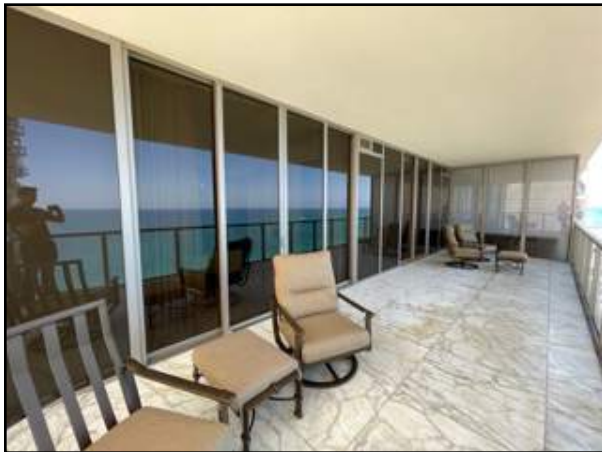
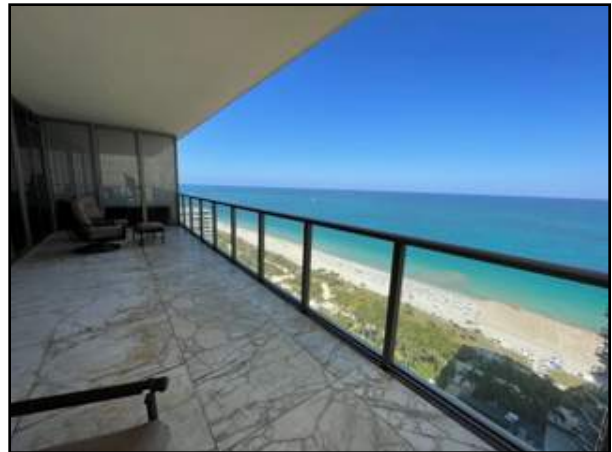
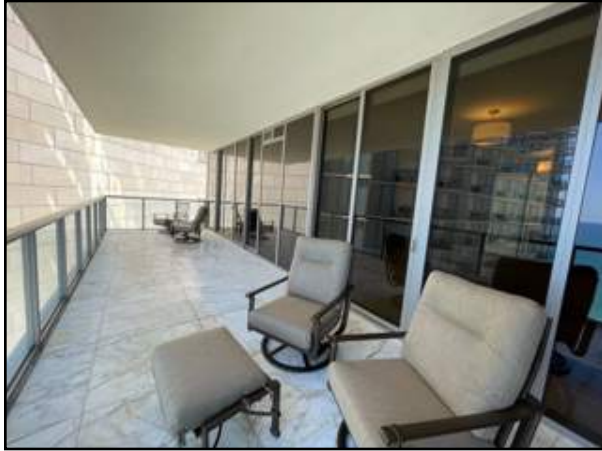
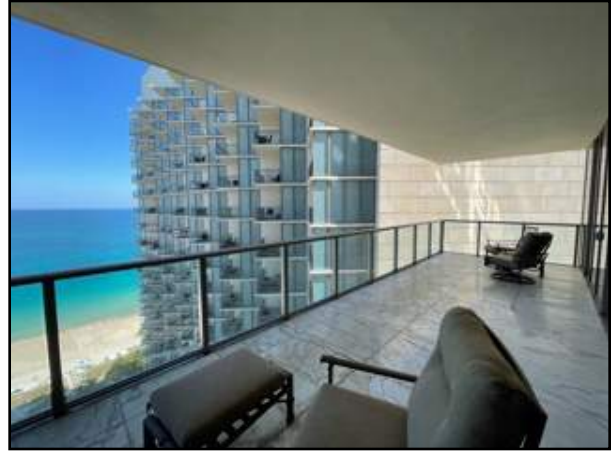
Comment 4:  
East balcony.

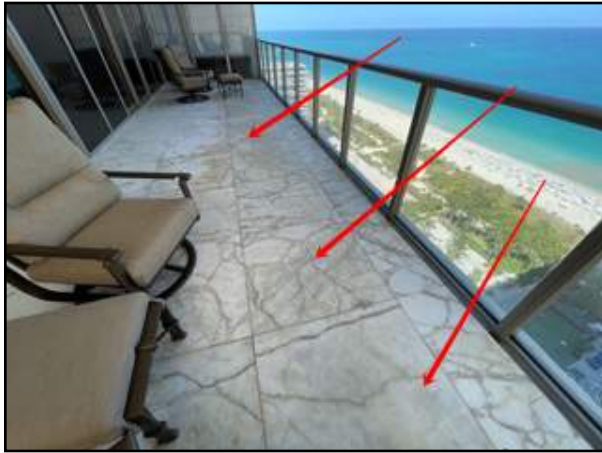
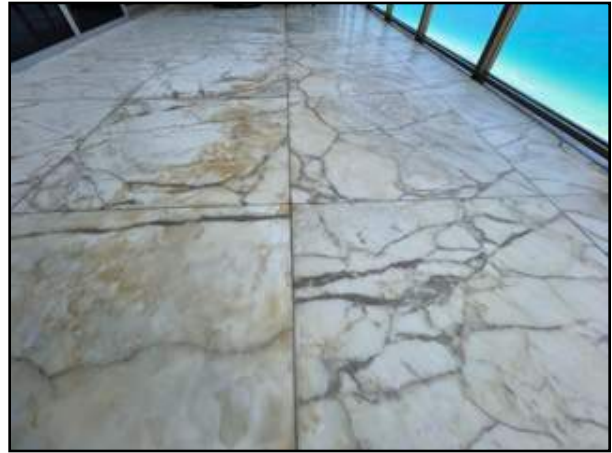
- Estimate discoloration may be natural texture & porous nature of marble stone tiling due to worn seal as well as moisture intrusion below tile flooring. Repair/Replace or re-polish/re-seal damaged or discolored tile flooring along exterior balcony as desired. (Estimate: \$2,000 - \$5,000)

If tile flooring is unable to be matched, complete replacement of flooring may be necessary. (Detailed quotation required)

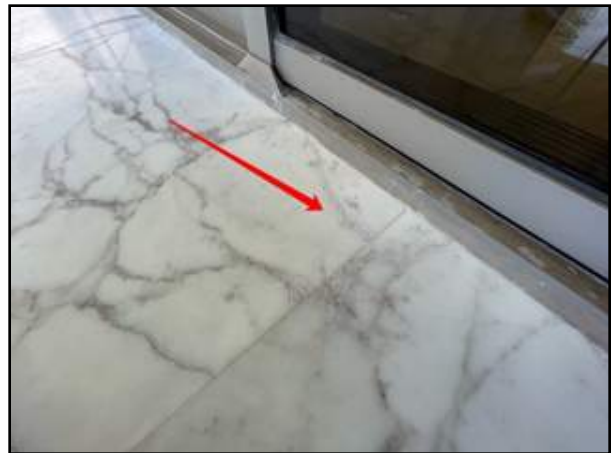
Figure 6-2

Cracked/broken flooring tile along east balcony outside of bedroom #2.  
Replace broken flooring tile along exterior balcony. (Estimate: \$200 - \$400)

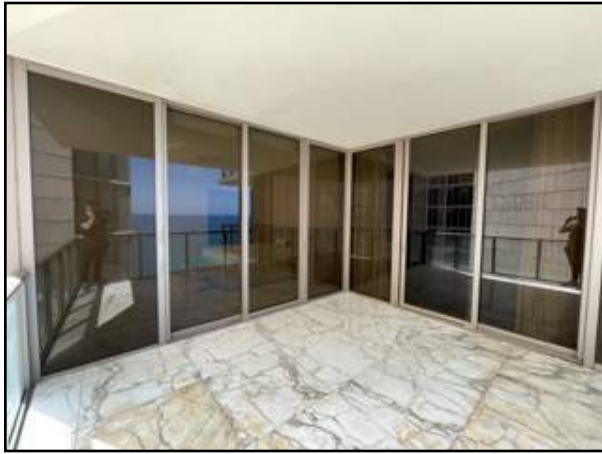
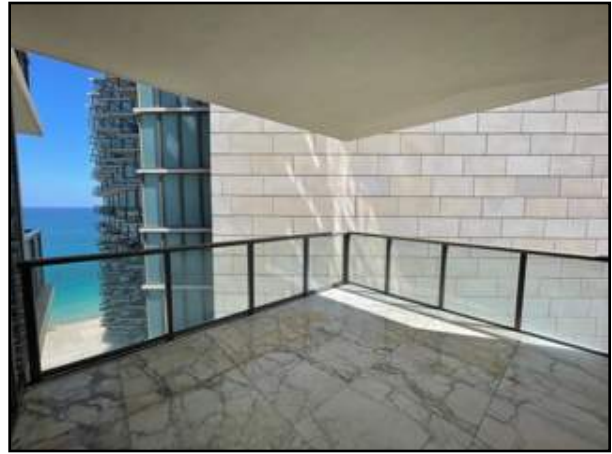
Master bedroom/ dining are balcony.

- Estimate discoloration may be natural texture & porous nature of marble stone tiling due to worn seal as well as moisture intrusion below tile flooring.

Repair/Replace or re-polish/re-seal damaged or discolored tile flooring along exterior balcony as desired. (Estimate: \$2,000 - \$5,000)

If tile flooring is unable to be matched, complete replacement of flooring may be necessary. (Detailed quotation required)

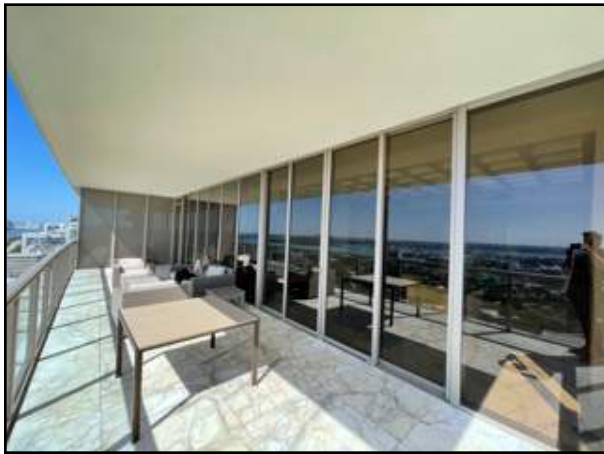
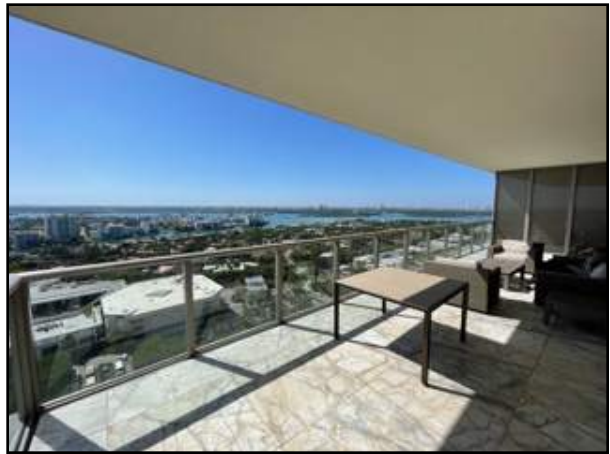
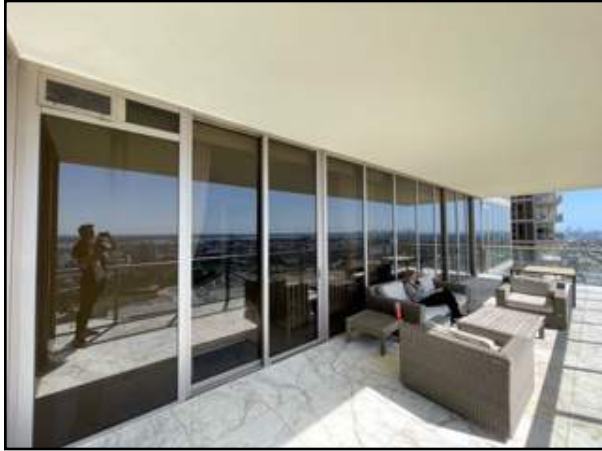
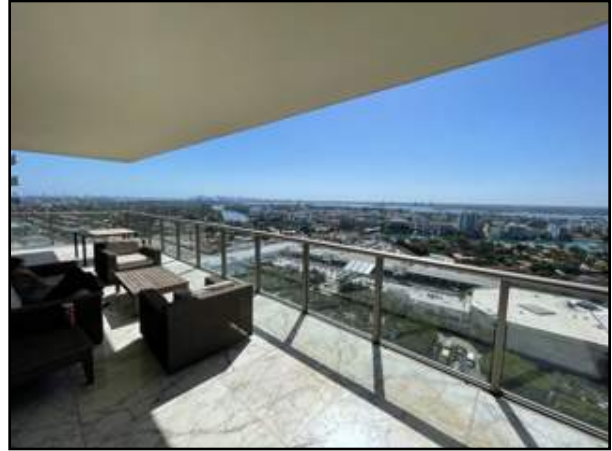
Comment 9:  
West balcony.

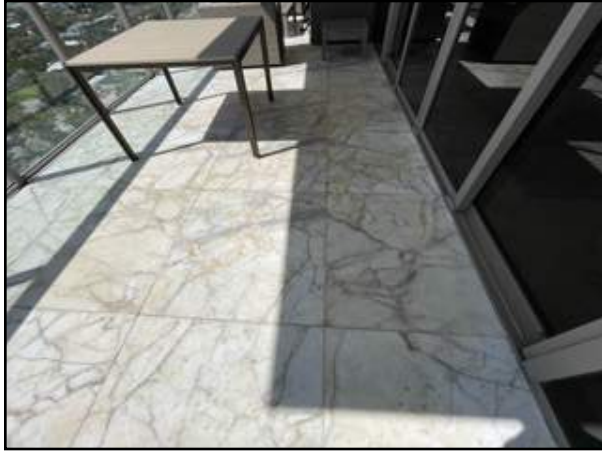
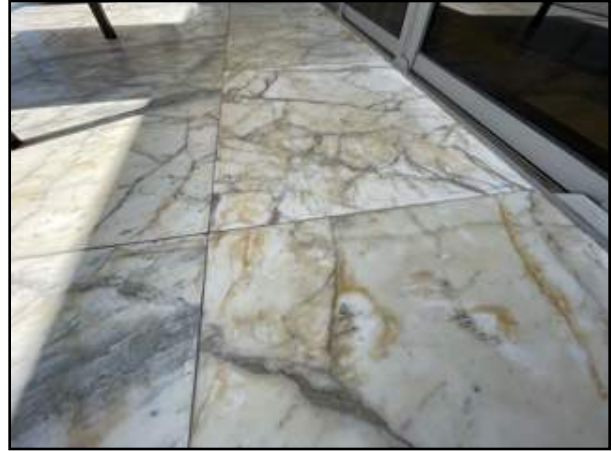
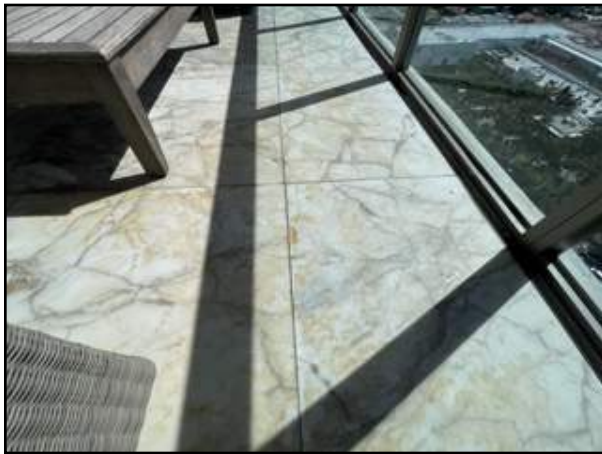
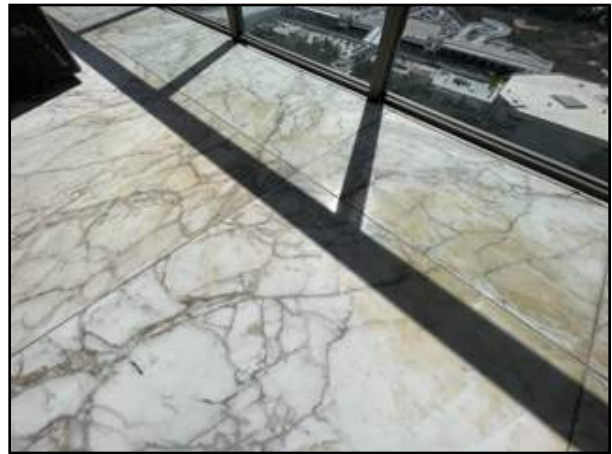
- Estimate discoloration may be natural texture & porous nature of marble stone tiling due to worn seal as well as moisture intrusion below tile flooring.

Repair/Replace or re-polish/re-seal damaged or discolored tile flooring along exterior balcony as desired. (Estimate: \$2,000 - \$5,000)

If tile flooring is unable to be matched, complete replacement of flooring may be necessary. (Detailed quotation required)

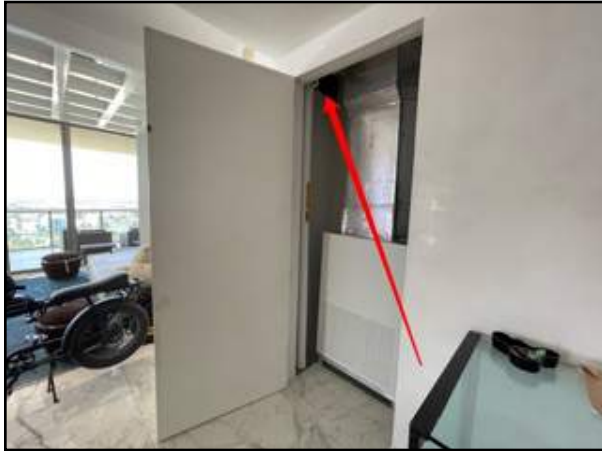
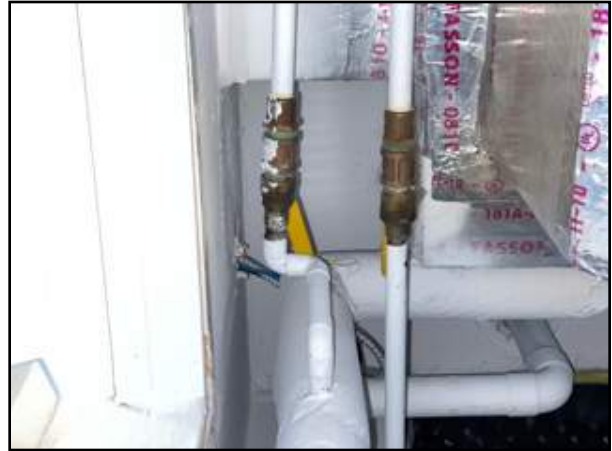
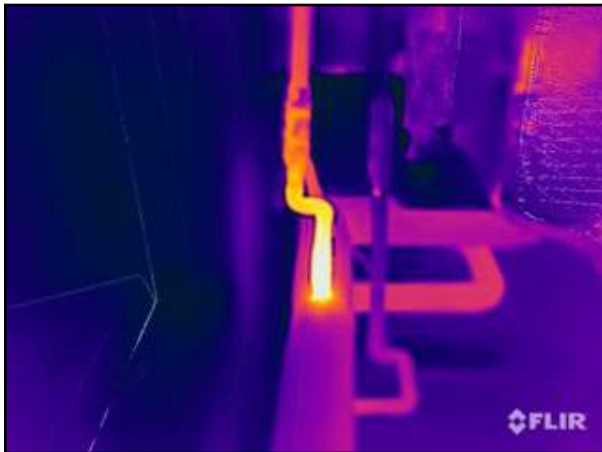
Main water shut-off valves (hot & cold water lines) for west side of unit are located in west side of property within A/C closet above to air handler unit.

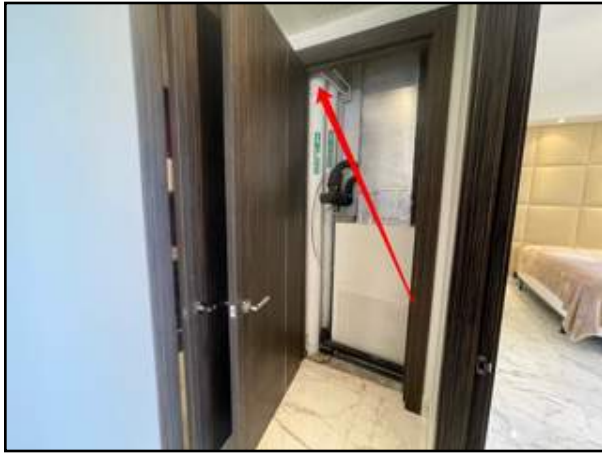
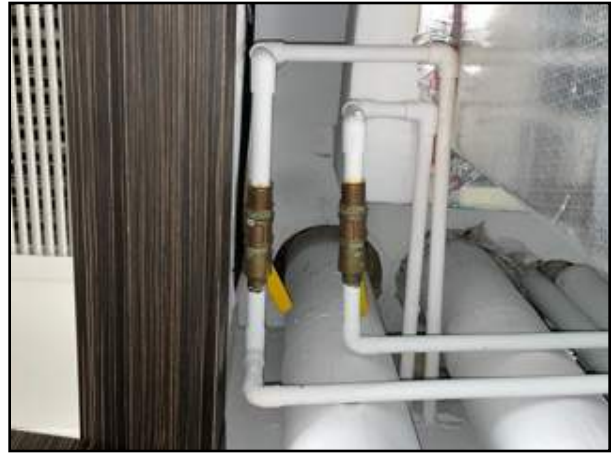
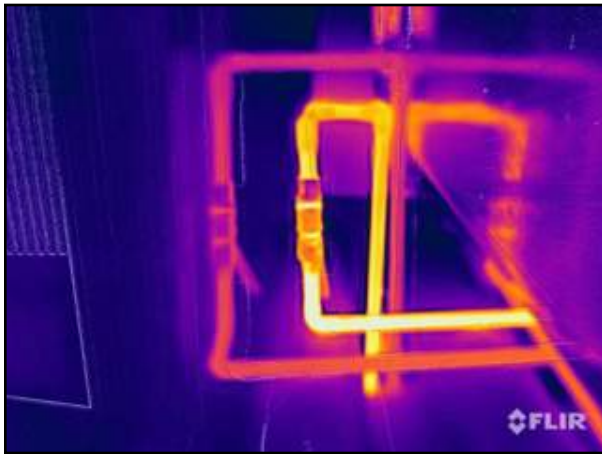
Main water shut-off valves (hot & cold water lines) for east side of unit are located in east side of property within A/C closet above to air handler unit.

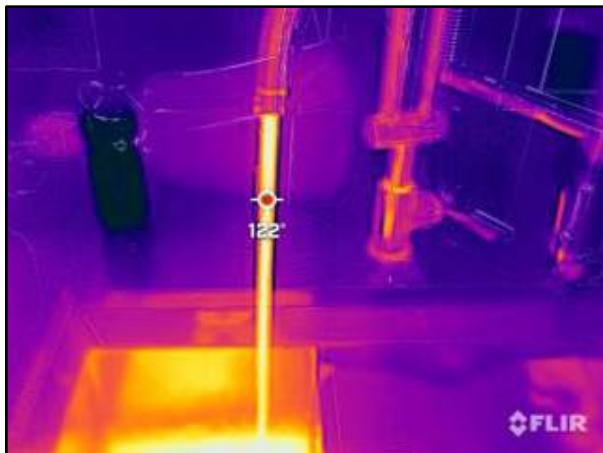
Figure 14-1

Hot water systems are controlled/maintained by building.

- Hot water systems functioning properly at the time of inspection.

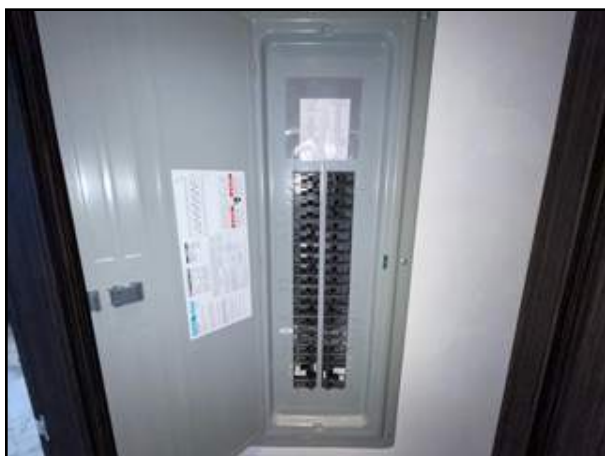
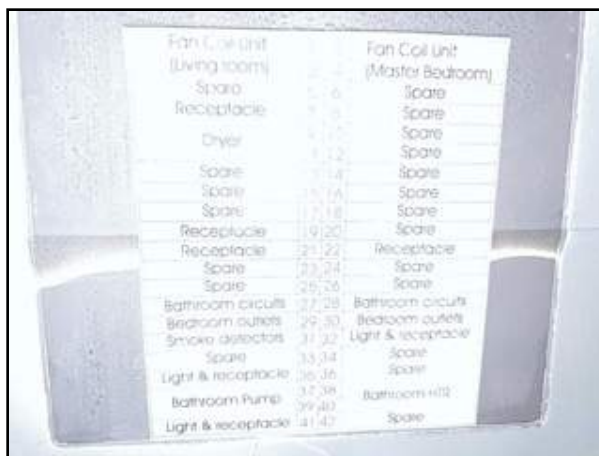
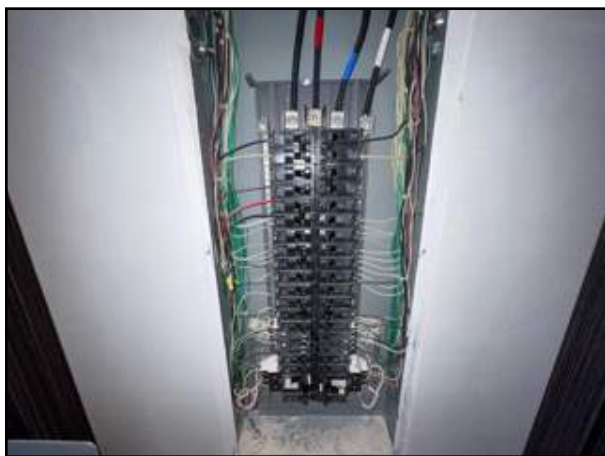
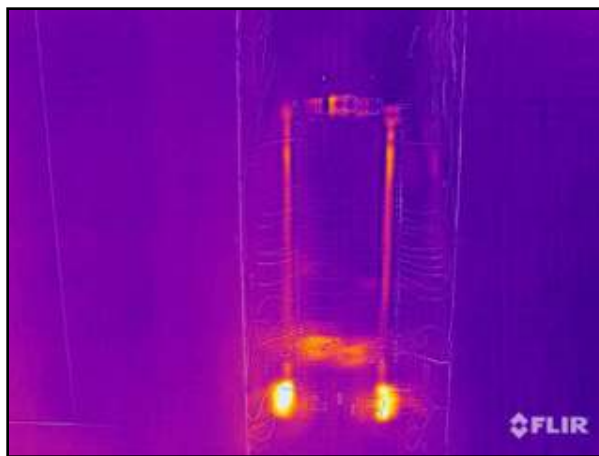
Main distribution panel A (110 AMPs) located within west bedroom hallway.

- Distribution panel, circuit breakers, and branch wiring appear in good & working condition at the time of inspection.

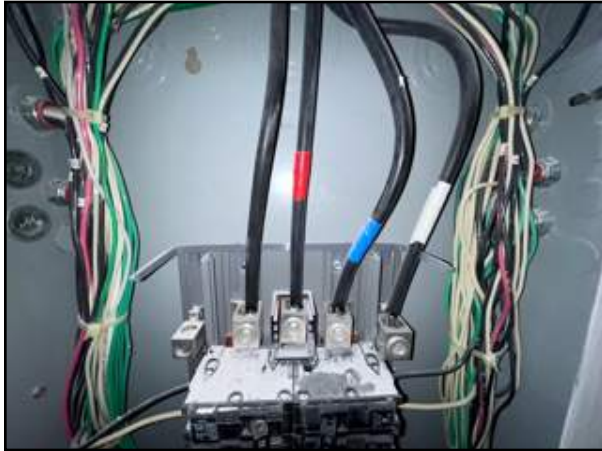
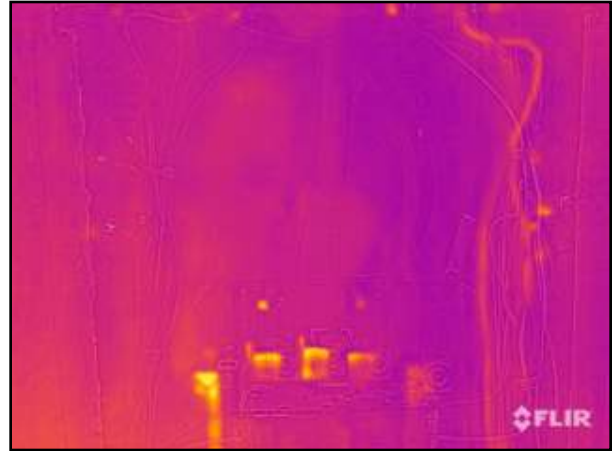
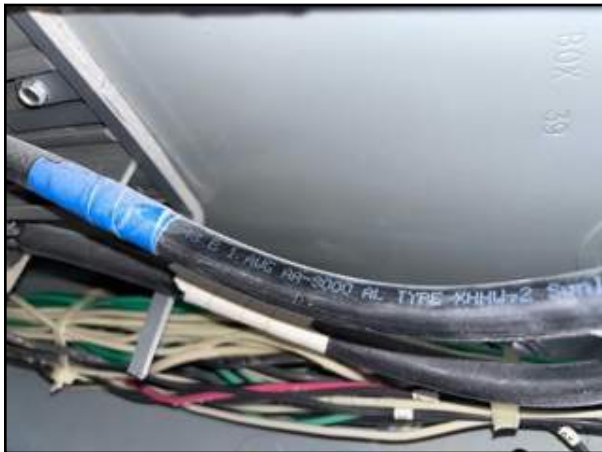
Electrical service entrance conductors (3 Phase) are in good & working condition within main distribution panel A.

- Electrical service is properly grounded in main distribution panel.
- Main service conductors are currently #1 AWG aluminum lines adequate for service up to 110 AMPs.

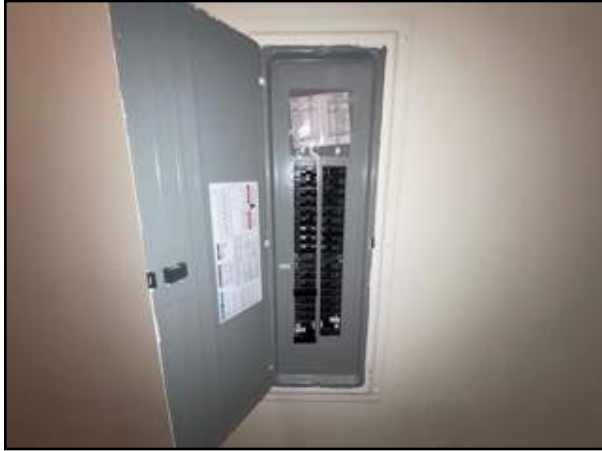
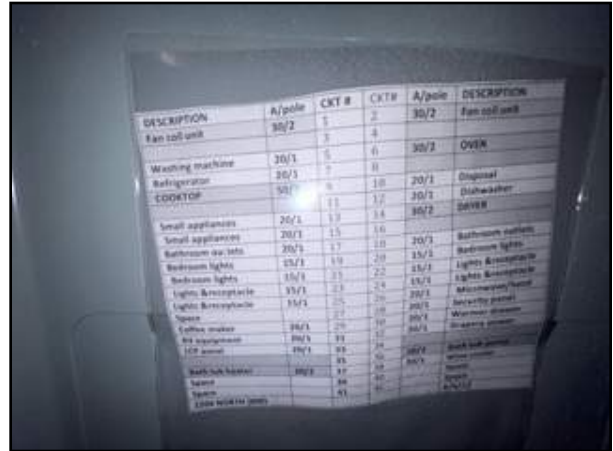
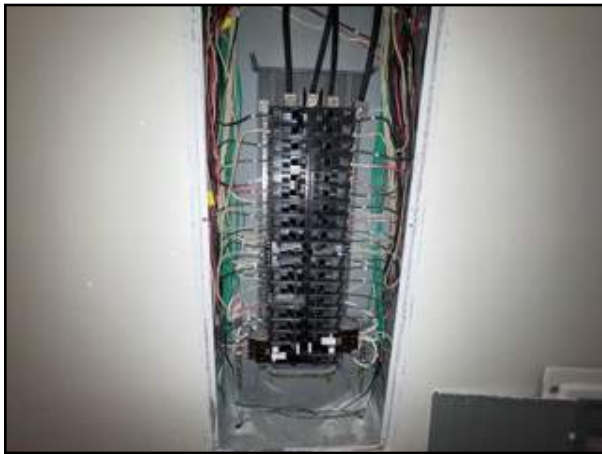
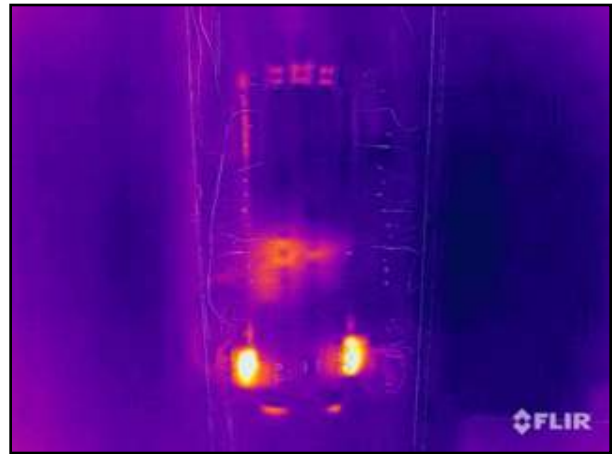
Main distribution panel B (110 AMPs) located within master bedroom closet.

- Distribution panel, circuit breakers, and branch wiring appear in good & working condition at the time of inspection.

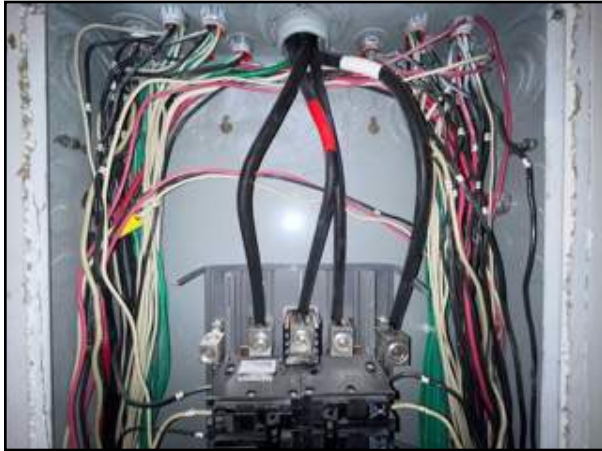
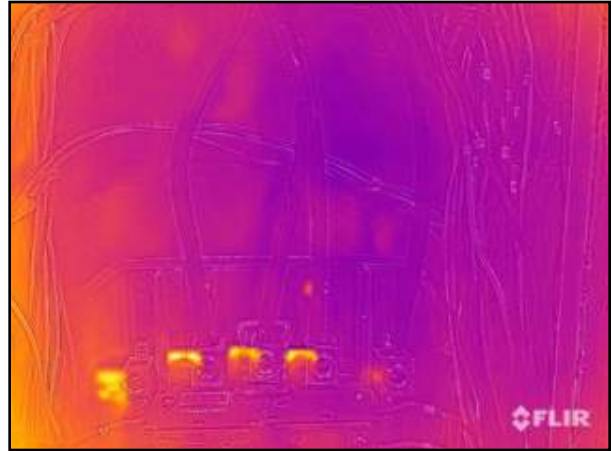
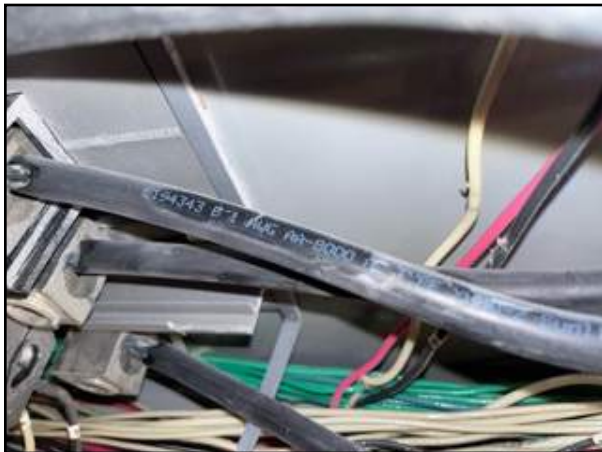
Electrical service entrance conductors (3 Phase) are in good & working condition within main distribution panel B.

- Electrical service is properly grounded in main distribution panel.
- Main service conductors are currently #1 AWG aluminum lines adequate for service up to 110 AMPs.

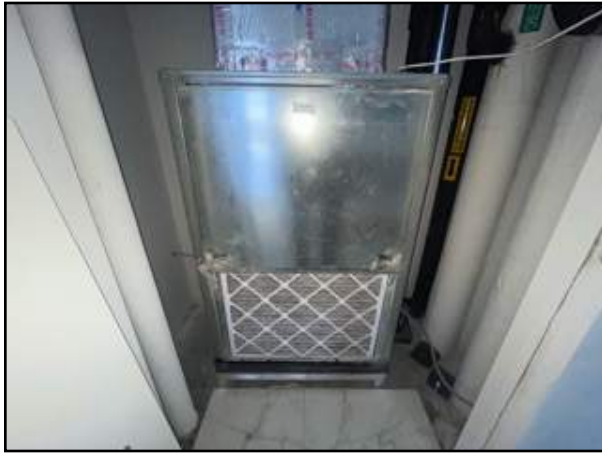
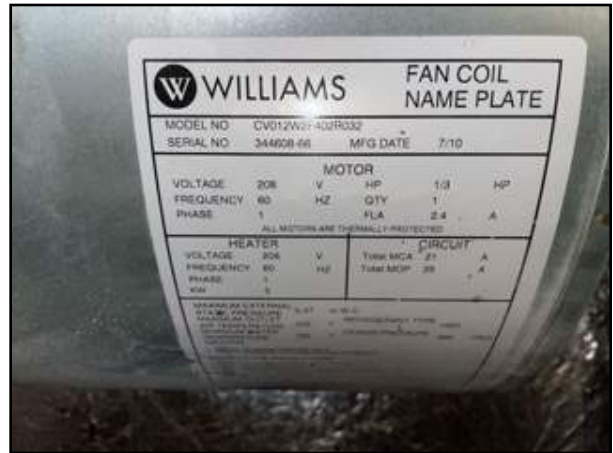
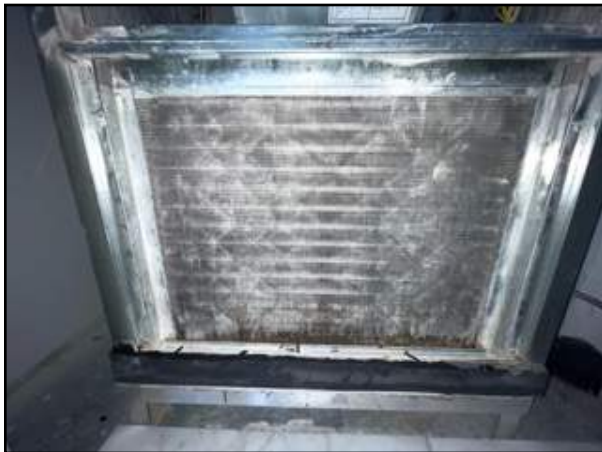
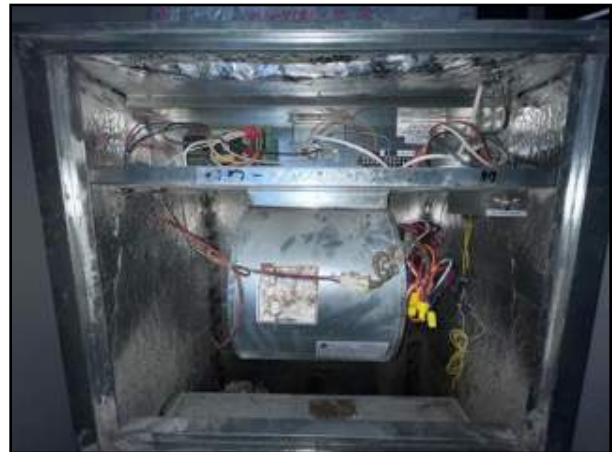
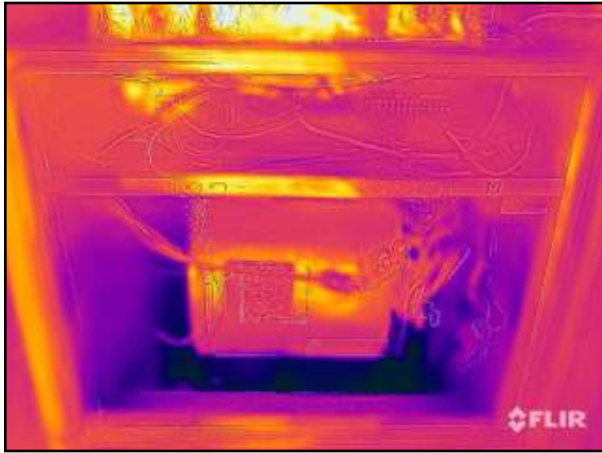
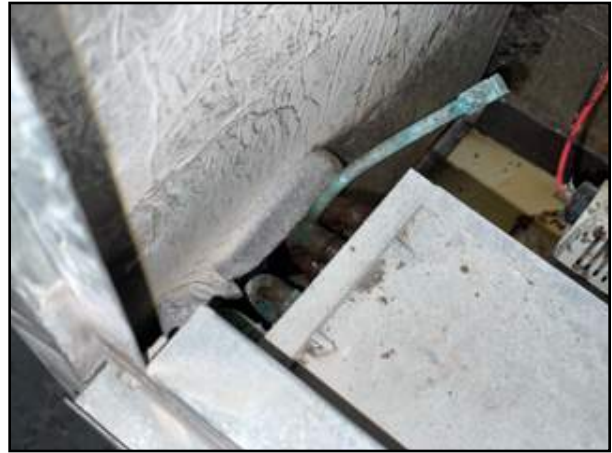
- HVAC system appears in good & working condition at the time of inspection.
- A/C radiator & coils appear in good condition at the time of inspection.
- Minor debris build up along exterior of radiator.

Recommend having HVAC system serviced/cleaned periodically by a licensed HVAC technician for better maintenance.

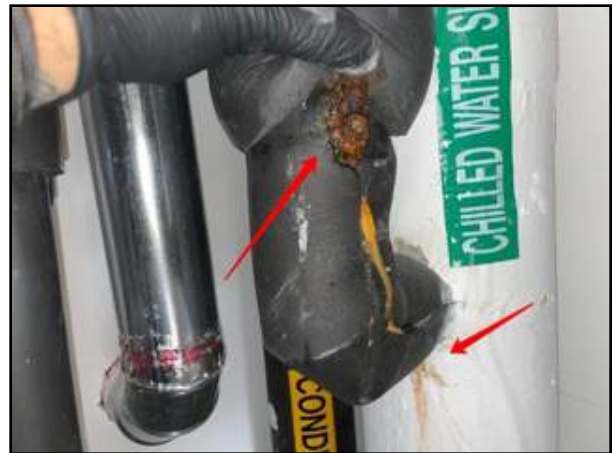
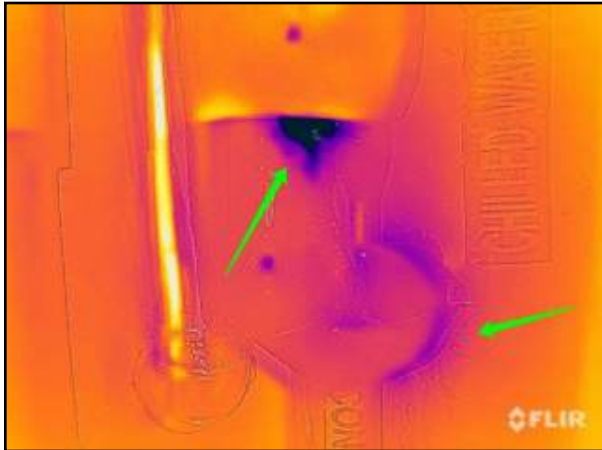
Apparent oxidation/rusting & corrosion around incoming & outgoing water valves for water source heat pump HVAC system within A/C closet.

- Apparent condensation/moisture from water valves at the time of inspection. Recommend monitoring these valves to make sure no leaking occurs in the future. If leaking from valves does happen to occur, report to building engineer to have building maintenance repair/replace valves.

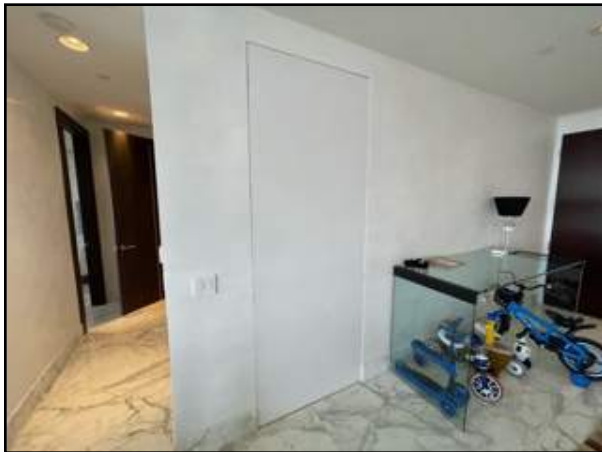
Figure 21-1

- Difficult to open A/C closet.

Recommend installation of hardware or handle to open A/C closet door.

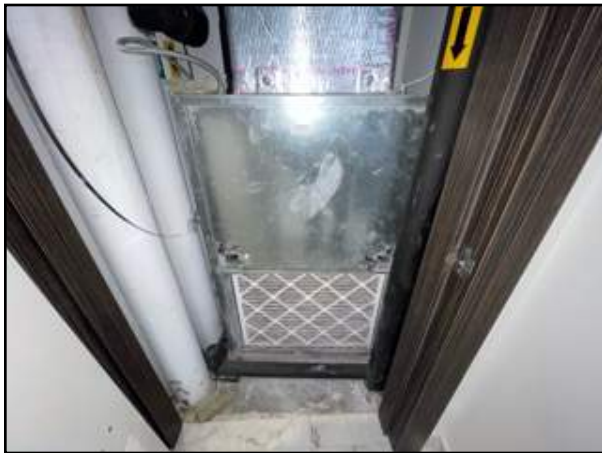
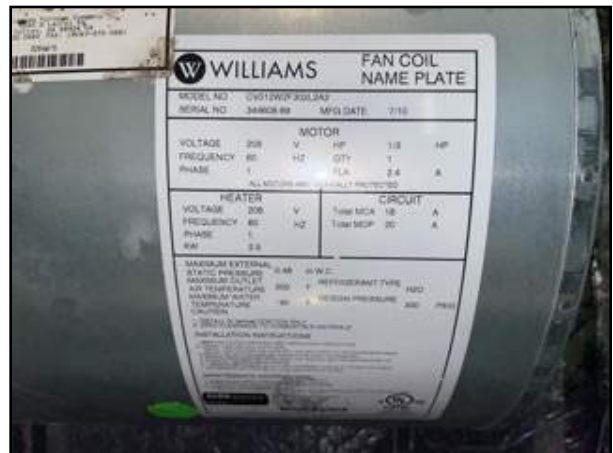
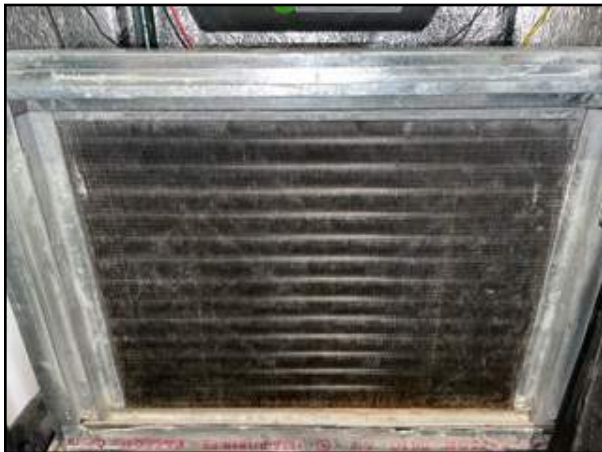
- HVAC system appears in good & working condition at the time of inspection.
- A/C radiator & coils appear in good condition at the time of inspection.
- Minor debris build up along exterior of radiator.

Recommend having HVAC system serviced/cleaned periodically by a licensed HVAC technician for better maintenance.

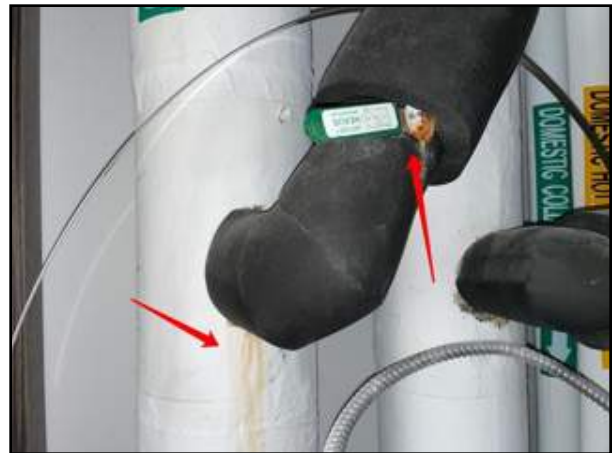
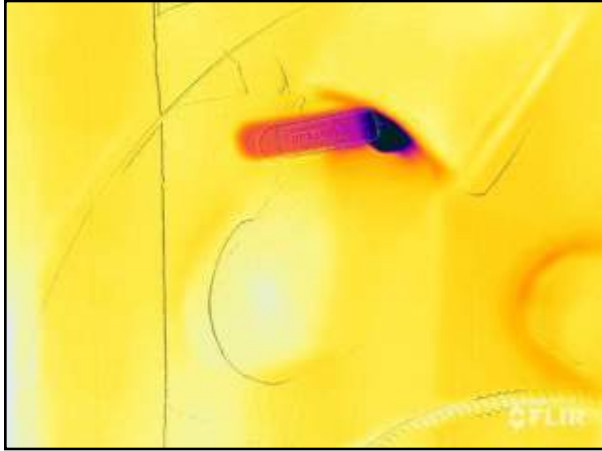
Figure 23-2

Apparent oxidation/rusting & corrosion around incoming & outgoing water valves for water source heat pump HVAC system within A/C closet.

- Apparent condensation/moisture from water valves at the time of inspection. Recommend monitoring these valves to make sure no leaking occurs in the future. If leaking from valves does happen to occur, report to building engineer to have building maintenance repair/replace valves.

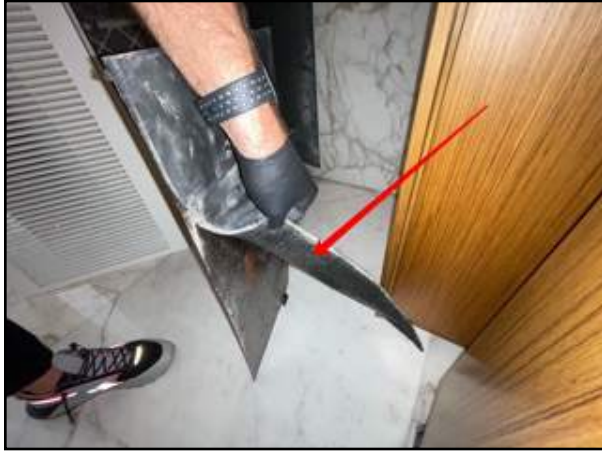
Figure 25-1

Loose insulation within air handler unit currently being sucked into unit around blower fan.

- Insulation surrounding blower fan can cause extensive wear & tear to fan motor and cause motor to burn out.

Recommend repairing insulation within air handler unit to keep clear from fan blower. (Estimate: \$150 - \$250)

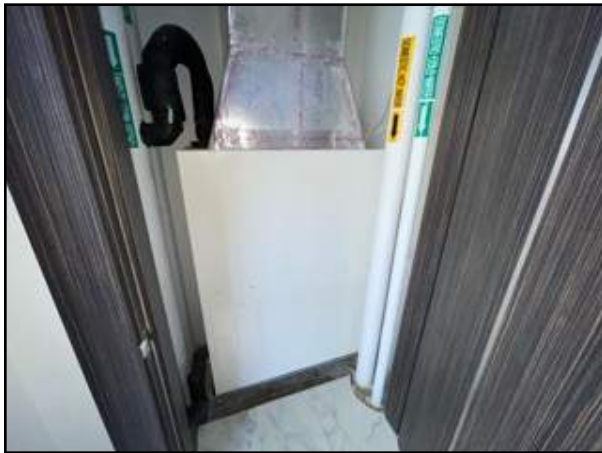
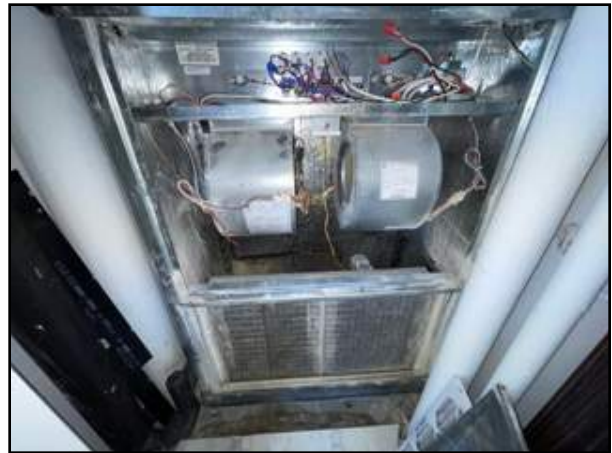
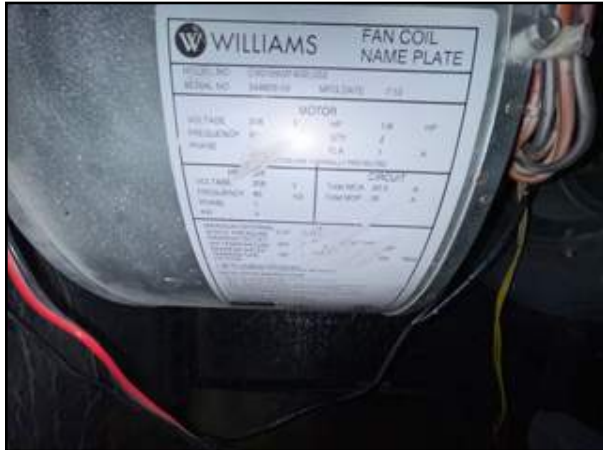
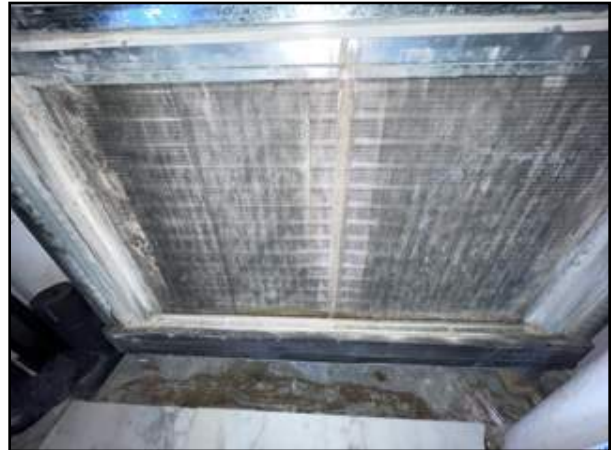
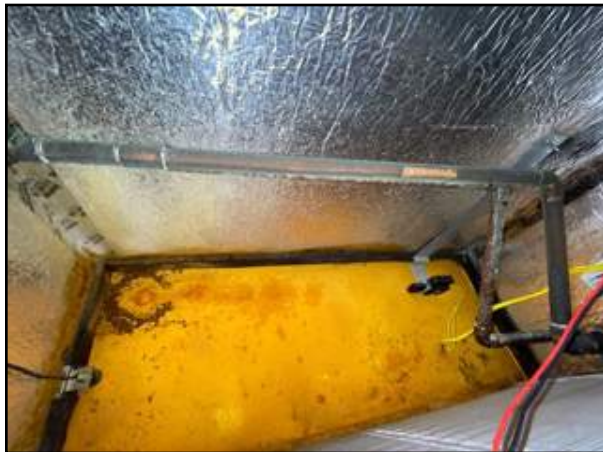
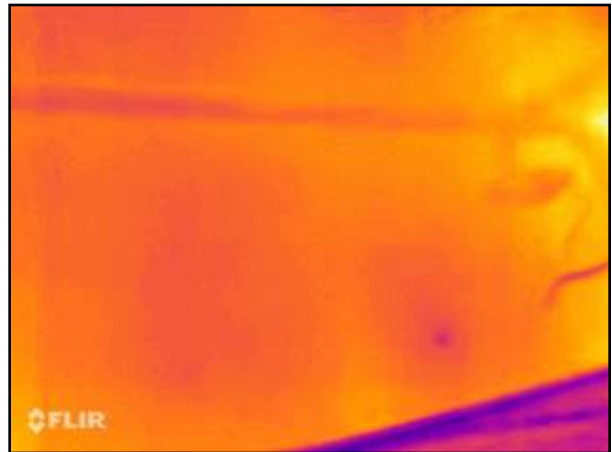
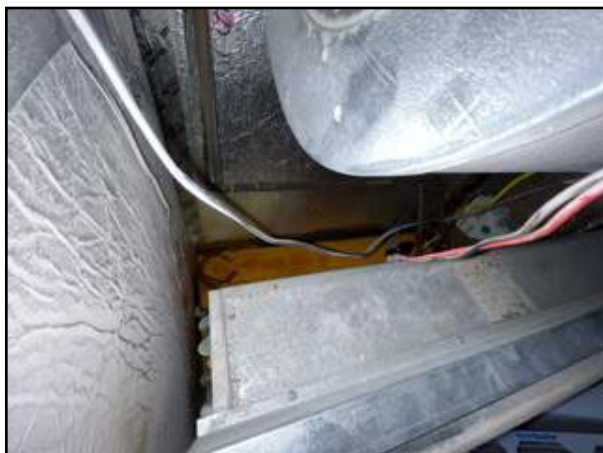
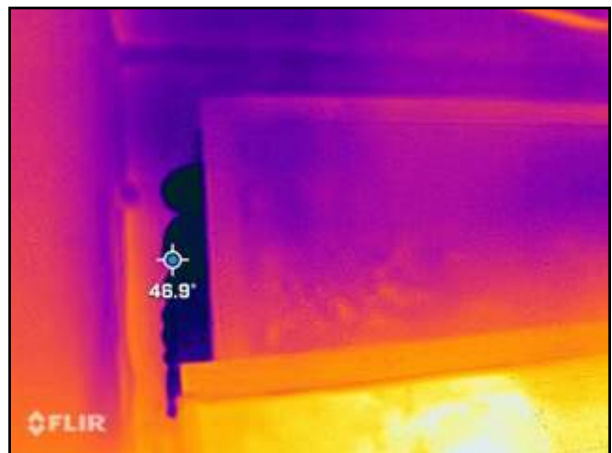
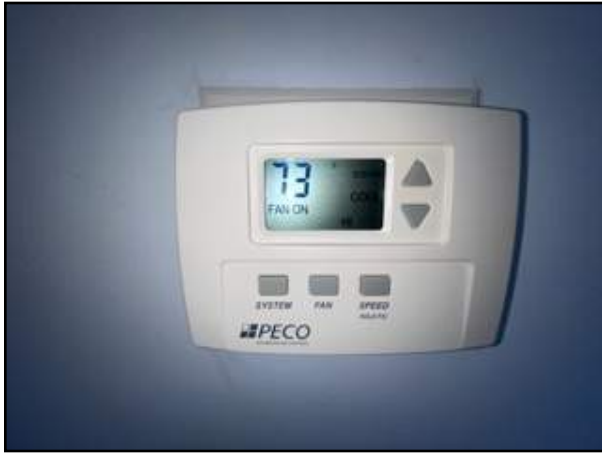
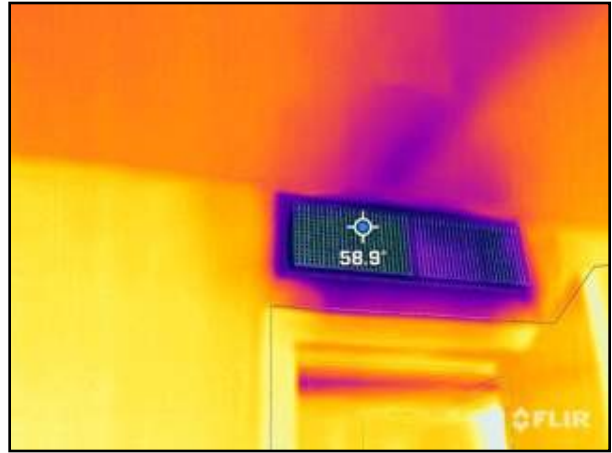
- HVAC system appears in good & working condition at the time of inspection.
- A/C radiator & coils appear in good condition at the time of inspection.
- Minor debris build up along exterior of radiator.

Recommend having HVAC systems serviced/cleaned periodically by a licensed HVAC technician for better maintenance.
