## Condo Inspection Report

**9705 Collins Ave**

**Unit 2204N/2205N**

Inspected on Tue, Mar 29 2022 at 1:00 PM

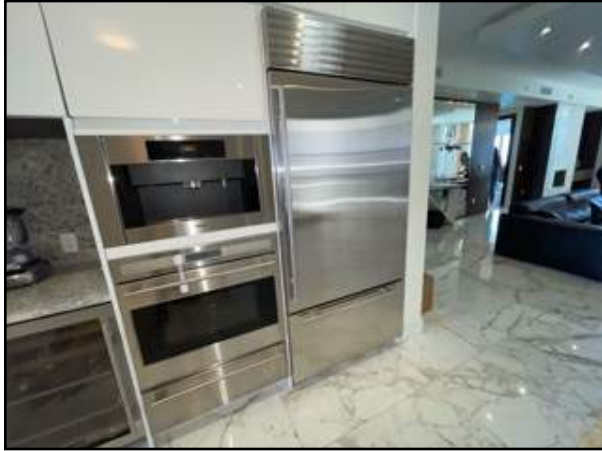
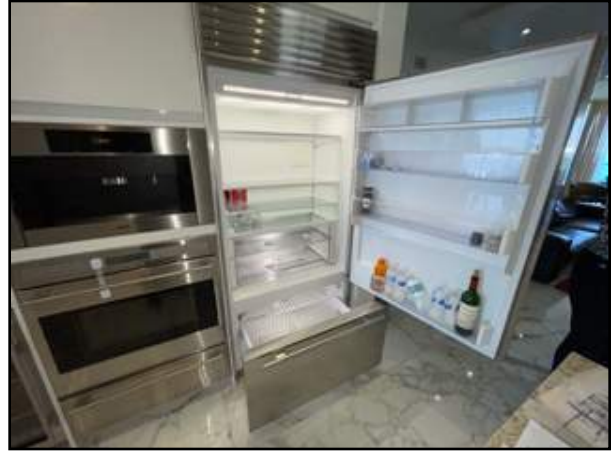
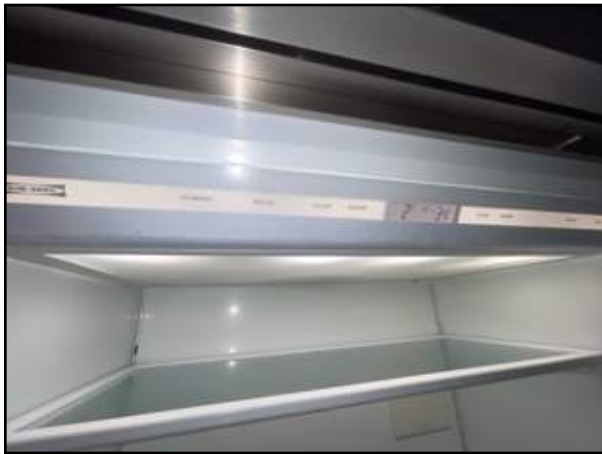
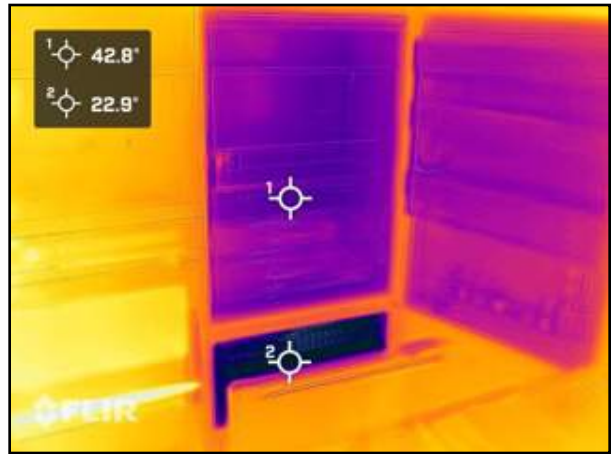
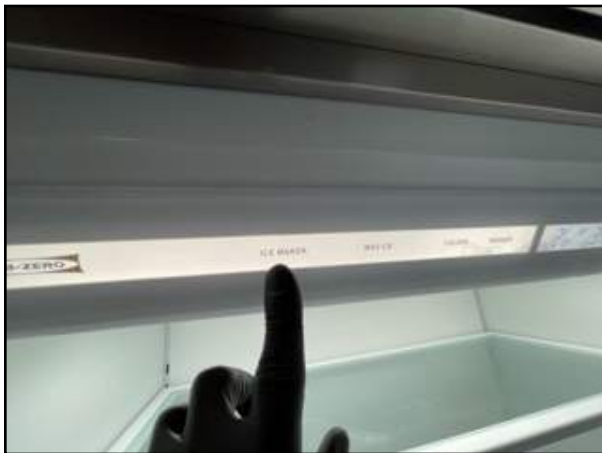
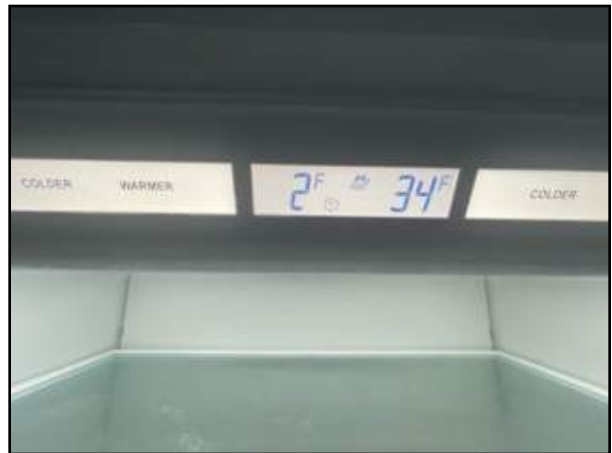
- Ice maker appears to be functioning properly. (Turned off prior to and following inspection)

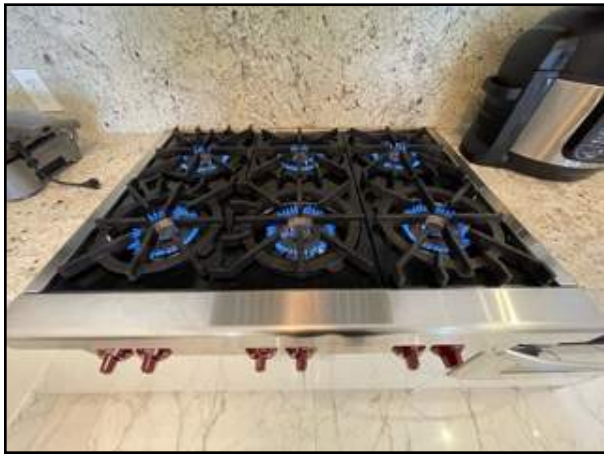
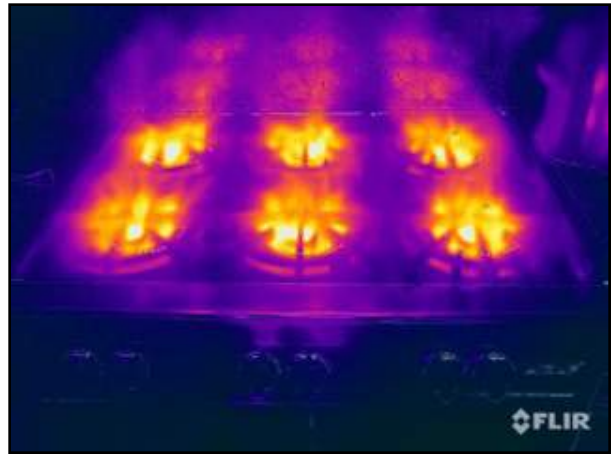
Comment 32:  
Range cooktop functioning properly.

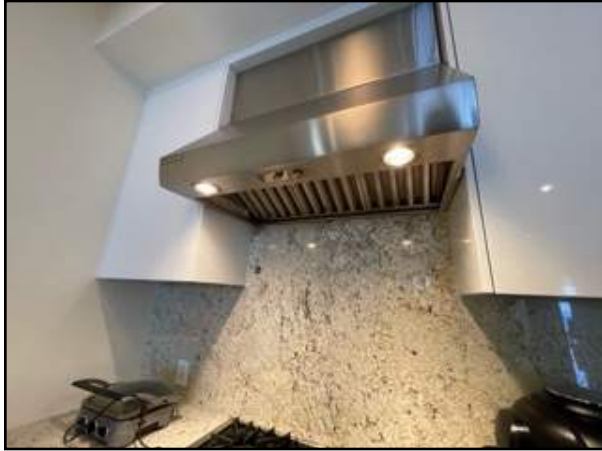
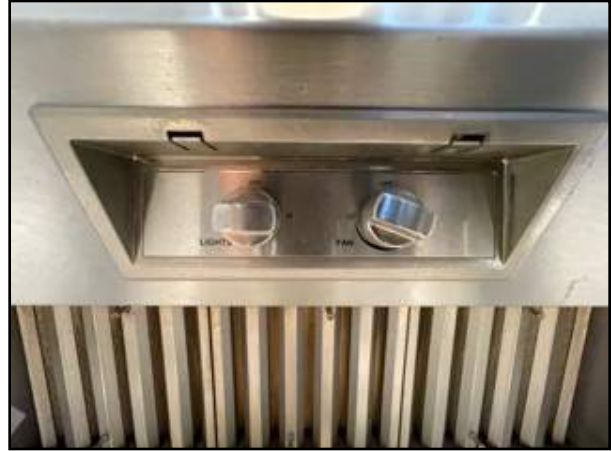
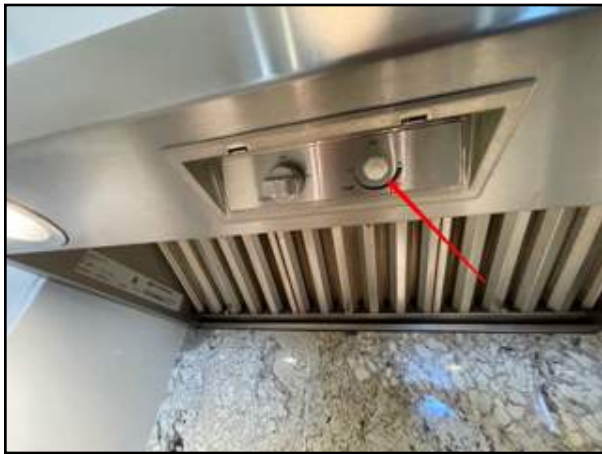
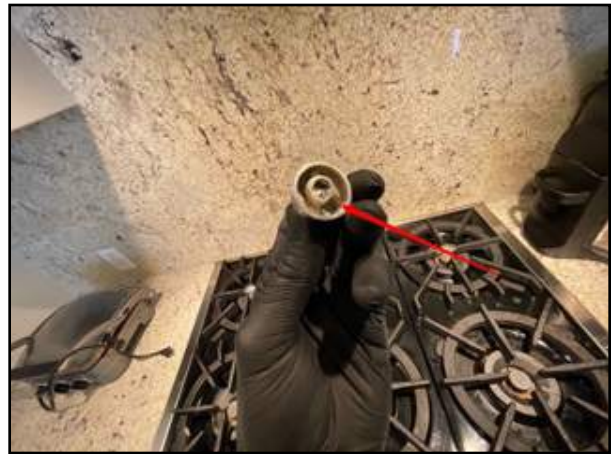
- ⚠ Comment 33:  
Range hood over cooktop functioning properly at the time of inspection.  
- Fan knob damaged.  
Repair/replace hood fan knob. (Estimate: \$25 - \$50)

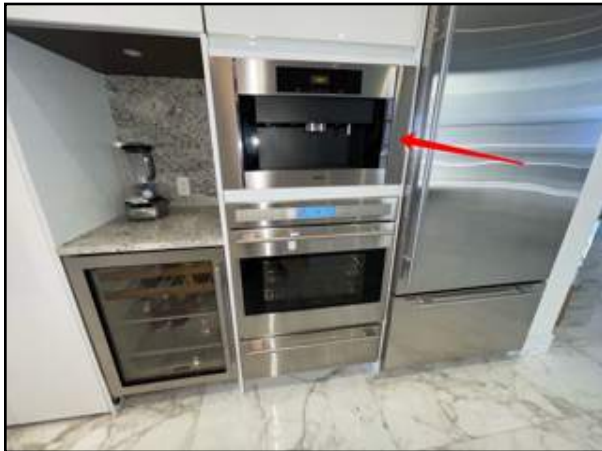
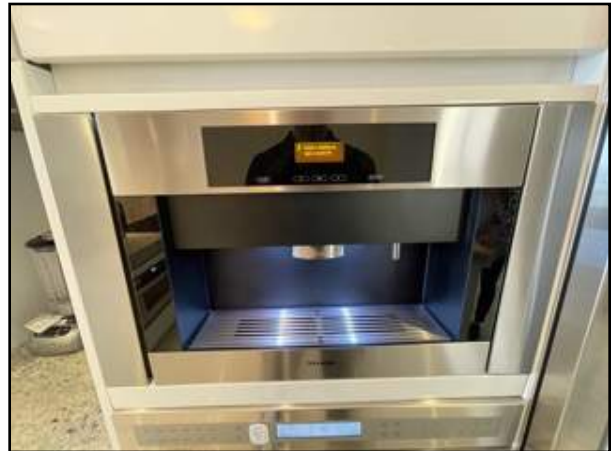
Built-in coffee/espresso maker appears to be functional, and in good condition.

- Not tested

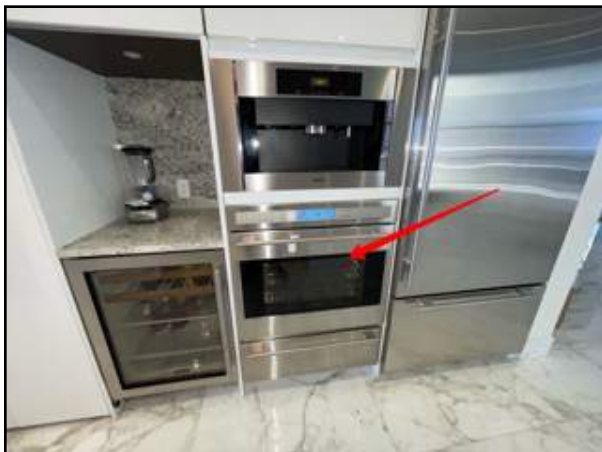
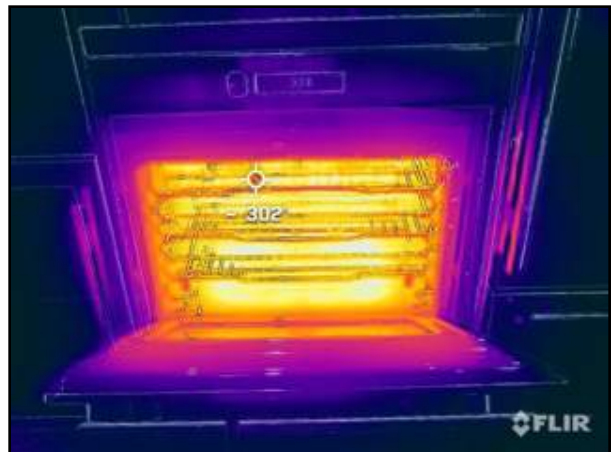
Built-in oven functioning properly.

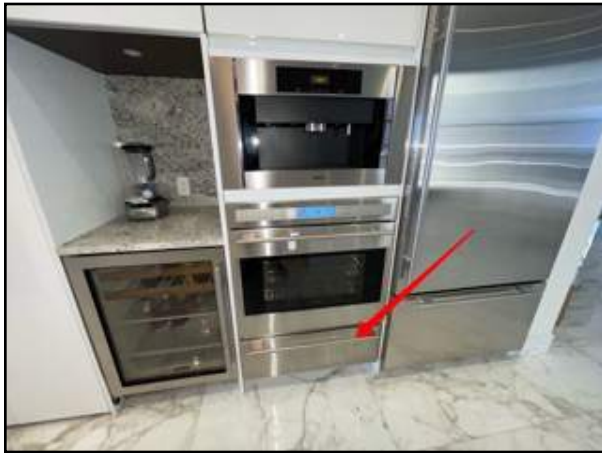
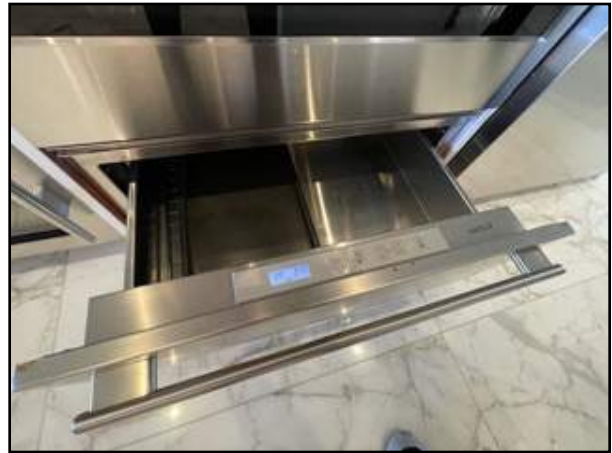
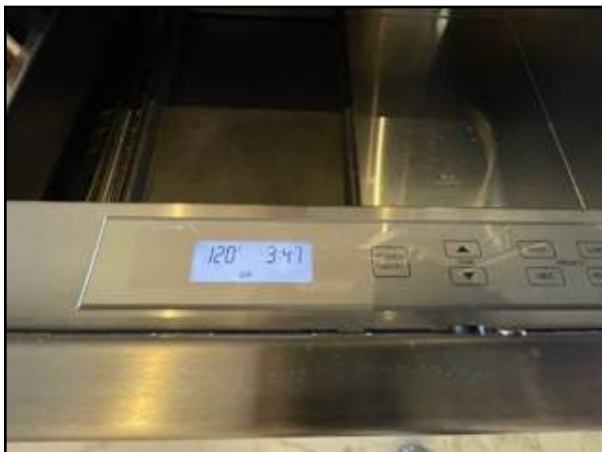
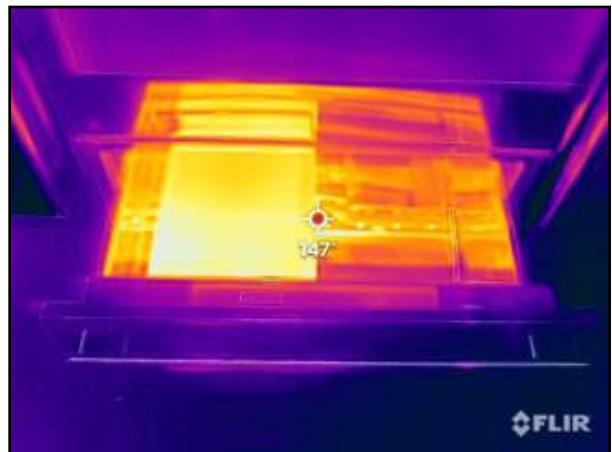
**Comment 36:**  
Built-in warming drawer appears to be functioning properly at the time of inspection.

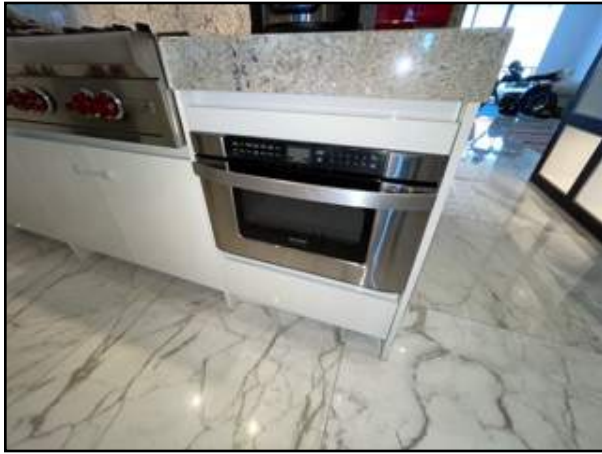
Figure 37-1

Microwave functioning properly at the time of inspection.

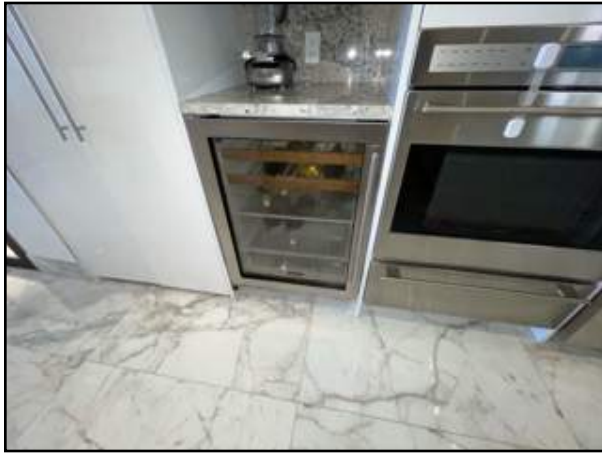
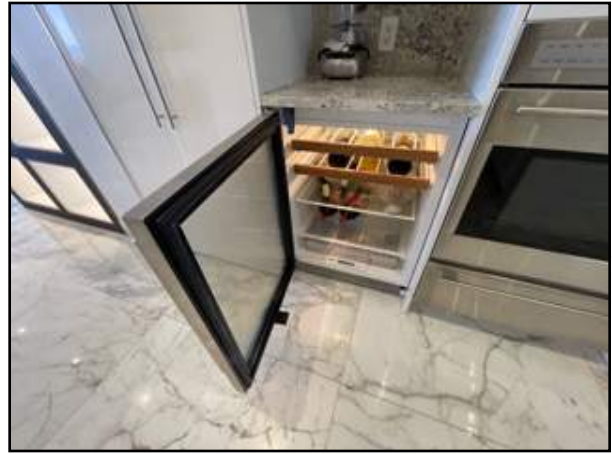
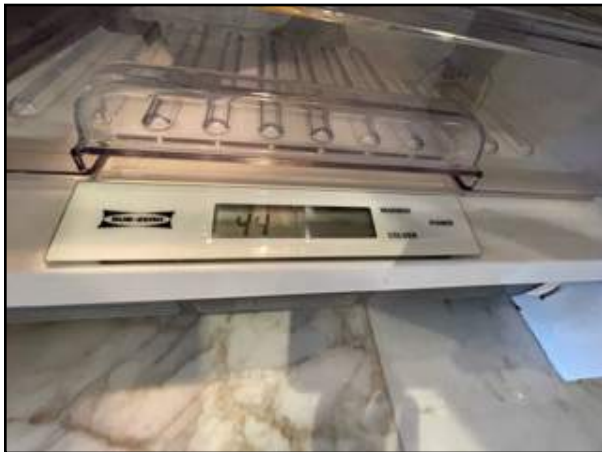
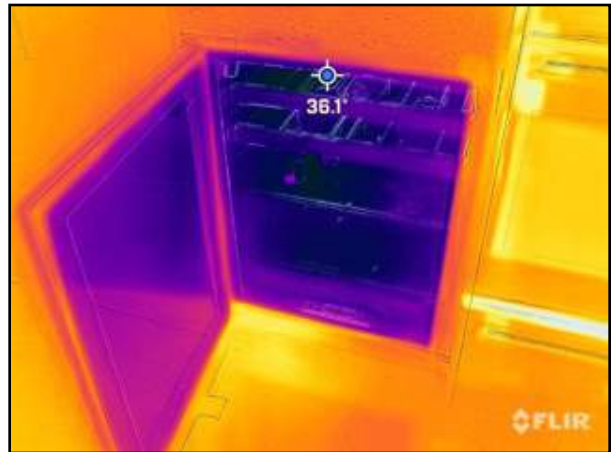
Comment 39:  
Mini wine refrigerator functioning properly.

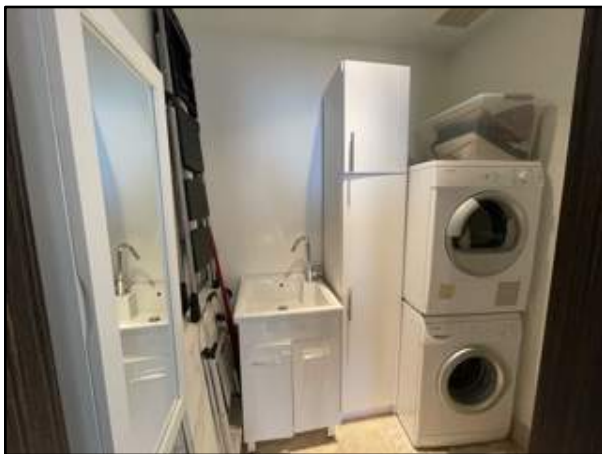
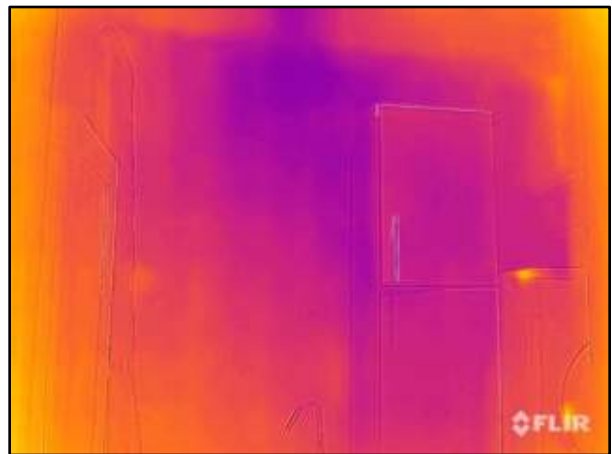
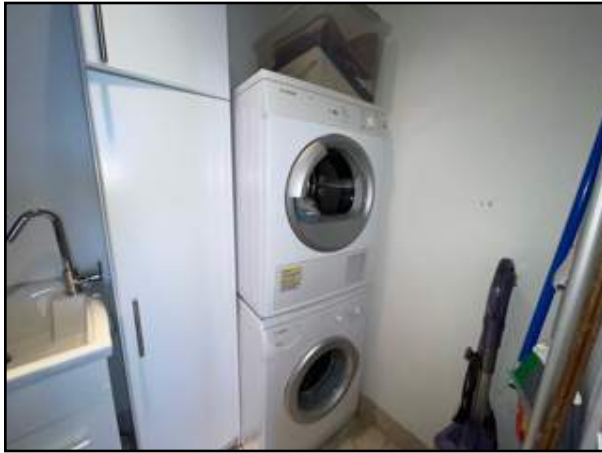
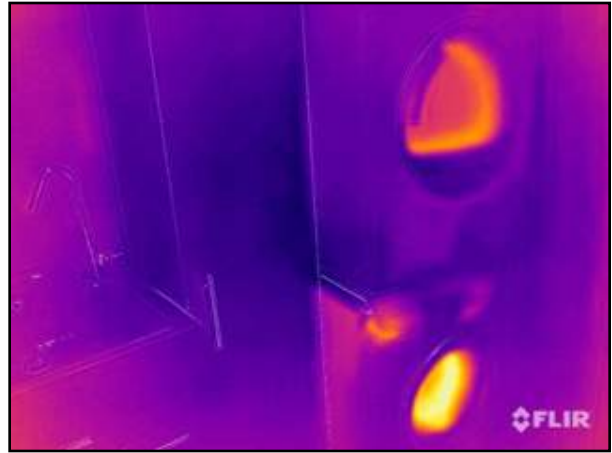
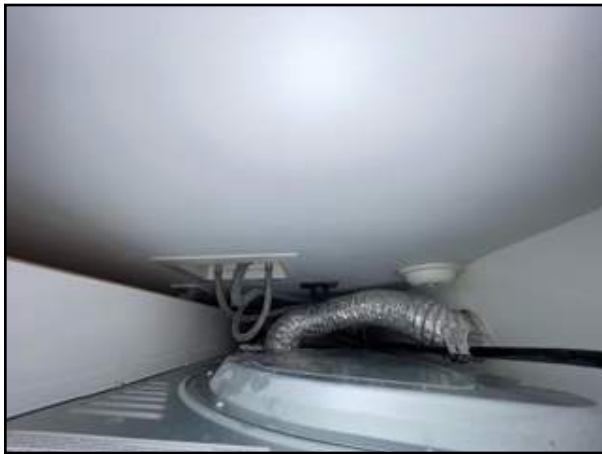
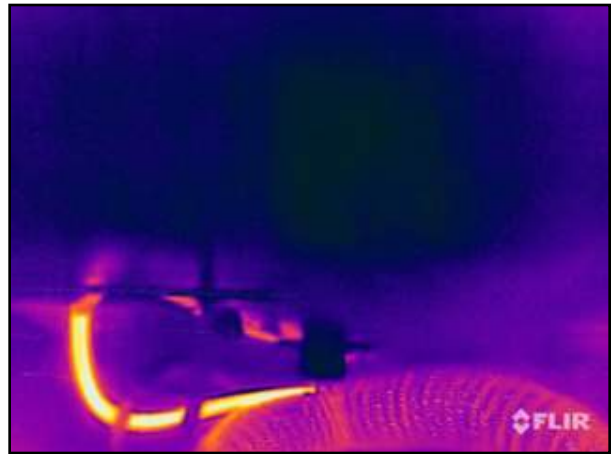
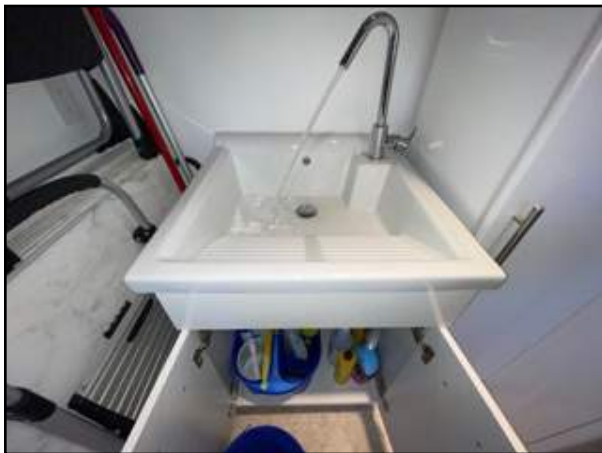
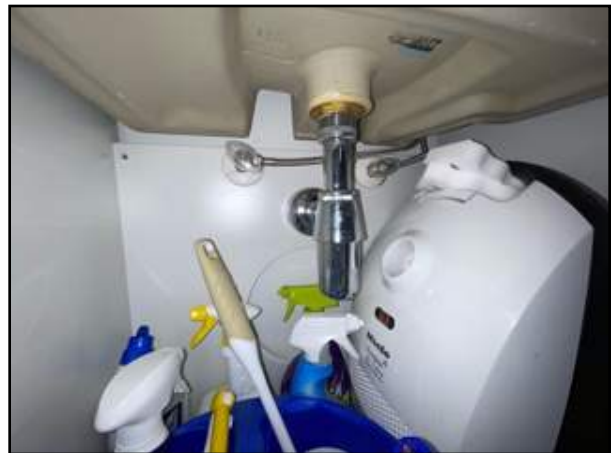
- Washer & dryer functioning properly at the time of inspection.
- No indications of water damage or leaking at the time of inspection.

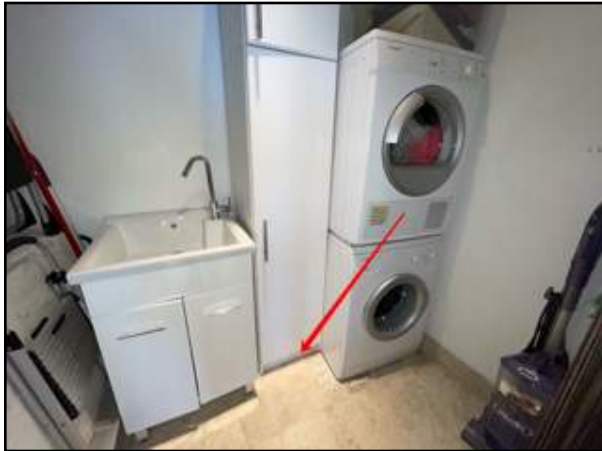
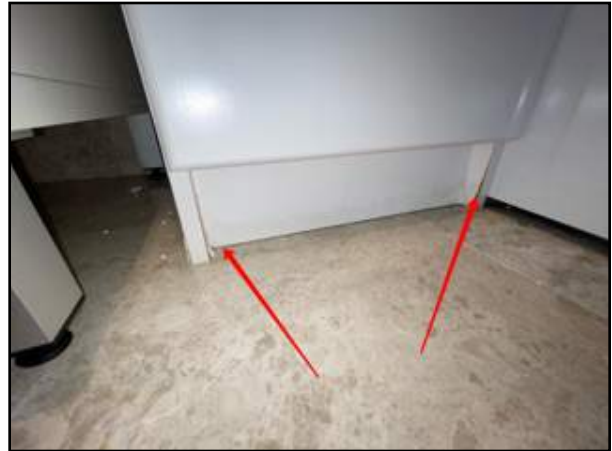
Minor water damage to base of cabinetry adjacent to washer & dryer.

- No active water damage detected at the time of inspection.

Recommend repair or replace damaged cabinetry within laundry room. (Estimate: \$200 - \$500)

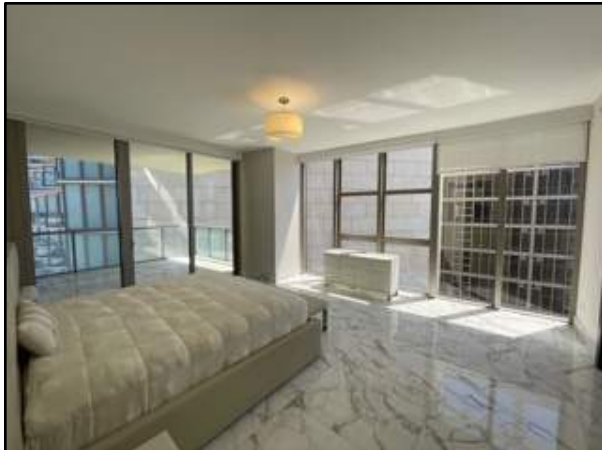
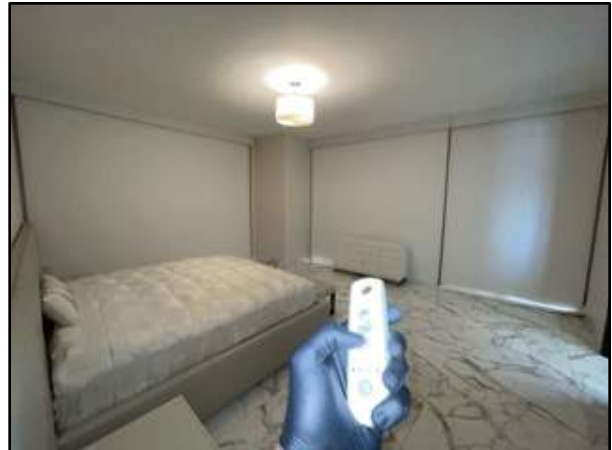
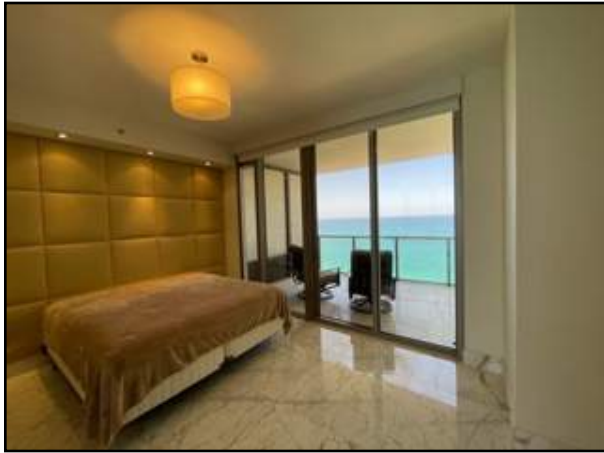
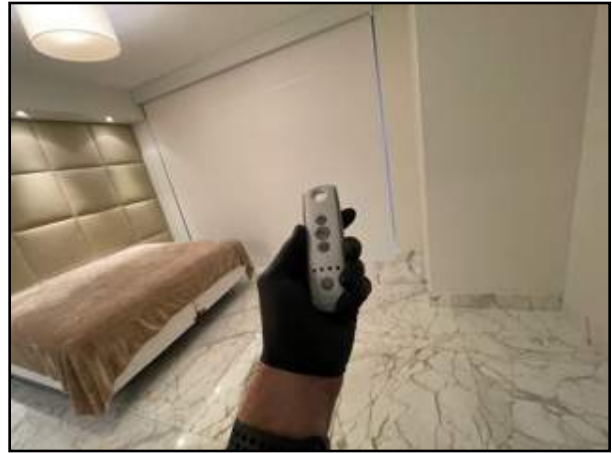
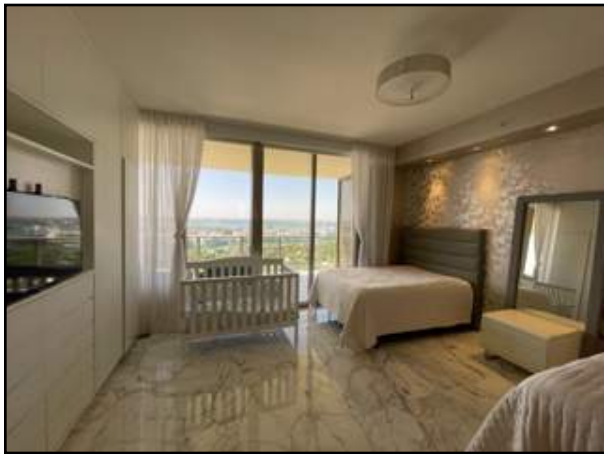
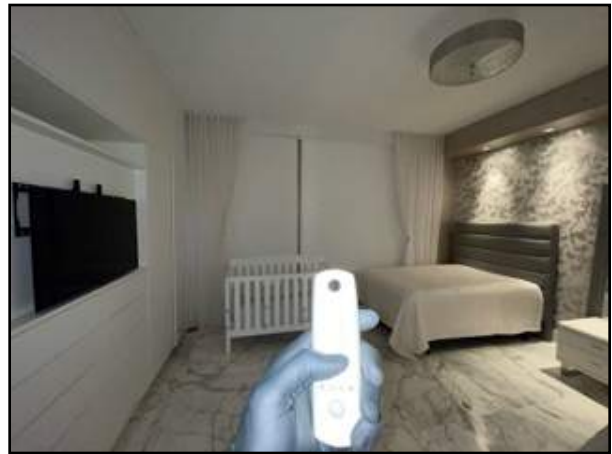
AV roll-down shade system throughout unit appears to be functioning properly at the time of inspection.

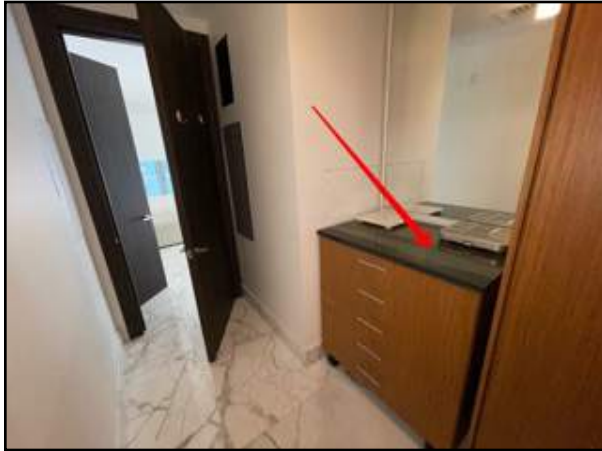
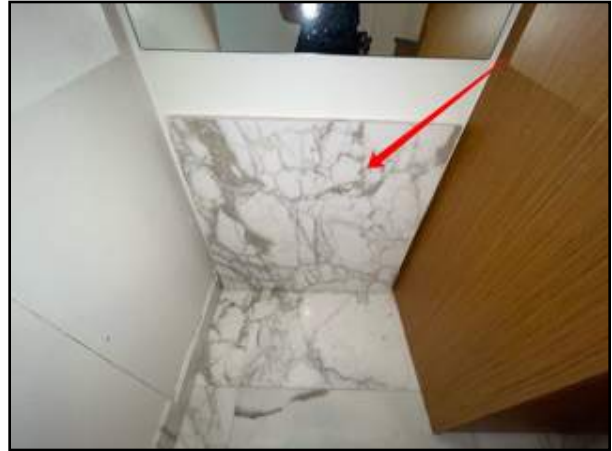
Additional flooring tiles currently stored within master bedroom closet concealed behind mobile island.

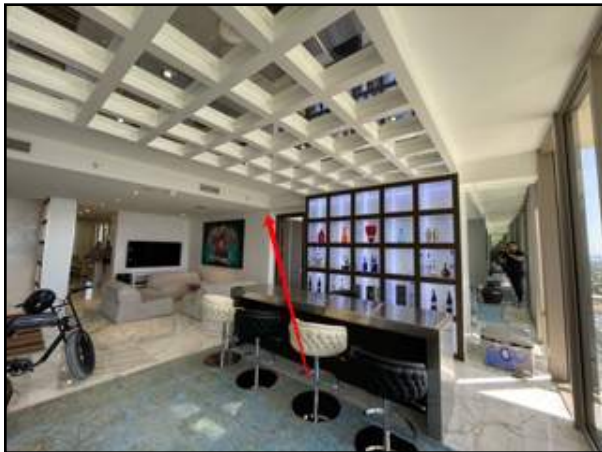
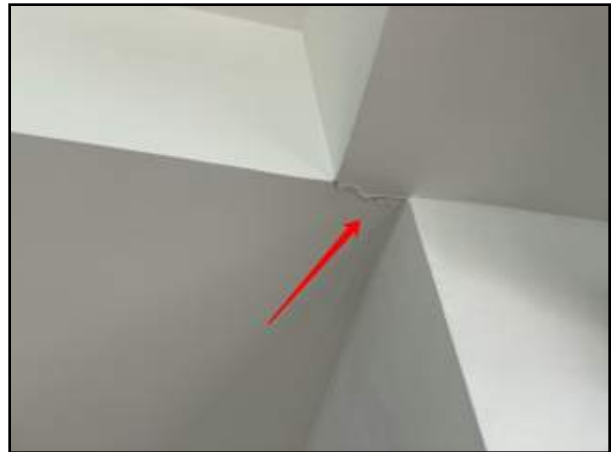
Minor cracking observed along living room ceiling drywall.

Recommend re-finishing surface of ceiling drywall to conceal cracking. (Estimate: \$150 - \$200)

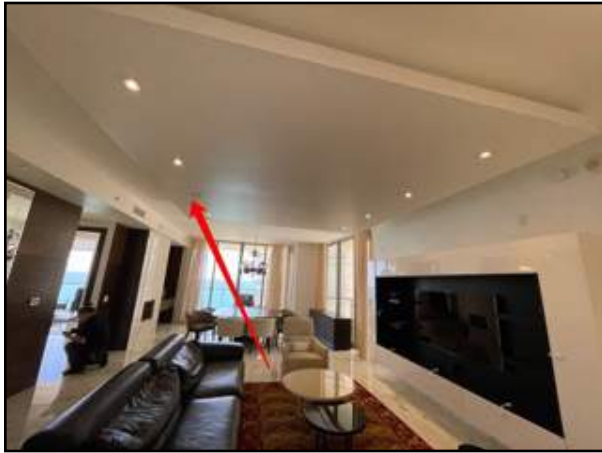
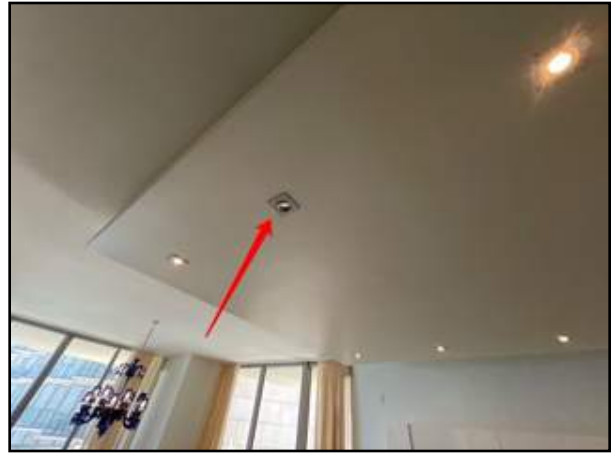
- Circuit is live when tested.
- Estimate light bulbs are burnt out.

Replace light bulbs to family room lights fixtures. (Estimate: \$10 - \$25)

If lighting fixture(s) continue not to function, recommend having a licensed electrician further evaluate fixtures & circuit. (Estimate: \$200 - \$500)

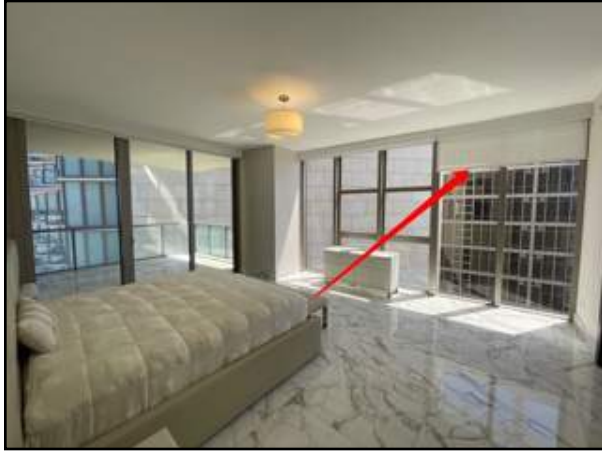
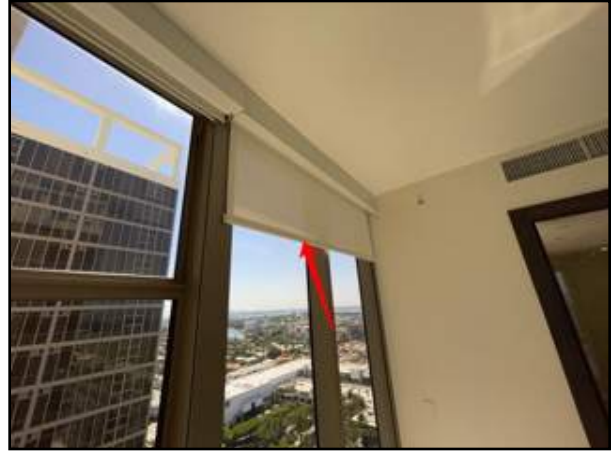
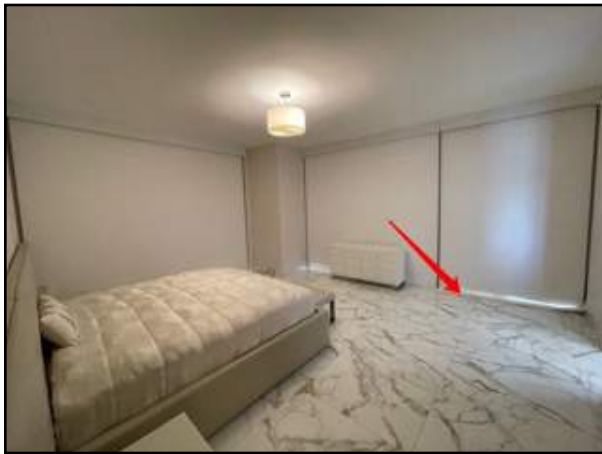
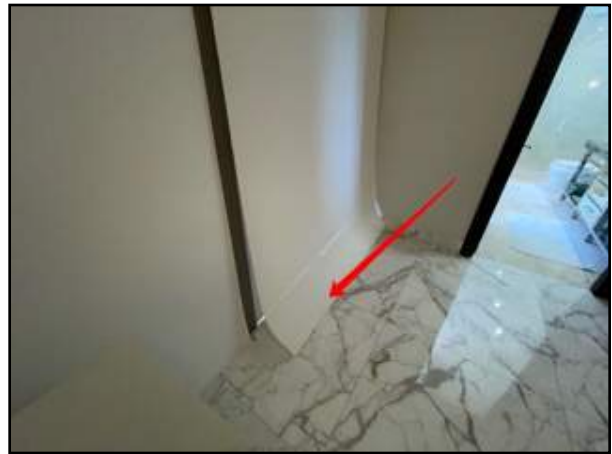
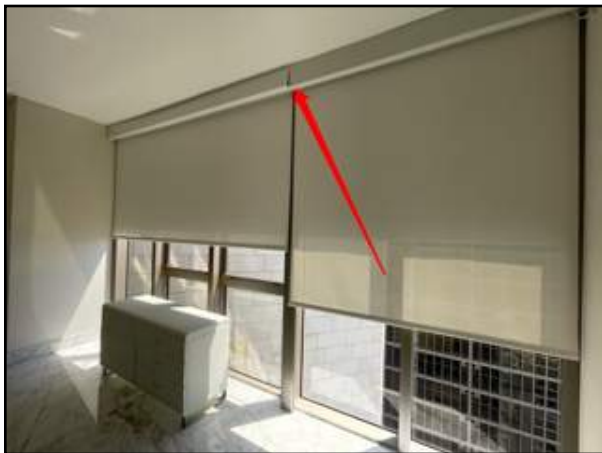
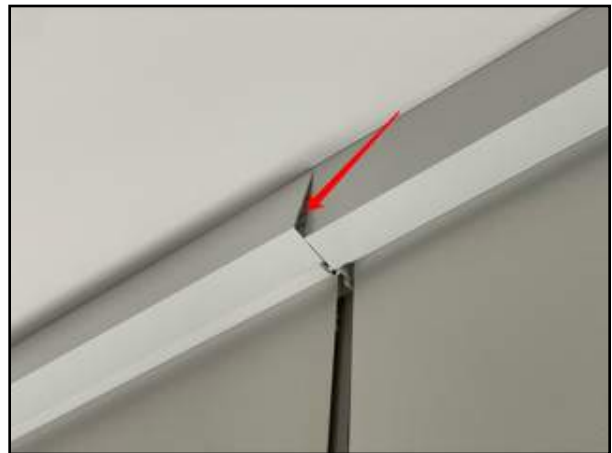
Comment 49:  
Roll down shade (sun screen) not properly calibrated within master bedroom.  
Recommend further evaluation by a qualified professional and repair roll down  
shade accordingly. (Estimate: \$100 - \$250)

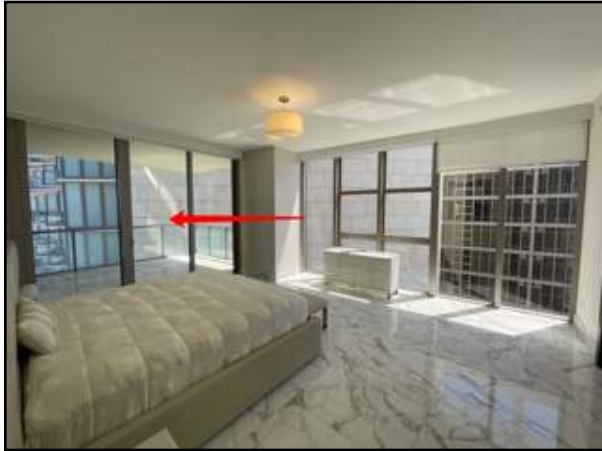
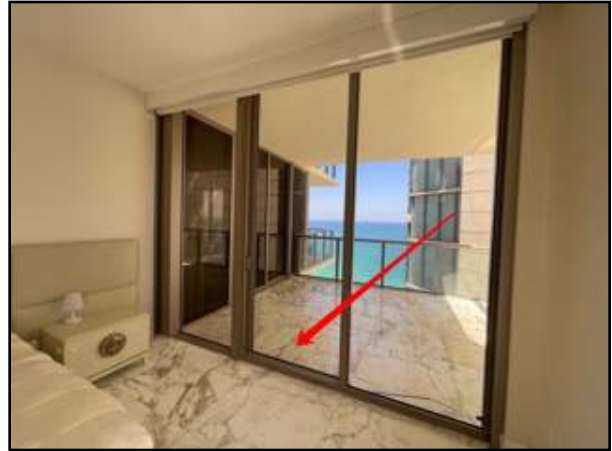
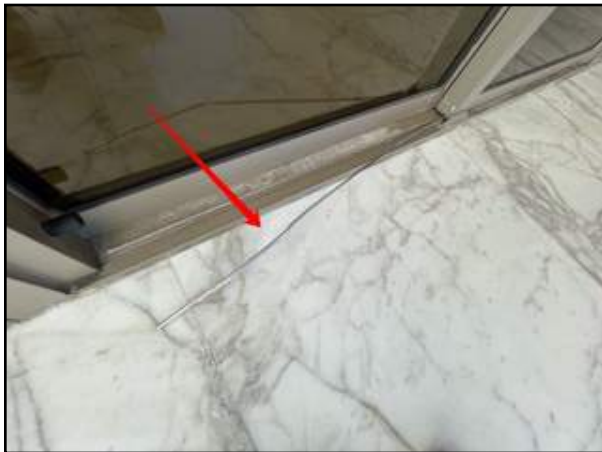
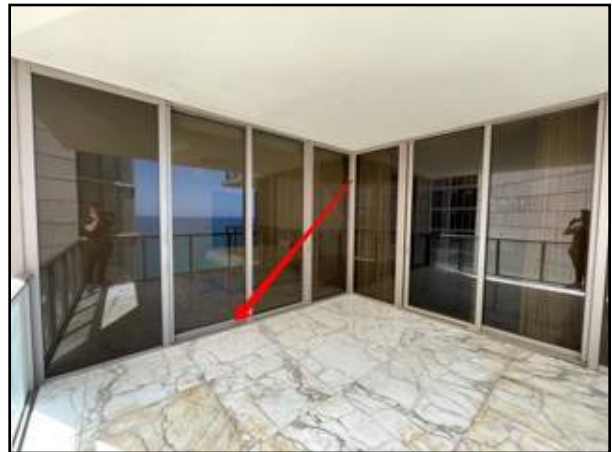
- Track is visibly damaged from exterior balcony.

Recommend further evaluation by a licensed professional & repair/replace sliding-glass door tracks & rollers as necessary. (Estimate: \$500 - \$1,000)

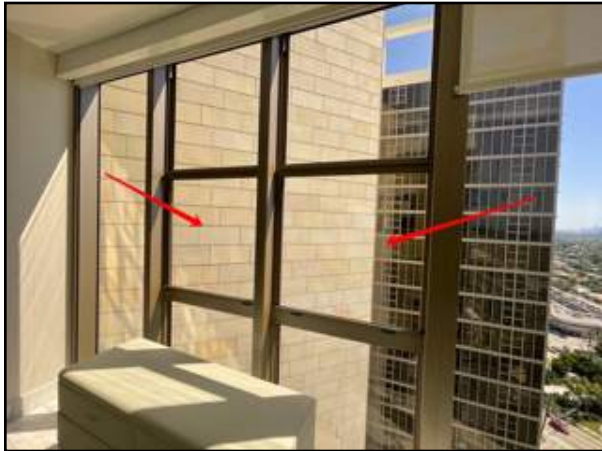
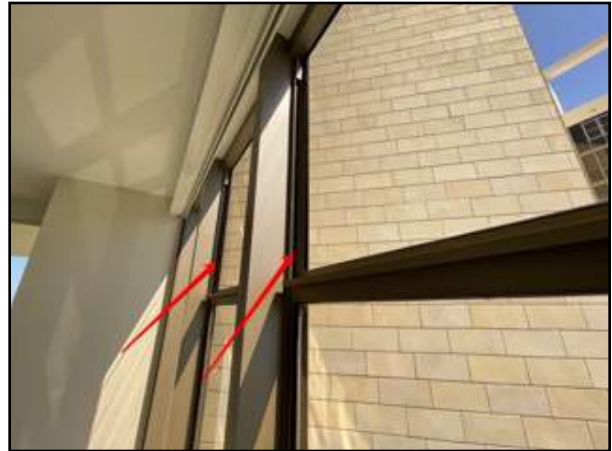
Master bedroom windows do not open/close properly due to broken spring-loaded tracks on the side of windows.

- Windows currently slide closed, and do not stay open.

Repair/adjust spring-loaded tracks to bedroom windows. (Estimate: \$150 - \$250)

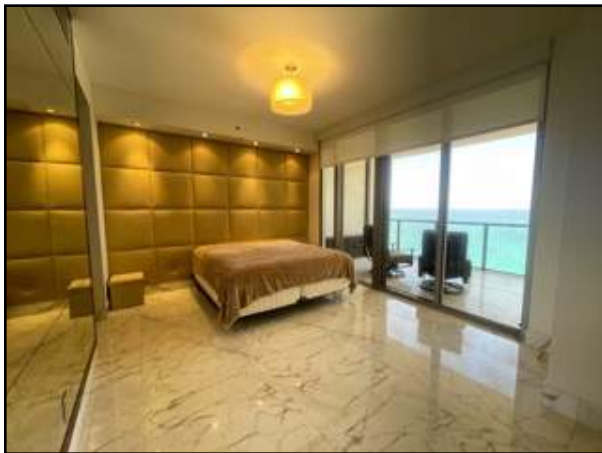
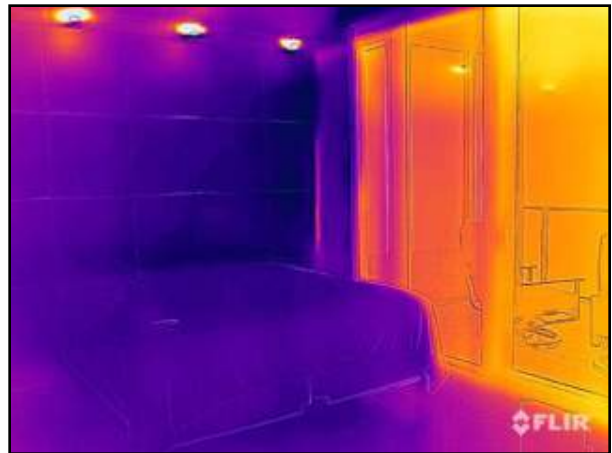
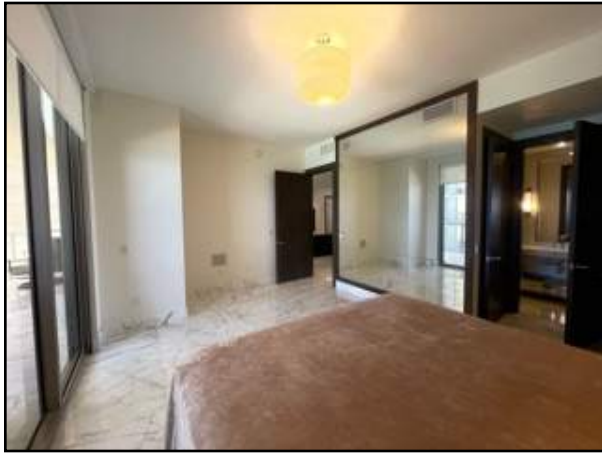
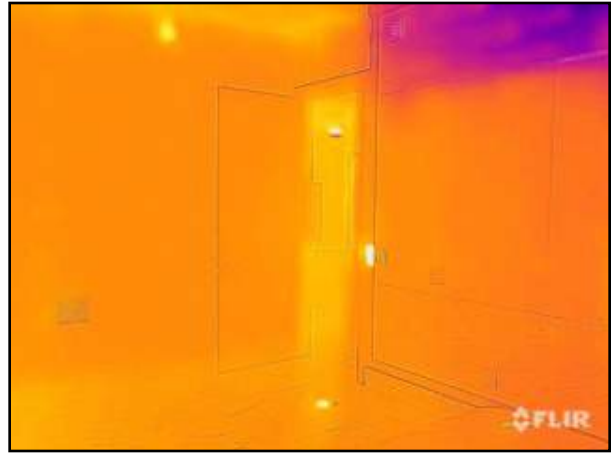
**Comment 52:**

Bedroom #2.

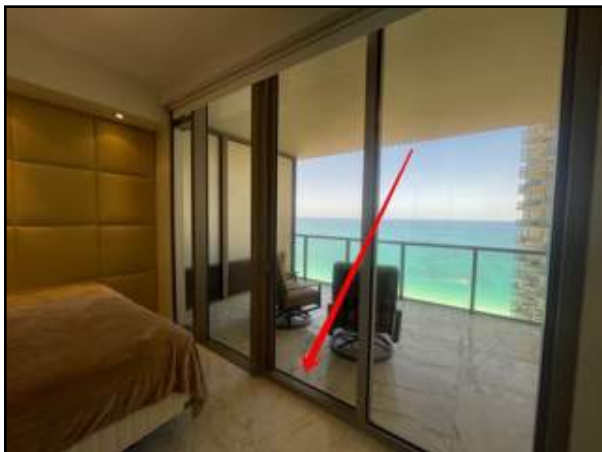
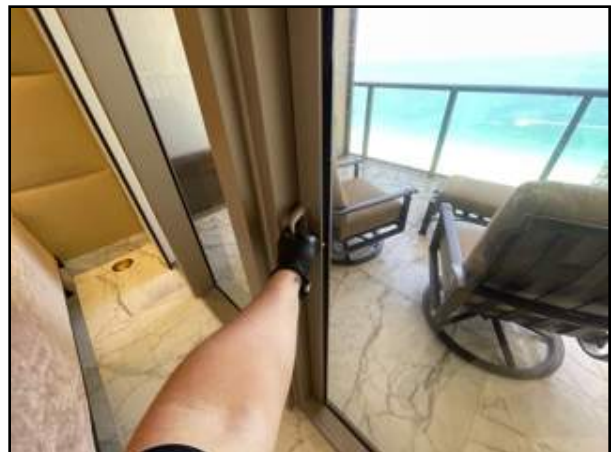
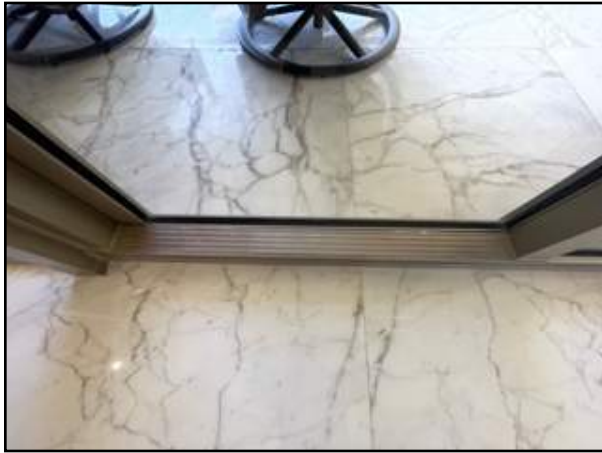
Bedroom #2 sliding glass doors are currently stuck on track within door frame, and does not open.

Recommend further evaluation by a licensed professional & repair/replace sliding-glass door tracks & rollers as necessary. (Estimate: \$500 - \$1,000)

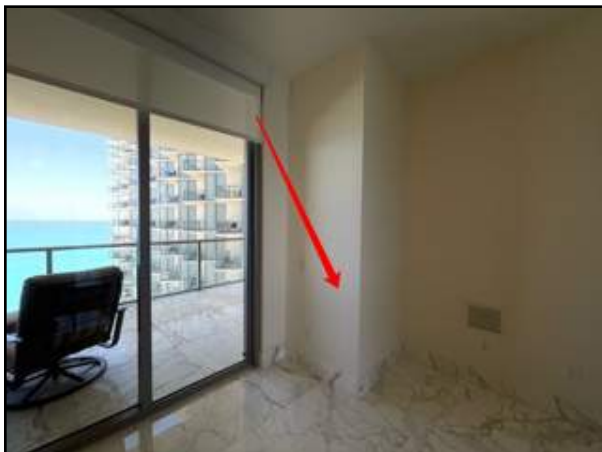
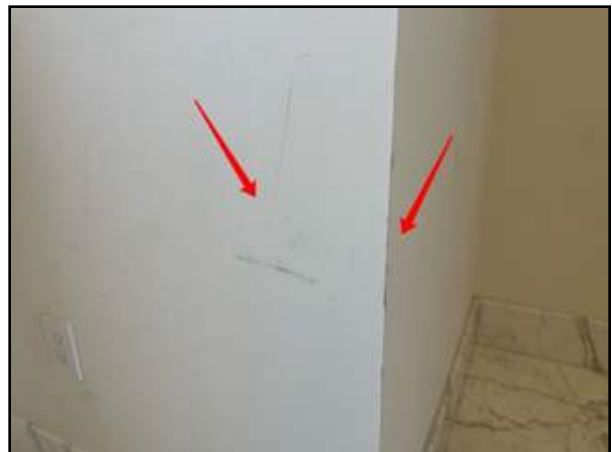
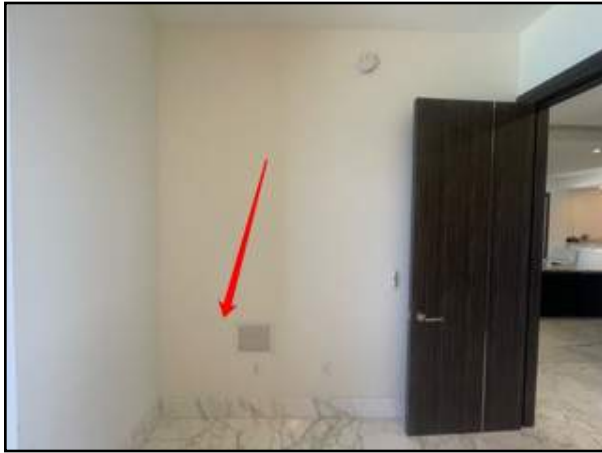
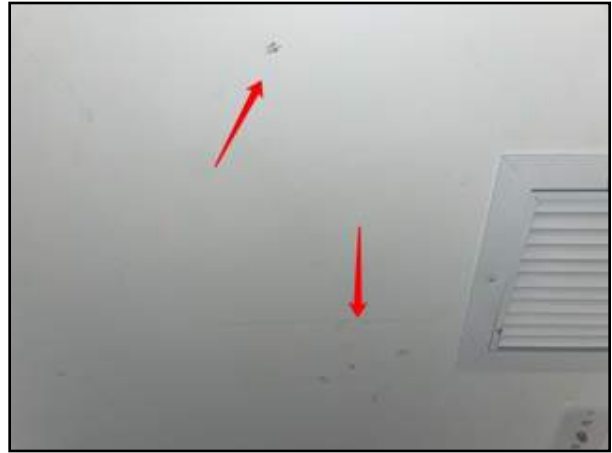
Apparent scuffs & markings to drywall in multiple locations throughout the bedroom area.

Recommend refinishing drywall throughout room as necessary. (Estimate: \$250 - \$500)

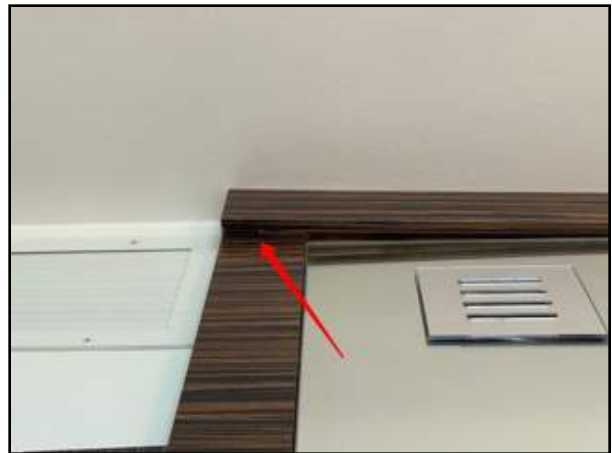
Figure 55-2

Loose wood panel along top of bedroom wall.  
Repair wood paneling. (Estimate: \$100 - \$200)

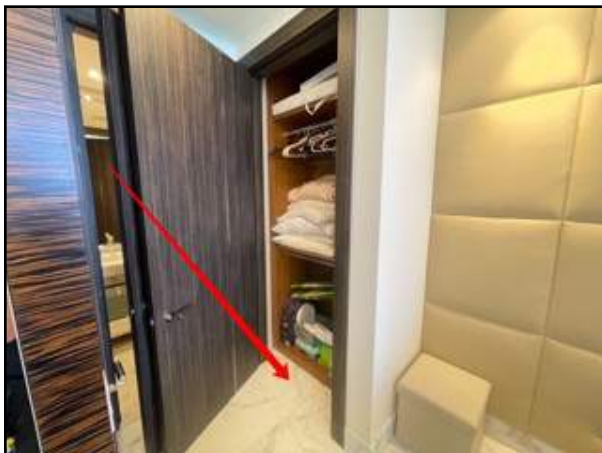
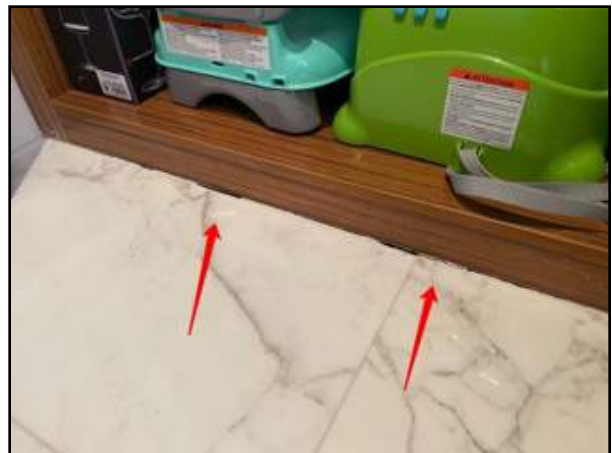
Apparent deterioration to caulking/seal along base of bedroom closet & flooring.

Recommend repairing closet door & caulking along base of closet & flooring.

(Estimate: \$100 - \$250)

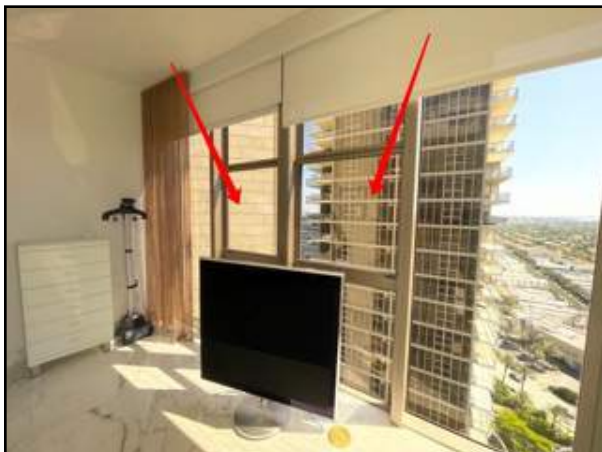
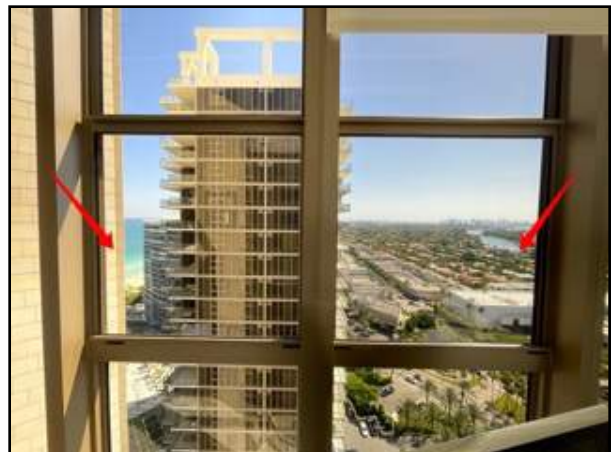
Bedroom windows do not open/close properly due to broken spring-loaded tracks on the side of windows.

- Windows currently slide closed, and do not stay open.

Repair/adjust spring-loaded tracks to bedroom windows. (Estimate: \$150 - \$250)

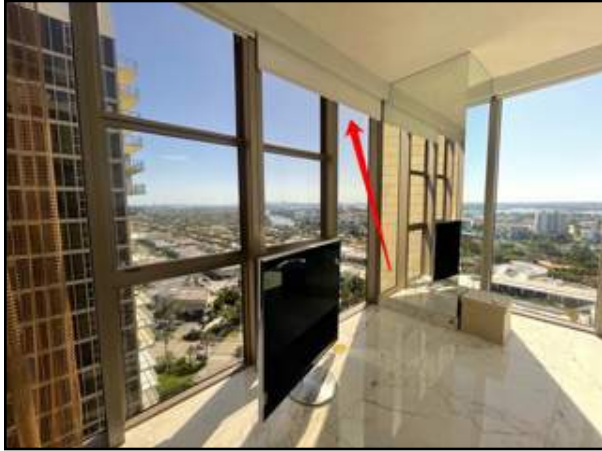
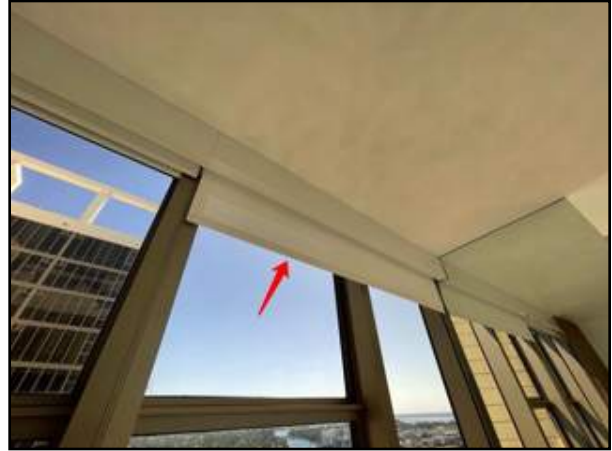
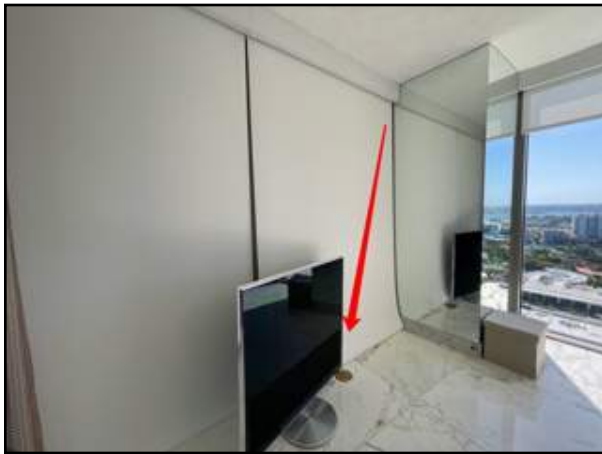
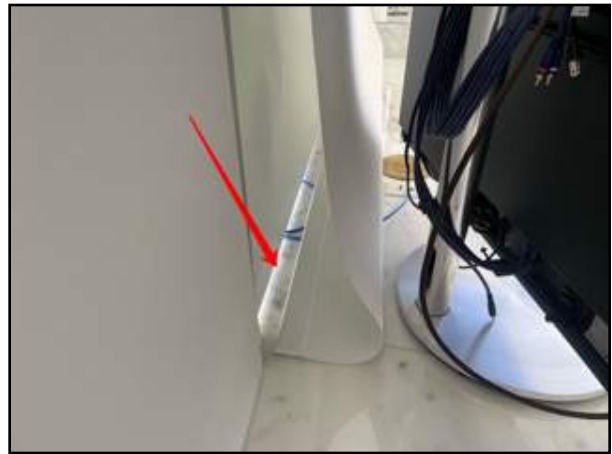
Comment 60:

Roll down shade (sun screen) not properly calibrated within bedroom #3. Recommend further evaluation by a qualified professional and repair roll down shade accordingly. (Estimate: \$100 - \$250)
