## Condo Inspection Report

**9705 Collins Ave**

**Unit 2204N/2205N**

Inspected on Tue, Mar 29 2022 at 1:00 PM

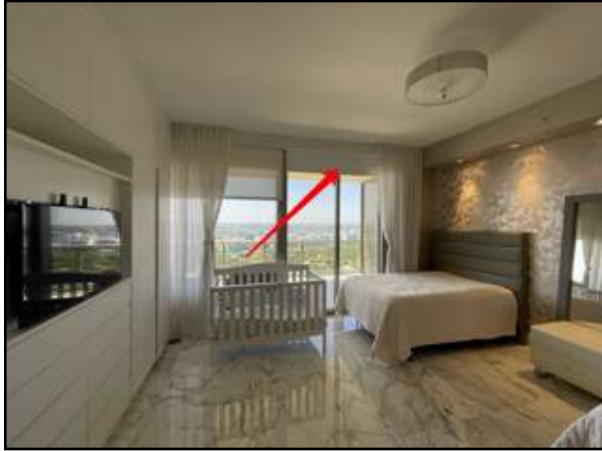
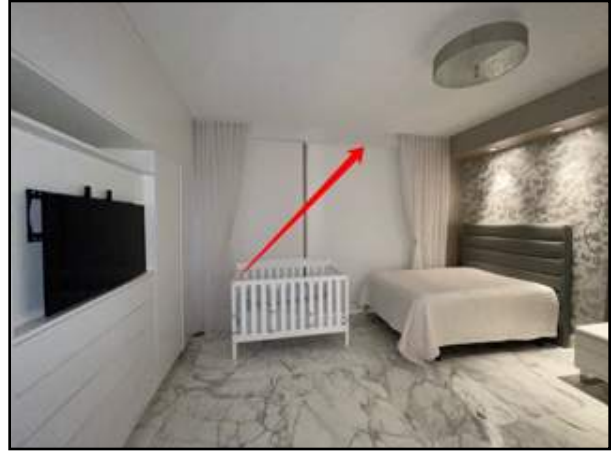
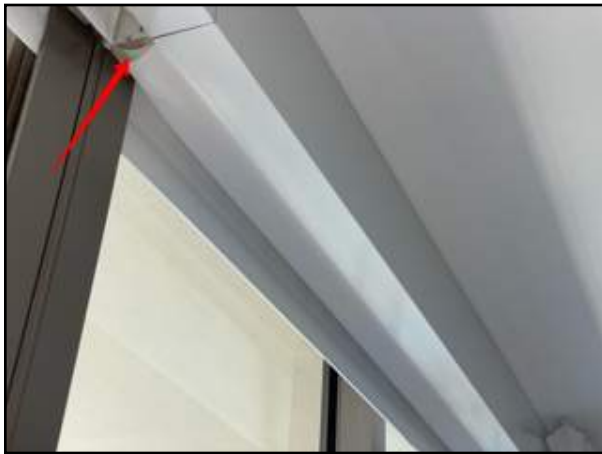
Comment 62:  
Roll down shade (sun screen) not properly calibrated and stuck in framing within bedroom #4.  
Recommend further evaluation by a qualified professional and repair roll down shade accordingly. (Estimate: \$100 - \$250)

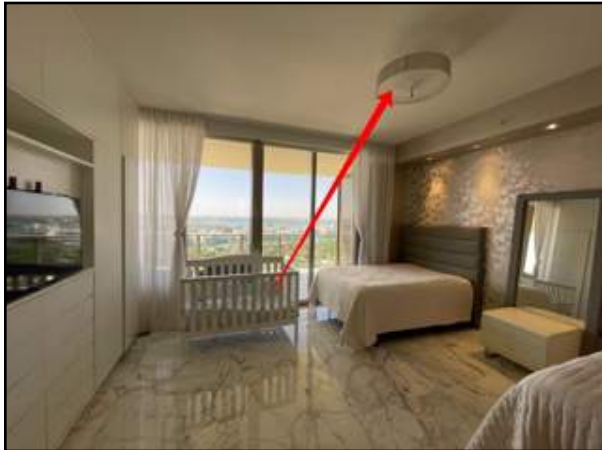
Figure 63-1

- Estimate light bulb is burnt out.

Replace light bulb to bedroom light fixture. (Estimate: \$10 - \$25)

If lighting fixture(s) continue not to function, recommend having a licensed electrician further evaluate circuit. (Estimate: \$200 - \$500)

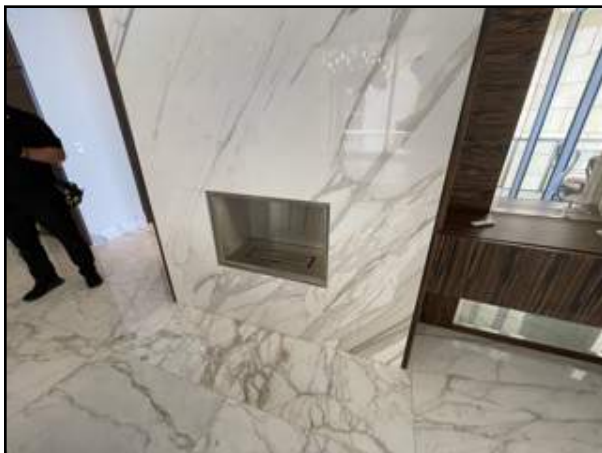
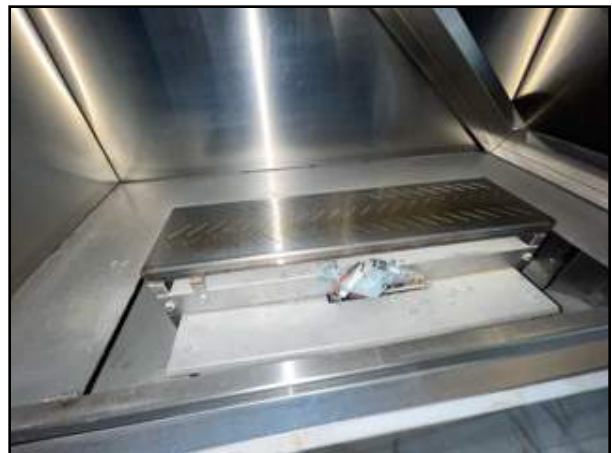
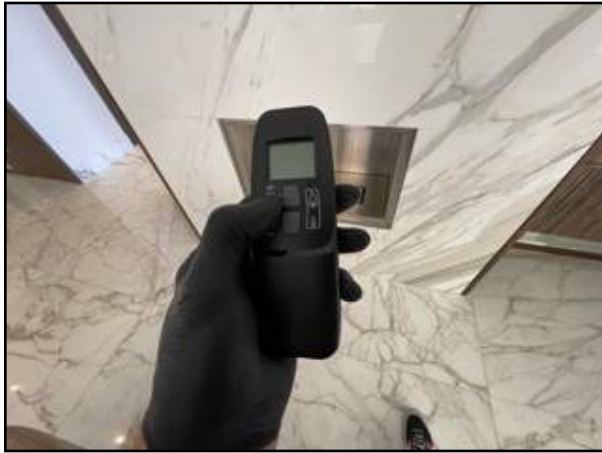
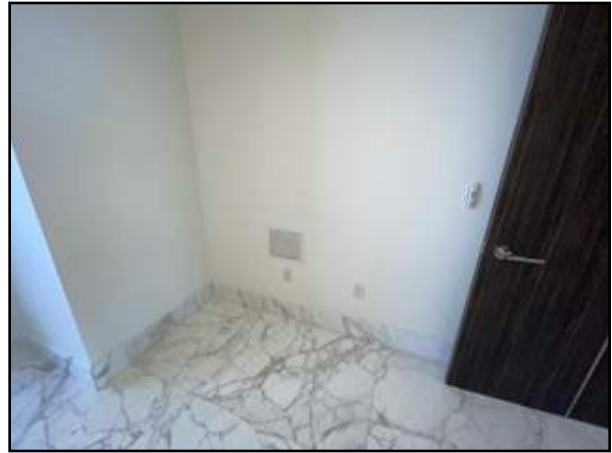
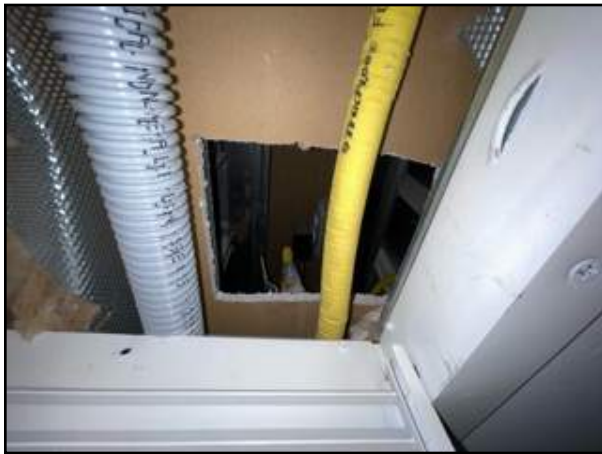
Comment 65:  
Gas ventless fire place located within dining room appears to be in good condition, but not functioning at the time of inspection as remote controls are not currently functional.

- Gas valve located within adjacent bedroom behind fireplace.

Repair remote activation controls for proper use of ventless fireplace within dining room. (Estimate: \$25 - \$150)

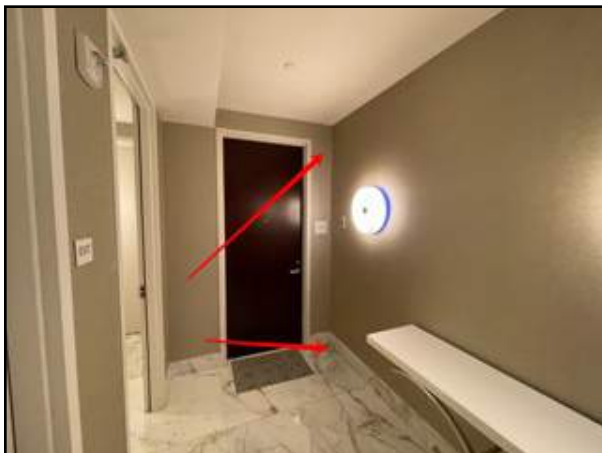
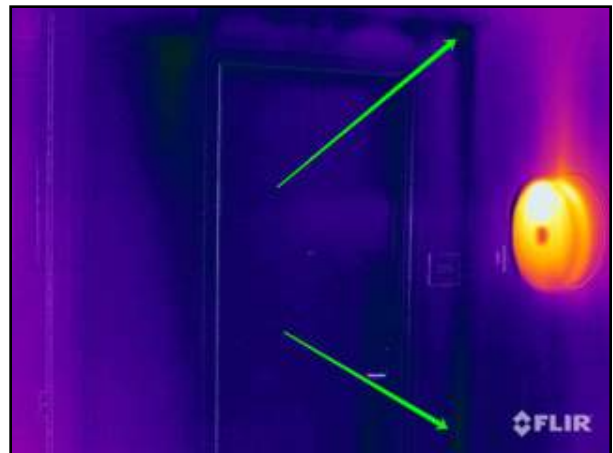
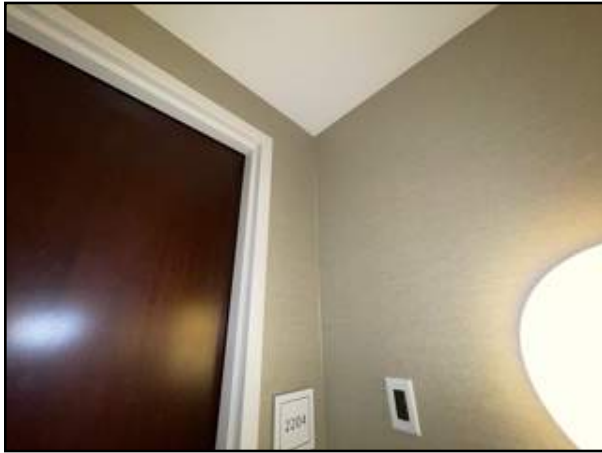
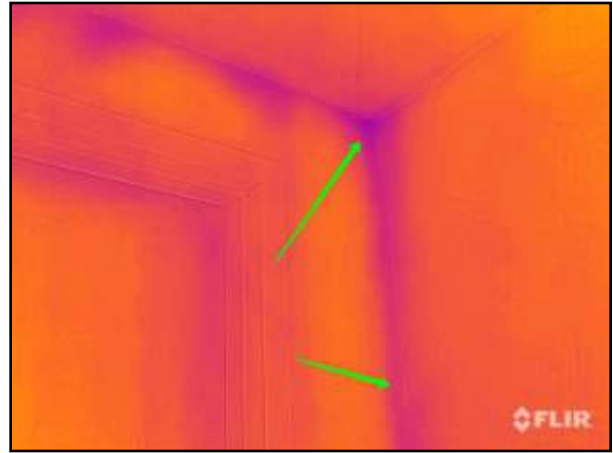
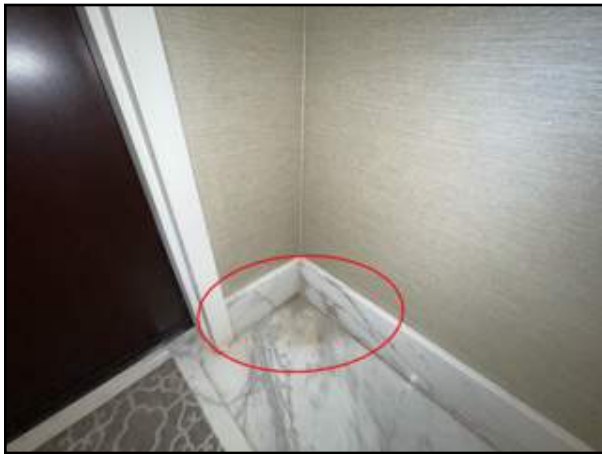
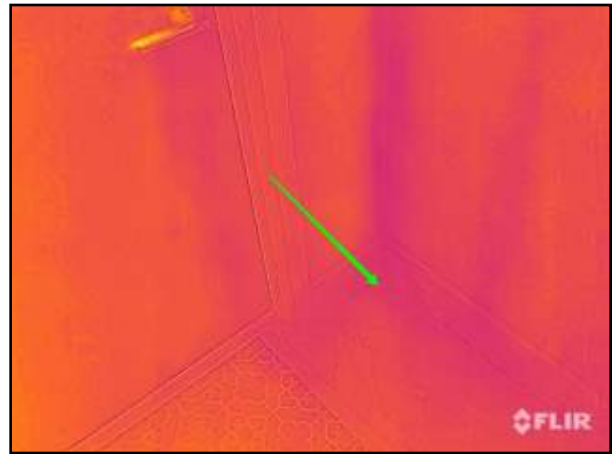
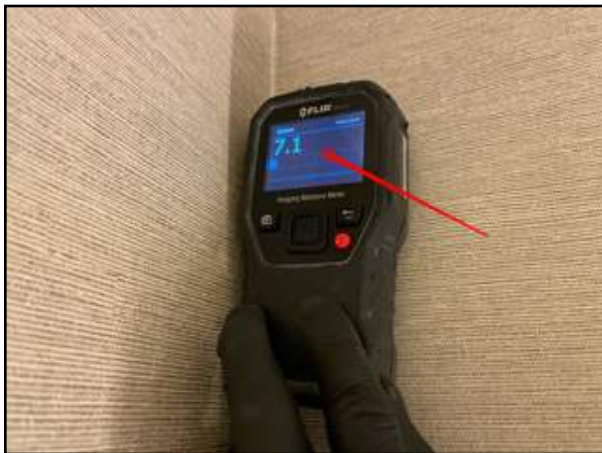
Concern for potential moisture intrusion over elevator entrance/foyer.

- Minor moisture detected via thermal imaging as well as moisture meters along top corner of wall & base of floor.
- Indications of discoloration to tile flooring along base of floor due to extended exposure to moisture.
- Estimate potential active leaking from unit above.

Recommend reporting to building for further investigation into potential leaking from unit above & repair accordingly.

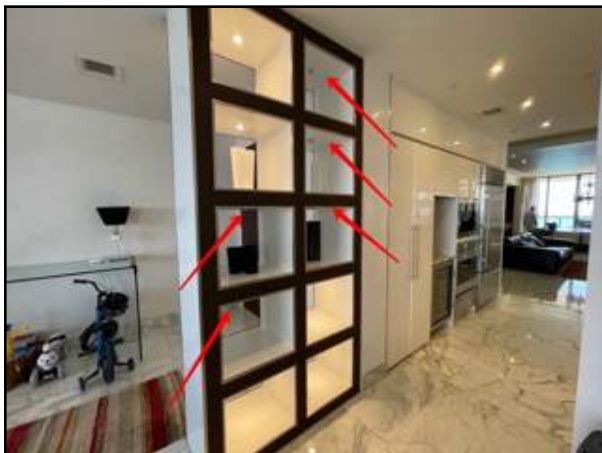
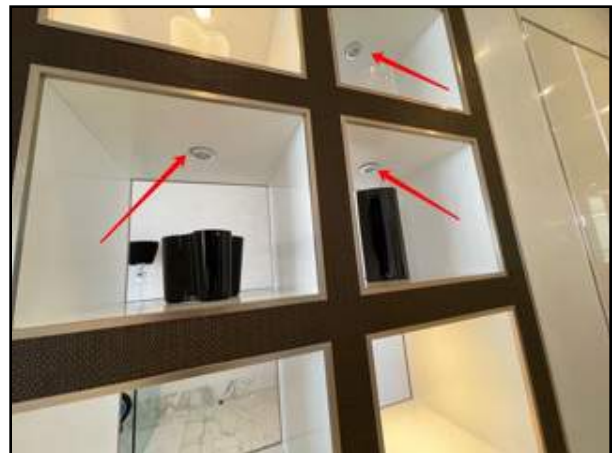
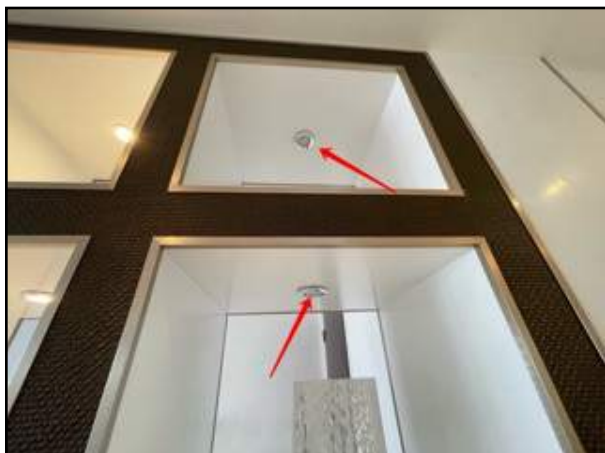
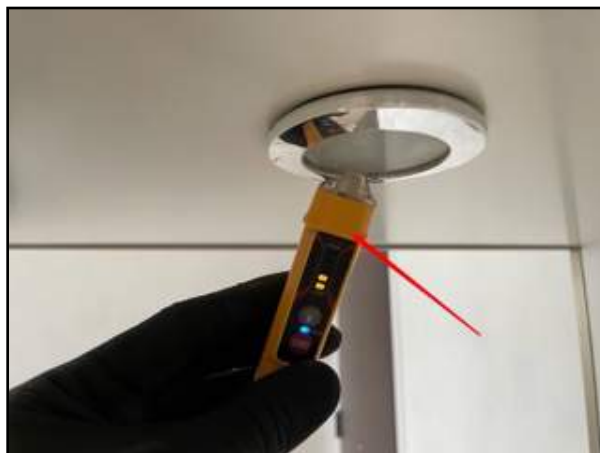
- Circuit is live when tested.
- Estimate light bulbs are burnt out.

Replace light bulbs to shelving light fixtures. (Estimate: \$10 - \$25)

If lighting fixture(s) continue not to function, recommend having a licensed electrician further evaluate fixtures & circuit. (Estimate: \$200 - \$500)

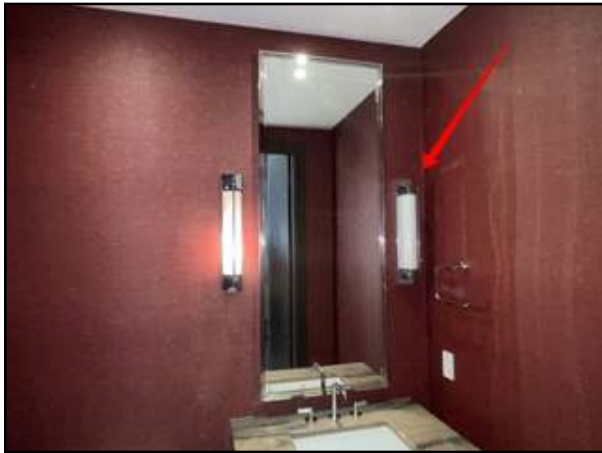
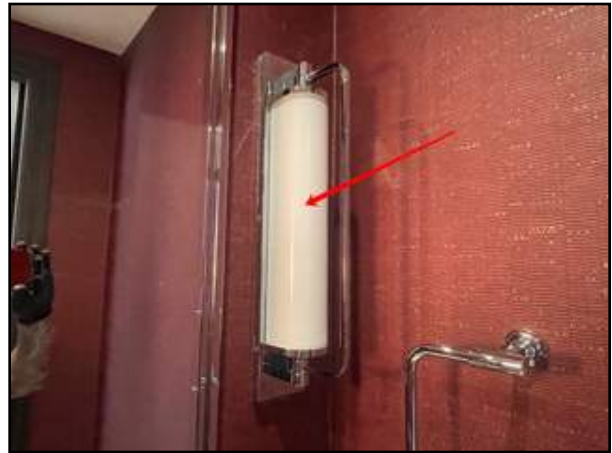
- Estimate light bulb is burnt out.

Replace light bulb to bathroom light fixture. (Estimate: \$10 - \$25)

If lighting fixture(s) continue not to function, recommend having a licensed electrician further evaluate circuit. (Estimate: \$200 - \$500)

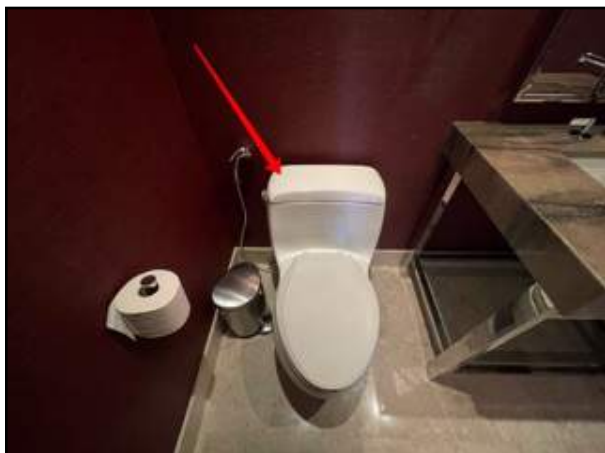
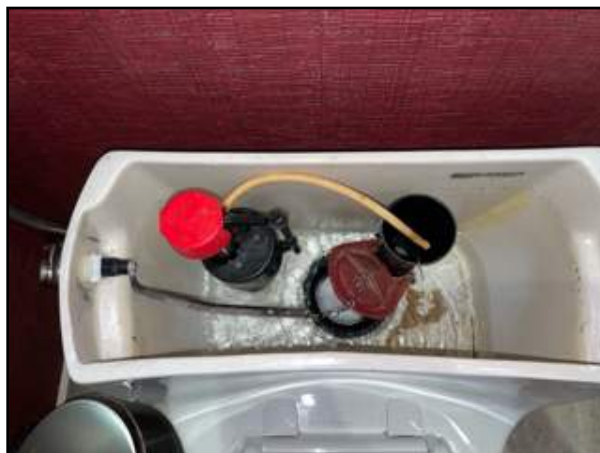
Flushing mechanism within toilet tank is broken preventing toilet from flushing and causing water to constantly run.

Replace flushing mechanism within tank of toilet. (Estimate: \$50 - \$100)

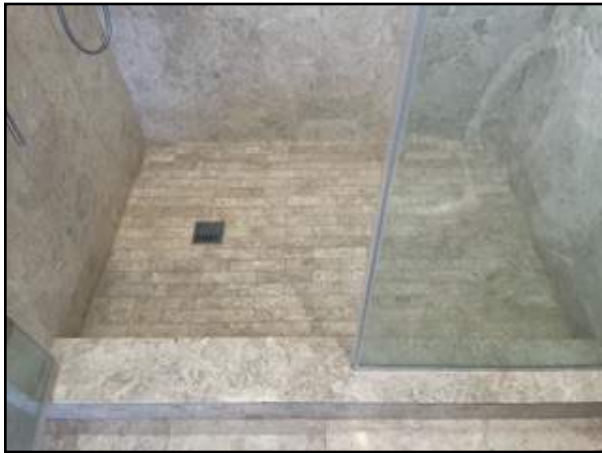
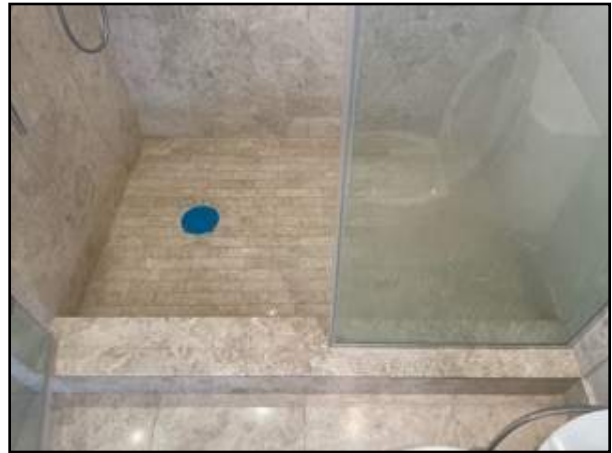
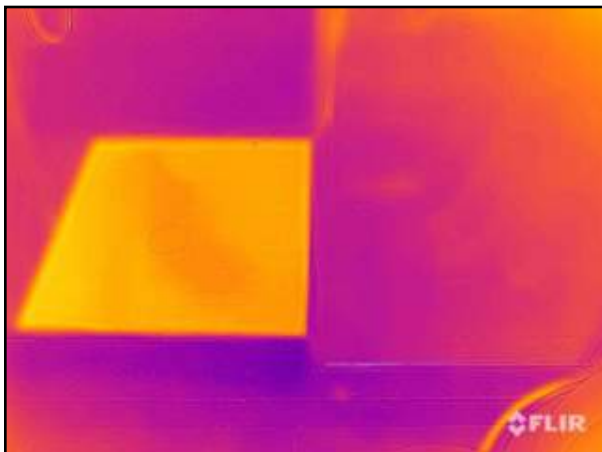
Shower pan tested.

- No indications of leaking from shower pan at the time of inspection.

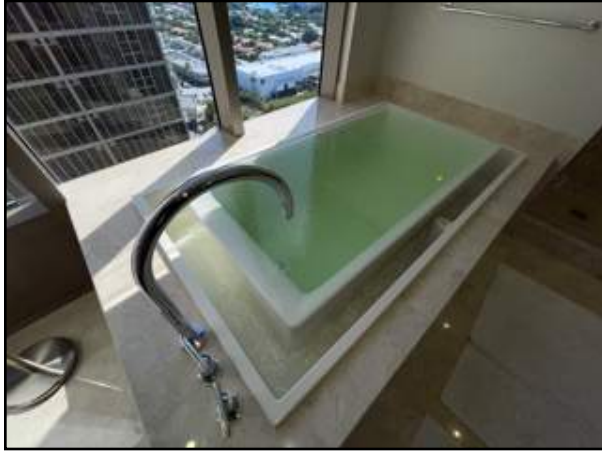
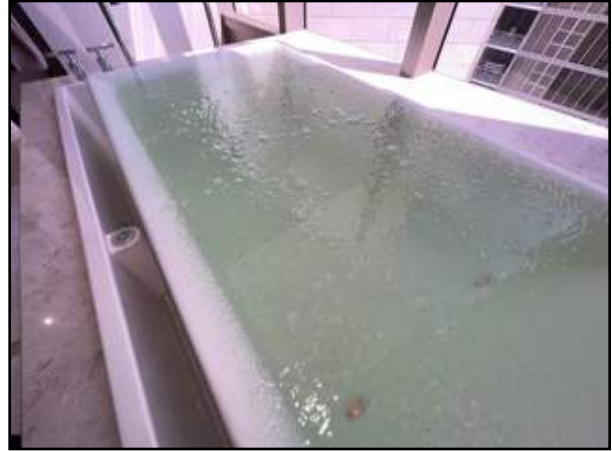
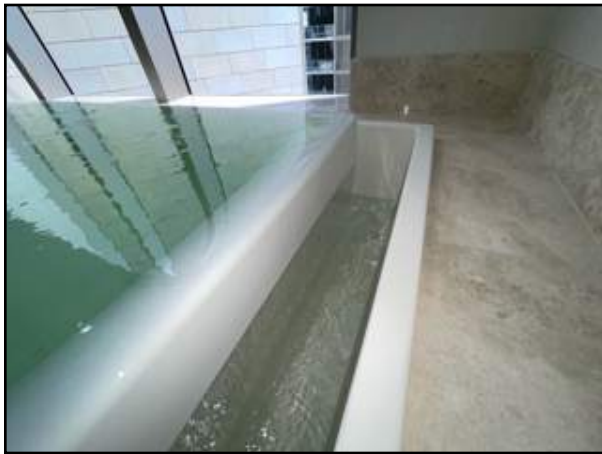
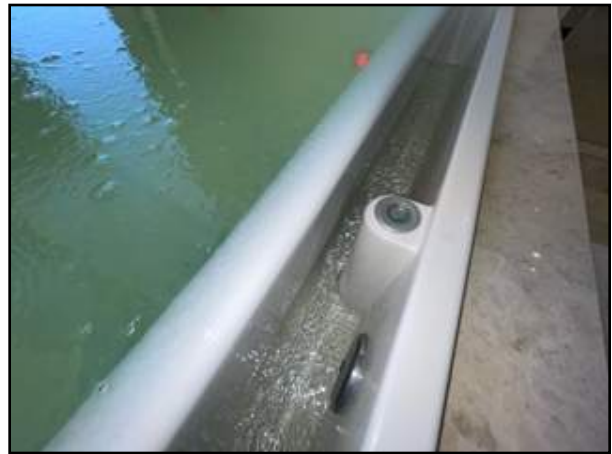
- No indications of leaking from around jacuzzi tub at the time of inspection.
- No access panel available to access jacuzzi motor or shut-off valves to tub fixture.

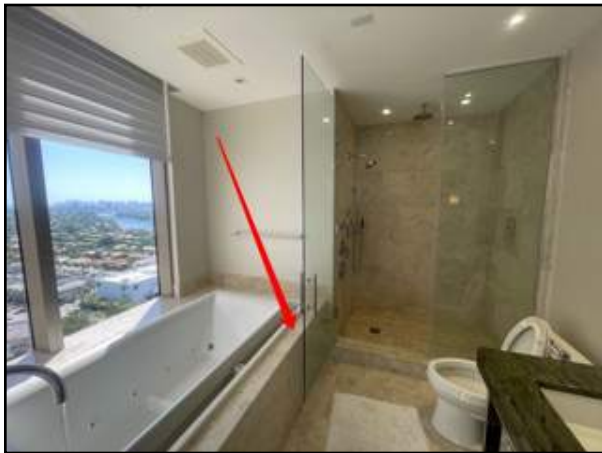
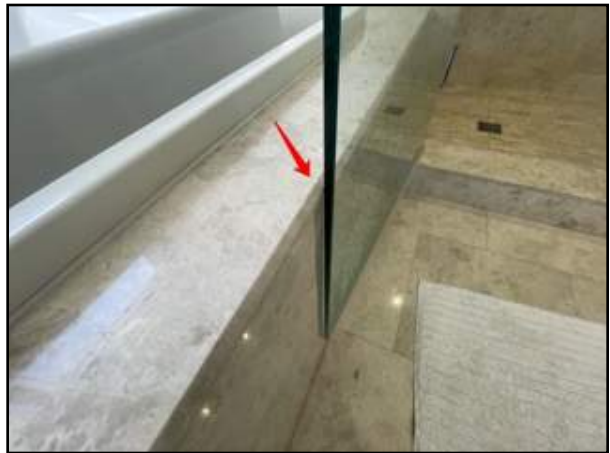
Frameless glass shower door within bathroom conflicting with adjacent tub wall when opening.

Recommend installing a door stopper or bumper prevent damaging wall. (Estimate: \$25 - \$50)

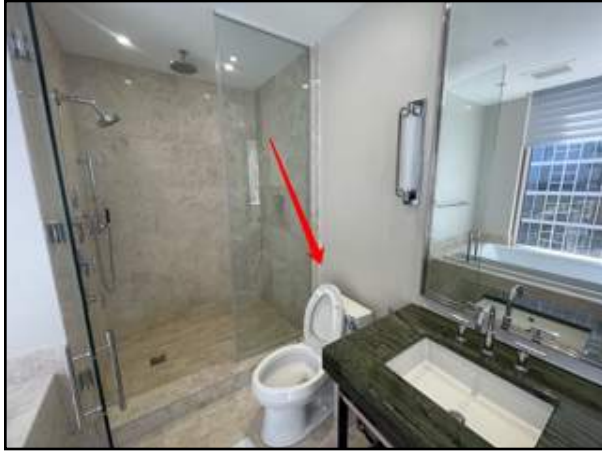
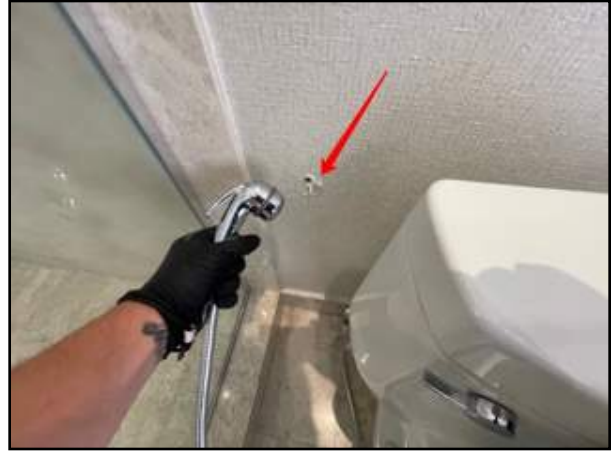
Hand held fixture to toilet functional, but wall mount appears to have been removed leaving damage to wall adjacent to toilet fixture.

Recommend repairing wall & re-mounting wall mount/bracket to hold hand held fixture. (Estimate: \$200 - \$300)

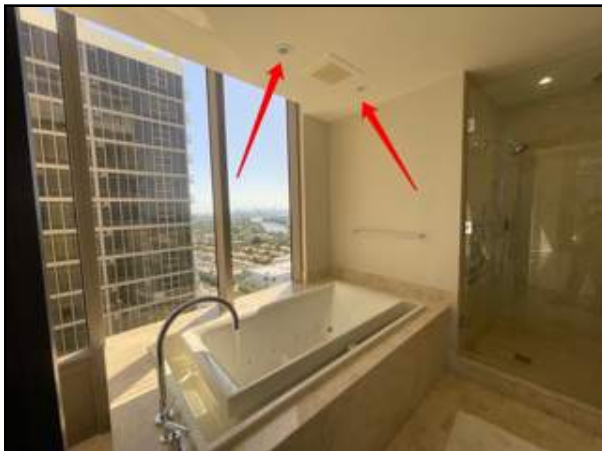
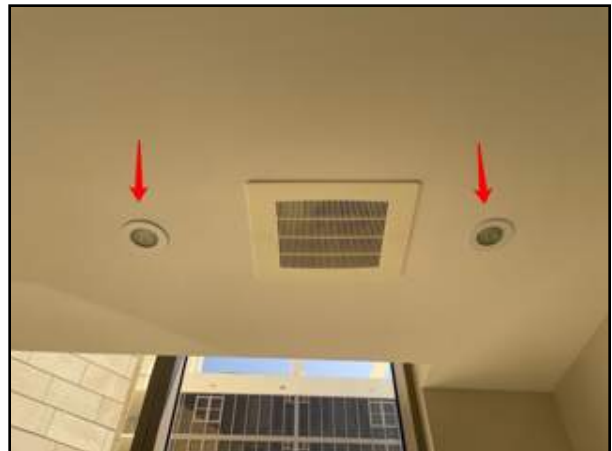
- Estimate light bulbs are burnt out.

Replace light bulbs to bathroom lighting fixtures. (Estimate: \$10 - \$25)

If lighting fixture(s) continue not to function, recommend having a licensed electrician further evaluate circuit. (Estimate: \$200 - \$500)

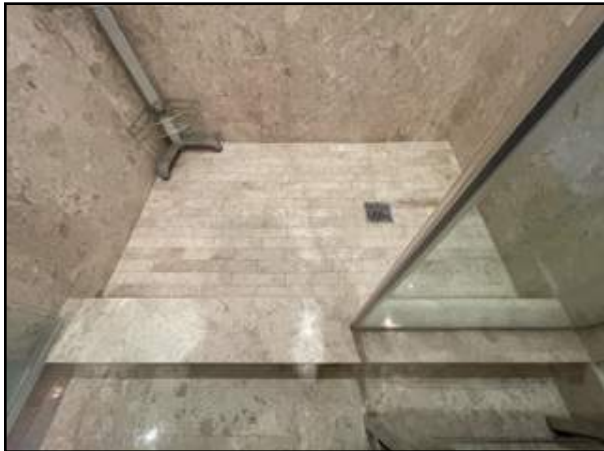
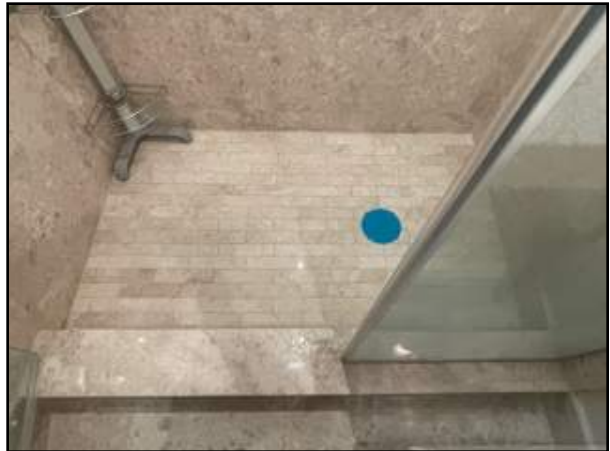
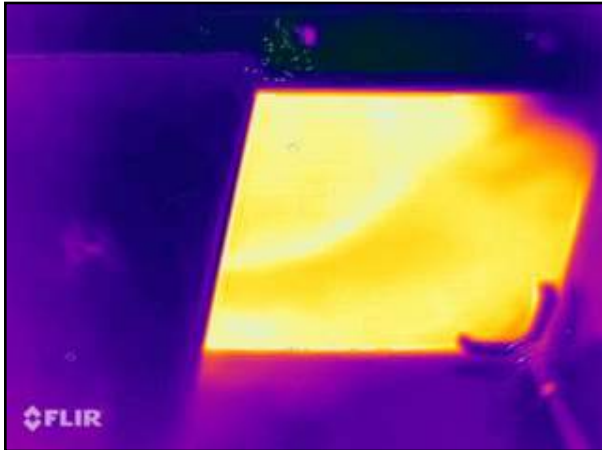
Comment 79:

No indications of leaking from around base of shower or shower pan within unit at the time of inspection.

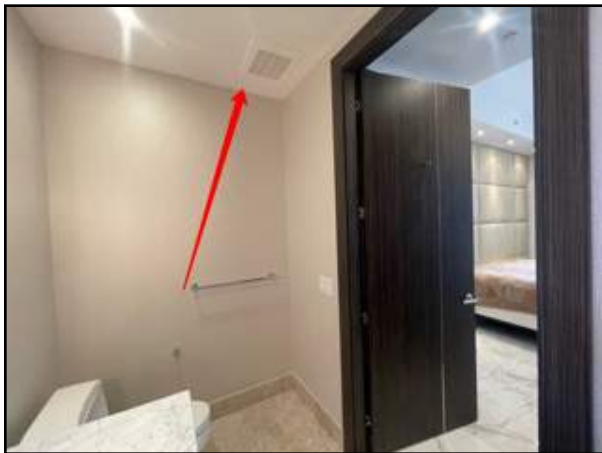
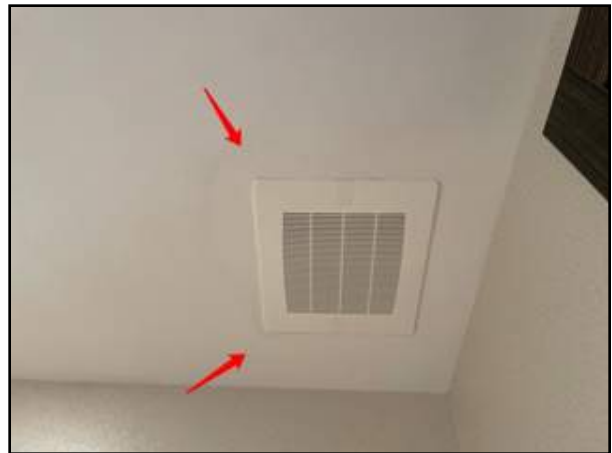
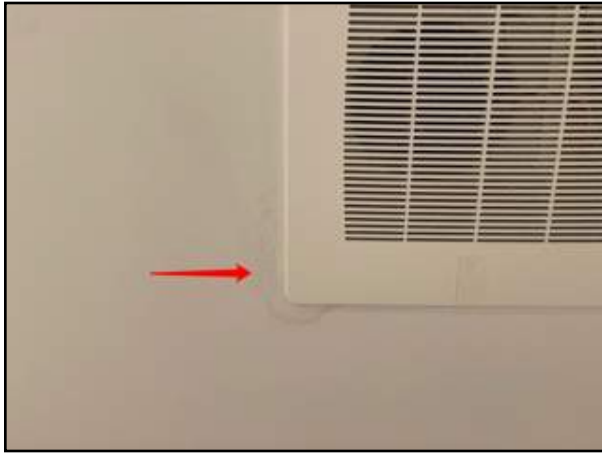
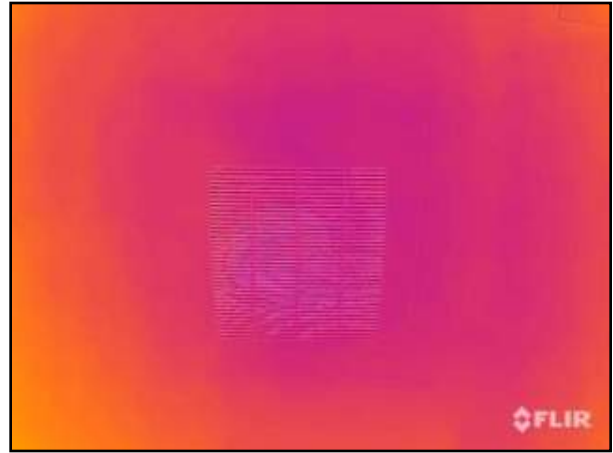
- Indications of dry water staining around exhaust fan at the time of inspection.

No active moisture detected at the time of inspection.

Repair/replace ventilation exhaust fan. (Estimate: \$250 - \$500)

Repair/refinish surrounding in drywall to conceal previous dry water staining. (Estimate: \$100 - \$200)

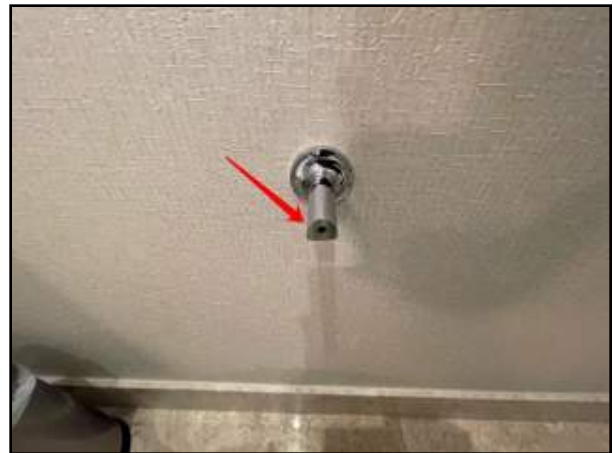
Figure 81-2

Toilet paper holder appears to have been damaged.  
Replace toilet paper holder. (Estimate: \$100 - \$200)

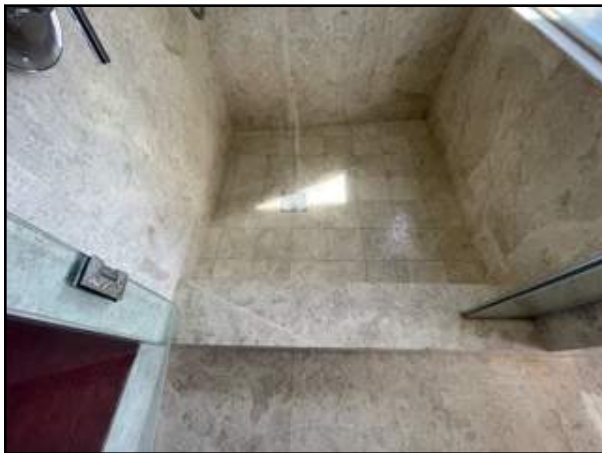
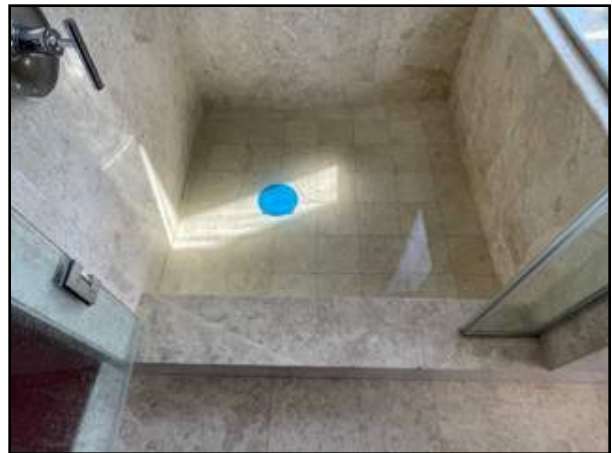
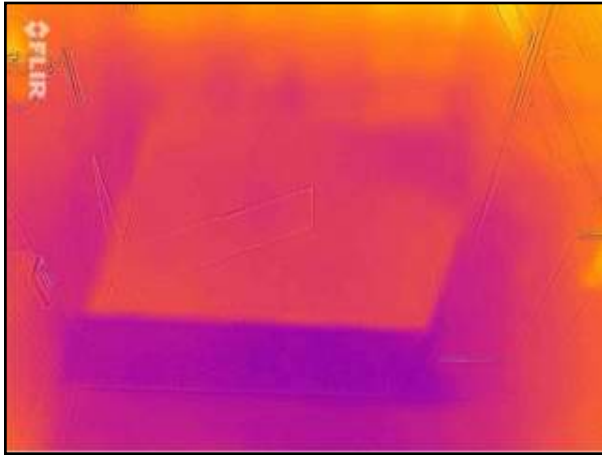
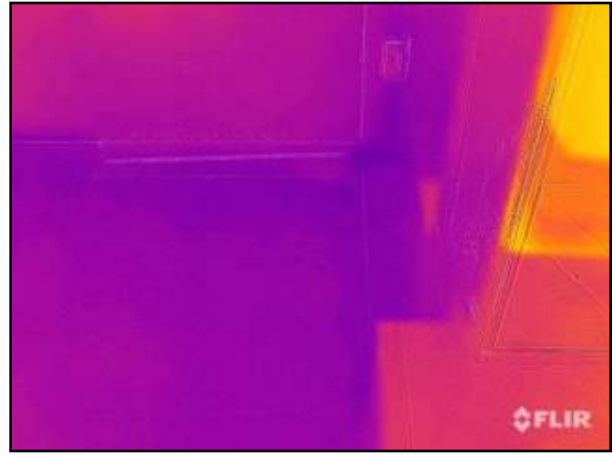
Shower pan tested.

- No indications of leaking from shower pan at the time of inspection.

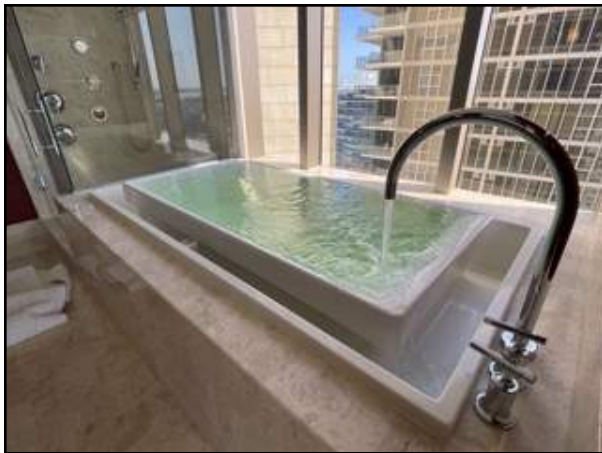
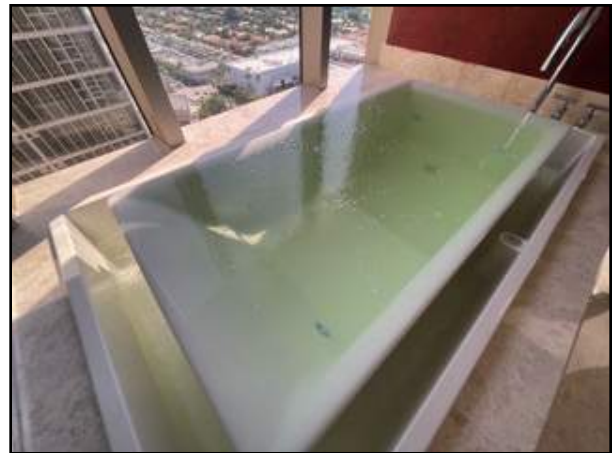
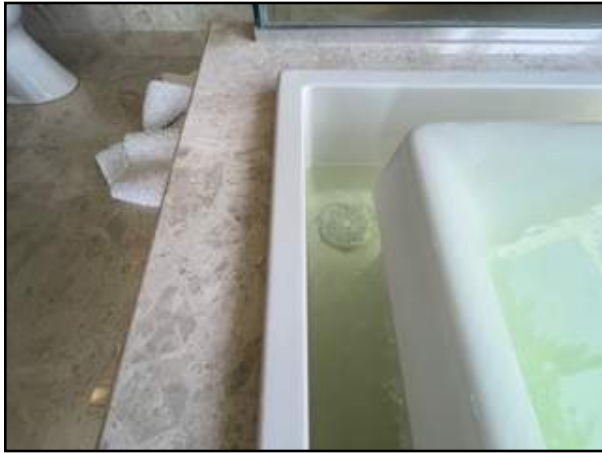
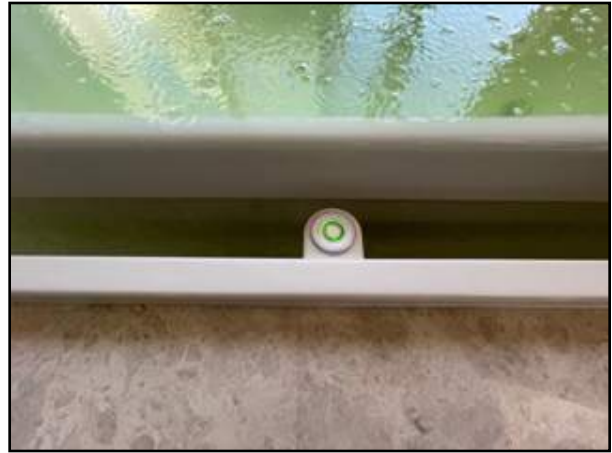
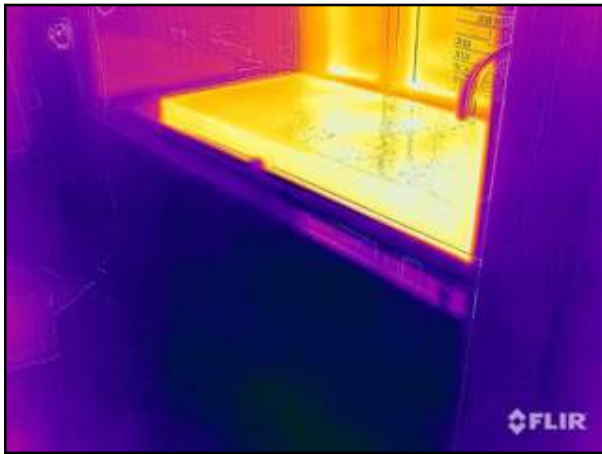
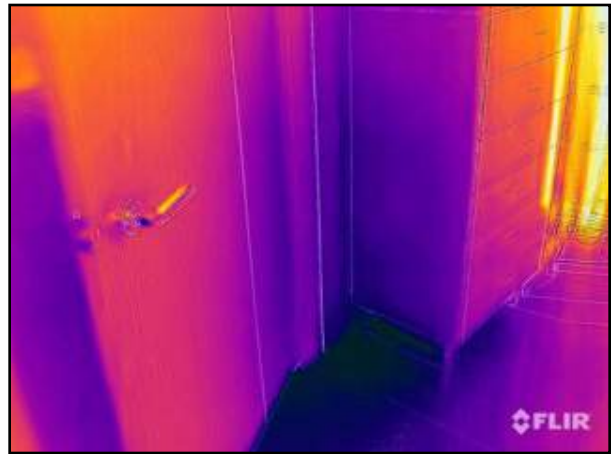
Jacuzzi tub functioning properly.

- No indications of leaking from around jacuzzi tub at the time of inspection.
- No access panel available to access jacuzzi motor or shut-off valves to tub fixture.

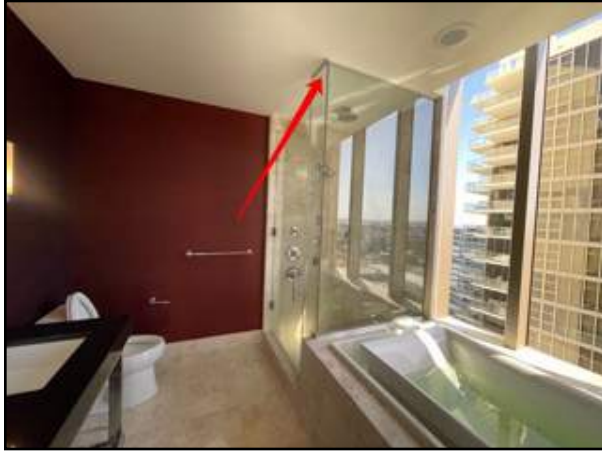
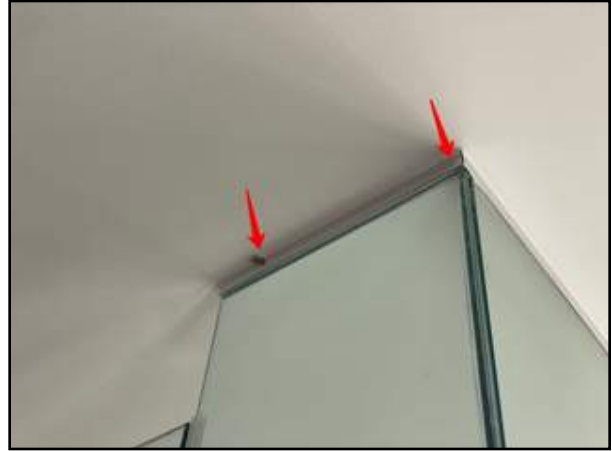
Loose trim along top of glass shower enclosure.

Recommend properly securing glass panel & trim along ceiling. (Estimate: \$100 - \$200)

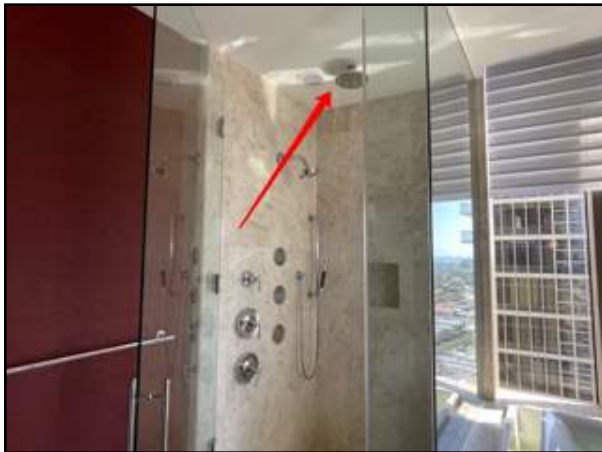
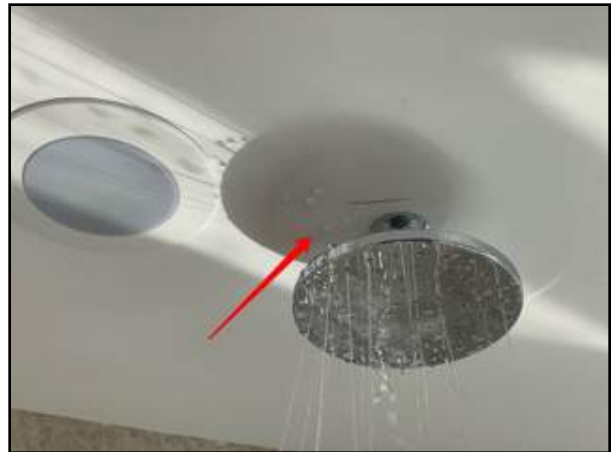
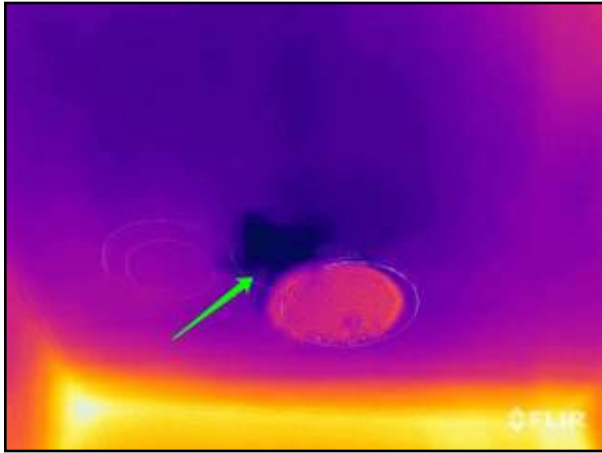
Broken rain shower head fixture causing water to spray towards ceiling.

- Active water damage caused to ceiling drywall due to broken shower fixture. Replace rain shower head fixture to prevent further water damage to ceiling over shower. (Estimate: \$200 - \$300)

Repair water damage ceiling drywall over shower fixture. (Estimate: \$150 - \$250)

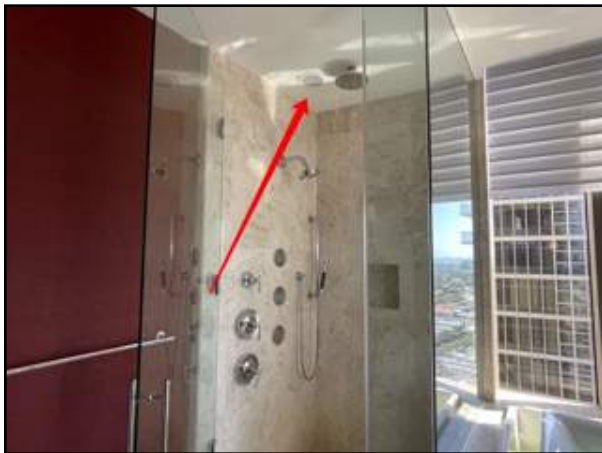
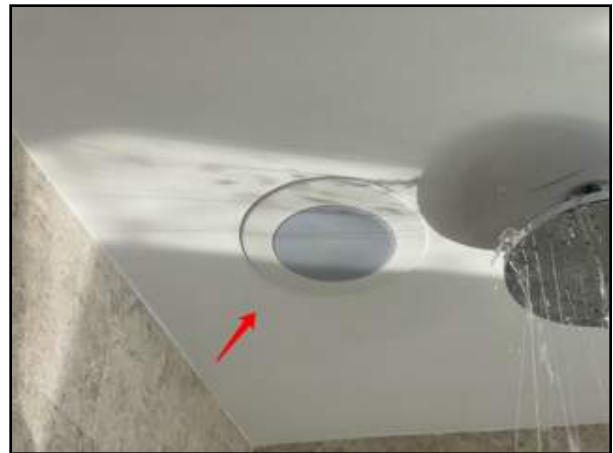
- Estimate light bulb is burnt out.

Replace light bulb to bathroom light fixture. (Estimate: \$10 - \$25)

If lighting fixture(s) continue not to function, recommend having a licensed electrician further evaluate circuit. (Estimate: \$200 - \$500)

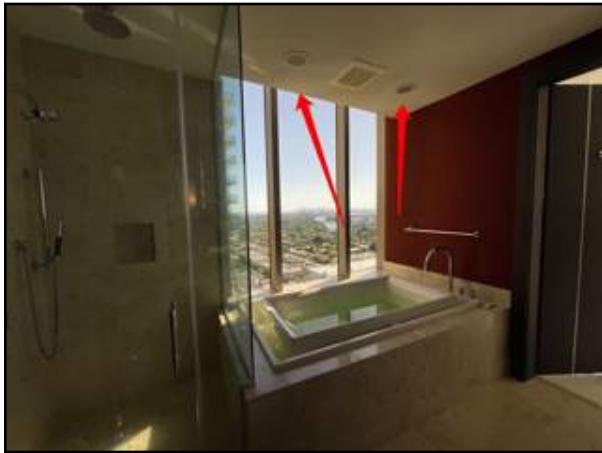
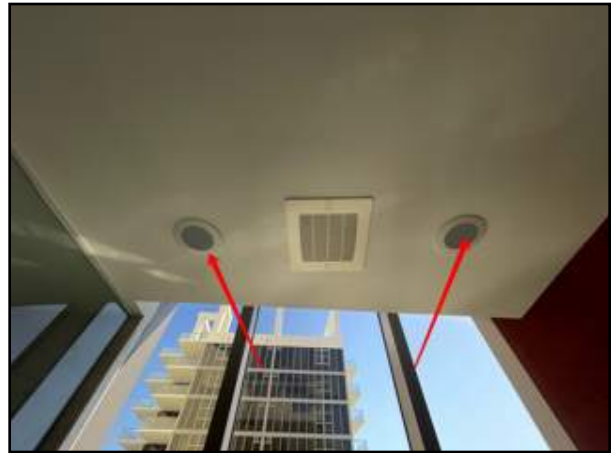
- Estimate light bulbs are burnt out.

Replace light bulbs to bathroom lighting fixtures. (Estimate: \$10 - \$25)

If lighting fixture(s) continue not to function, recommend having a licensed electrician further evaluate circuit. (Estimate: \$200 - \$500)

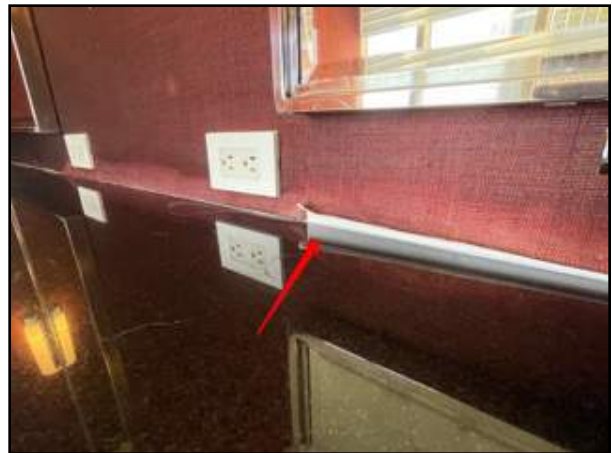
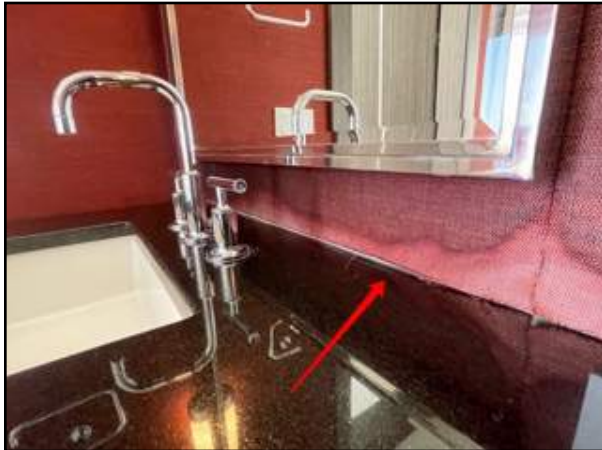
Indications of deterioration to wallpaper over vanity fixture.  
Repair/replace wallpaper. (Detailed quotation required)

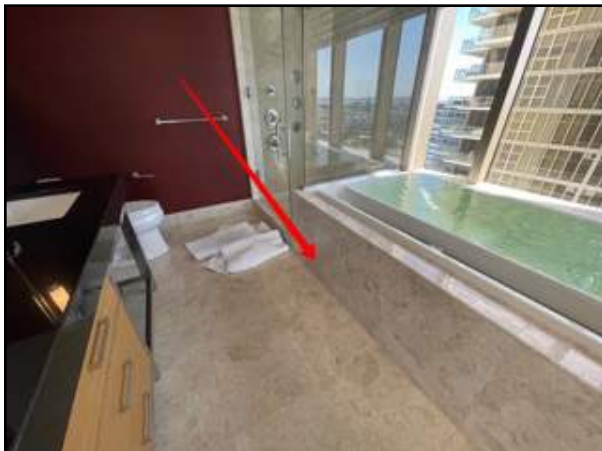
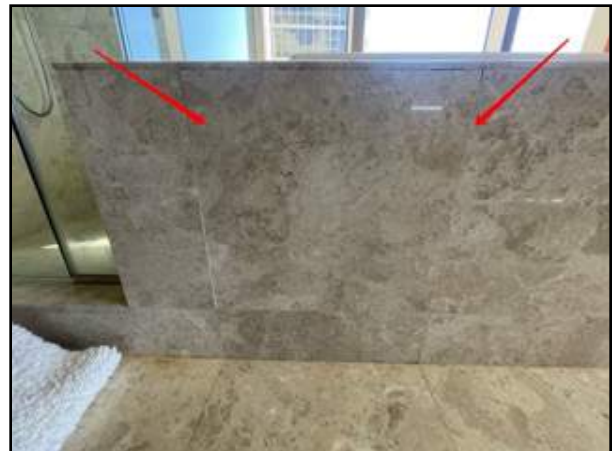
Loos tile around tub fixture within bathroom.

Recommend securing & re-grouting tile around tub fixture. (Estimate: \$100 - \$250)

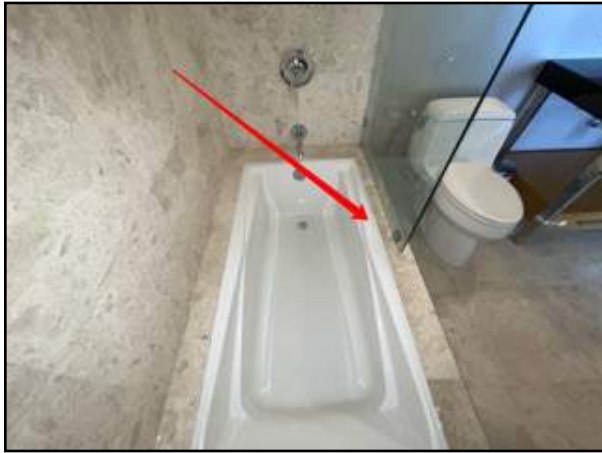
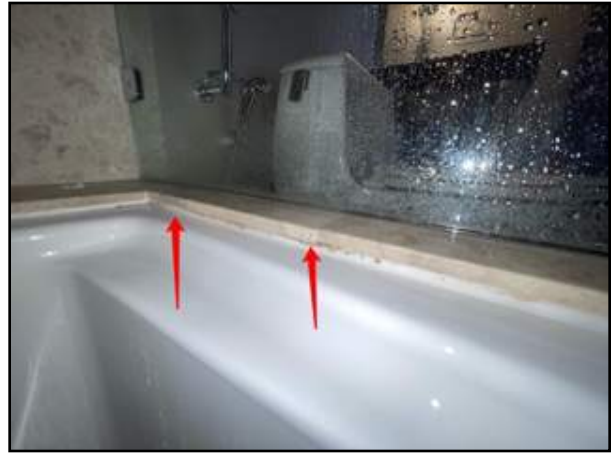
Apparent deterioration to caulking around tub fixture.

Recommend re-caulking/re-sealing around tub fixture. (Estimate: \$100 - \$200)

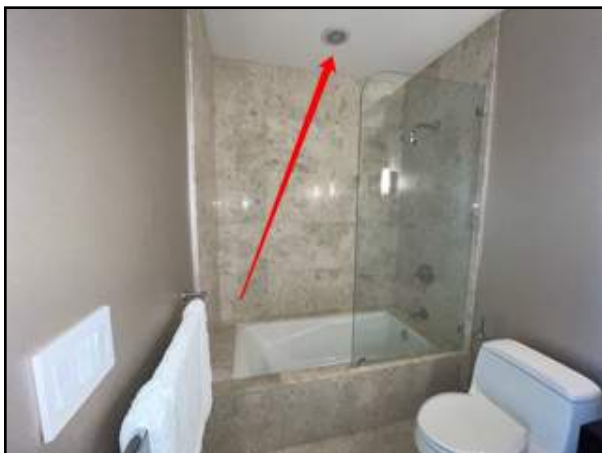
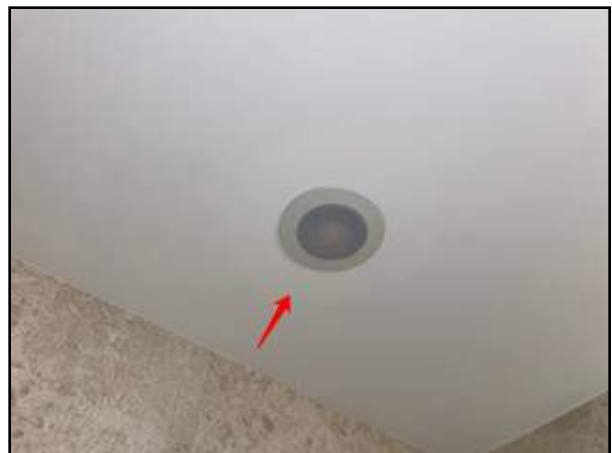
- Estimate light bulb is burnt out.

Replace light bulb to bathroom light fixture. (Estimate: \$10 - \$25)

If lighting fixture(s) continue not to function, recommend having a licensed electrician further evaluate circuit. (Estimate: \$200 - \$500)

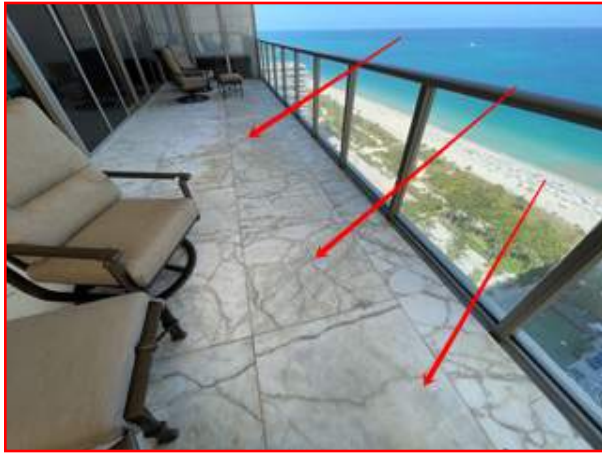
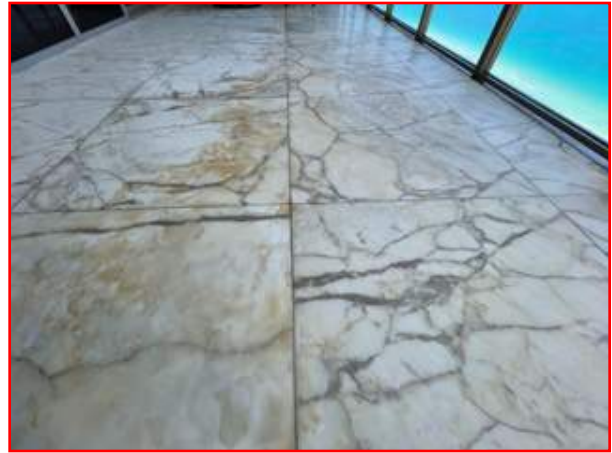
3) Comment 6: Cracked/broken flooring tile along east balcony outside of bedroom #2. Replace broken flooring tile along exterior balcony. (Estimate: \$200 - \$400)

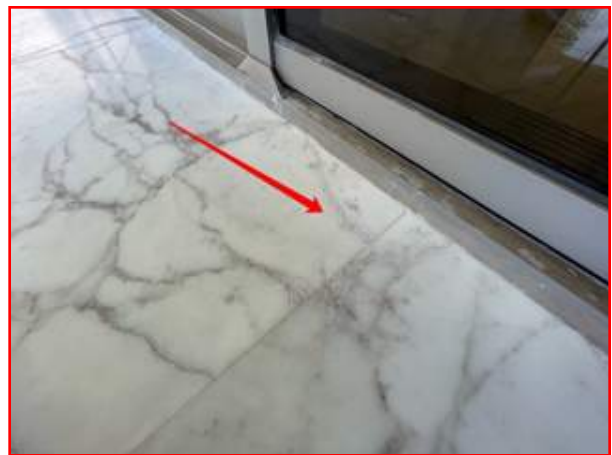
Figure 6-2

4) Comment 8: Exterior balcony tile flooring tiles throughout interior of unit appear to be discolored at the time of inspection.

- Estimate discoloration may be natural texture & porous nature of marble stone tiling due to worn seal as well as moisture intrusion below tile flooring.

Repair/Replace or re-polish/re-seal damaged or discolored tile flooring along exterior balcony as desired. (Estimate: \$2,000 - \$5,000)

If tile flooring is unable to be matched, complete replacement of flooring may be necessary. (Detailed quotation required)

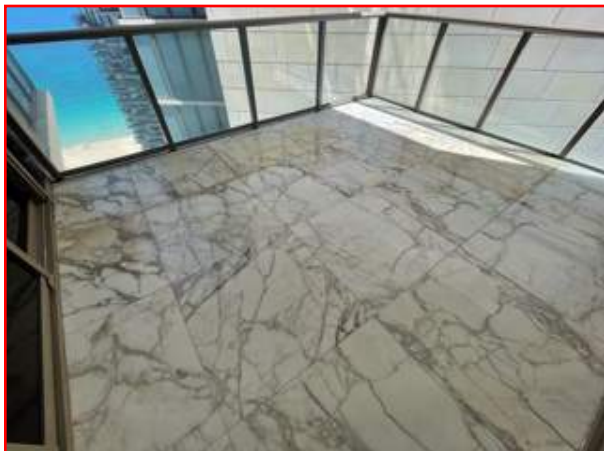
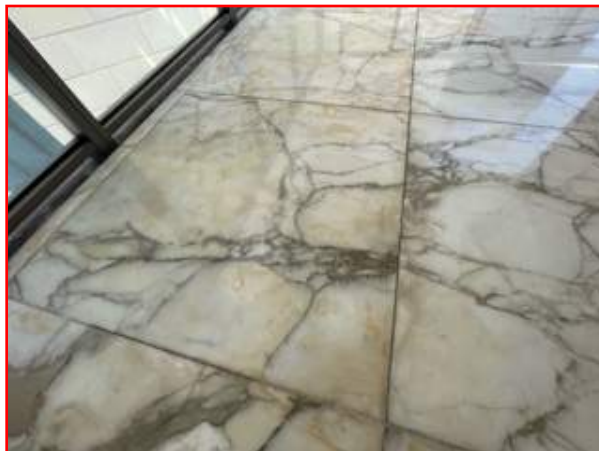
5) Comment 10: Exterior balcony tile flooring tiles throughout interior of unit appear to be discolored at the time of inspection.

- Estimate discoloration may be natural texture & porous nature of marble stone tiling due to worn seal as well as moisture intrusion below tile flooring.

Repair/Replace or re-polish/re-seal damaged or discolored tile flooring along exterior balcony as desired. (Estimate: \$2,000 - \$5,000)

If tile flooring is unable to be matched, complete replacement of flooring may be necessary. (Detailed quotation required)
