## Condo Inspection Report

**9705 Collins Ave**

**Unit 2204N/2205N**

Inspected on Tue, Mar 29 2022 at 1:00 PM

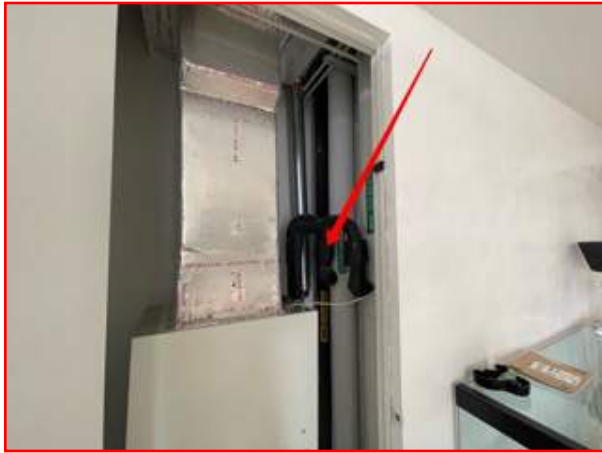
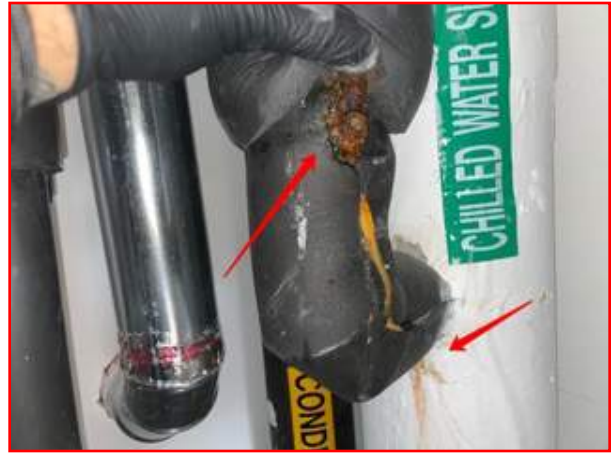
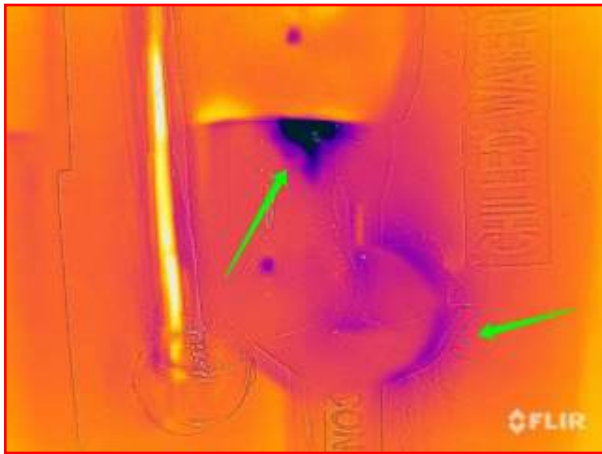
7) Comment 20: Apparent oxidation/rusting & corrosion around incoming & outgoing water valves for water source heat pump HVAC system within A/C closet.

- Apparent condensation/moisture from water valves at the time of inspection.

Recommend monitoring these valves to make sure no leaking occurs in the future. If leaking from valves does happen to occur, report to building engineer to have building maintenance repair/replace valves.

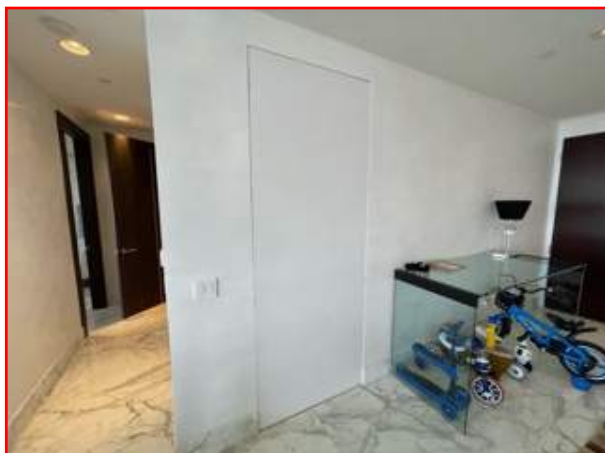
Figure 21-1

8) Comment 21: No opening hardware present to A/C closet.

Recommend installation of hardware or handle to open A/C closet door.

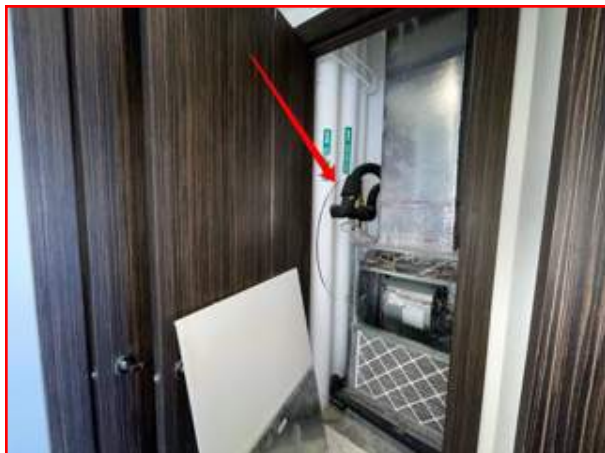
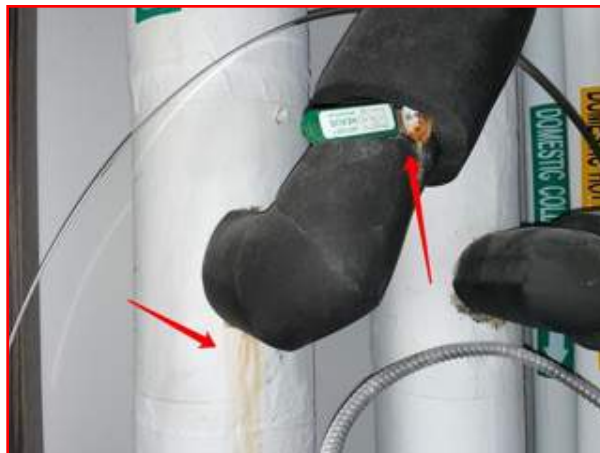
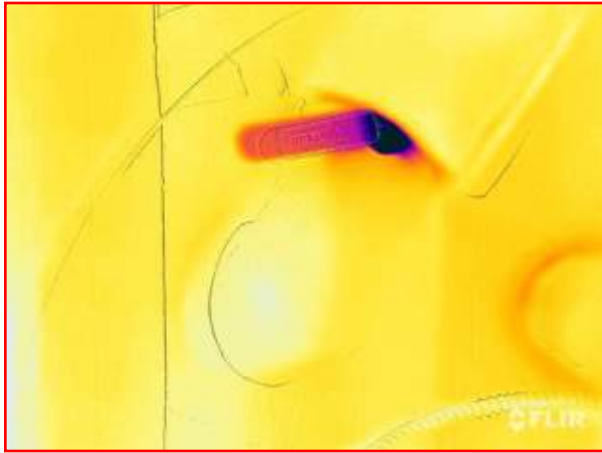
9) Comment 23: Apparent oxidation/rusting & corrosion around incoming & outgoing water valves for water source heat pump HVAC system within A/C closet.

- Apparent condensation/moisture from water valves at the time of inspection.

Recommend monitoring these valves to make sure no leaking occurs in the future. If leaking from valves does happen to occur, report to building engineer to have building maintenance repair/replace valves.

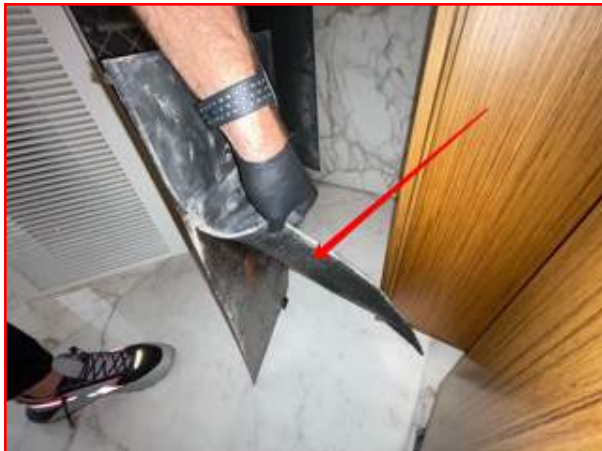
Figure 25-1

10) Comment 25: Loose insulation within air handler unit currently being sucked into unit around blower fan.

- Insulation surrounding blower fan can cause extensive wear & tear to fan motor and cause motor to burn out.

Recommend repairing insulation within air handler unit to keep clear from fan blower.

(Estimate: \$150 - \$250)

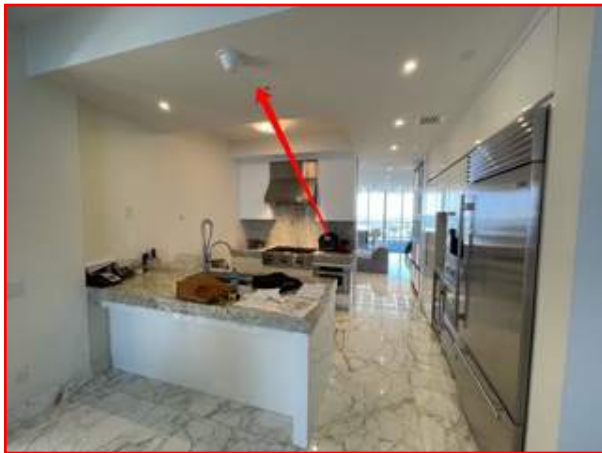
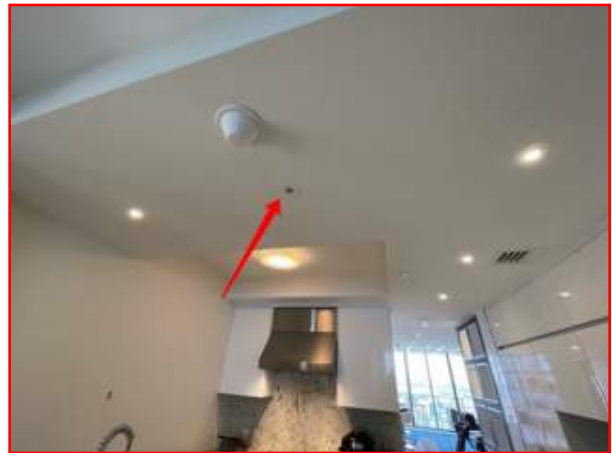
- Circuit is live when tested.
- Estimate light bulbs are burnt out.

Replace light bulbs to kitchen lights fixtures. (Estimate: \$10 - \$25)

If lighting fixture(s) continue not to function, recommend having a licensed electrician further evaluate fixtures & circuit. (Estimate: \$200 - \$500)

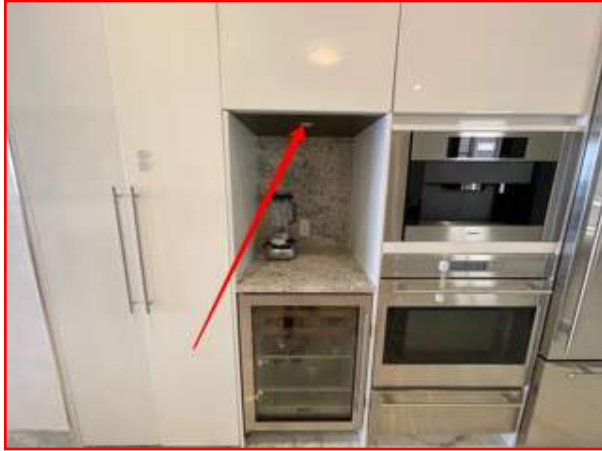
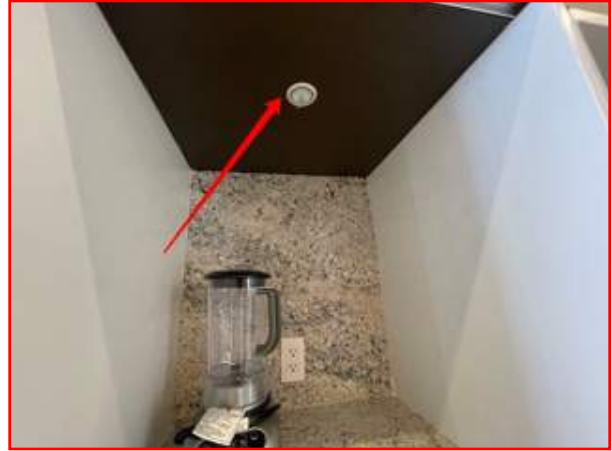
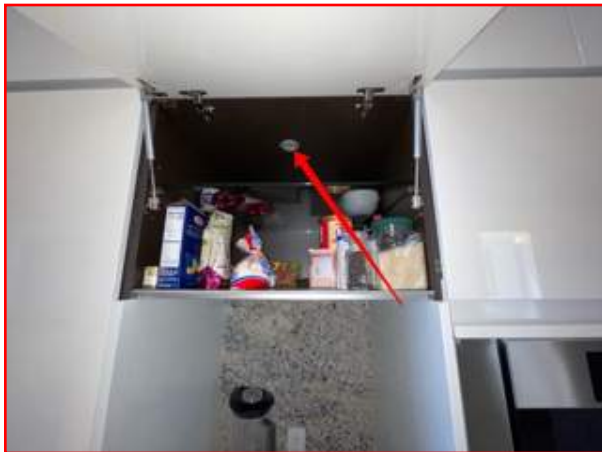
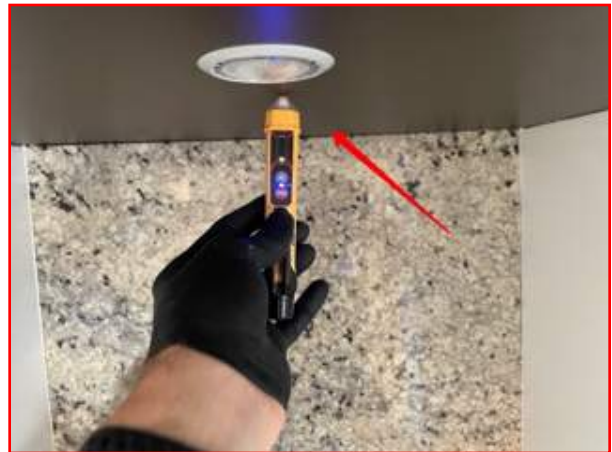
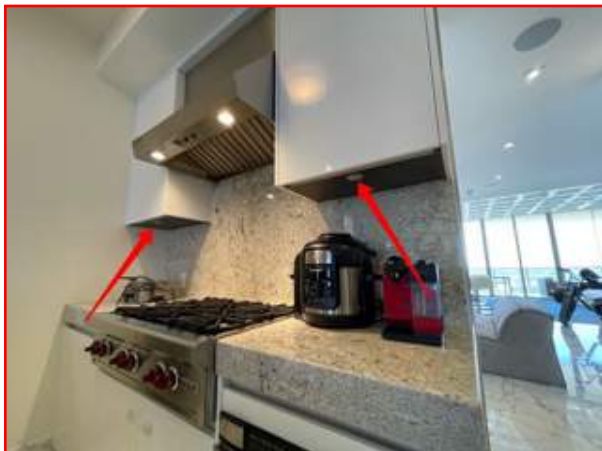
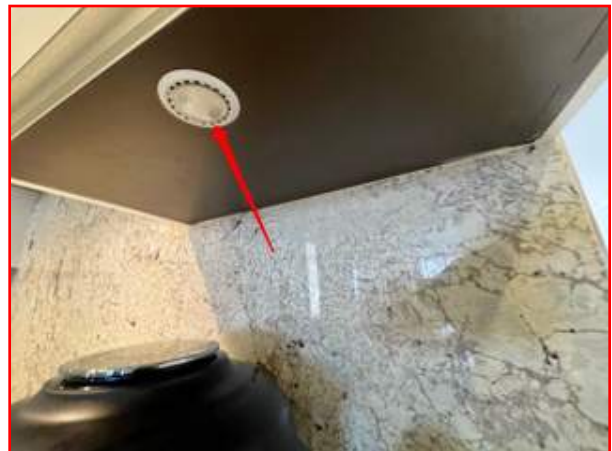
12) Comment 29: Recessed light below kitchen cabinetry not functioning at the time of inspection.

- Circuit is live when tested.
- Estimate light bulbs are burnt out.

Replace light bulb to cabinetry light fixtures. (Estimate: \$25 - \$50)

If lighting fixture(s) continue not to function, recommend having a licensed electrician further evaluate fixtures & circuit. (Estimate: \$200 - \$500)

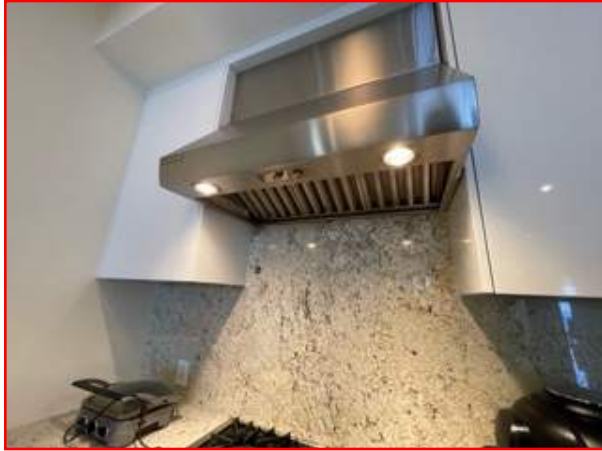
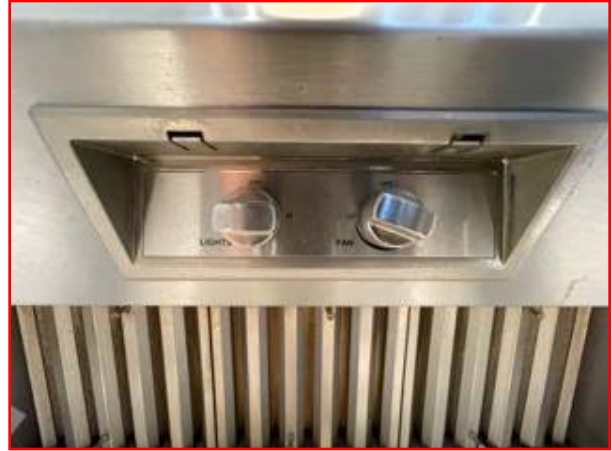
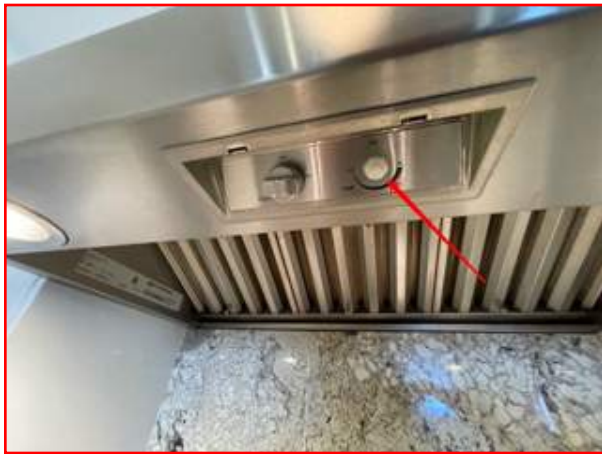
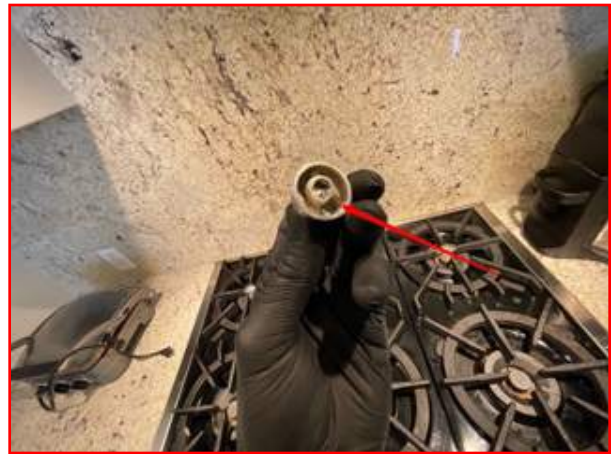
- Fan knob damaged.

Repair/replace hood fan knob. (Estimate: \$25 - \$50)

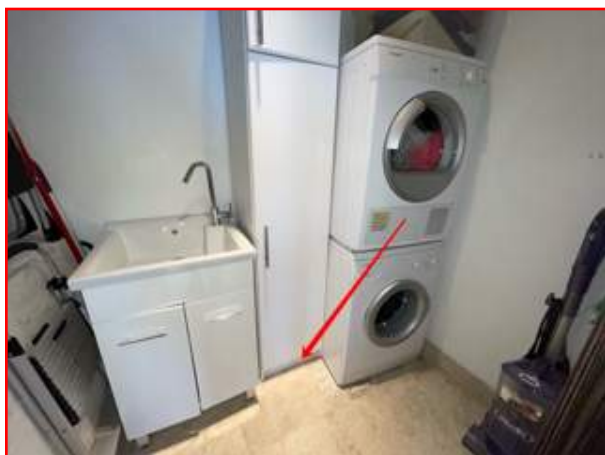
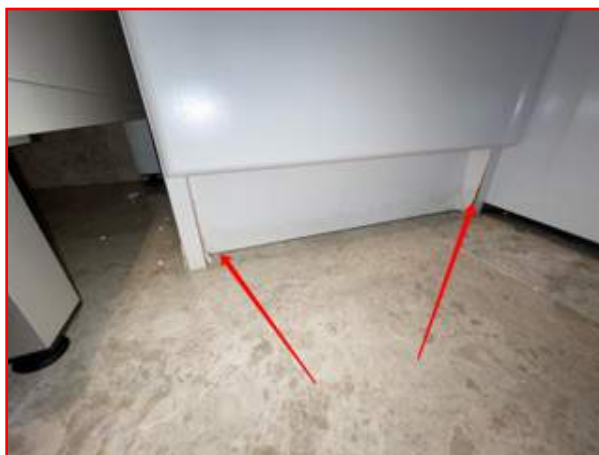
14) Comment 41: Minor water damage to base of cabinetry adjacent to washer & dryer.  
- No active water damage detected at the time of inspection.

Recommend repair or replace damaged cabinetry within laundry room. (Estimate: \$200 - \$500)

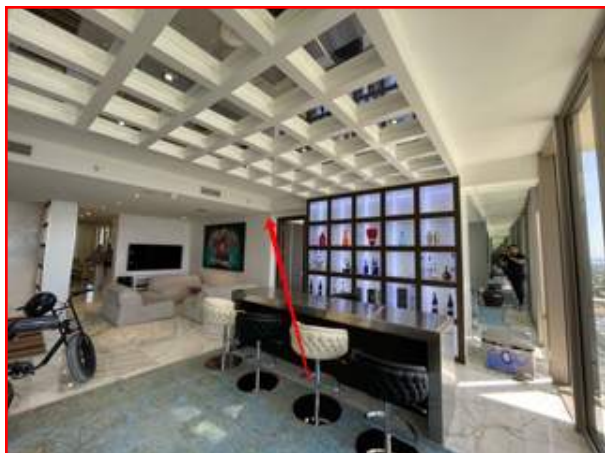
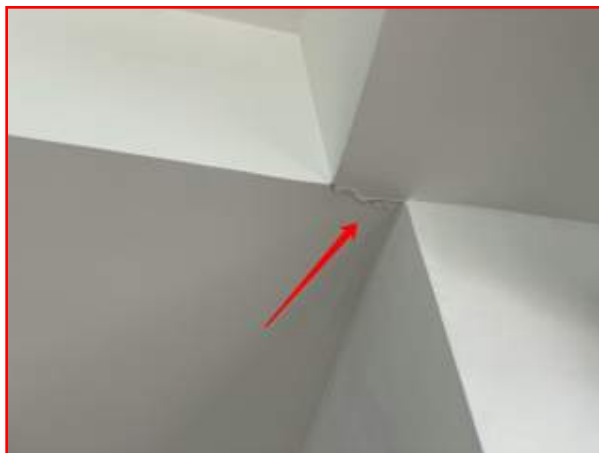
15) Comment 45: Minor cracking observed along living room ceiling drywall.

Recommend re-finishing surface of ceiling drywall to conceal cracking. (Estimate: \$150 - \$200)

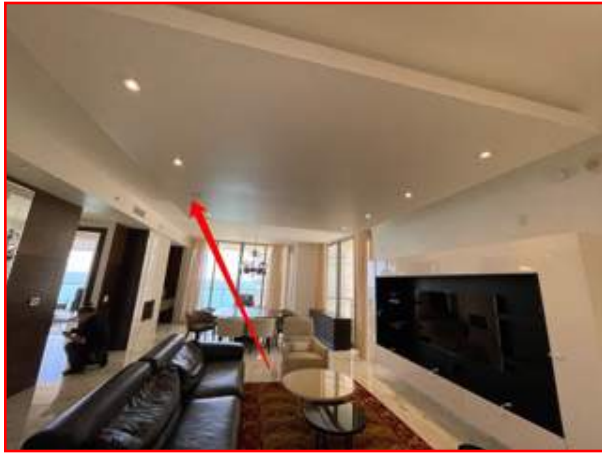
Figure 47-1

- Circuit is live when tested.
- Estimate light bulbs are burnt out.

Replace light bulbs to family room lights fixtures. (Estimate: \$10 - \$25)

If lighting fixture(s) continue not to function, recommend having a licensed electrician further evaluate fixtures & circuit. (Estimate: \$200 - \$500)

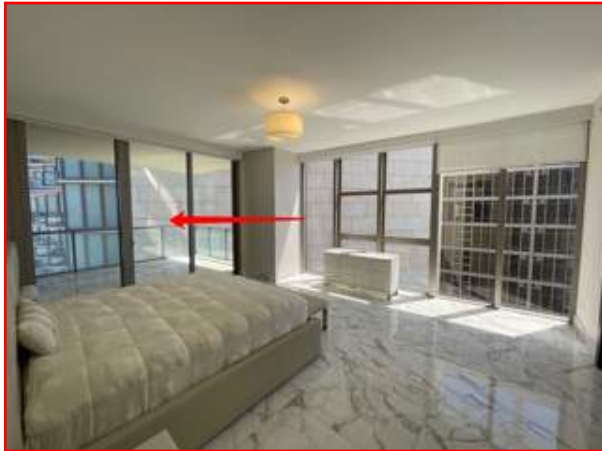
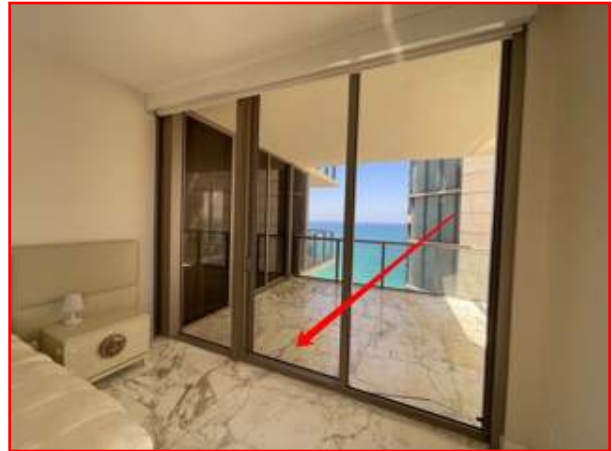
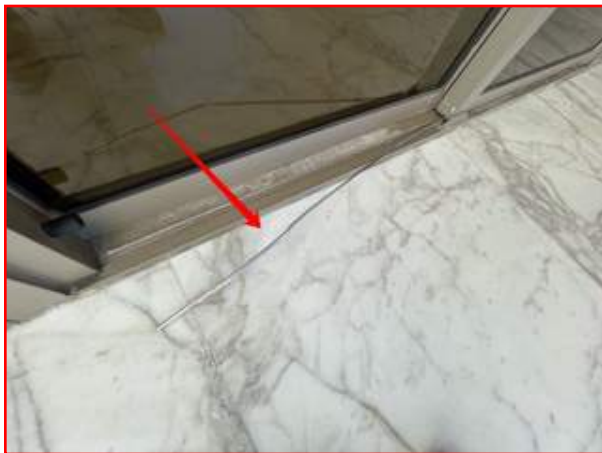
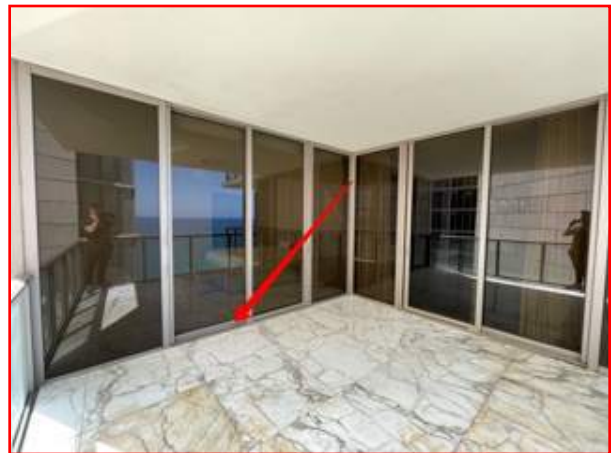
19) Comment 51: Master bedroom windows do not open/close properly due to broken spring-loaded tracks on the side of windows.

Repair/adjust spring-loaded tracks to bedroom windows. (Estimate: \$150 - \$250)

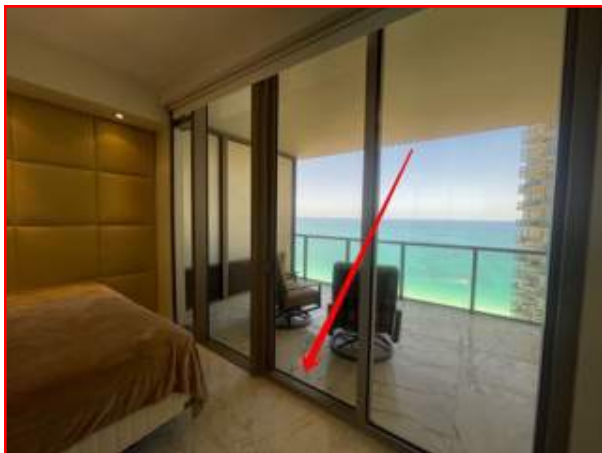
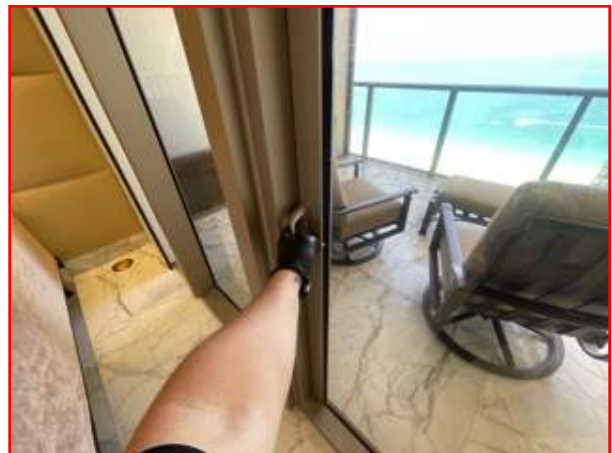
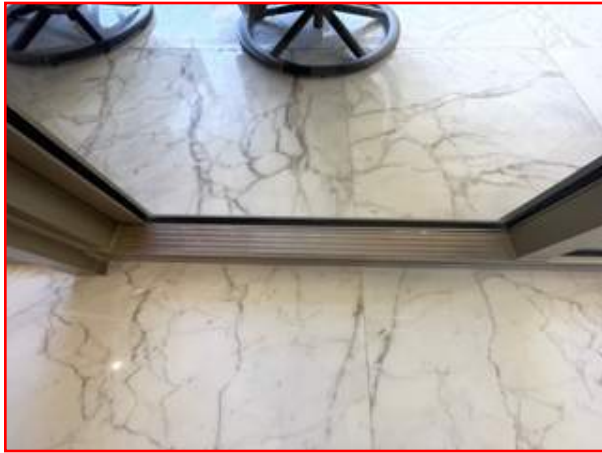
20) Comment 53: Bedroom #2 sliding glass doors are currently stuck on track within door frame, and does not open.

Recommend further evaluation by a licensed professional & repair/replace sliding-glass door tracks & rollers as necessary. (Estimate: \$500 - \$1,000)

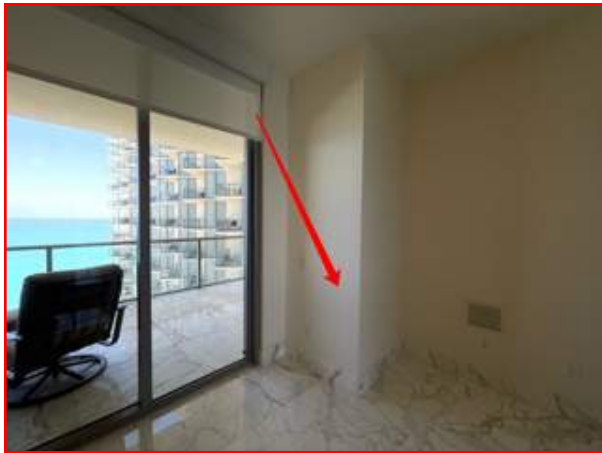
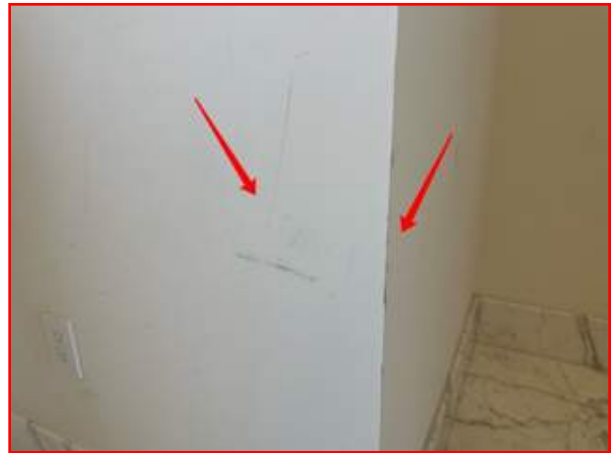
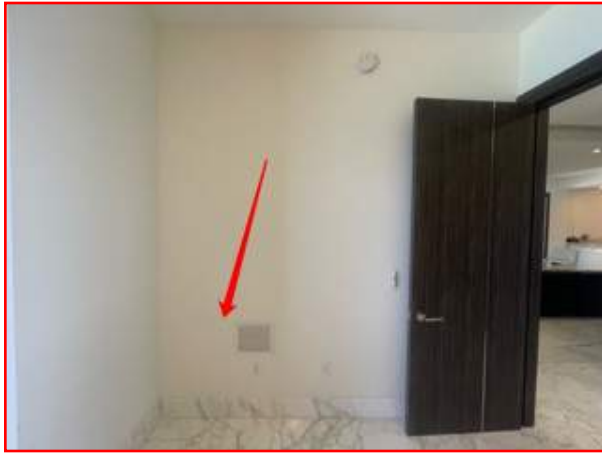
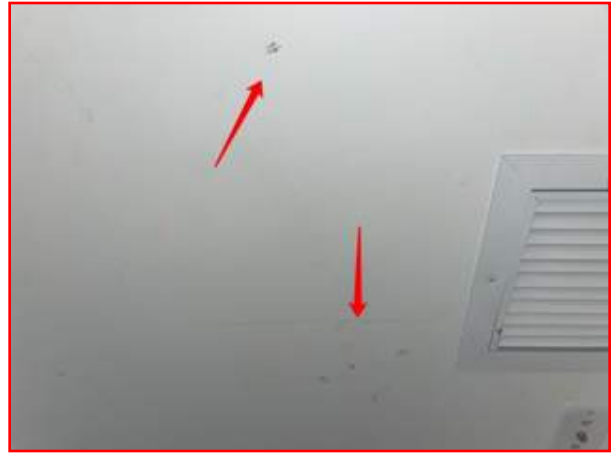
21) Comment 54: Apparent scuffs & markings to drywall in multiple locations throughout the bedroom area.

Recommend refinishing drywall throughout room as necessary. (Estimate: \$250 - \$500)

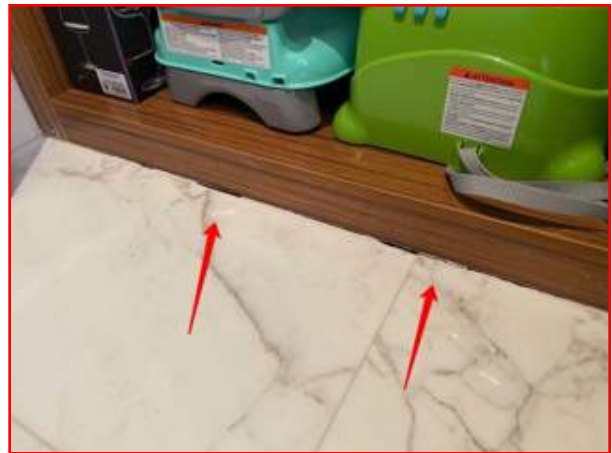
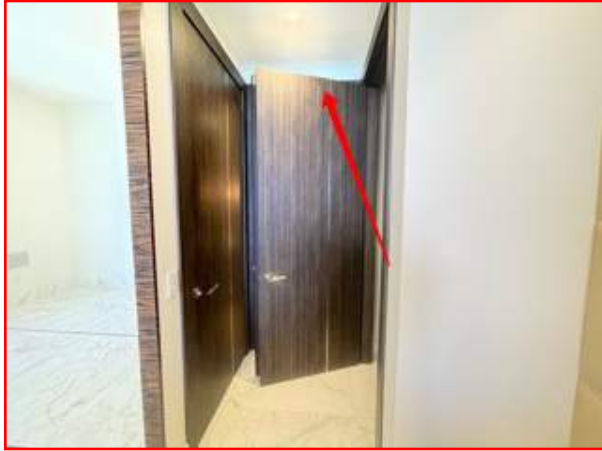
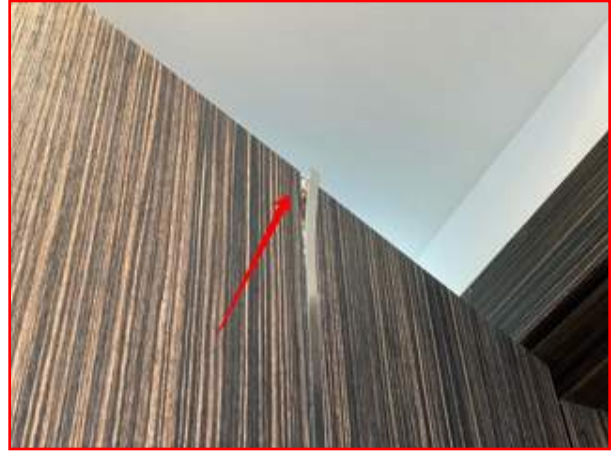
24) Comment 57: Apparent deterioration to caulking/seal along base of bedroom closet & flooring.

Recommend repairing closet door & caulking along base of closet & flooring. (Estimate: \$100 - \$250)

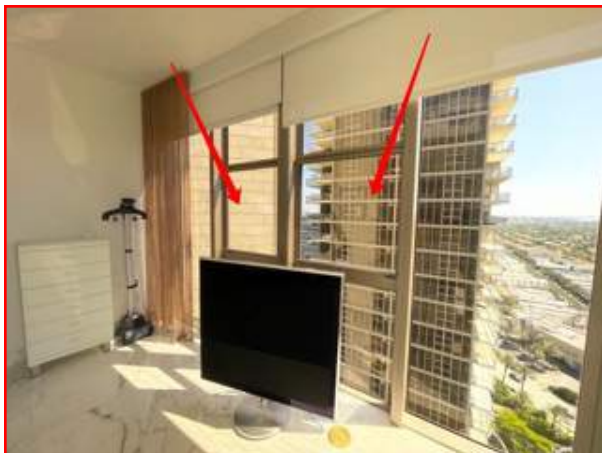
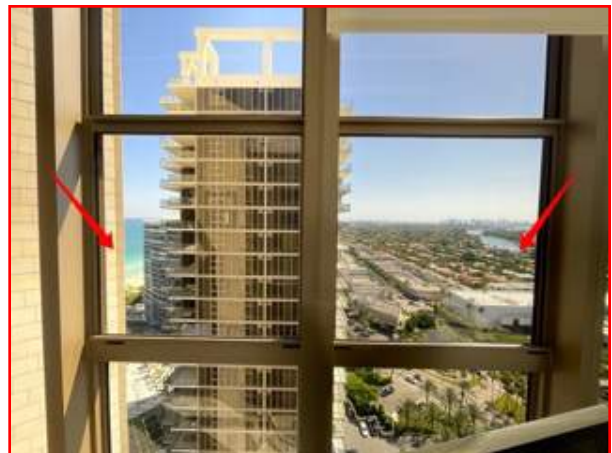
25) Comment 59: Bedroom windows do not open/close properly due to broken spring-loaded tracks on the side of windows.

- Windows currently slide closed, and do not stay open.

Repair/adjust spring-loaded tracks to bedroom windows. (Estimate: \$150 - \$250)

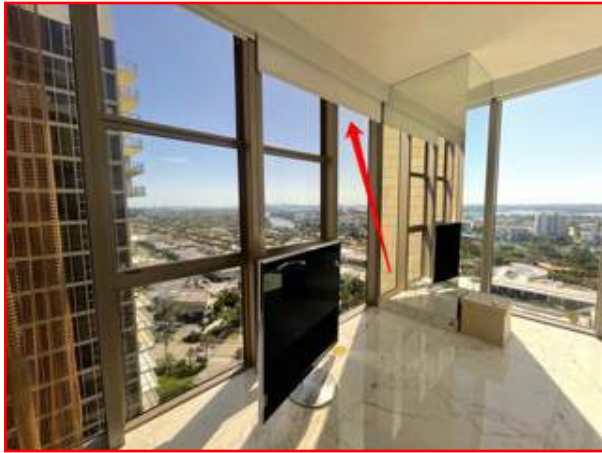
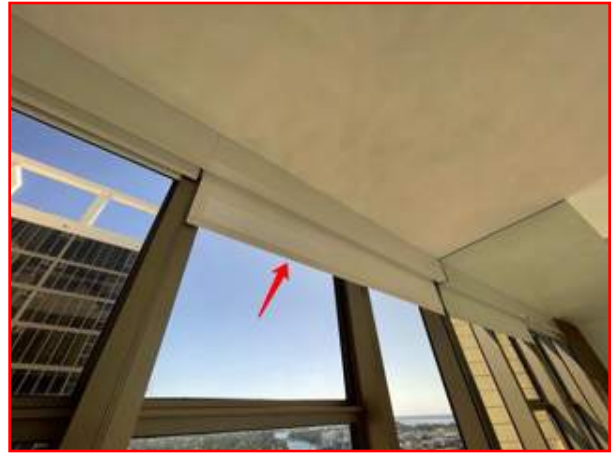
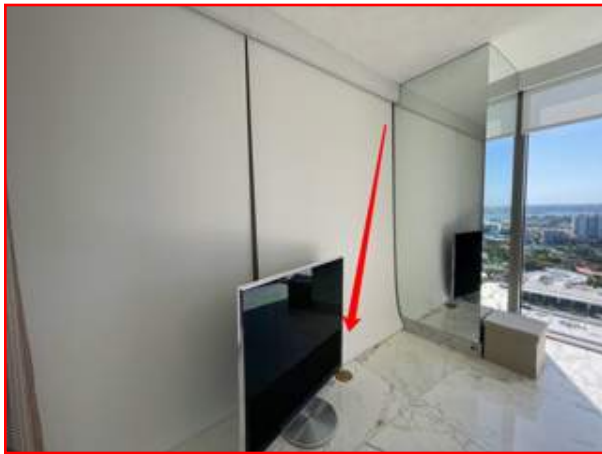
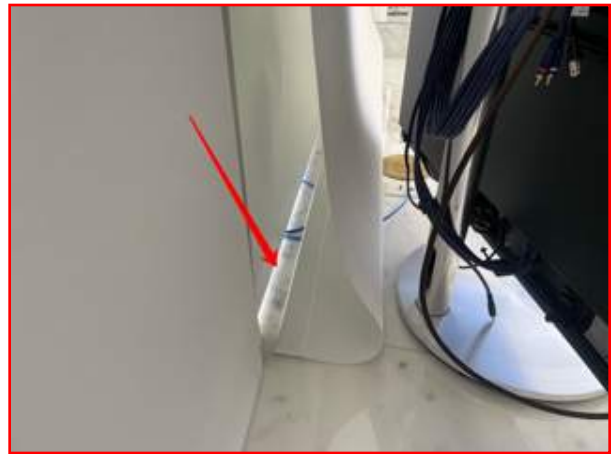
26) Comment 60: Roll down shade (sun screen) not properly calibrated within bedroom #3.

Recommend further evaluation by a qualified professional and repair roll down shade accordingly. (Estimate: \$100 - \$250)

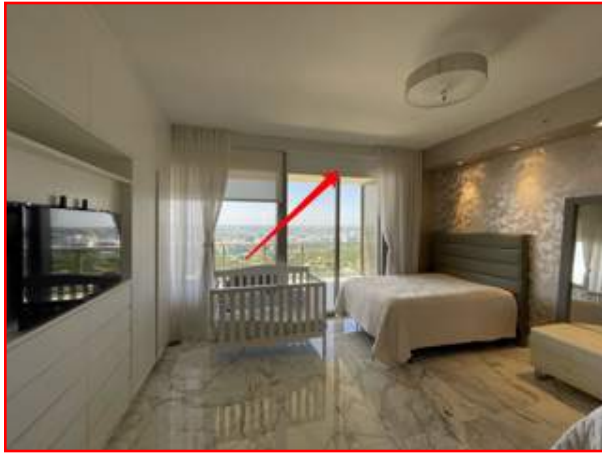
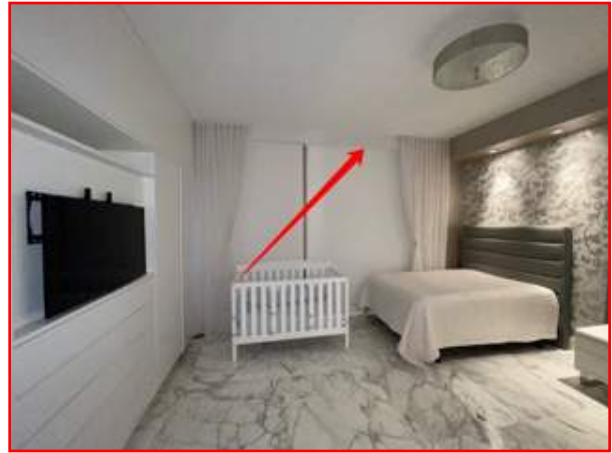
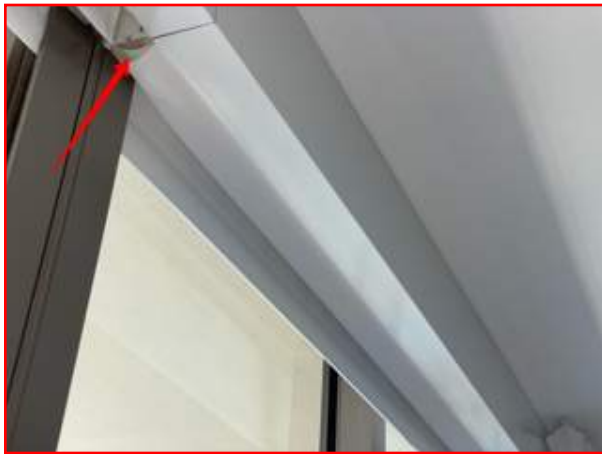
27) Comment 62: Roll down shade (sun screen) not properly calibrated and stuck in framing within bedroom #4.  
Recommend further evaluation by a qualified professional and repair roll down shade accordingly. (Estimate: \$100 - \$250)

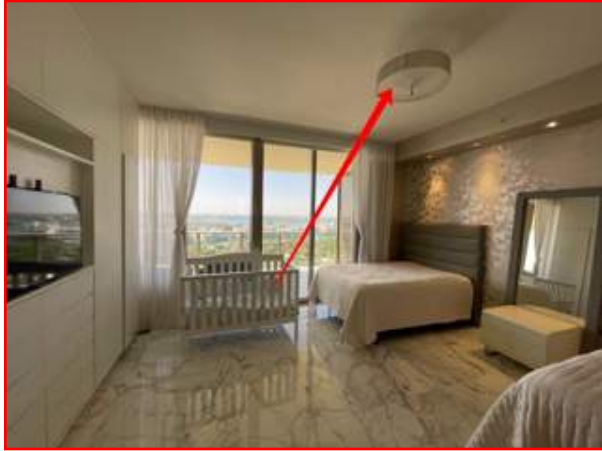
Figure 63-1

28) Comment 63: Bedroom #4 overhead light not functioning at the time of inspection.

- Estimate light bulb is burnt out.

Replace light bulb to bedroom light fixture. (Estimate: \$10 - \$25)

If lighting fixture(s) continue not to function, recommend having a licensed electrician further evaluate circuit. (Estimate: \$200 - \$500)

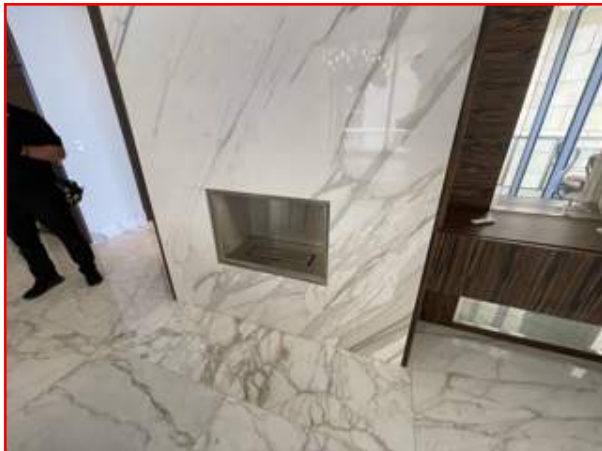
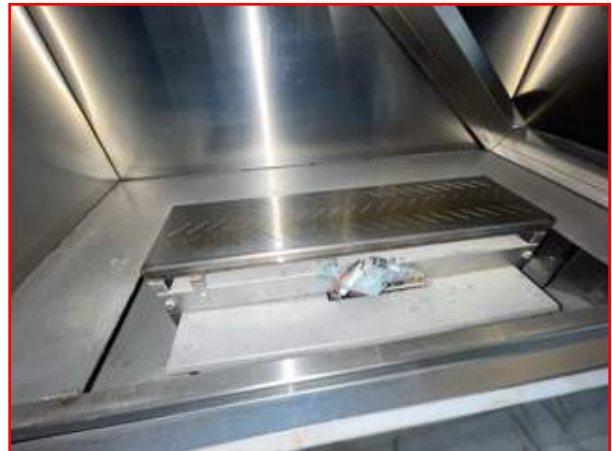
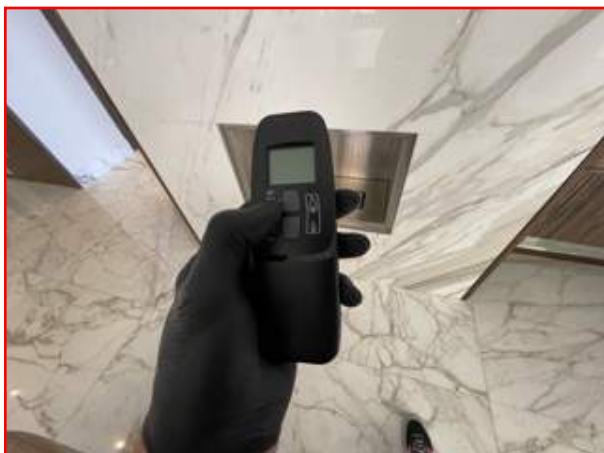
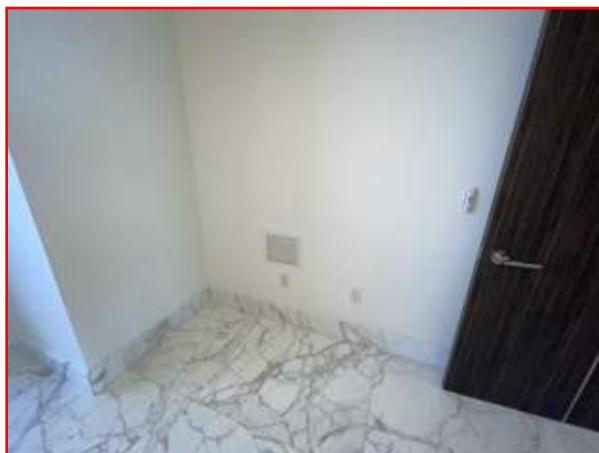
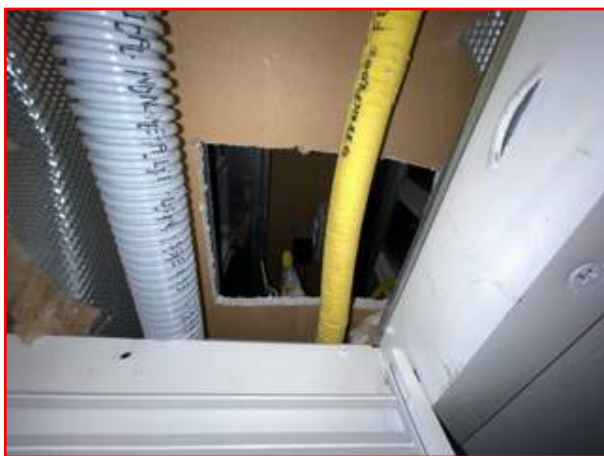
29) Comment 65: Gas ventless fire place located within dining room appears to be in good condition, but not functioning at the time of inspection as remote controls are not currently functional.

- Gas valve located within adjacent bedroom behind fireplace.

Repair remote activation controls for proper use of ventless fireplace within dining room.  
(Estimate: \$25 - \$150)

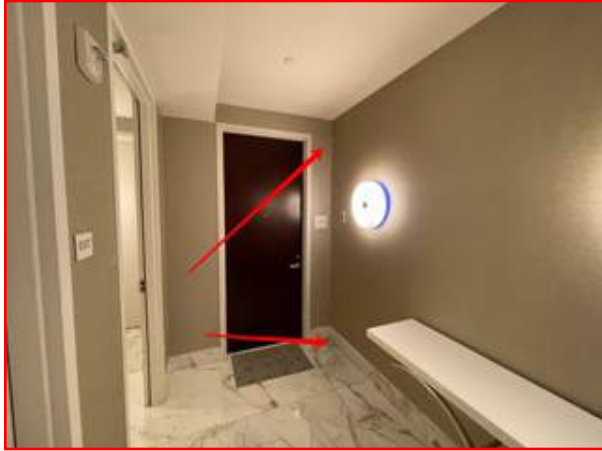
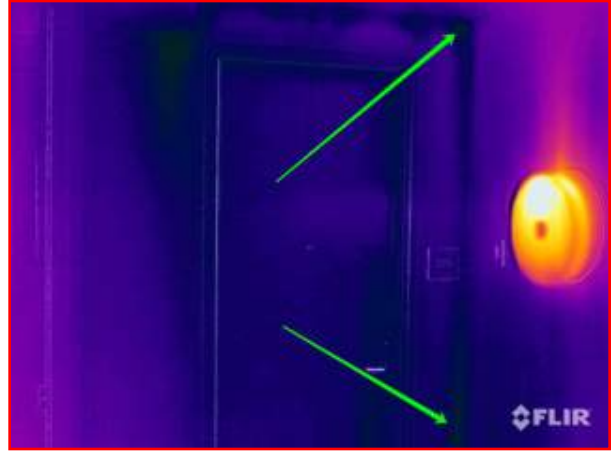
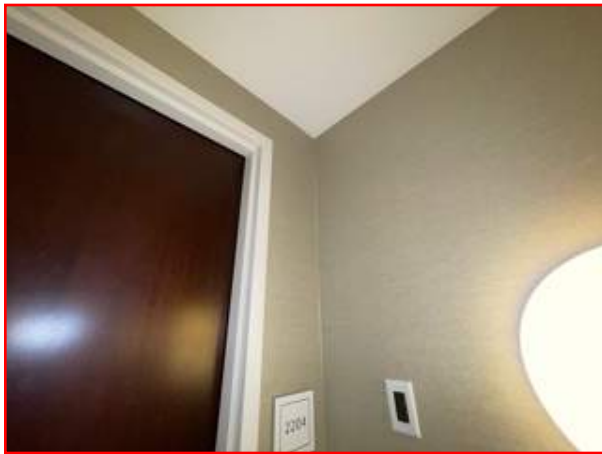
30) Comment 67: Concern for potential moisture intrusion over elevator entrance/foyer.

- Minor moisture detected via thermal imaging as well as moisture meters along top corner of wall & base of floor.

- Indications of discoloration to tile flooring along base of floor due to extended exposure to moisture.

- Estimate potential active leaking from unit above.

Recommend reporting to building for further investigation into potential leaking from unit above & repair accordingly.

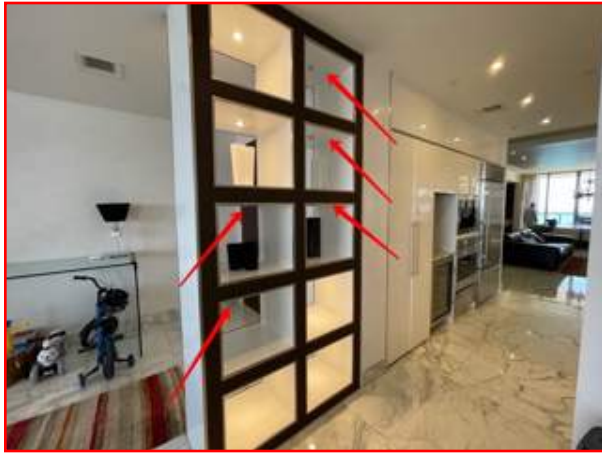
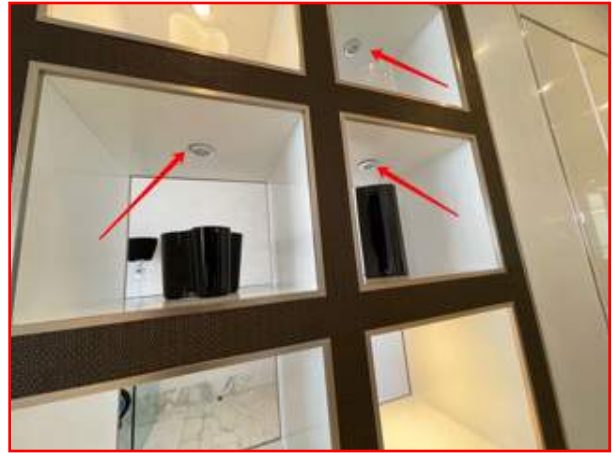
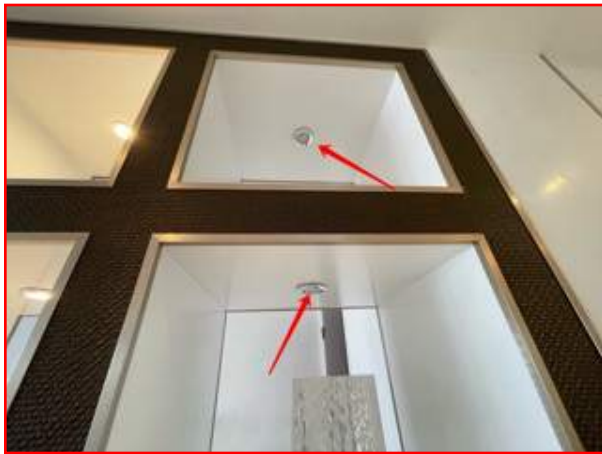
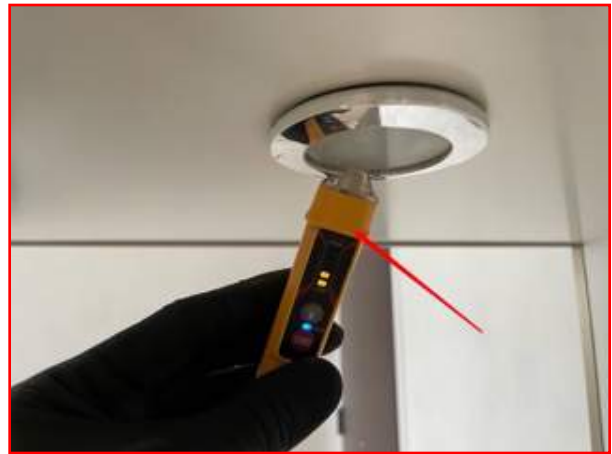
31) Comment 68: Select recessed lighting within built-in cubby shelving not functioning at the time of inspection.

- Circuit is live when tested.
- Estimate light bulbs are burnt out.

Replace light bulbs to shelving light fixtures. (Estimate: \$10 - \$25)

If lighting fixture(s) continue not to function, recommend having a licensed electrician further evaluate fixtures & circuit. (Estimate: \$200 - \$500)

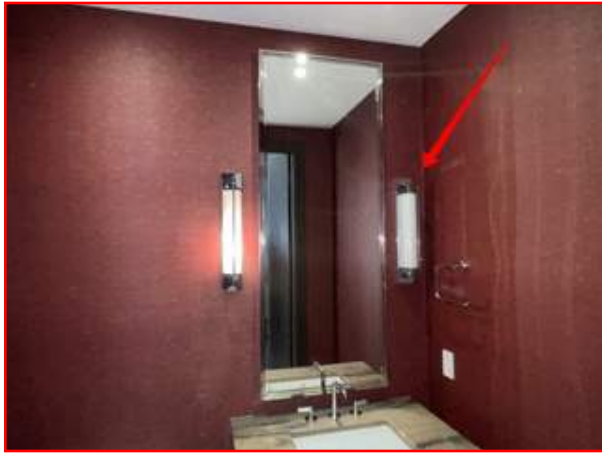
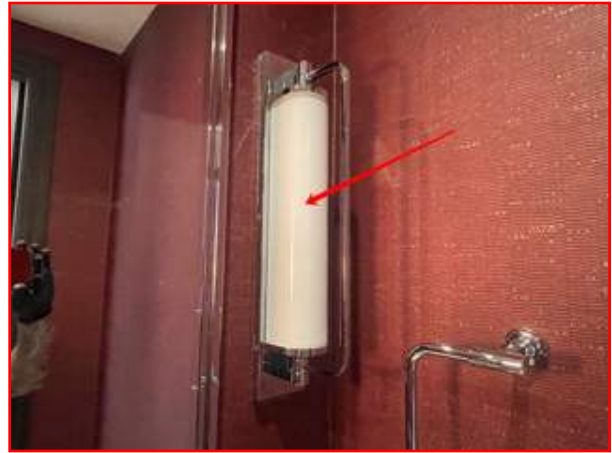
- Estimate light bulb is burnt out.

Replace light bulb to bathroom light fixture. (Estimate: \$10 - \$25)

If lighting fixture(s) continue not to function, recommend having a licensed electrician further evaluate circuit. (Estimate: \$200 - \$500)

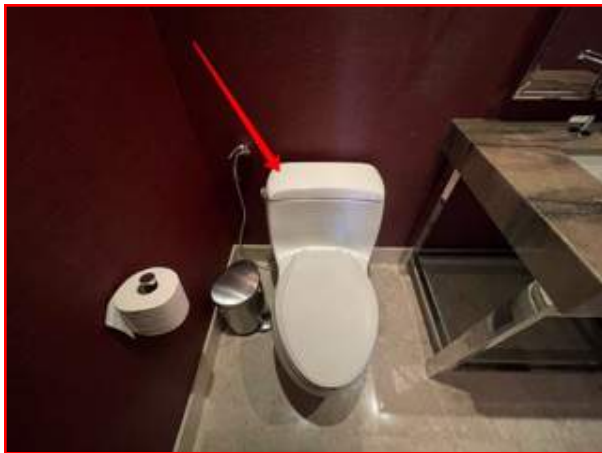
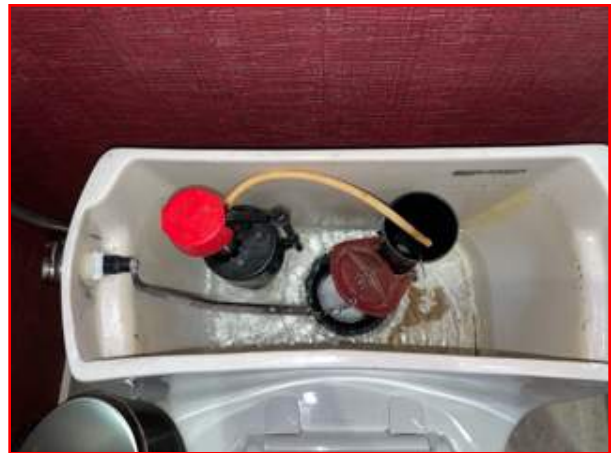
33) Comment 71: Flushing mechanism within toilet tank is broken preventing toilet from flushing and causing water to constantly run.

- Water turned off to toilet fixture following inspection to prevent water from continuously running.

Replace flushing mechanism within tank of toilet. (Estimate: \$50 - \$100)

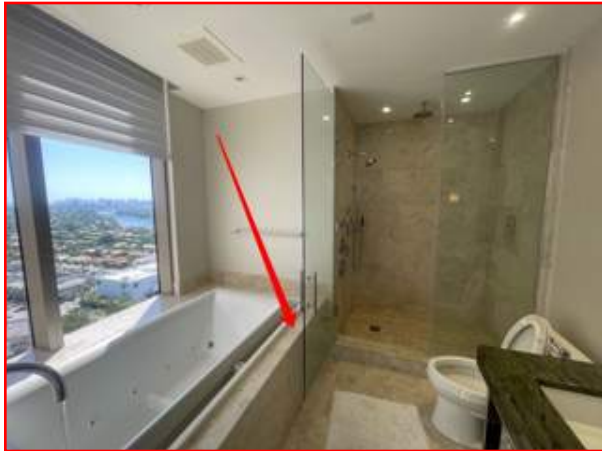
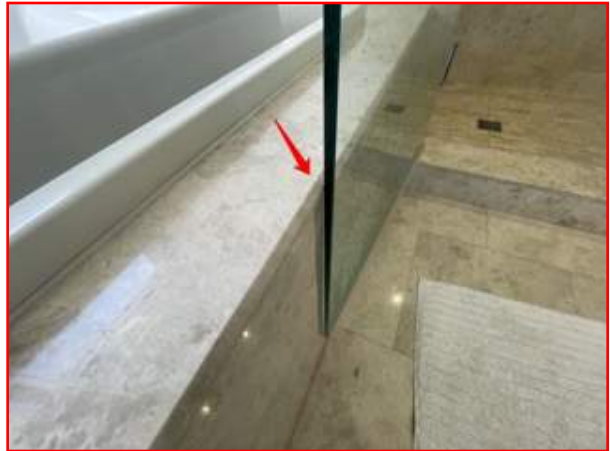
34) Comment 75: Frameless glass shower door within bathroom conflicting with adjacent tub wall when opening.

Recommend installing a door stopper or bumper prevent damaging wall. (Estimate: \$25 - \$50)

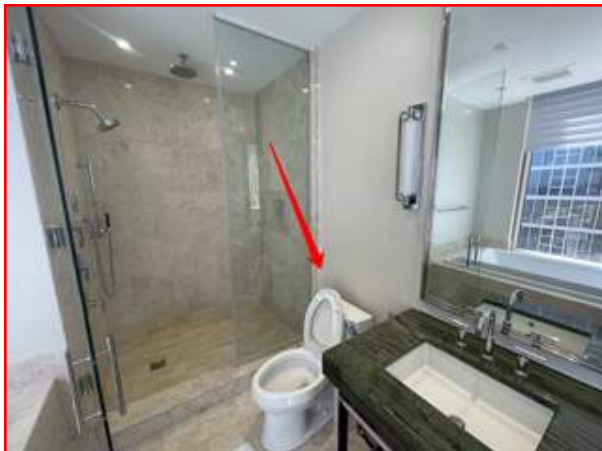
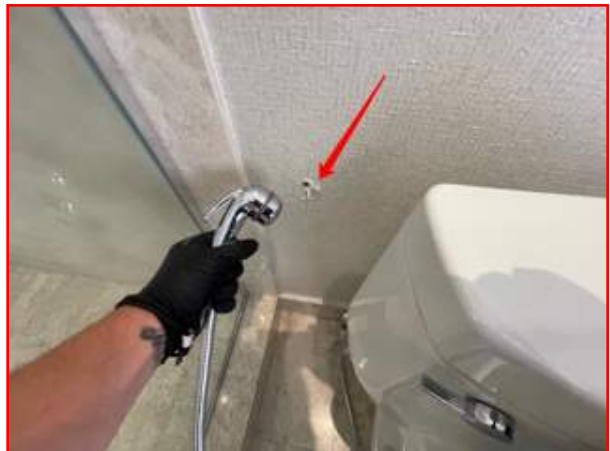
35) Comment 76: Hand held fixture to toilet functional, but wall mount appears to have been removed leaving damage to wall adjacent to toilet fixture.

Recommend repairing wall & re-mounting wall mount/bracket to hold hand held fixture. (Estimate: \$200 - \$300)

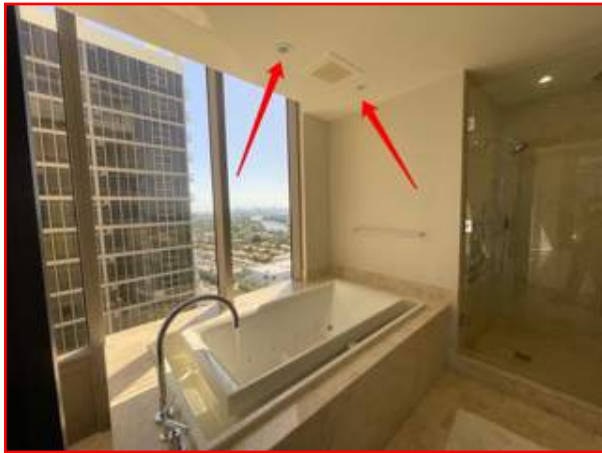
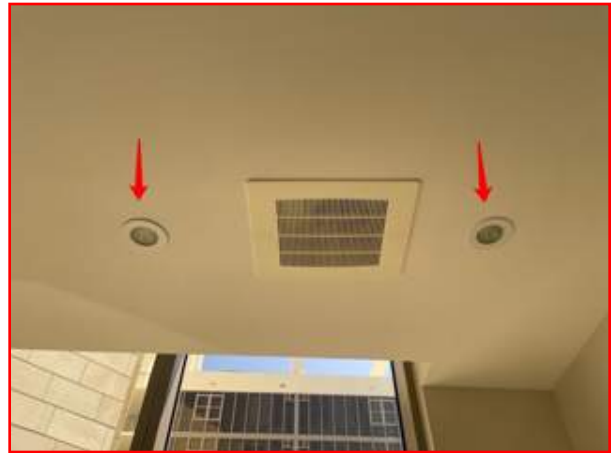
- Estimate light bulbs are burnt out.

Replace light bulbs to bathroom lighting fixtures. (Estimate: \$10 - \$25)

If lighting fixture(s) continue not to function, recommend having a licensed electrician further evaluate circuit. (Estimate: \$200 - \$500)

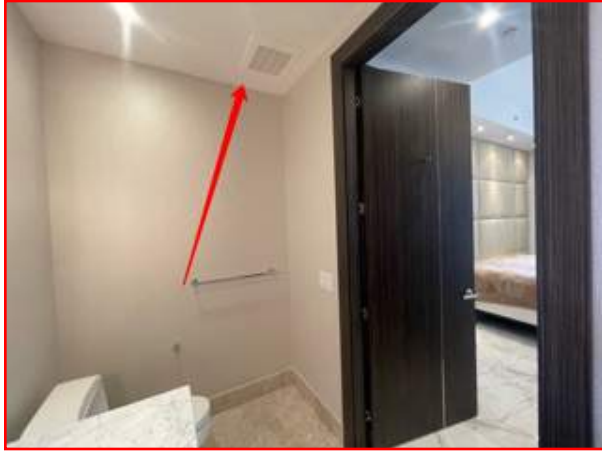
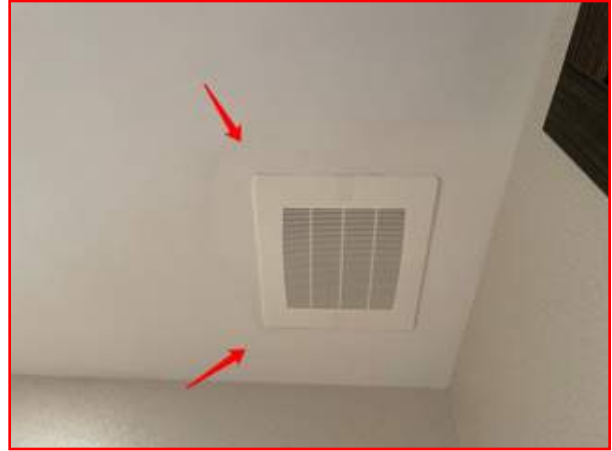
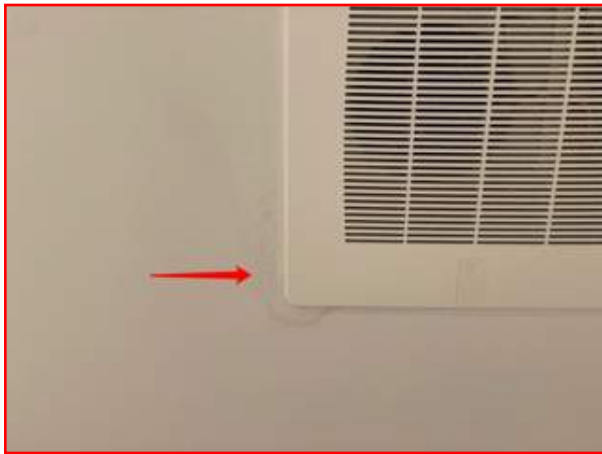
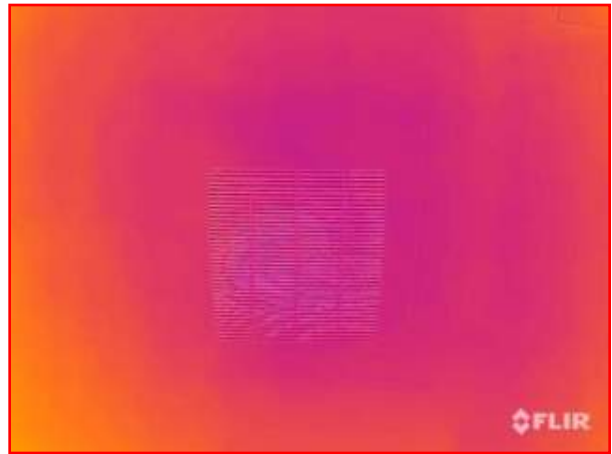
- Indications of dry water staining around exhaust fan at the time of inspection. No active moisture detected at the time of inspection.

Repair/replace ventilation exhaust fan. (Estimate: \$250 - \$500)

Repair/refinish surrounding in drywall to conceal previous dry water staining. (Estimate: \$100 - \$200)

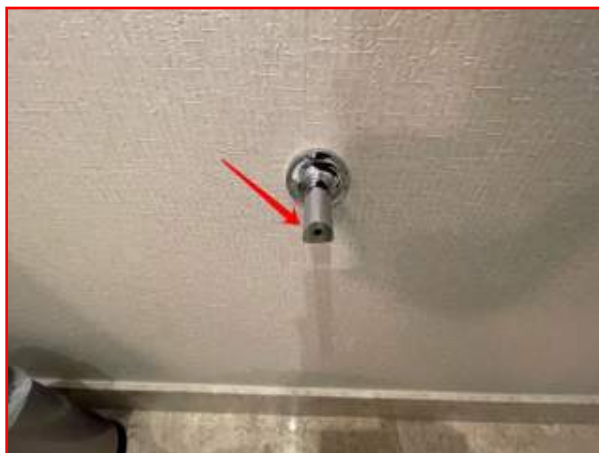
Figure 81-2

38) Comment 81: Toilet paper holder appears to have been damaged.  
Replace toilet paper holder. (Estimate: \$100 - \$200)
