## Condo Inspection Report

**9705 Collins Ave**

**Unit 2204N/2205N**

Inspected on Tue, Mar 29 2022 at 1:00 PM

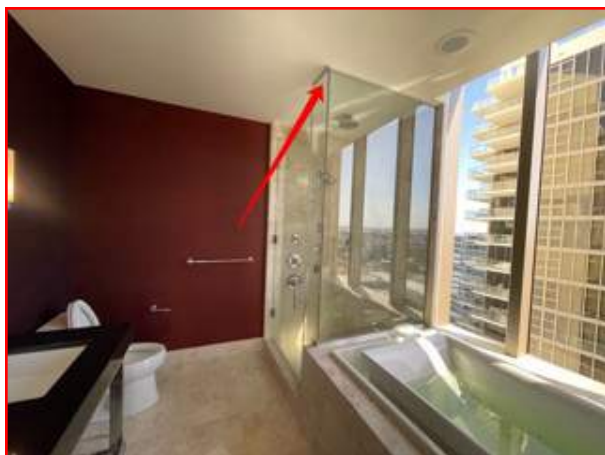
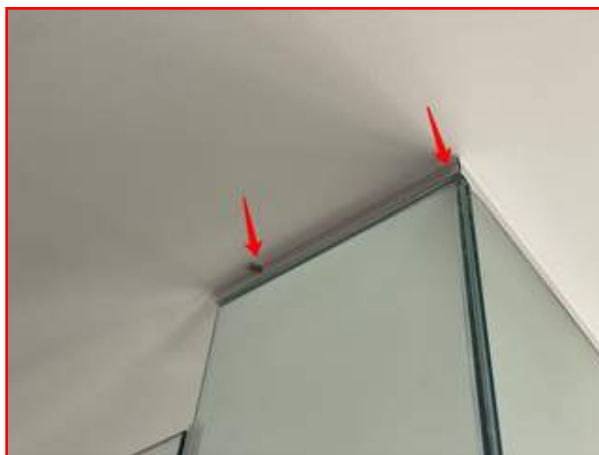
39) Comment 85: Loose trim along top of glass shower enclosure.

Recommend properly securing glass panel & trim along ceiling. (Estimate: \$100 - \$200)

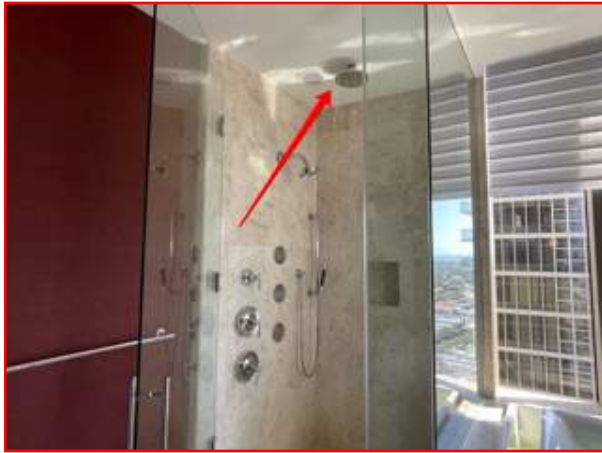
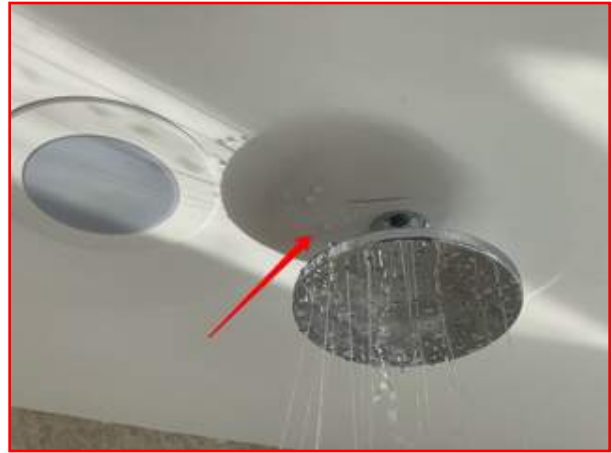
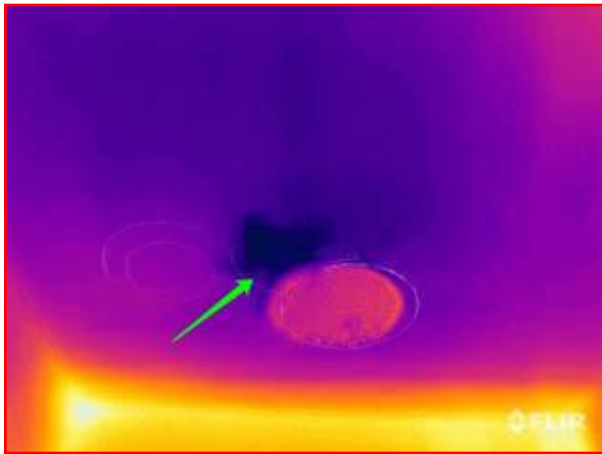
40) Comment 86: Broken rain shower head fixture causing water to spray towards ceiling.

- Active water damage caused to ceiling drywall due to broken shower fixture.

Replace rain shower head fixture to prevent further water damage to ceiling over shower.  
(Estimate: \$200 - \$300)

Repair water damage ceiling drywall over shower fixture. (Estimate: \$150 - \$250)

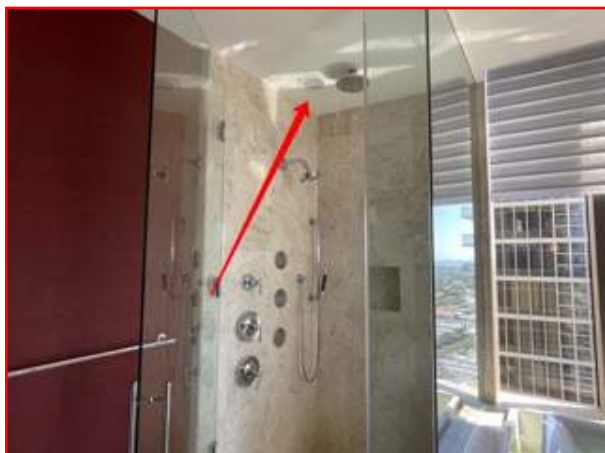
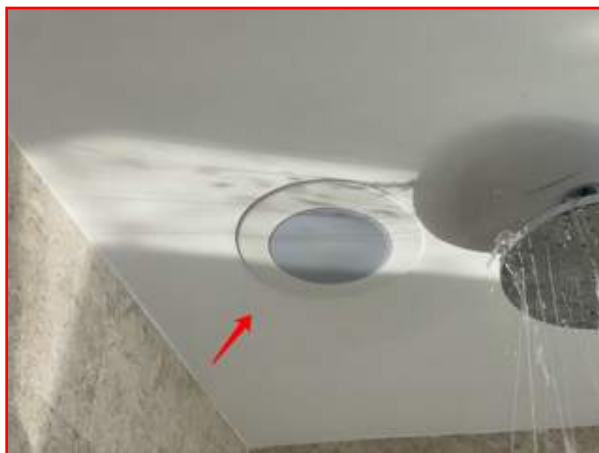
41) Comment 87: Bathroom light over shower fixture not functioning at the time of inspection.

- Estimate light bulb is burnt out.

Replace light bulb to bathroom light fixture. (Estimate: \$10 - \$25)

If lighting fixture(s) continue not to function, recommend having a licensed electrician further evaluate circuit. (Estimate: \$200 - \$500)

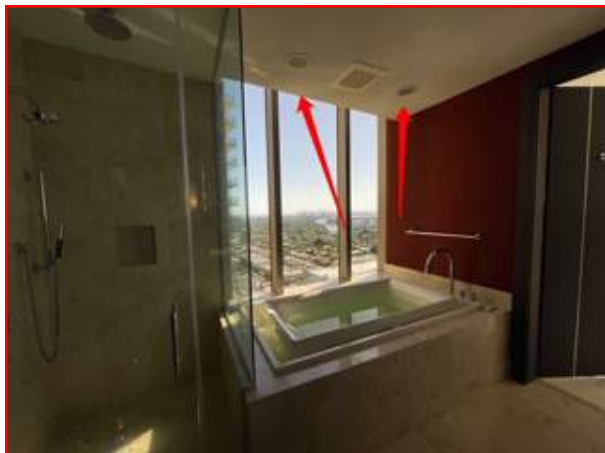
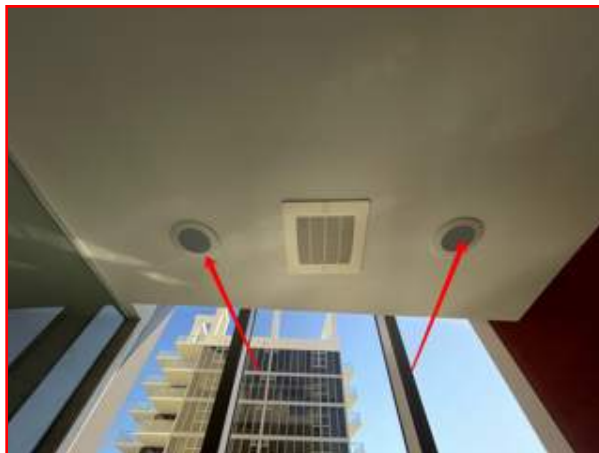
42) Comment 88: Bathroom lights over tub fixture not functioning at the time of inspection.

- Estimate light bulbs are burnt out.

Replace light bulbs to bathroom lighting fixtures. (Estimate: \$10 - \$25)

If lighting fixture(s) continue not to function, recommend having a licensed electrician further evaluate circuit. (Estimate: \$200 - \$500)

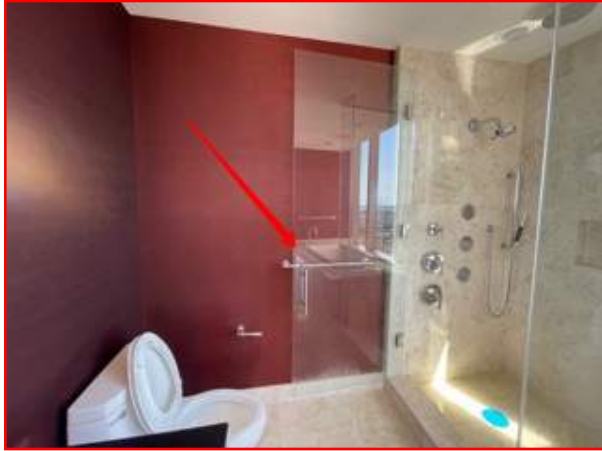
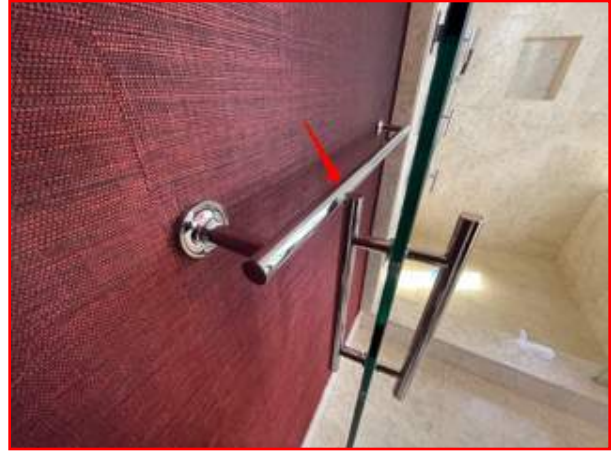
43) Comment 89: Frameless glass shower door within bathroom conflicting with adjacent wall & towel rack when opening.

Recommend installing a door stopper or bumper prevent damaging wall. (Estimate: \$25 - \$50)

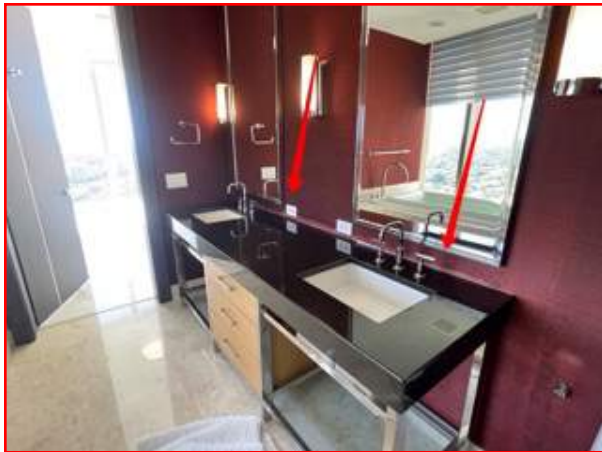
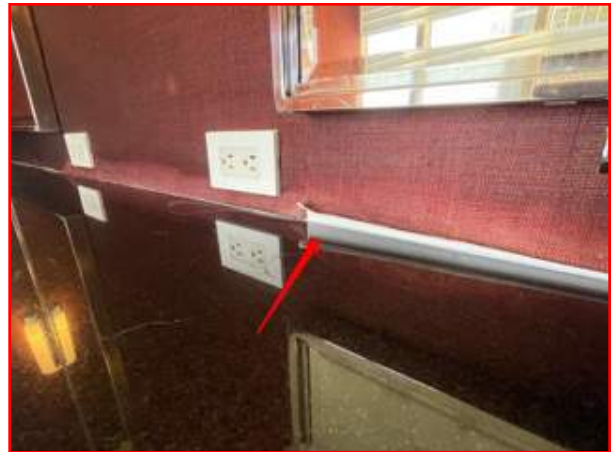
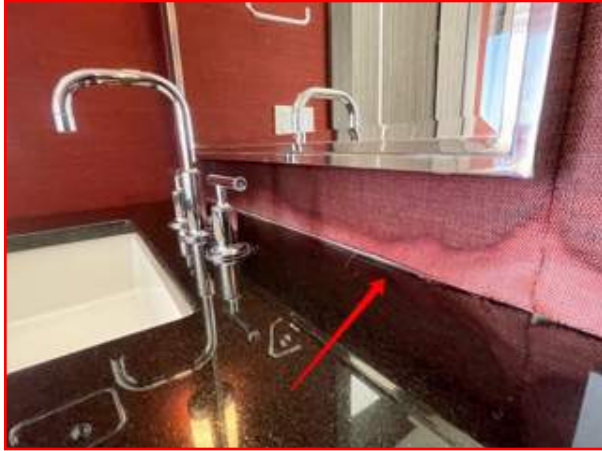
44) Comment 90: Indications of deterioration to wallpaper over vanity fixture. Repair/replace wallpaper. (Detailed quotation required)

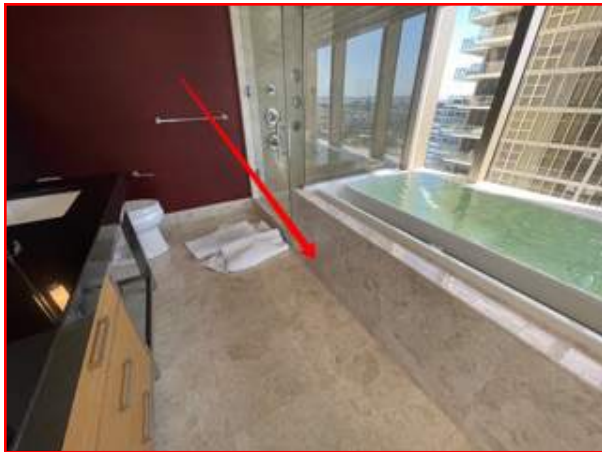
Figure 91-1

45) Comment 91: Loos tile around tub fixture within bathroom.  
Recommend securing & re-grouting tile around tub fixture. (Estimate: \$100 - \$250)

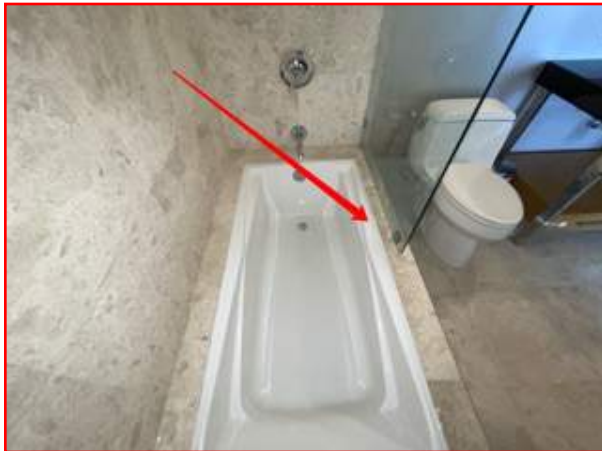
Figure 93-1

46) Comment 93: Apparent deterioration to caulking around tub fixture.  
Recommend re-caulking/re-sealing around tub fixture. (Estimate: \$100 - \$200)

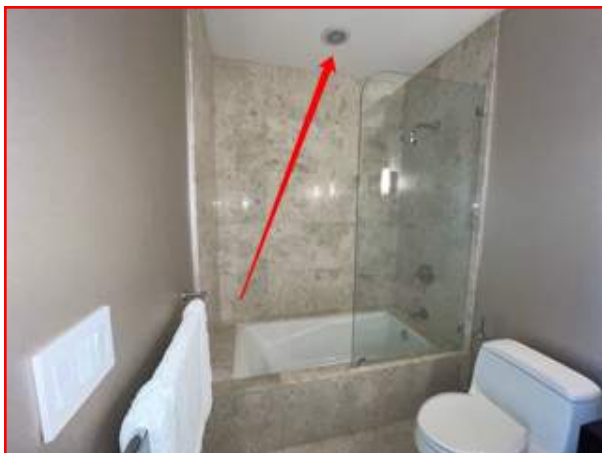
Figure 94-1

47) Comment 94: Bathroom light not functioning at the time of inspection.  
- Estimate light bulb is burnt out.  
Replace light bulb to bathroom light fixture. (Estimate: \$10 - \$25)

If lighting fixture(s) continue not to function, recommend having a licensed electrician further evaluate circuit. (Estimate: \$200 - \$500)
