Home Inspection Report

5191 Pinetree Dr
Miami Beach, FL 33141

Inspected By: Tracy Woodard

Home Pro Miami
(786) 558-5286
www.homepromiami.com
info@homepromiami.com

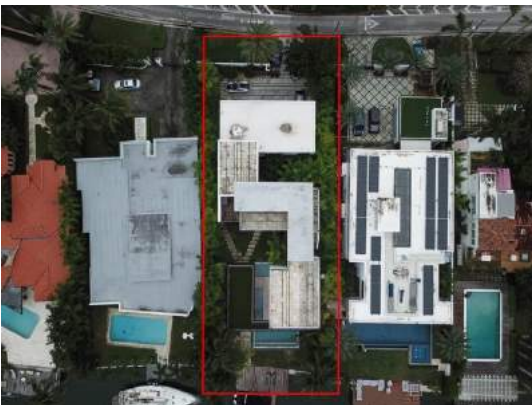
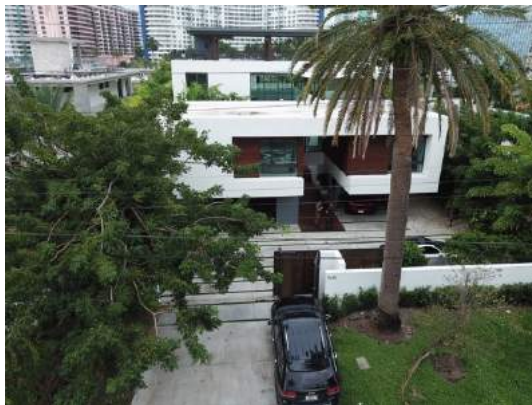
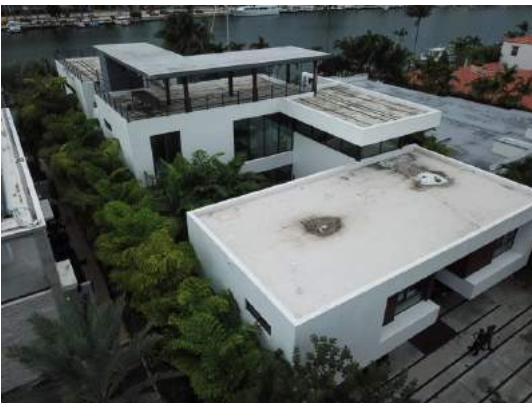
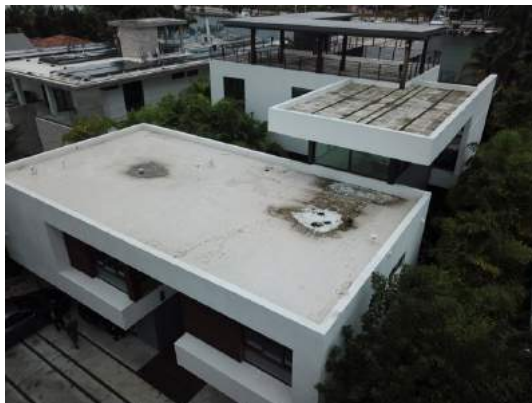
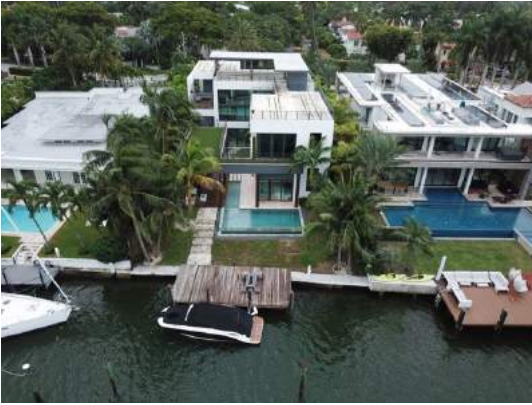
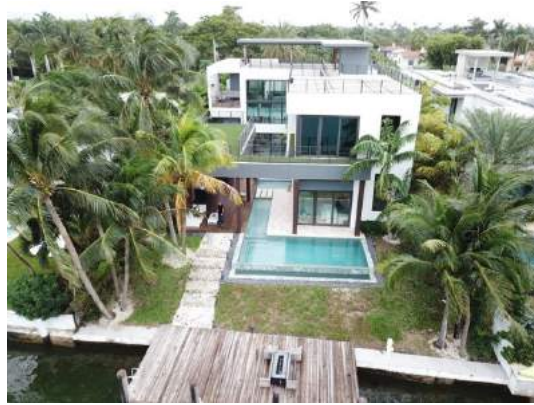
Aerial Site Photos.

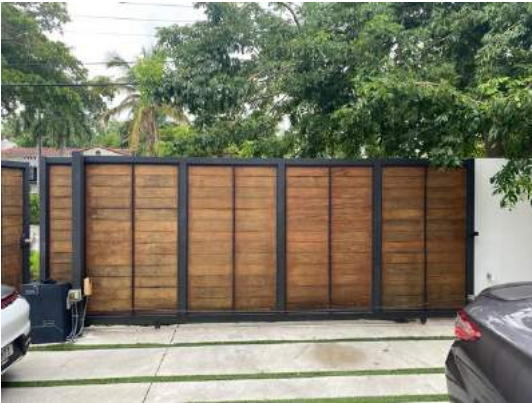
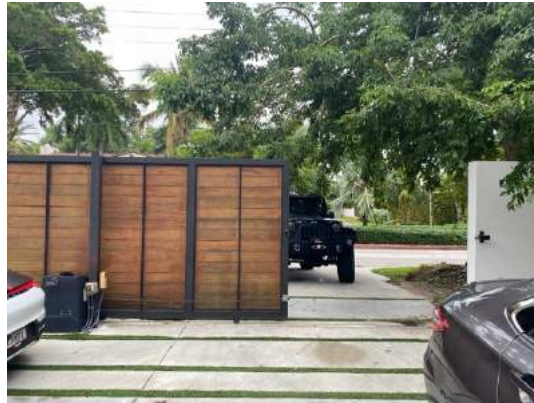
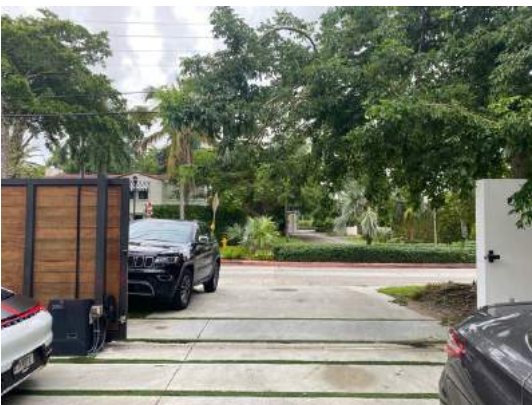
Automatic driveway gate functioning properly at the time of inspection.

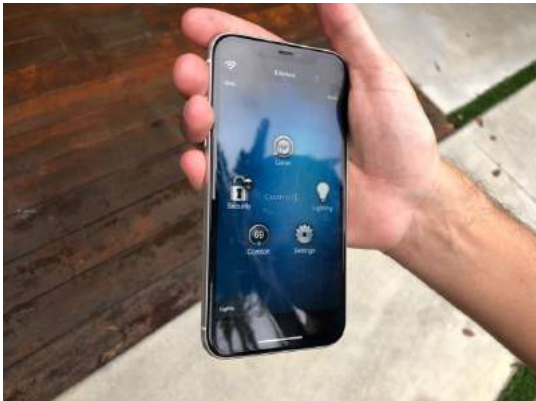
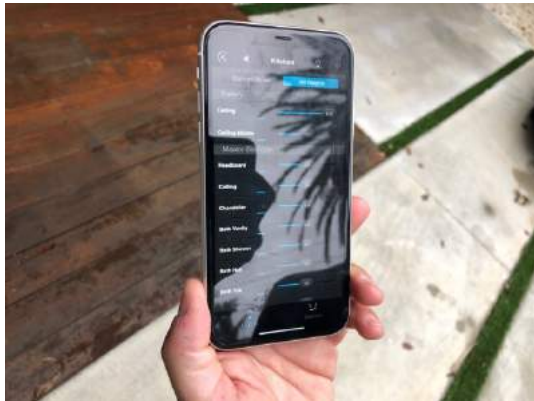
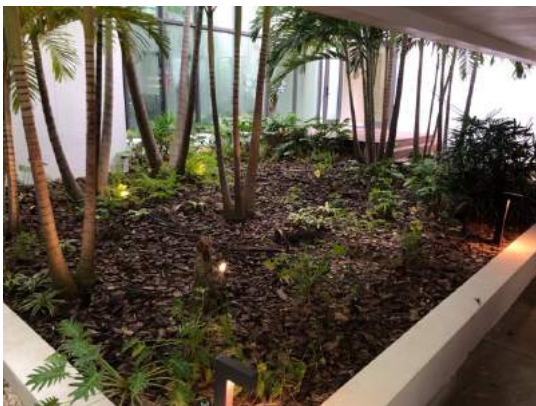
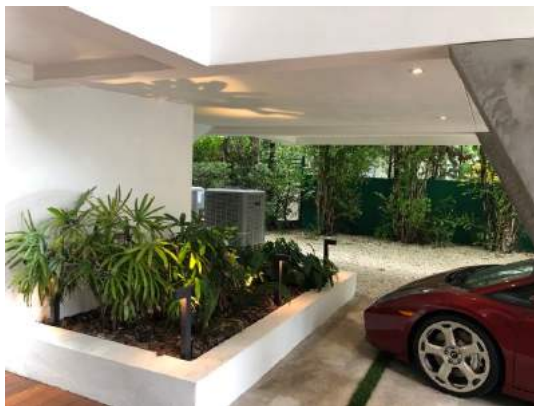
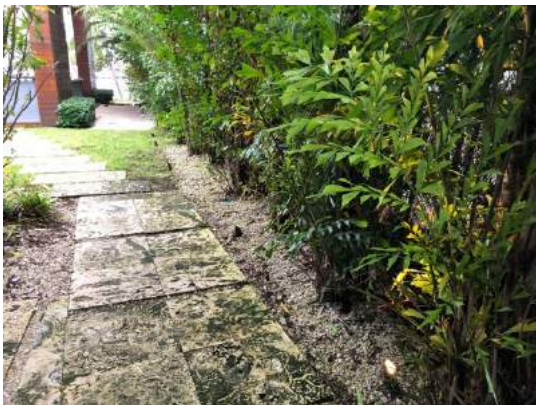
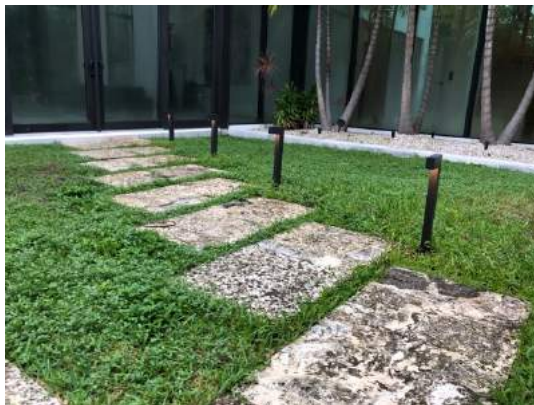
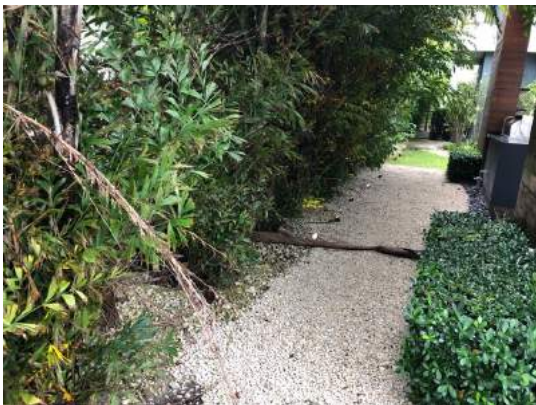
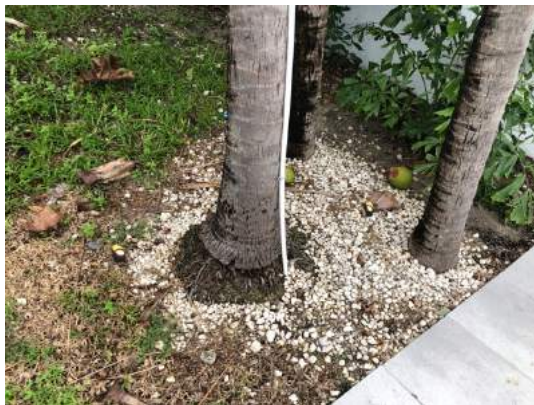
Exterior landscaping lighting run off timer control panels around property.

- Landscape lighting controlled via remote application.

- Landscape lighting functioning properly at the time of inspection.

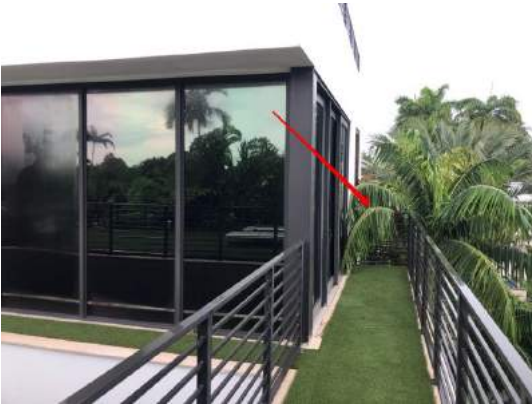
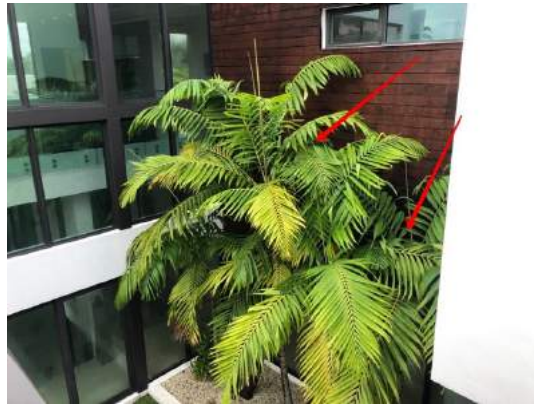
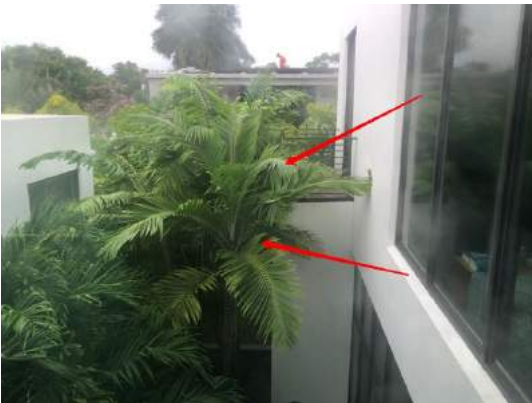
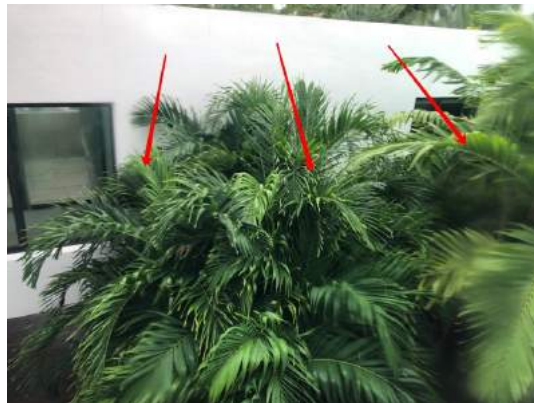
- Debris collecting within roof covering.

Recommend keeping vegetation/trees cut back from side & roof of home as well as properly clear debris from roof to prevent damage to home siding & roof coverings.

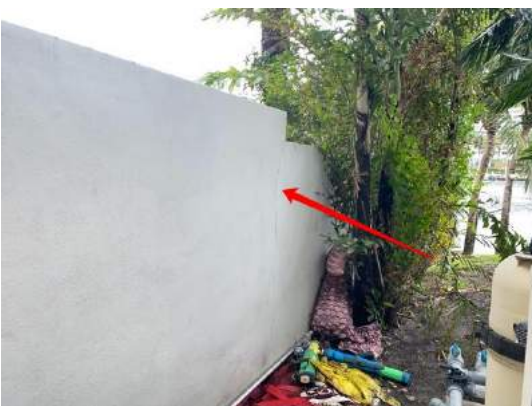
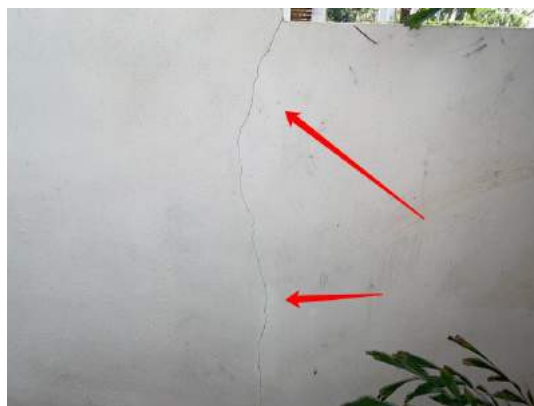
Apparent settlement cracking along structural wall on north side of property.

- Cracking does not appear to be structurally splitting at the time of inspection.

Recommend repairing/re-finishing stucco siding along wall to conceal settlement cracking. (Estimate: \$250 - \$500)

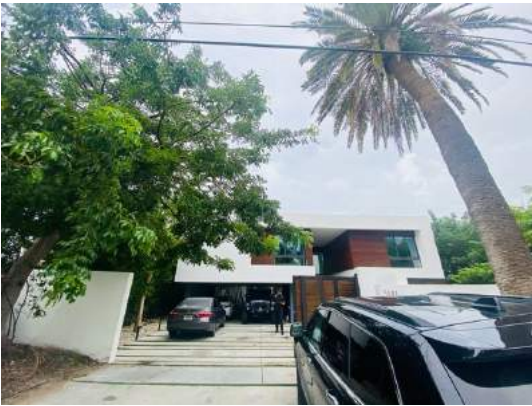
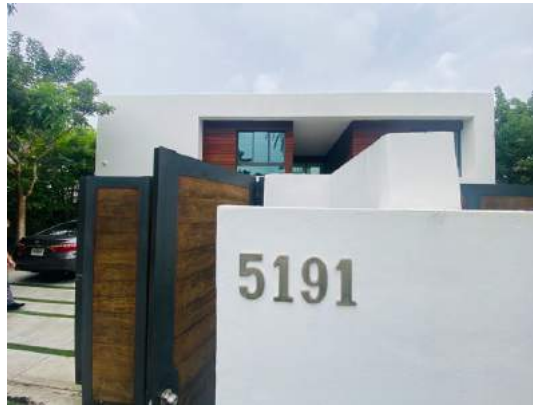
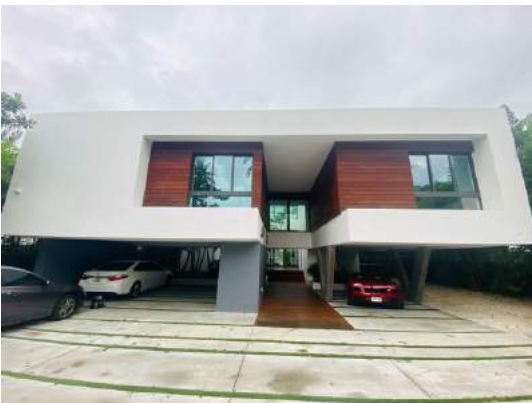
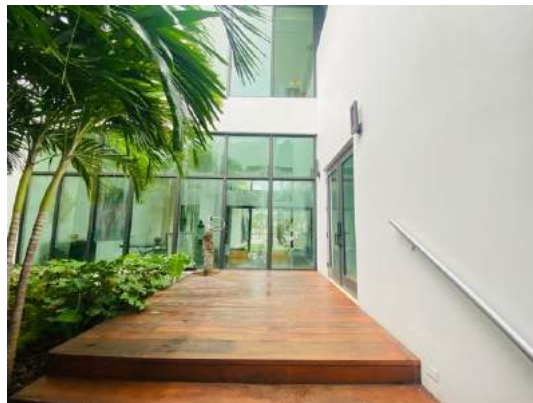
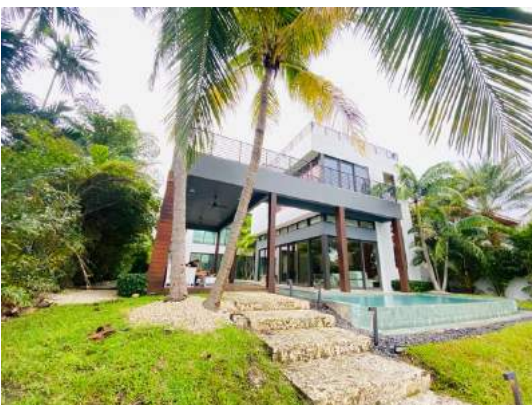
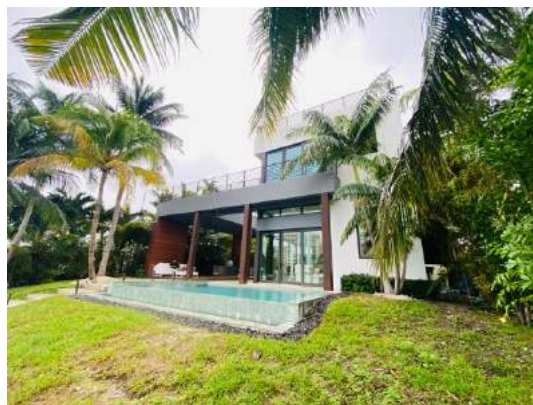
Exterior/Site Photos.

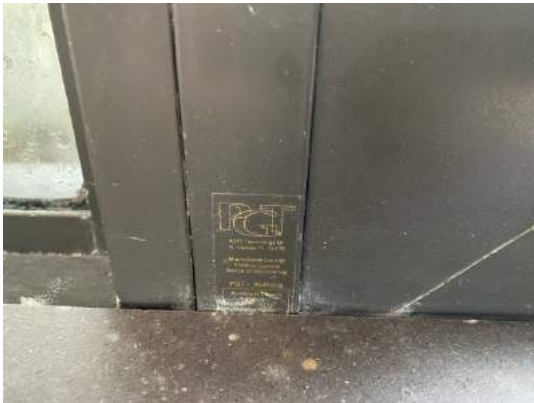
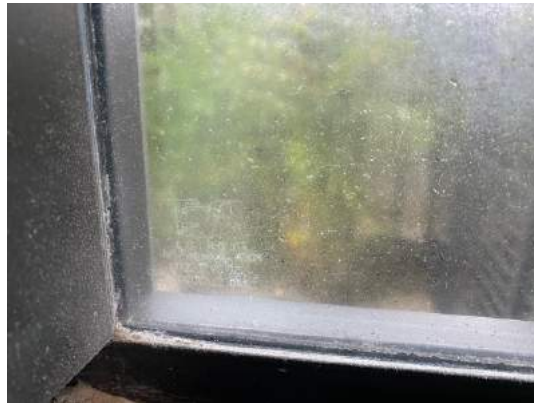
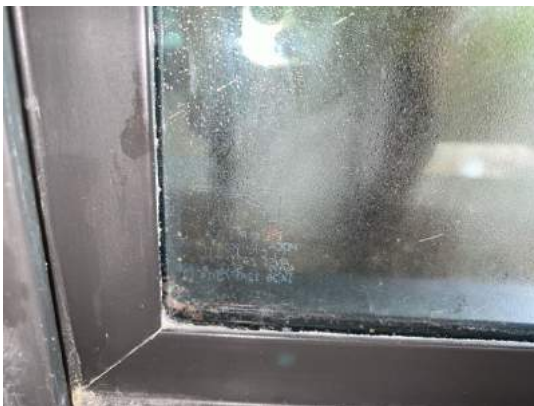
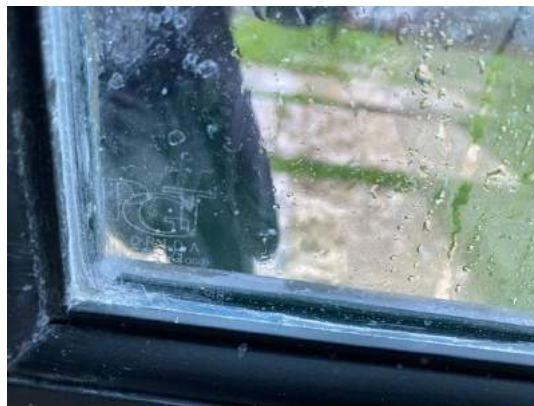
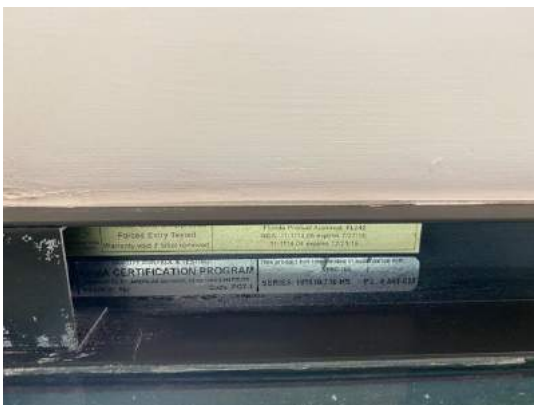
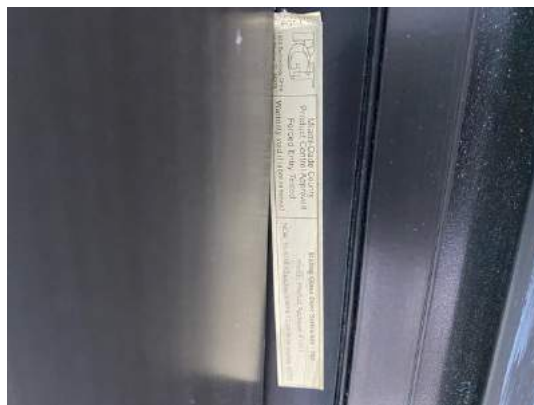
Wind Mitigation / Storm Protection.

- Impact Windows & Doors

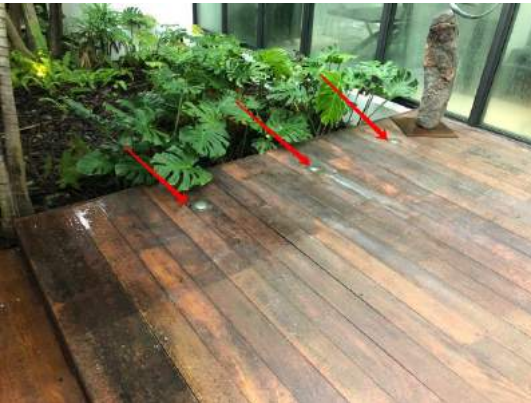
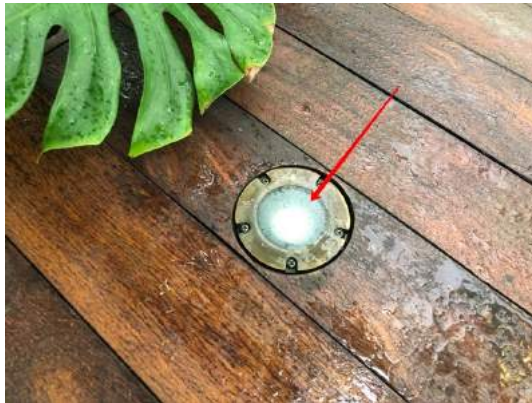
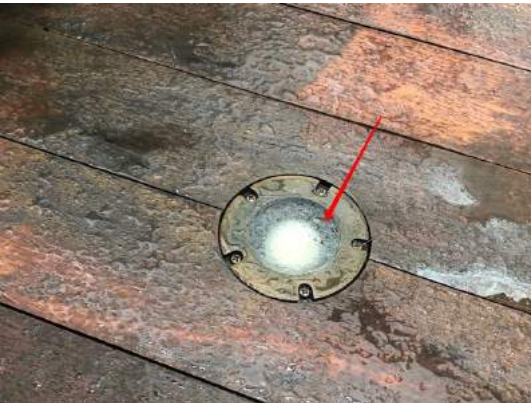
Exterior lighting fixtures built into decking around front entry walkway appear to have moisture intrusion within outlet housing.

Recommend further evaluation of lighting fixtures by a licensed professional contractor, and repair/re-seal or replace exterior lighting fixtures accordingly. (Estimate: \$500 - \$1,000)

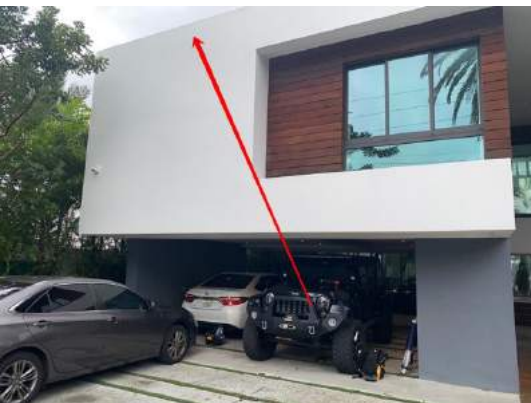
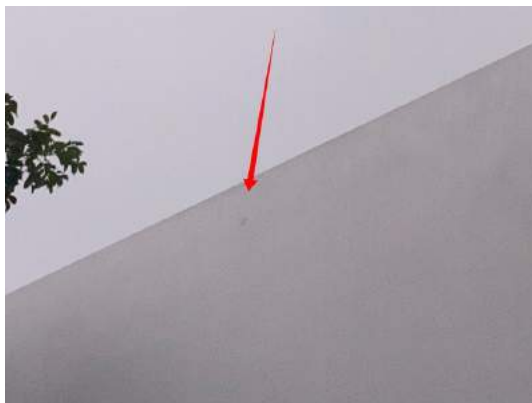
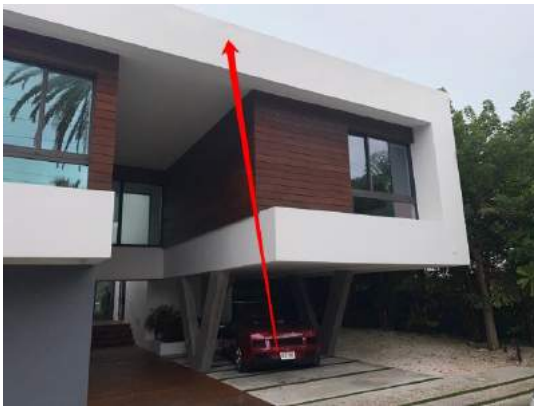
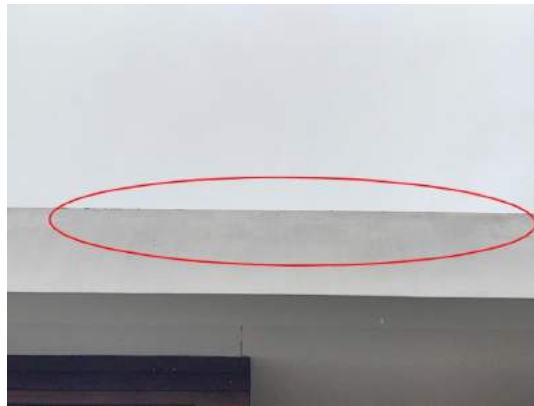
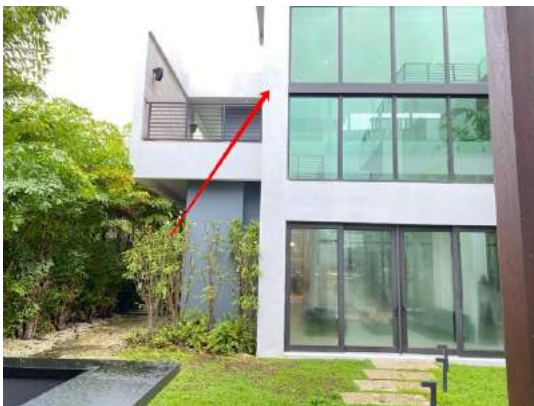
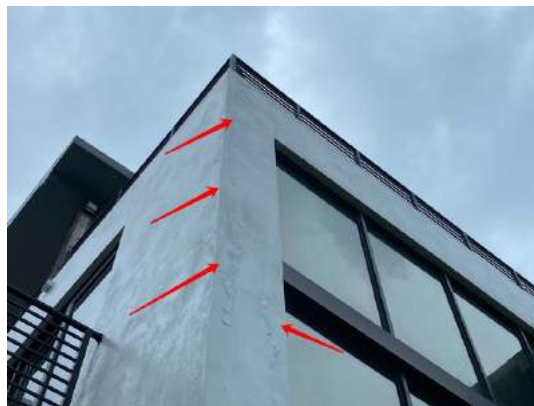
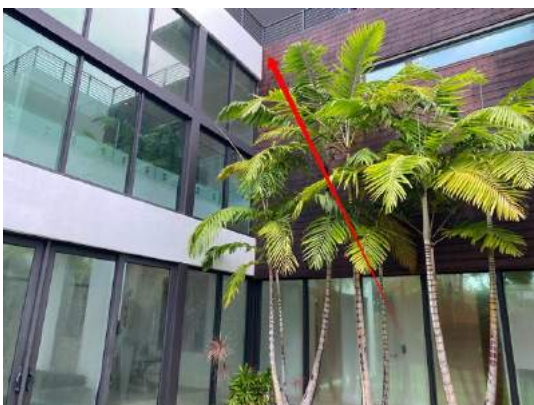
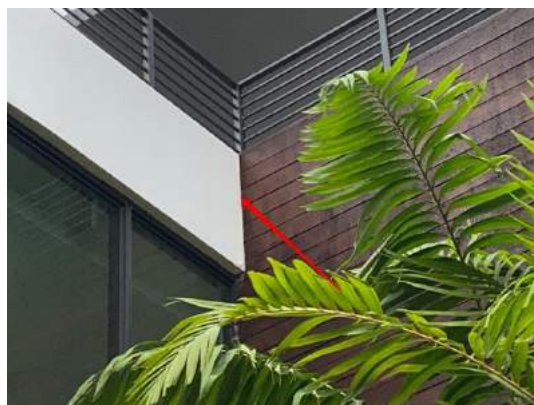
Comment 9
Deficiency

Apparent water damage & deterioration to exterior paint & waterproofing around exterior of property.

- Indications of moisture intrusion below paint & waterproofing.

Recommend having a licensed professional re-finish & re-paint/waterproof exterior stucco siding around exterior of property. (Estimate: \$5,000 - \$10,000)

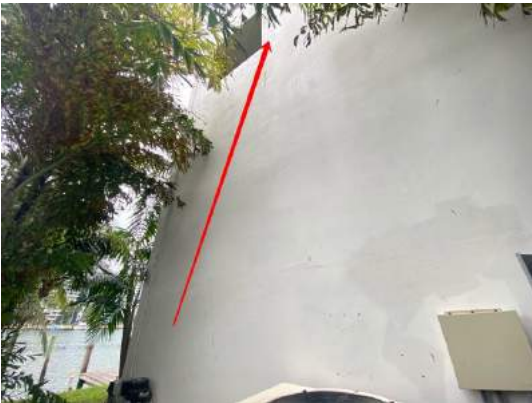
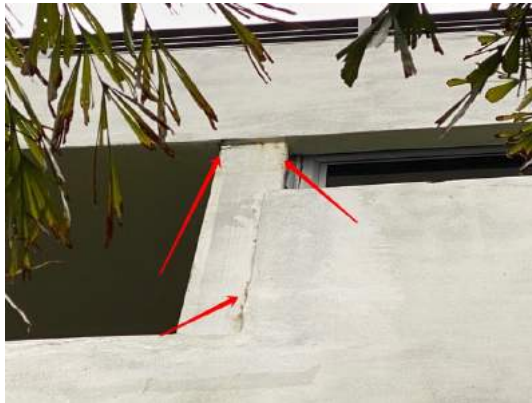
Comment 10
Deficiency

Apparent deterioration to exterior siding along north side of property outside of master bathroom outdoor shower.
- Apparent oxidation/rusting along siding, indication of potential oxidation to interior rebar reinforcements.

Recommend further evaluation by a licensed contractor & repair to prevent further deterioration or spalling. (Estimate: \$500 - \$1,000)

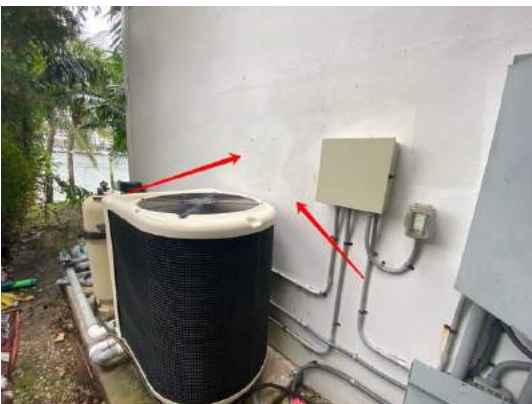
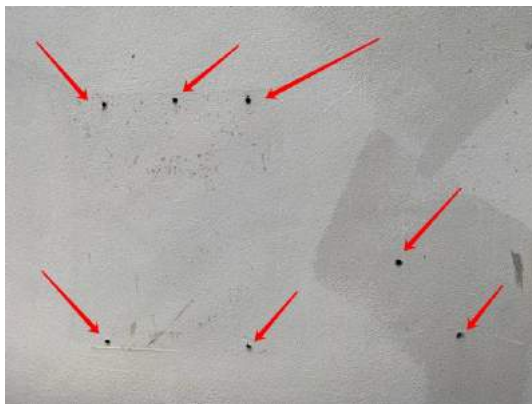
Comment 11
Deficiency

Damage & holes in exterior wall along northeast corner of home around pool pump & filtration equipment.

- Estimate holes left in wall after previously installed panel of junction box had been removed.

Recommend reaping exterior stucco siding to prevent potential moisture intrusion into exterior wall. (Estimate: \$100 - \$250)

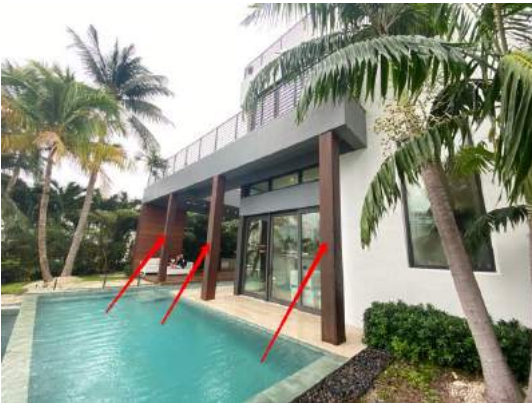
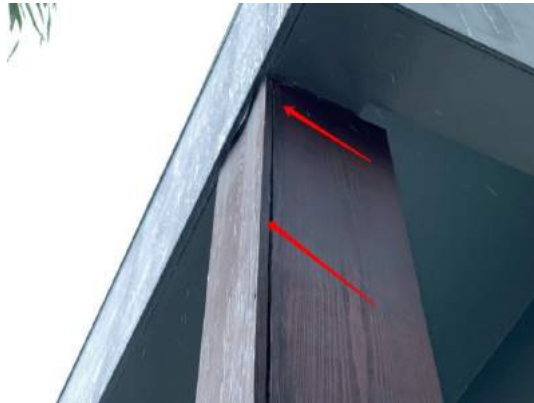
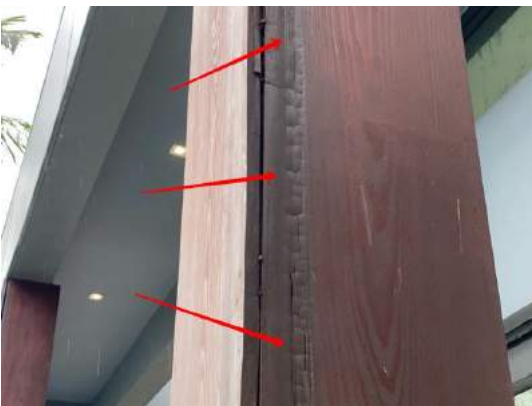
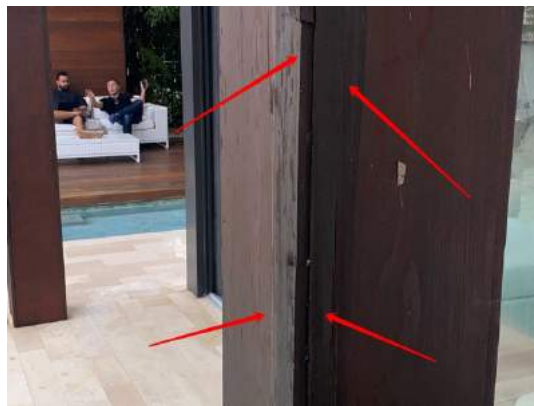
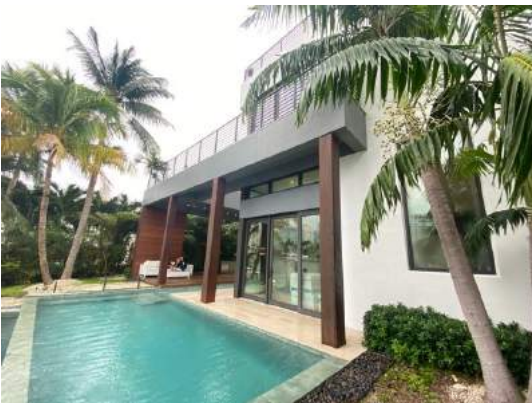
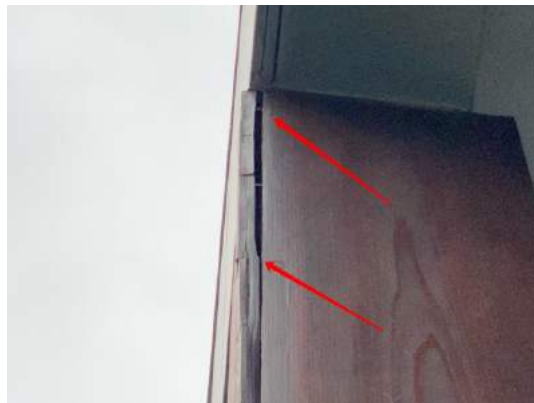
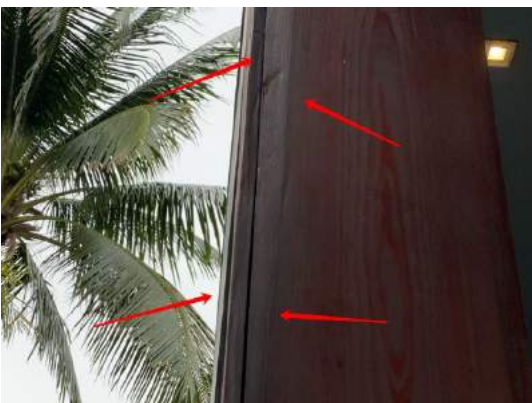
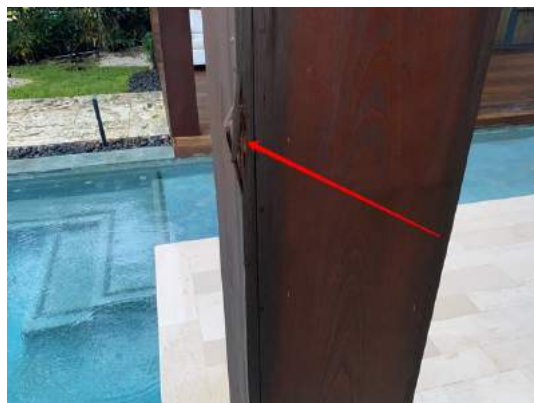
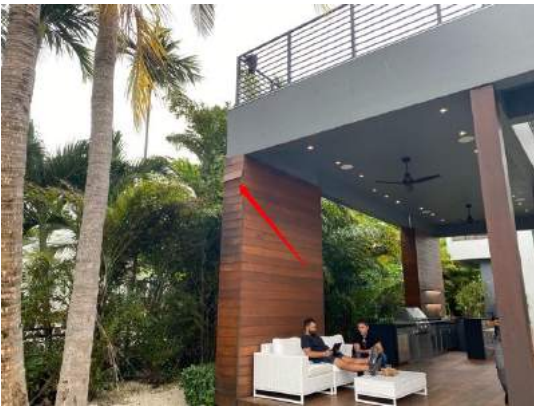
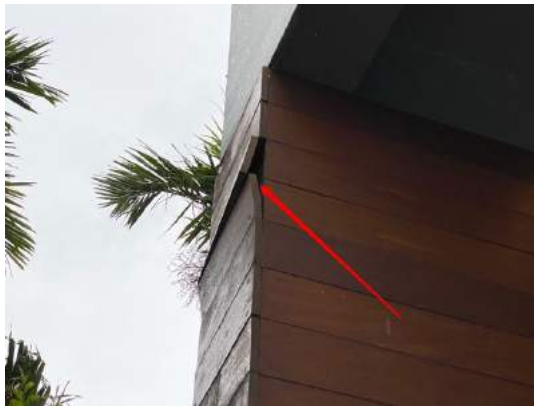
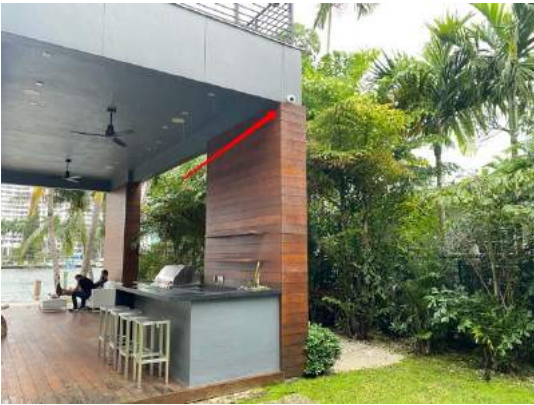
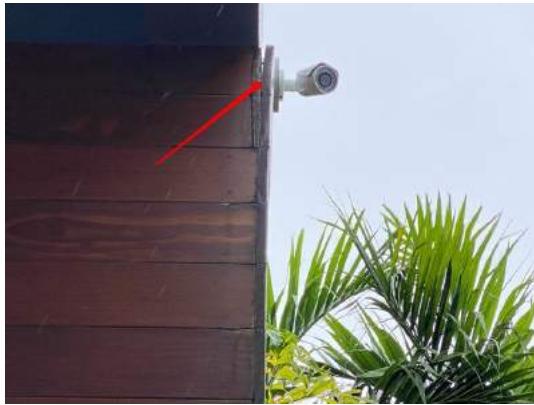
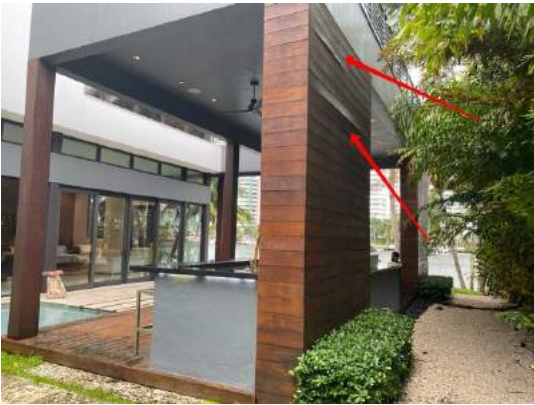
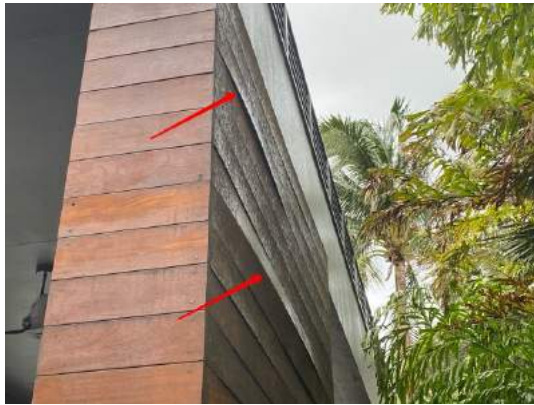
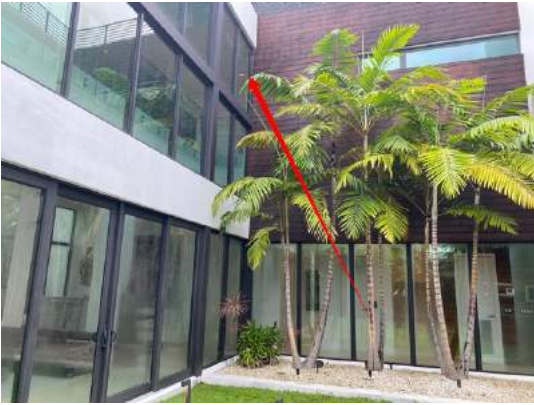
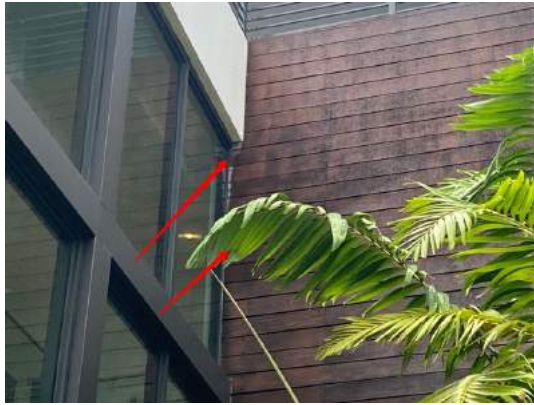
Comment 12
Deficiency

Apparent water damage to wood facade around exterior columns and accent walls around east side (back) of property.

- Wood facade around columns adjacent to pool showing indications of water damage & warping estimated to be due to excessive rain & sun exposure.
- Wood facade around structural supporting walls in along rear terrace showing indications of water damage & warping estimated to be due to excessive rain & sun exposure.
- Wood accent wall on south facing wall adjacent adjacent to living room & 3rd level common area showing indications of water damage.

Recommend further evaluation by a licensed contractor & repair or replace wood facade accordingly. (Estimate: \$5,000 - \$10,000)

Exterior wood facade should be properly treated & sealed for exposure to exterior elements.

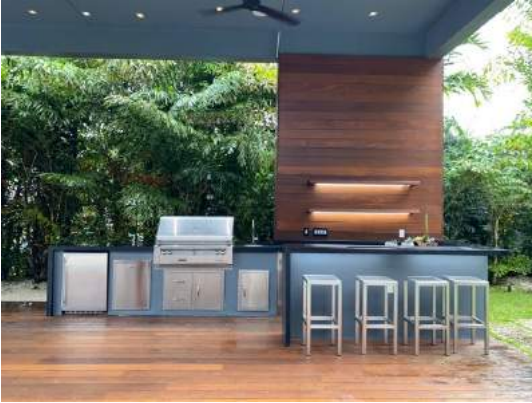
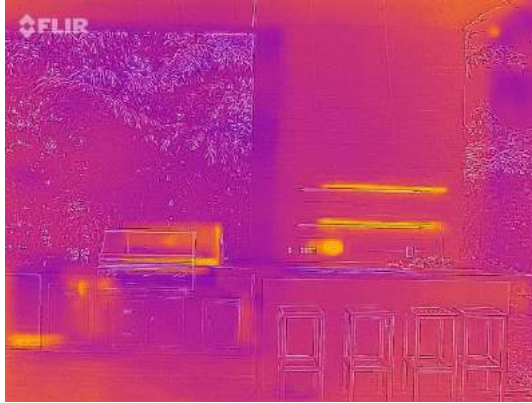
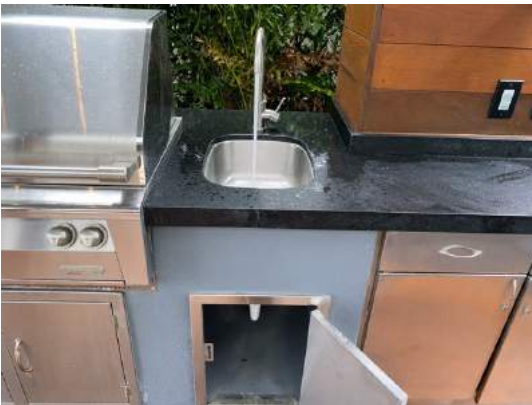
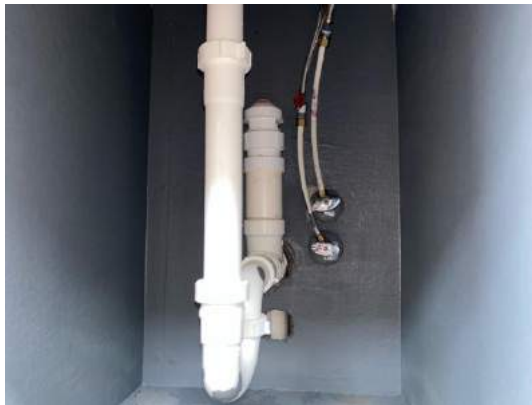
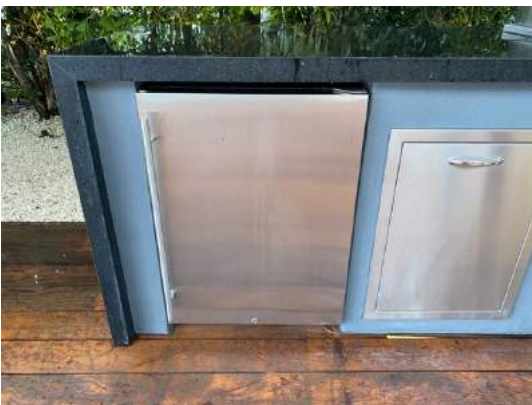
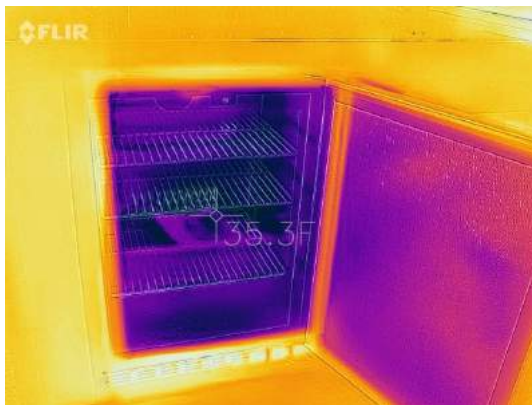
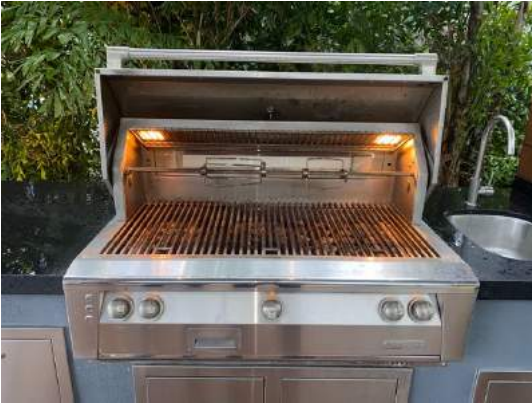
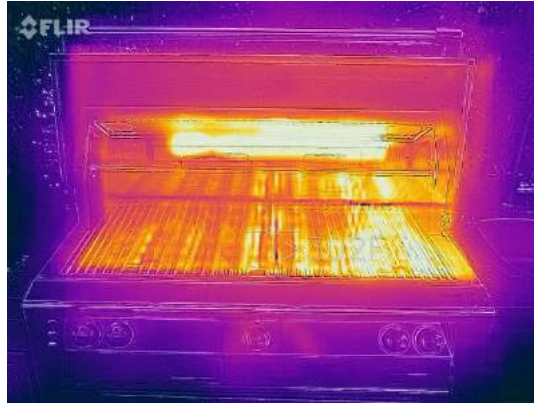
Comment 13
Information

Summer kitchen in back of property.

- Mini-refrigerator functioning properly at the time of inspection.
- Gas grill functioning properly at the time of inspection.

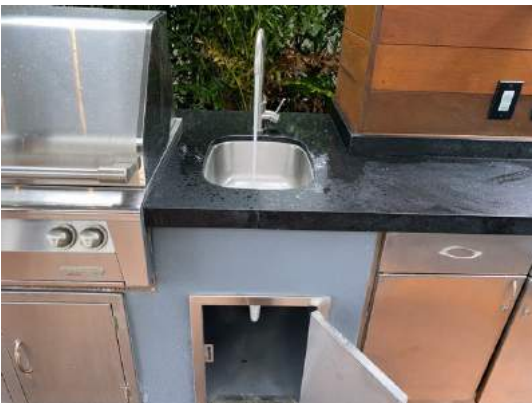
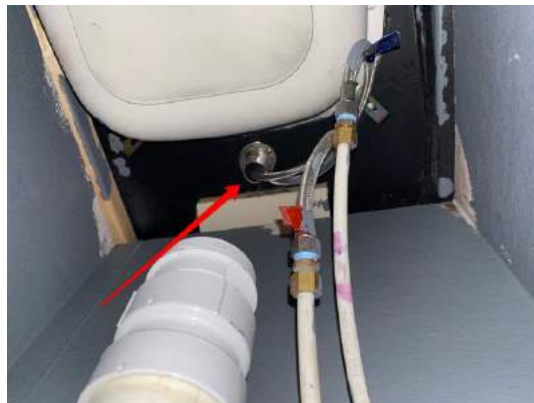
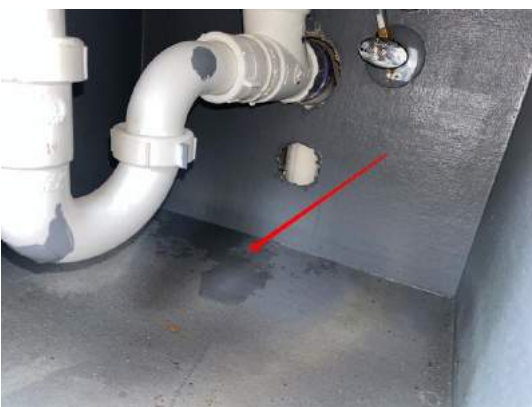
Comment 14

Flexible supply hose to summer kitchen sink faucet fixture appears to be leaking below sink.

Recommend repair or replacement to faucet fixture to prevent further leaking below sink & water damage. (Estimate: \$100 - \$250)

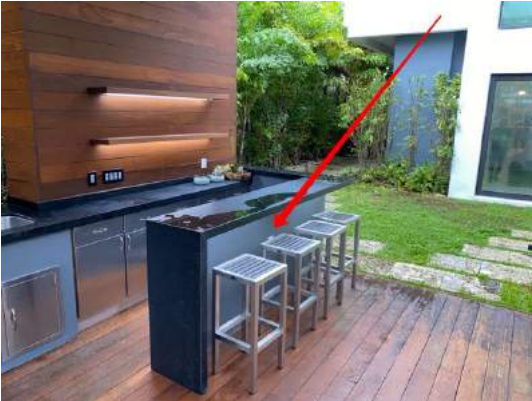
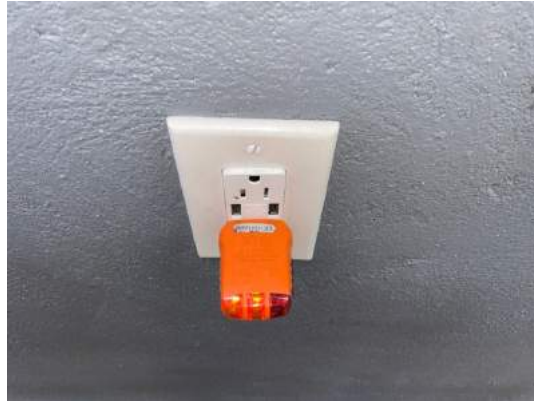
Exterior GFCI outlet along summer kitchen bar functioning properly, but does not appear to be on a proper GFCI circuit and does not trip when electrical surge is detected.

Recommend replacing exterior outlet with GFCI outlet. (Estimate: \$50 - \$100)

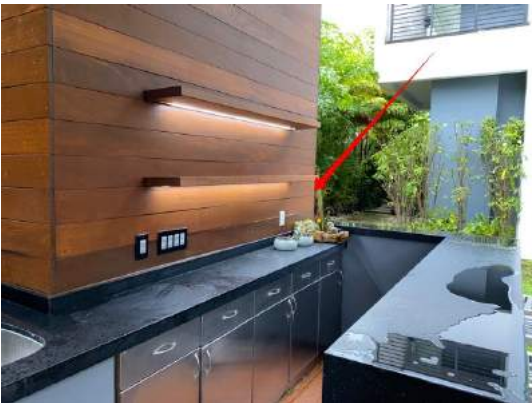
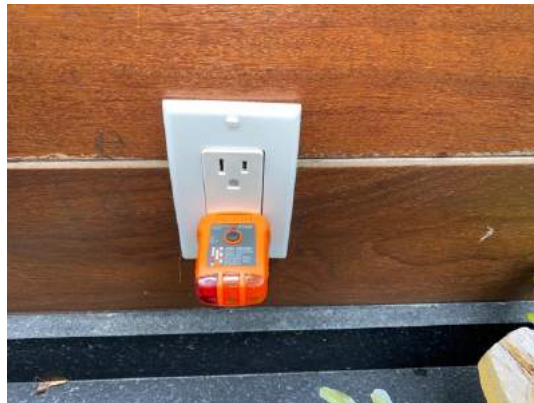
Comment 16
Deficiency

Exterior GFCI outlet along summer kitchen wall functioning properly, but does not appear to be on a proper GFCI circuit and does not trip when electrical surge is detected.

Recommend replacing exterior outlet with GFCI outlet. (Estimate: \$50 - \$100)

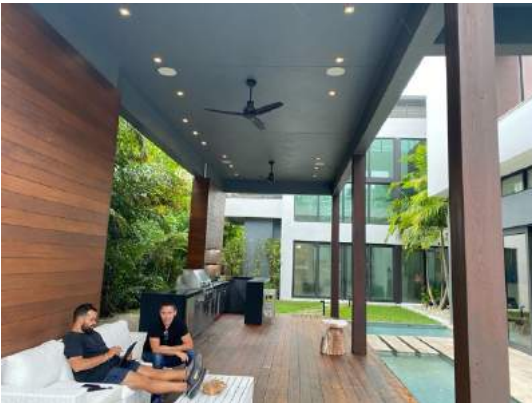
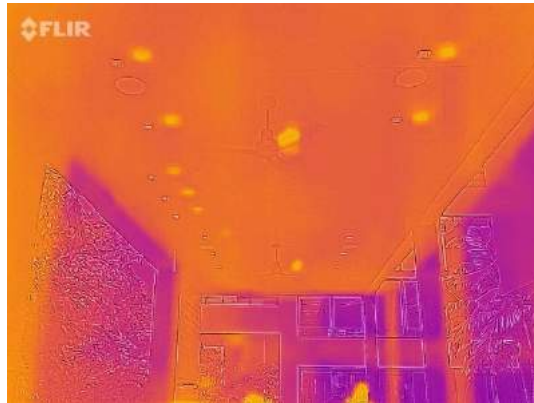
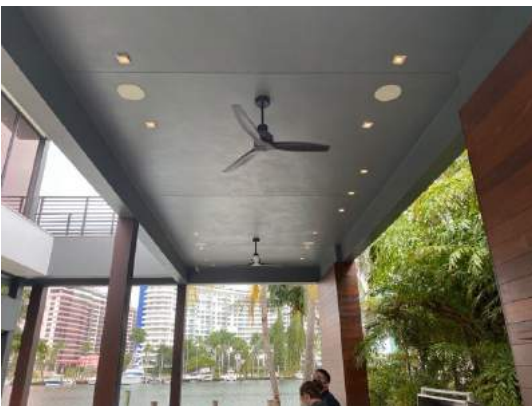
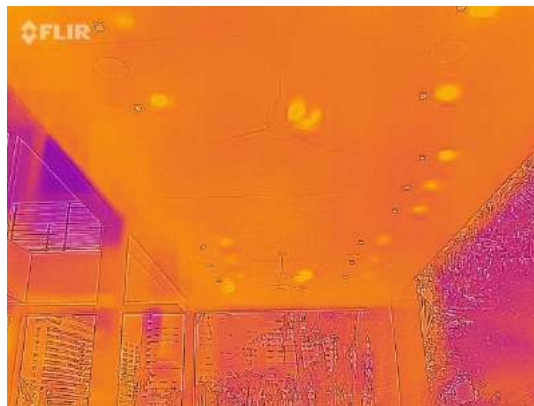
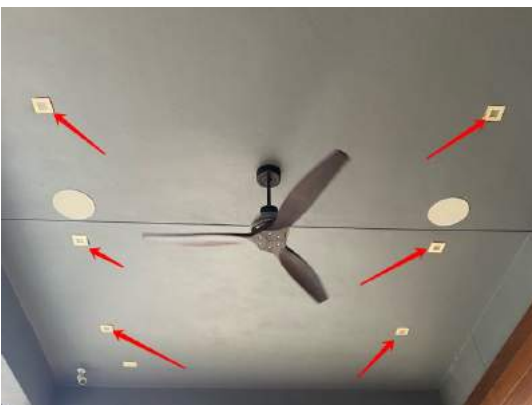
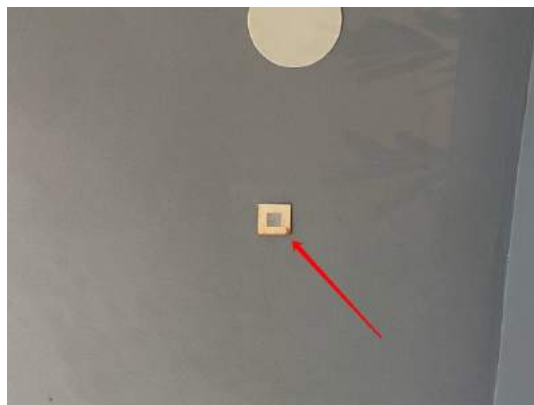
Comment 17
Deficiency

Excessive corrosion & loose recessed light fixtures along exterior terrace/summer kitchen covering.

- No indications of active moisture intrusion or leaking from master bedroom rooftop

Replace damaged recessed lighting fixtures with proper outdoor fixtures. (Estimate: \$500 - \$1,500)

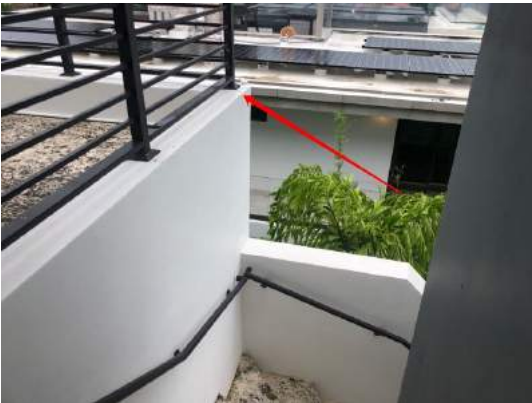
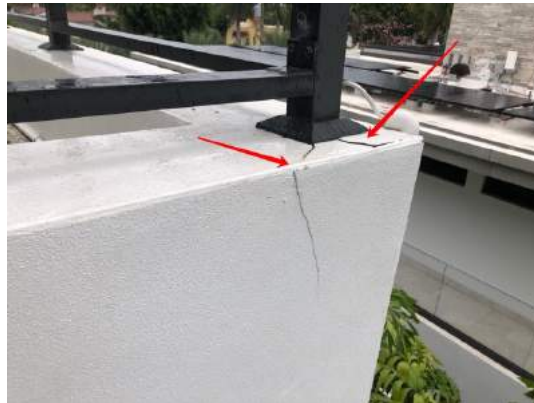
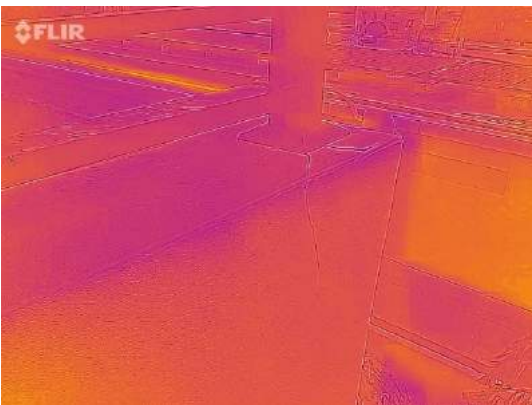
Comment 18

Apparent cracking & damage to top of exterior wall around exterior stairwell to rooftop terrace.

- No indications of moisture intrusion into wall at the time of inspection.

Recommend repairing & waterproofing exterior stucco siding to prevent potential moisture intrusion into wall.

(Estimate: \$250 - \$500)

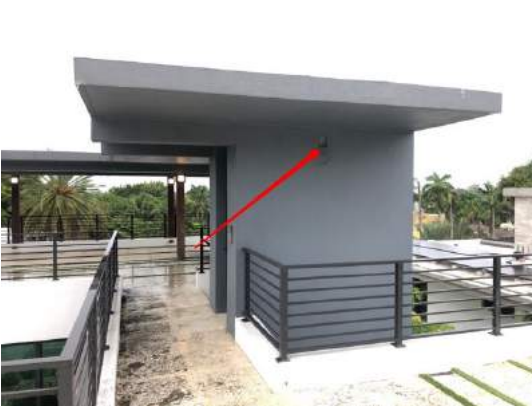
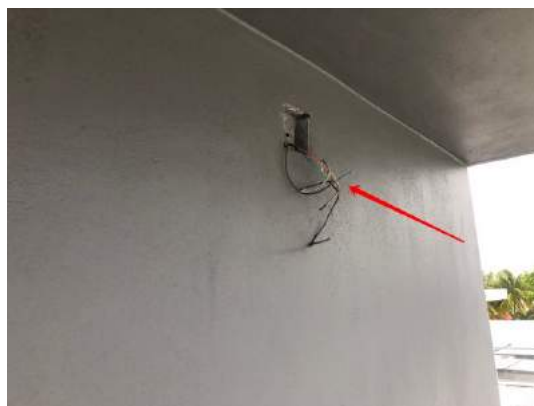
Comment 19

Missing light fixture along rooftop terrace exterior wall.

- Missing fixtures exposing live wiring.

Recommend replacing missing exterior lighting fixture. (Estimate: \$200 - \$400)

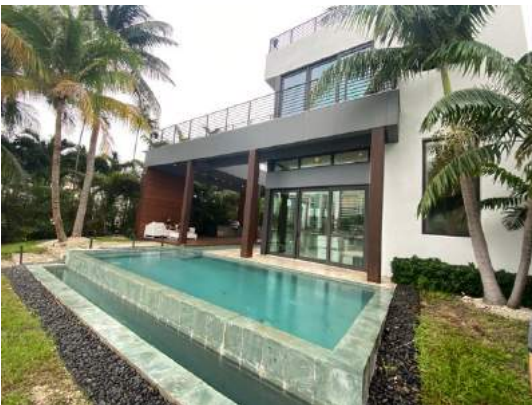
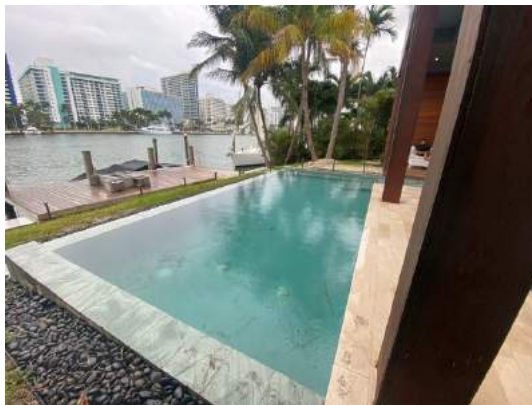
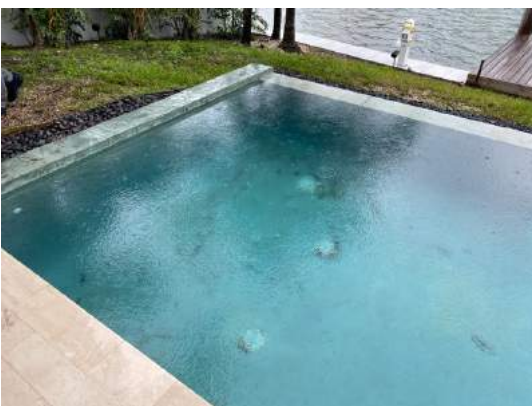
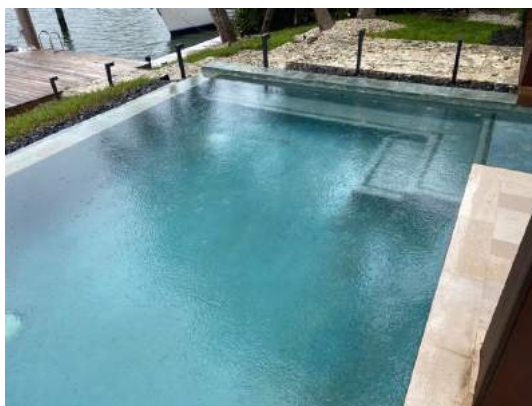
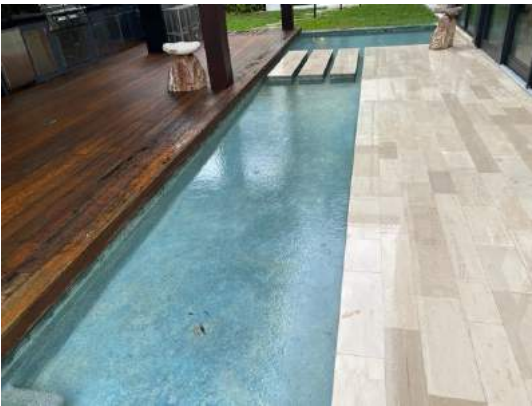
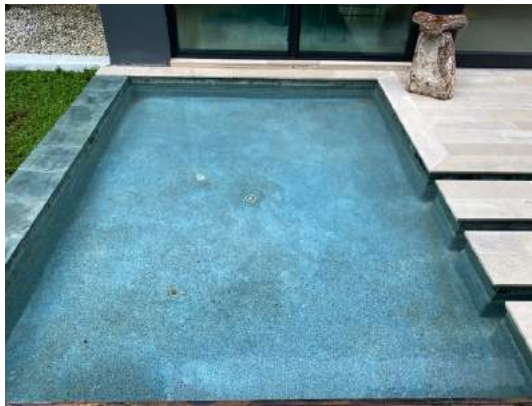
**Comment 21
Information**

Pool and pool lining appears in good condition.
