Home Inspection Report

5191 Pinetree Dr
Miami Beach, FL 33141

Inspected By: Tracy Woodard

Home Pro Miami
(786) 558-5286
www.homepromiami.com
info@homepromiami.com

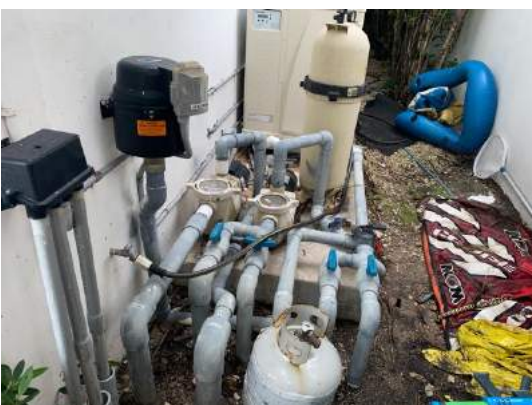
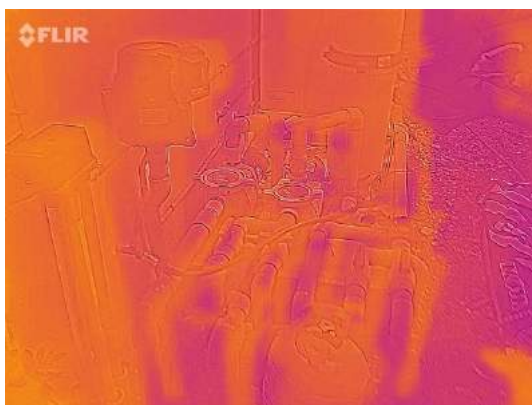
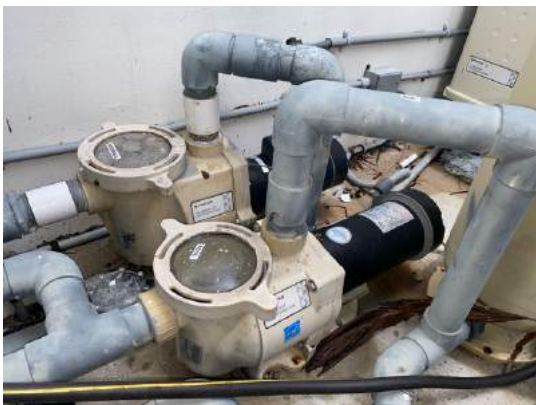
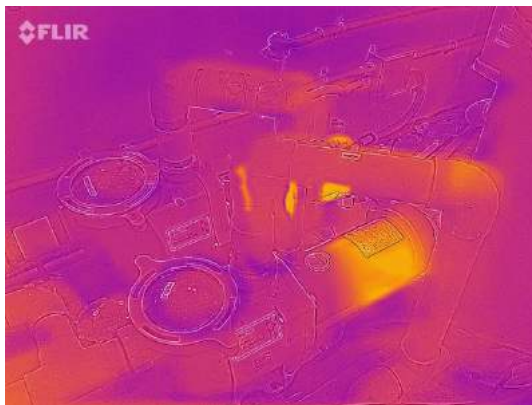
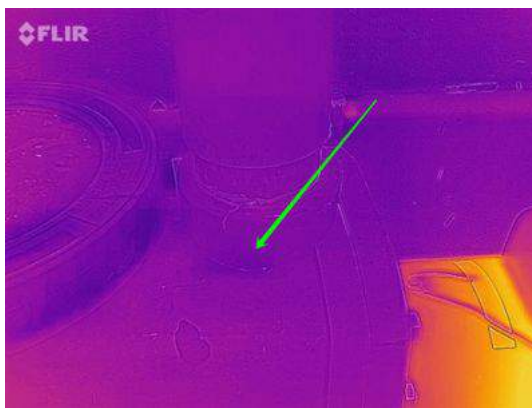
Comment 22
Deficiency

Pool pump & filtration equipment appears to be functioning properly at the time of inspection.

- Leaking pipe connection to pump at the time of inspection.

Recommend further evaluation by a licensed professional & repair accordingly. (Estimate: \$100 - \$250)

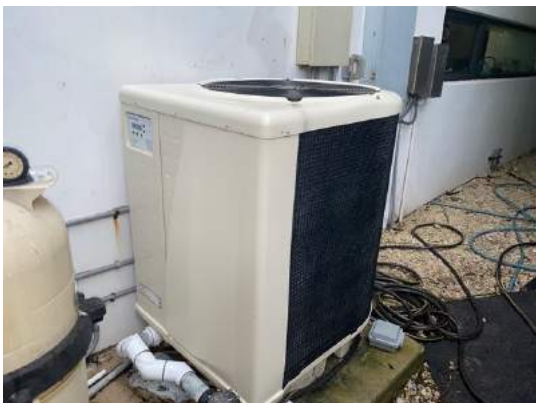
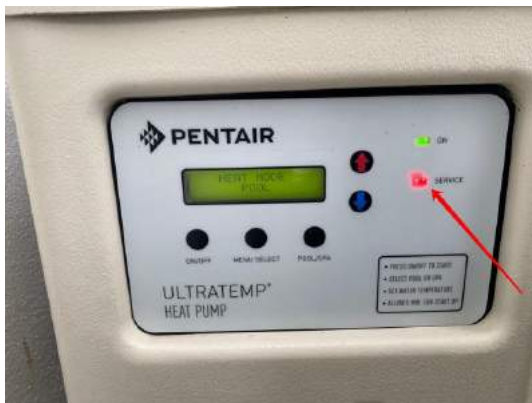
Comment 23
Deficiency

Pool heater appears to be functioning properly.

- Not tested.
- Service indicator on at the time of inspection.

Recommend further evaluation by a licensed professional and service accordingly. (Detailed quotation required)

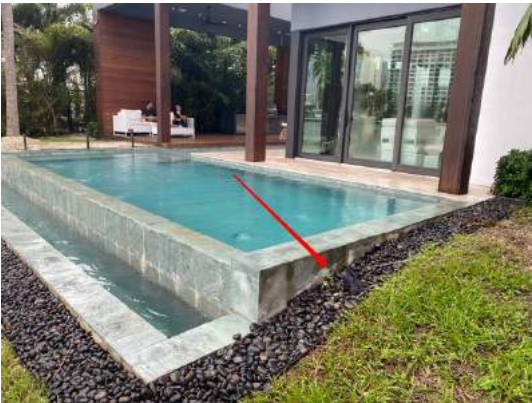
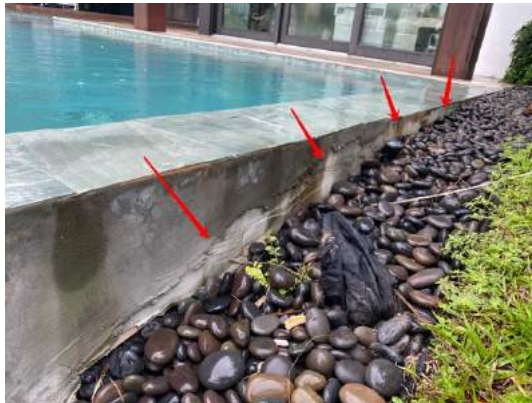
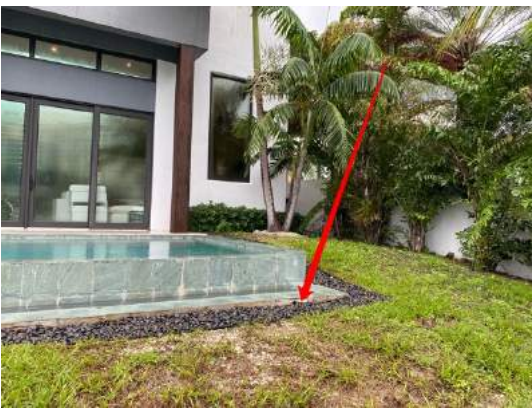
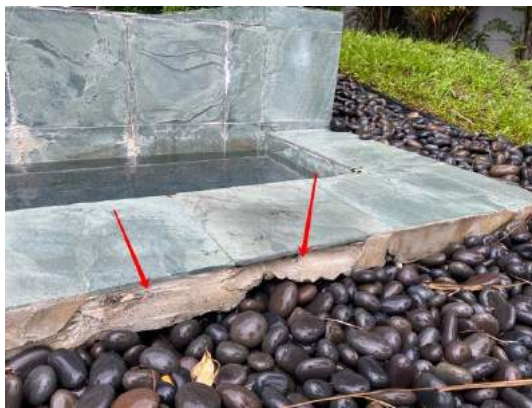
Comment 24
Deficiency

Unfinished stucco siding along outer barrier of pool.

Recommend re-finishing exterior stucco siding around exterior barrier walls of pool. (Estimate: \$500 - \$1,000)

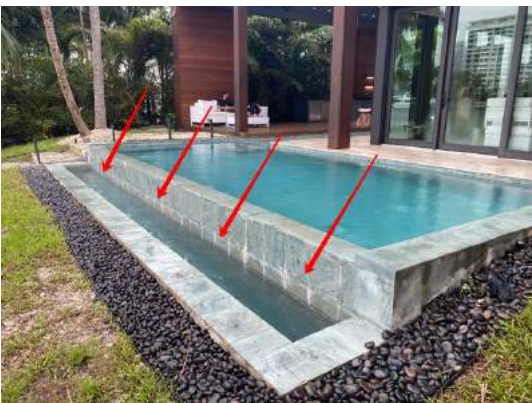
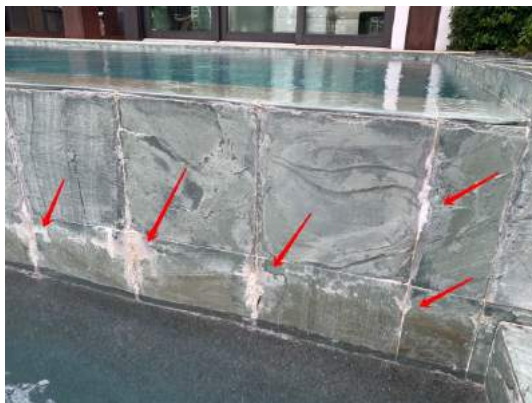
Comment 25

- Estimate minor moisture intrusion below tiles due to minor deterioration to tile grouting causing masonry bonding below tile to cause the crystalline deposit (efflorescence) visible from the surface of the tile.

Recommend repairing & re-sealing grouting along tiled waterfall wall to prevent further excessive efflorescence deposits. (Estimate: \$1,000 - \$1,500)

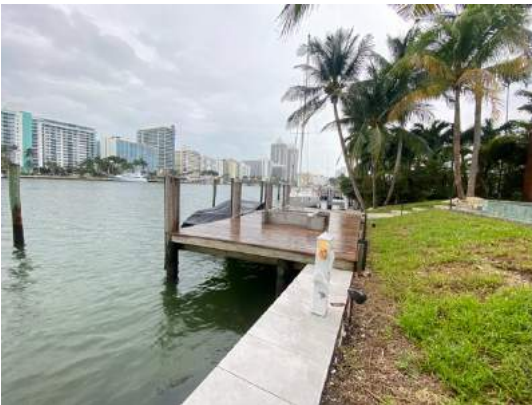
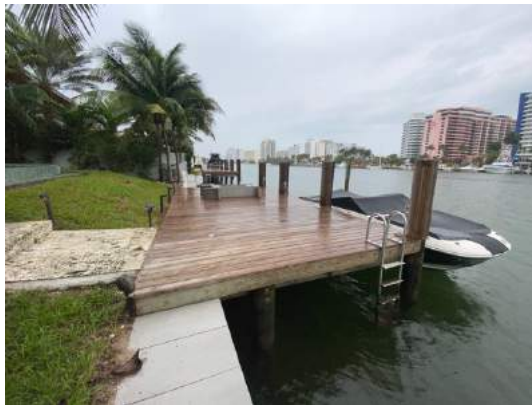
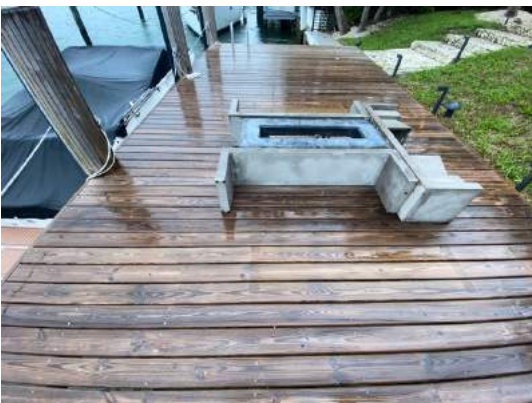
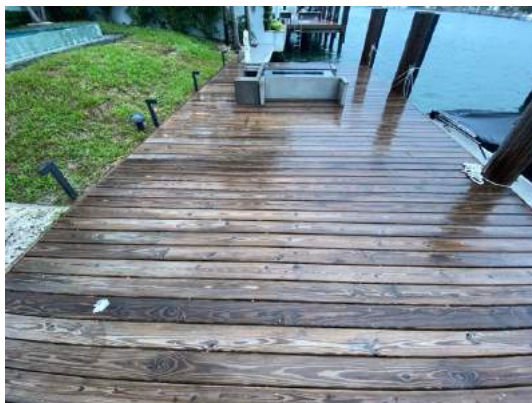
- Dock appears to be in fair condition at time of inspection.
- Minor cracking apparent along concrete seawall/bulkhead, but cracking does not appear to be structurally splitting from surface above water.
- Top of bulkhead has been tiled over and may be concealing cracking or damage.

As we can only check for visual deficiencies above water level, we recommend further evaluation of dock & seawall by a licensed structural engineer or seawall contractor for proper structural evaluation of seawall.

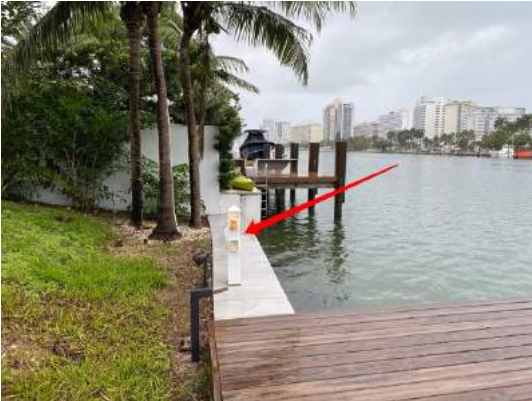
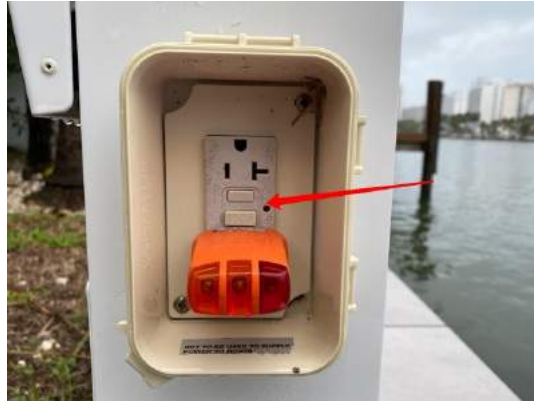
Comment 29

- GFCI function is tripped and does not appear to reset.

Recommend replacing faulty exterior GFCI outlet. (Estimate: \$50 - \$100)

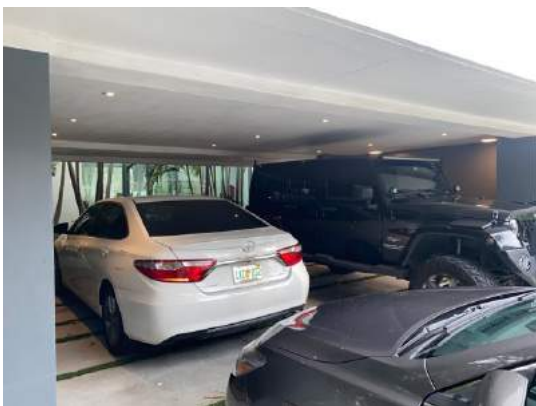
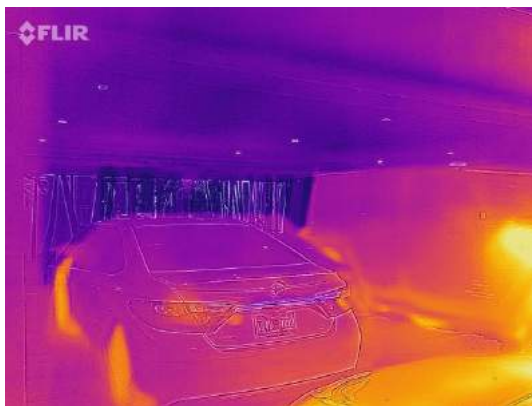
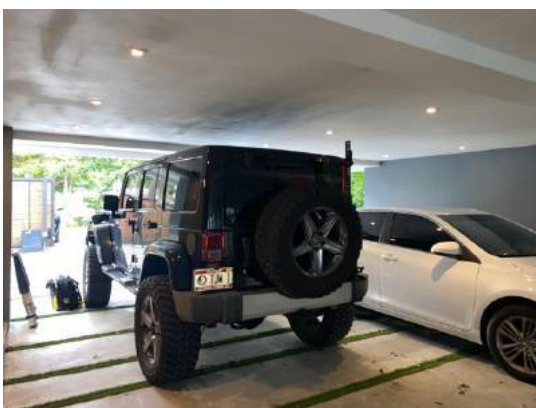
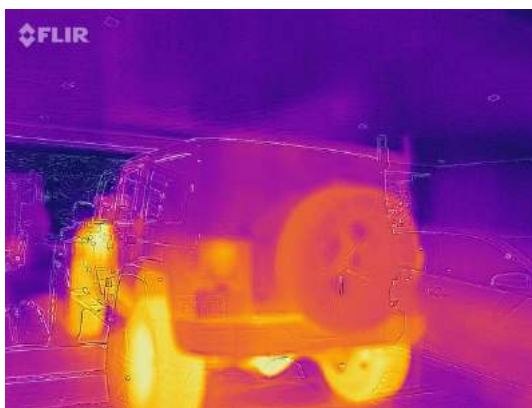
**Comment 30
Information**

Covered Parking / Carport Area.

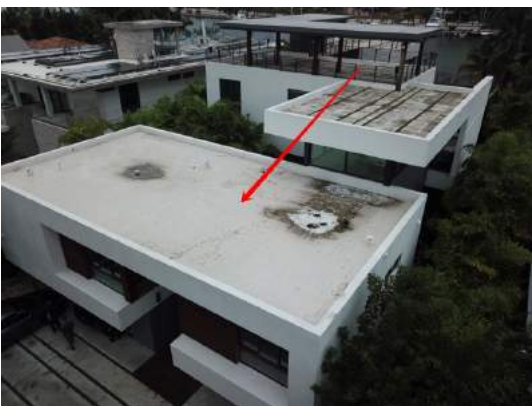
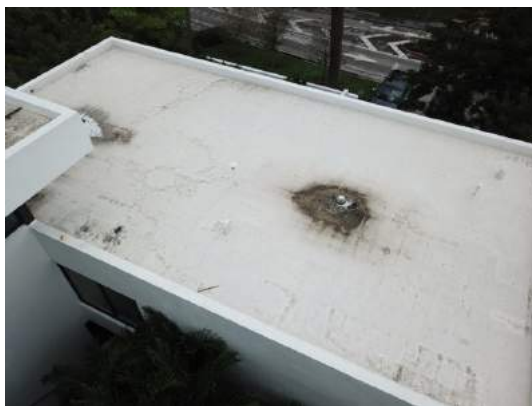
TPO membrane roof coverings installed during original construction in 2015 (Permit #B1600346), and currently appear in fair condition at the time of inspection.

- Indications of repairs to TPO membrane in select areas.
- No indications of moisture intrusion or leaking at the time of inspection.
- Roof appears to be graded properly for adequate drainage to roof drains installed on north & south sides of roof.

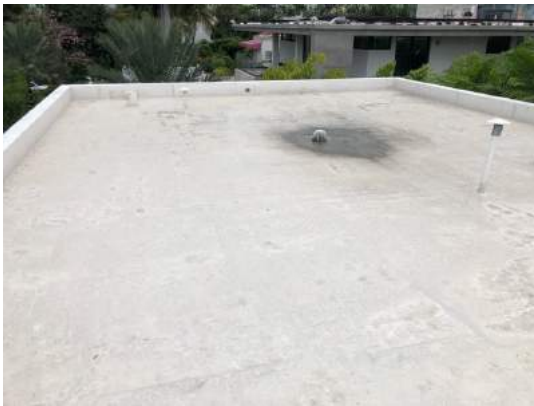
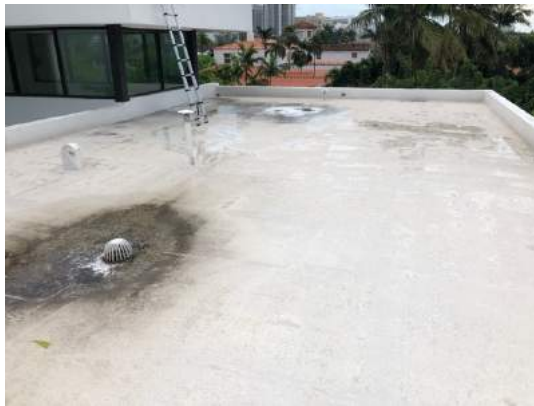
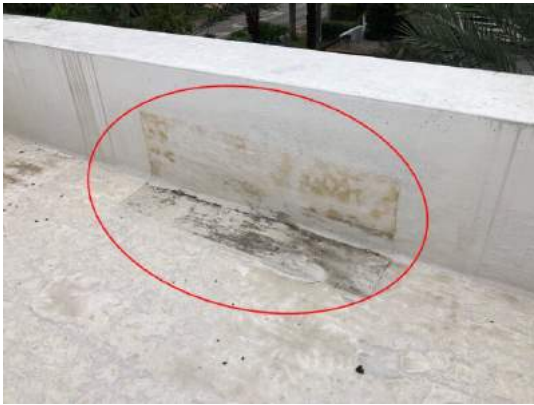
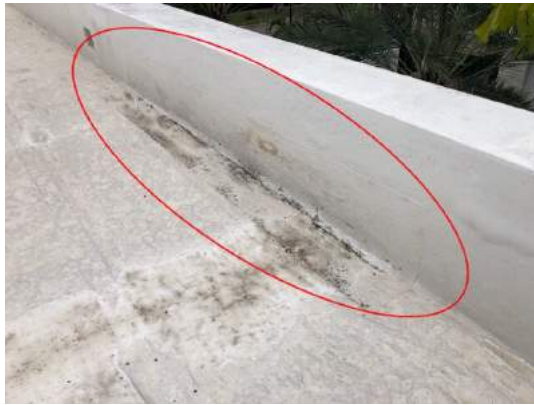
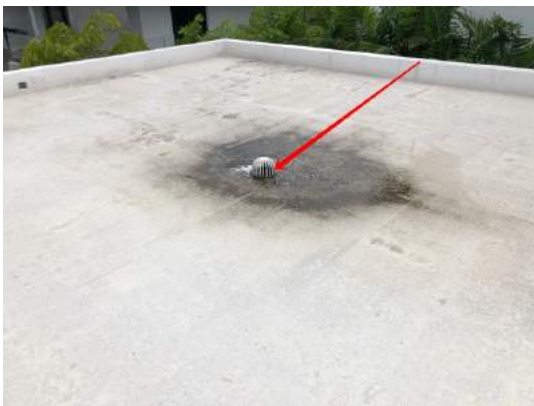
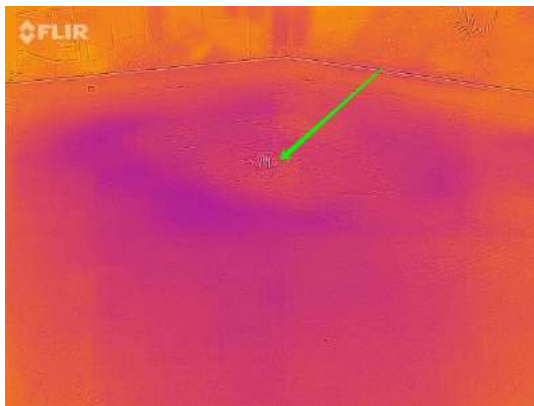
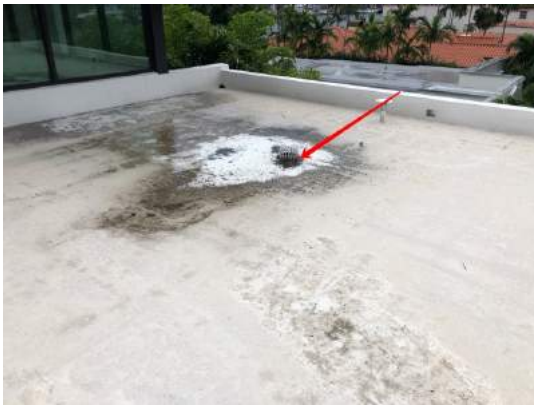
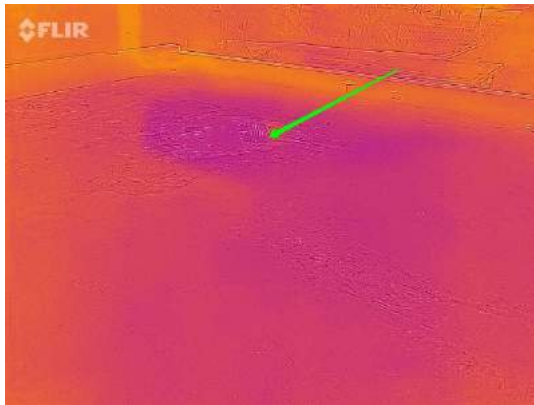
Comment 32

- Bubbling is an indication of moisture intrusion below liquid roof sealant around parapet wall which has expanded with heat.

- Paintbrush left along top of parapet wall from application of liquid roof sealant is currently sealed to crown of wall & oxidizing along wall.

Recommend repairing liquid roofing sealant to prevent possible leaking & water damage. (Estimate: \$1,000 - \$2,500)

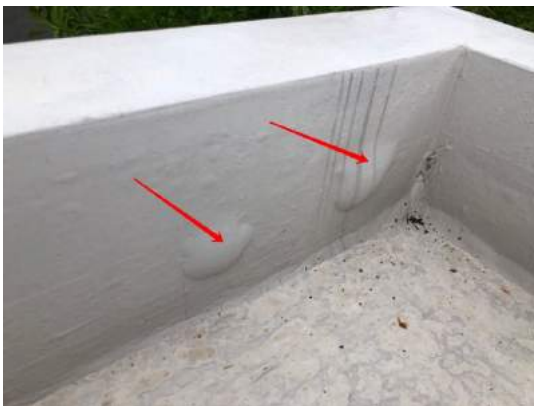
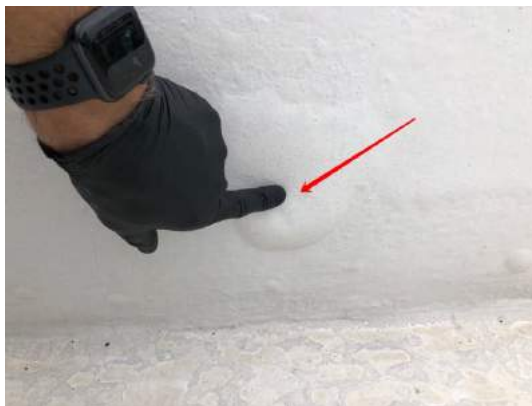
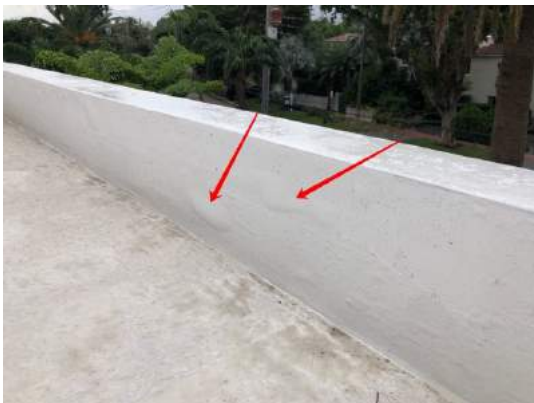
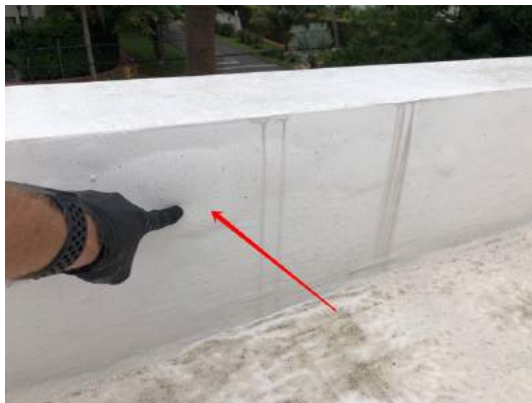
Comment 33

- South side of terrace appears to have been recently replaced.
- Terrace appears to be properly graded for adequate drainage to roof drains.
- Active leaking from roof terrace detected over 3rd level master bathroom.

Recommend further evaluation of leaking by a licensed roofing contractor & repair accordingly. (Detailed quotation required)

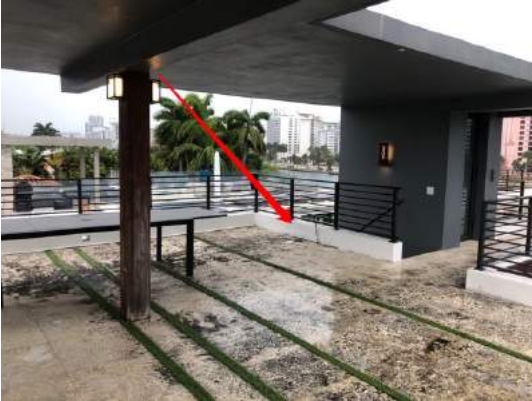
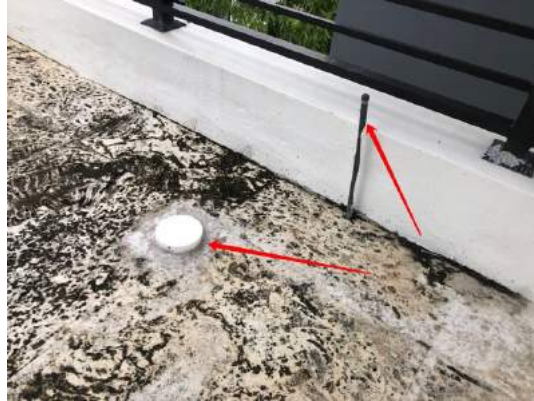
Comment 35
Deficiency

Apparent minor damage along exterior parapet wall around terrace causing minor oxidation from within wall.
Recommend repairing exterior siding around parapet wall to prevent further oxidation & water damage to wall.
(Estimate: \$100 - \$250)

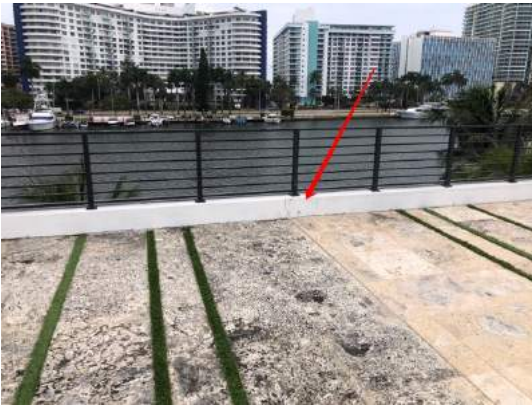
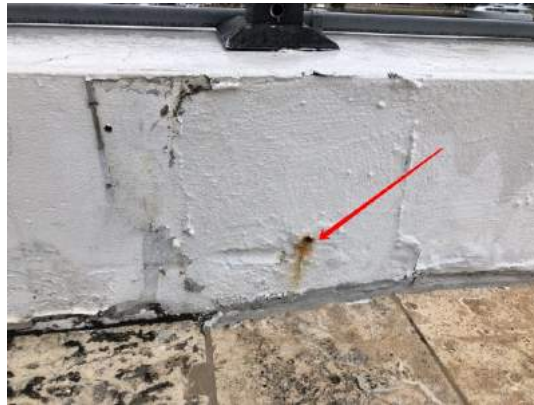
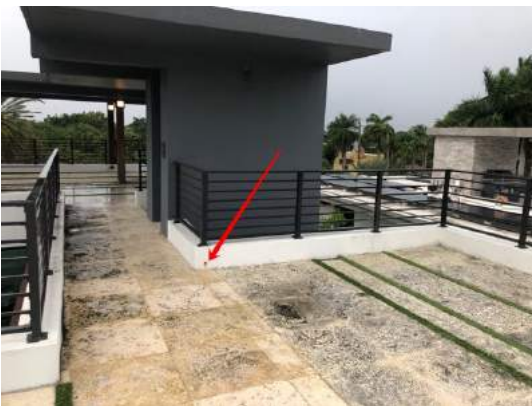
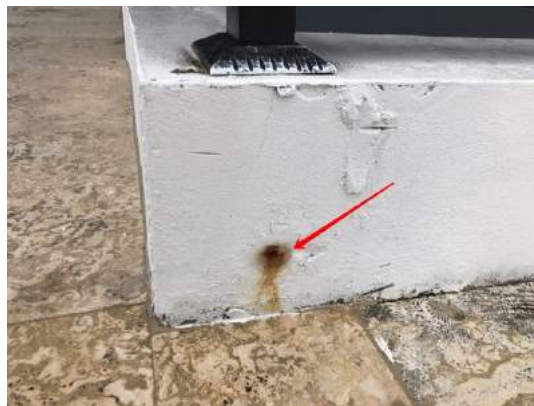
Comment 36
Deficiency

Apparent patch repair to parapet wall round scupper drain. Patch currently peeling away from parapet wall. Recommend properly repairing parapet wall to prevent potential moisture from roof. (Estimate: \$250 - \$500)

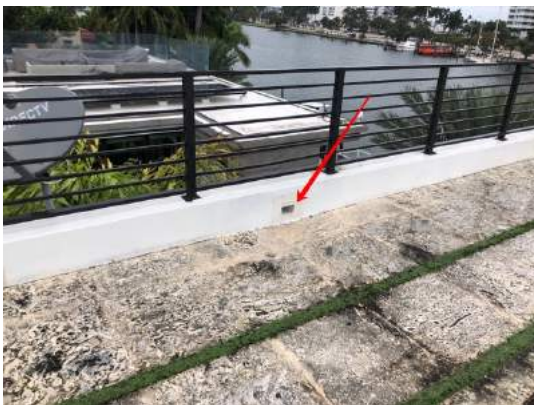
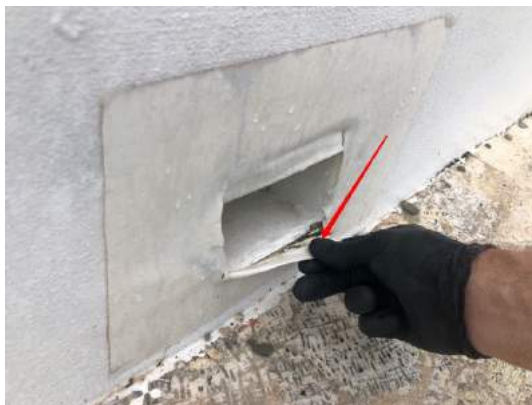
Comment 37
Deficiency

Liquid roof coverings installed in 2015 (Permit #B1600346), and currently appear in poor condition with multiple indications of deterioration/damage & previous attempts to re-seal/repair roof at the time of inspection.

- Liquid roofing/waterproofing to seal reinforced concrete slab roofing structure.
- No indications of active leaking or moisture intrusion below roof at the time of inspection.

Recommend replacement of roof sealant/waterproofing. (Estimate: \$2,500 - \$5,000)

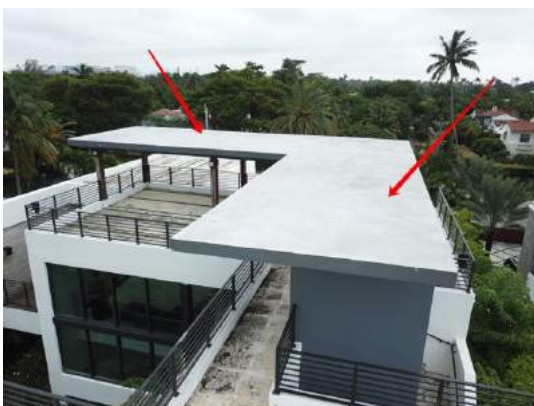
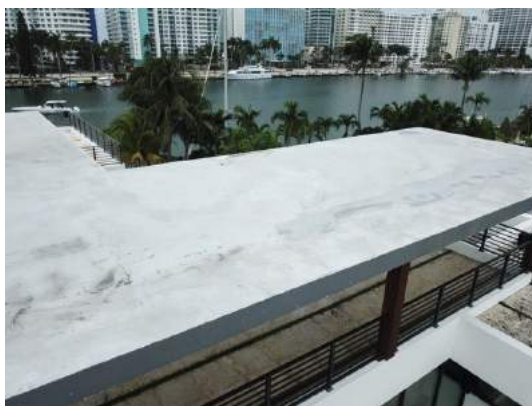
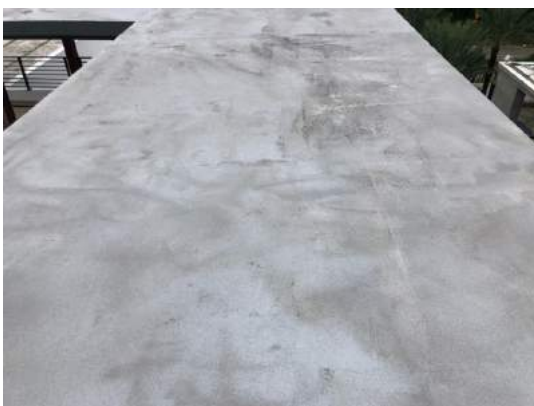
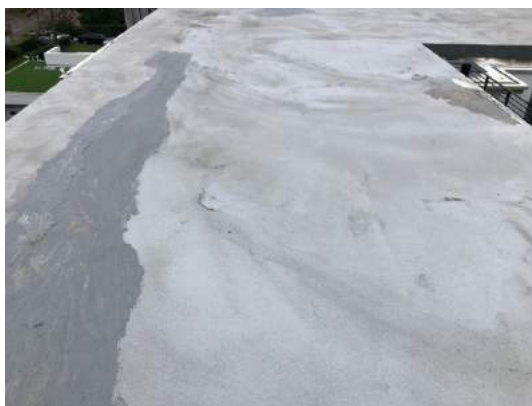
Comment 38
Deficiency

- Roof appears to be properly graded for adequate drainage to roof drain.
- Apparent patch repair to parapet wall round scupper drain. Patch currently peeling away from parapet wall.

Recommend properly repairing parapet wall to prevent potential moisture from roof. (Estimate: \$250 - \$500)

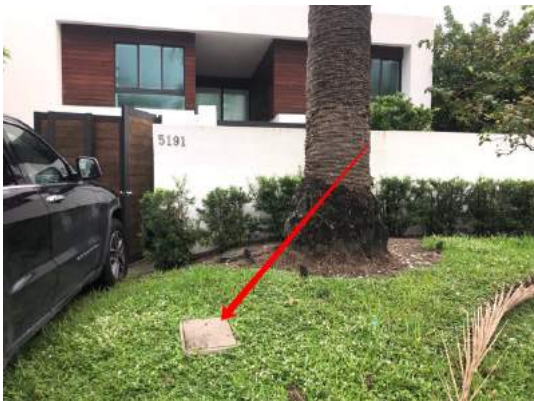
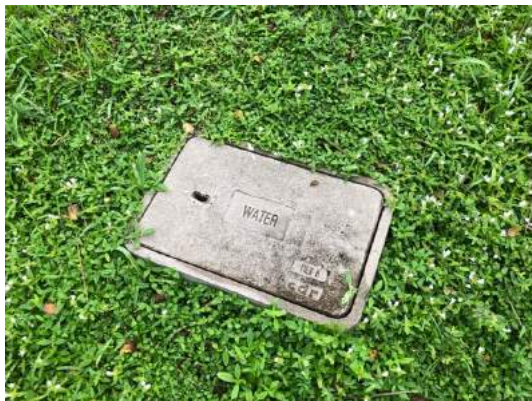
No main water shut-off valve found around exterior of property.

- Main water shut-off valve is located next to water meter.

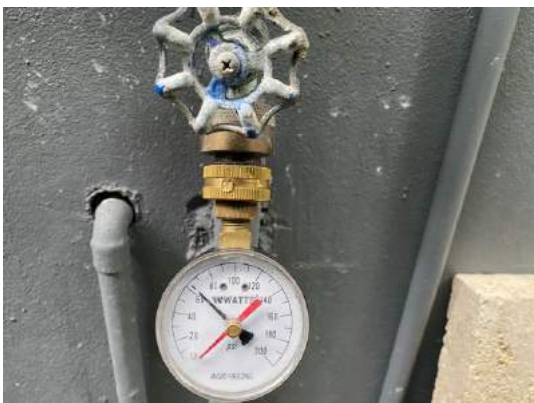
Water pressure is good going into home. (Around 65 PSI)

- Average water pressure for residential properties ranges between 30 - 50 PSI.

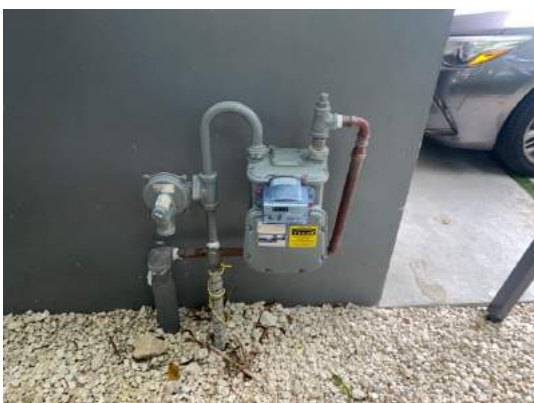
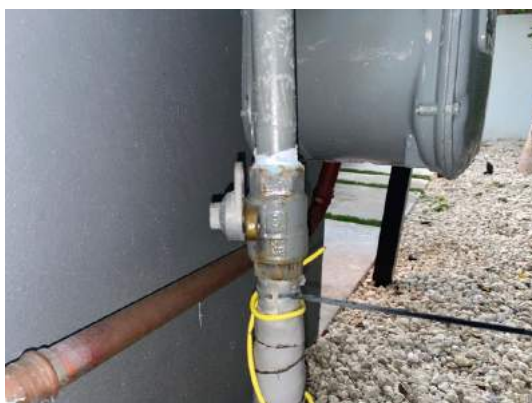
City gas meter/fuel connection to property is located on north side of property.

- Main fuel shut-off valve is located next to city meter.

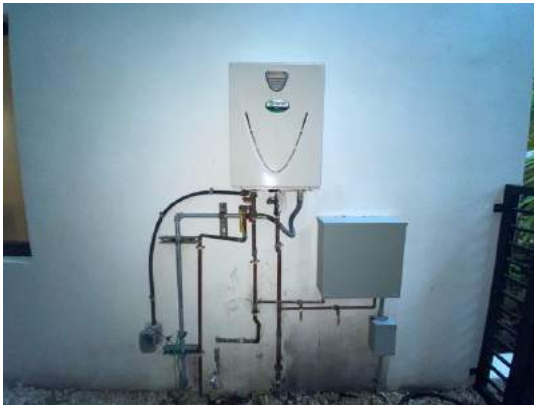
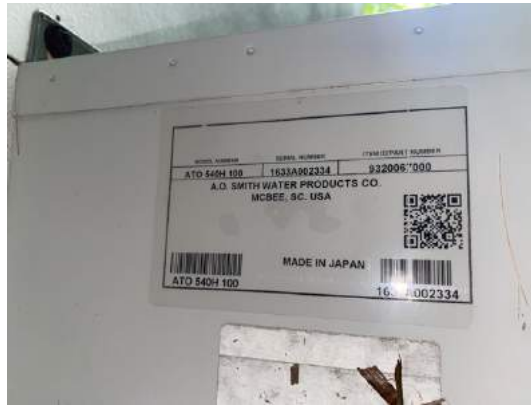
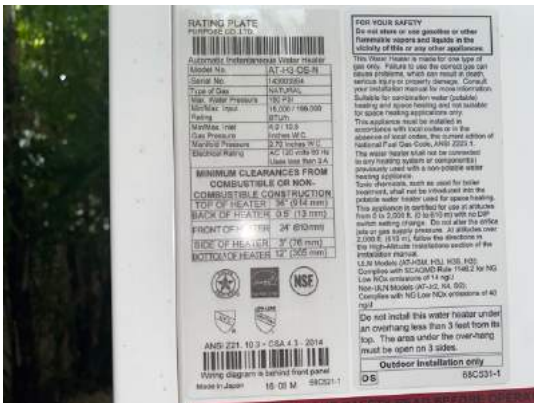
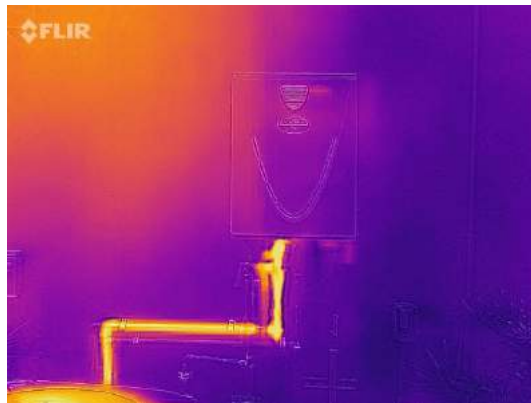
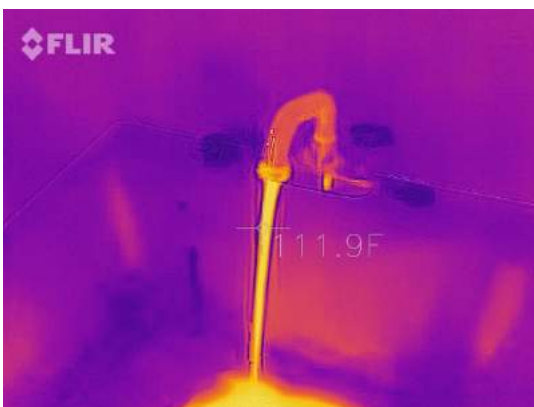
Hot water heater appears in good condition and functioning properly at the time of inspection.

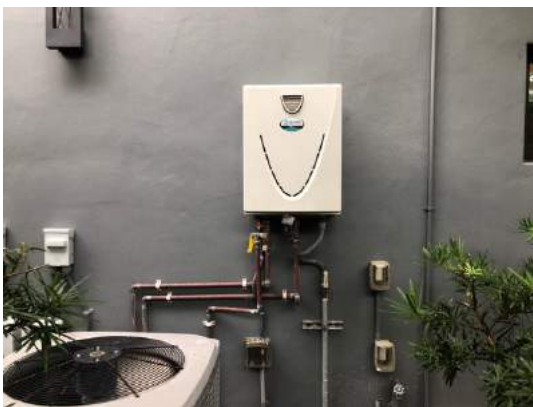
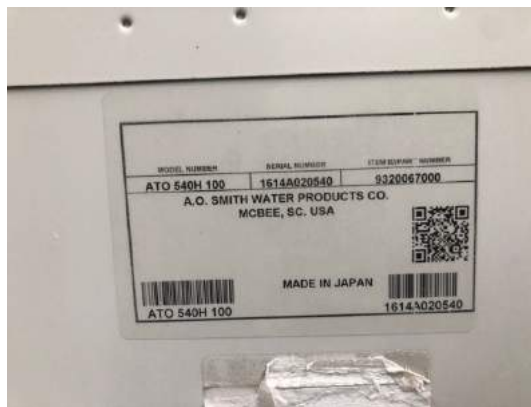
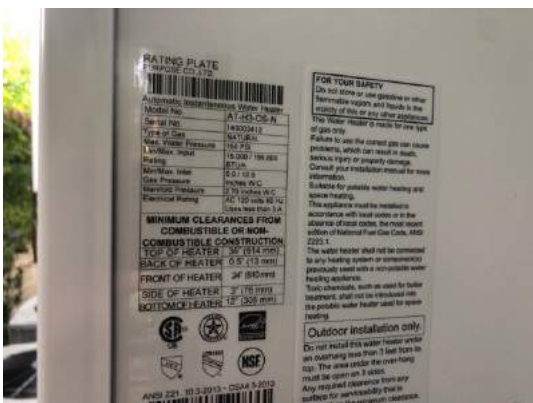
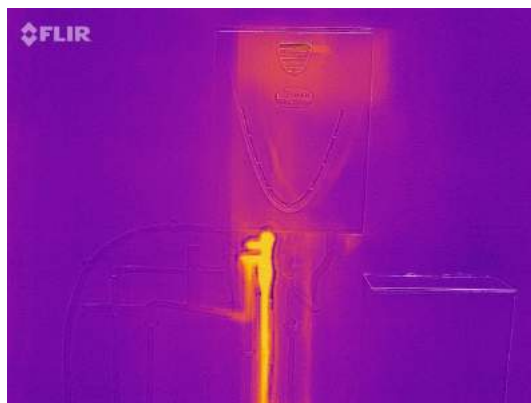
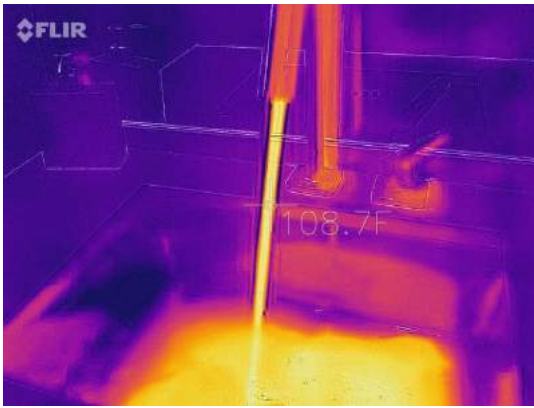
Hot water heater appears in good condition and functioning properly at the time of inspection.

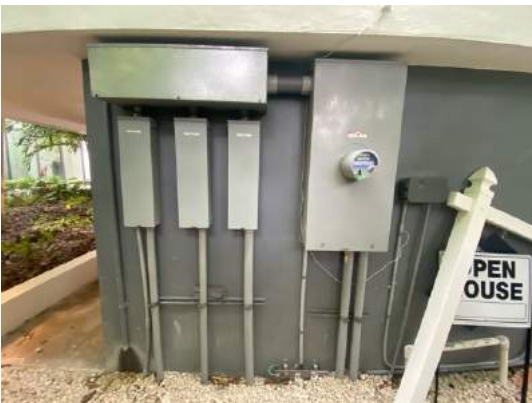
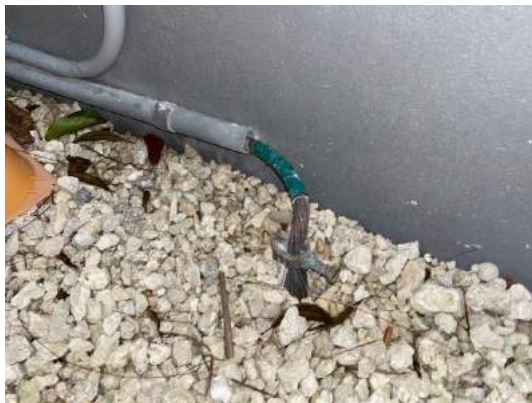
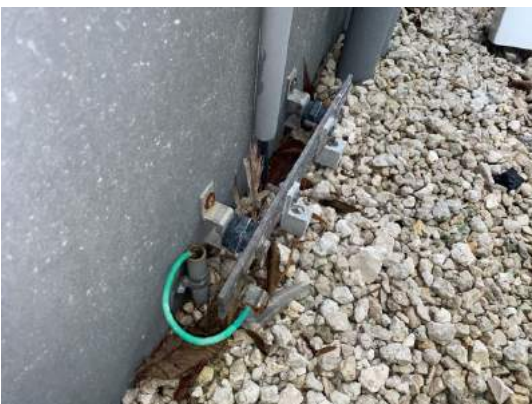
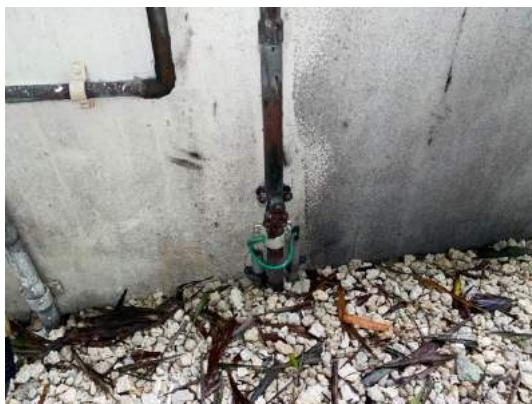
Electrical service entrance & meter located in back of garage on north side of property.

- Electrical service entrance conductors are in good & working condition.
- Electrical service is grounded.
- Main service disconnect breakers located next to service meter.
- Service entrance conductors appear in good condition within service disconnect panels.
- Service entrance conductors appear in good condition within main distribution panels.

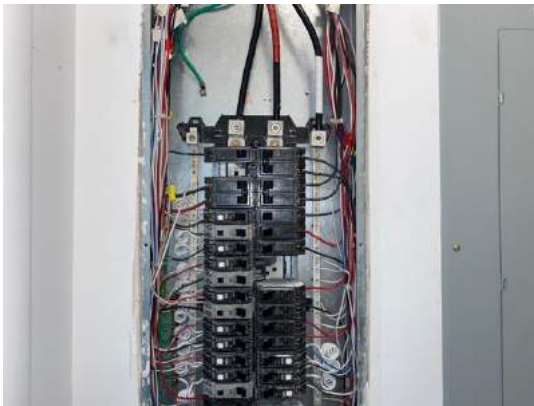
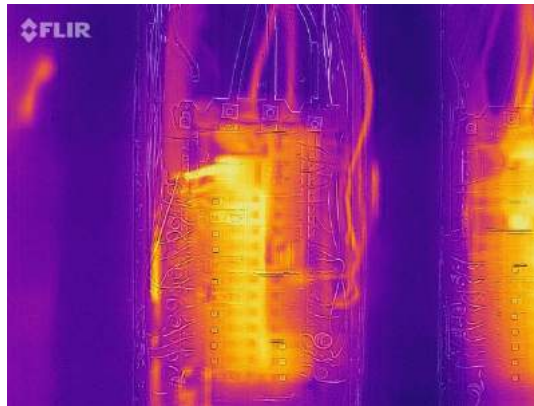
Comment 47

Deficiency

Circuit breaker currently concealed behind dead front cover.

Adjust/modify dead front cover to properly provide opening for all installed circuit breakers.

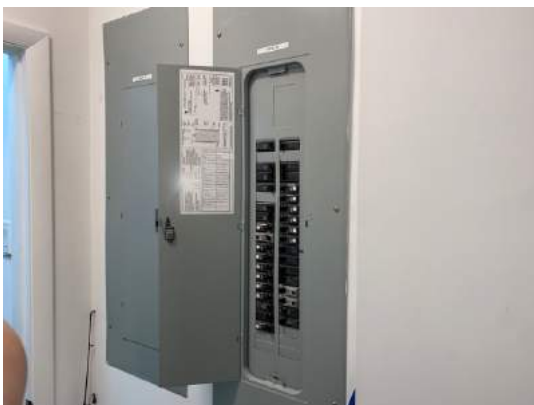
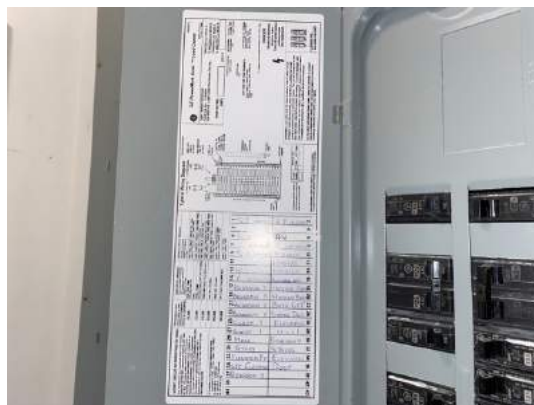
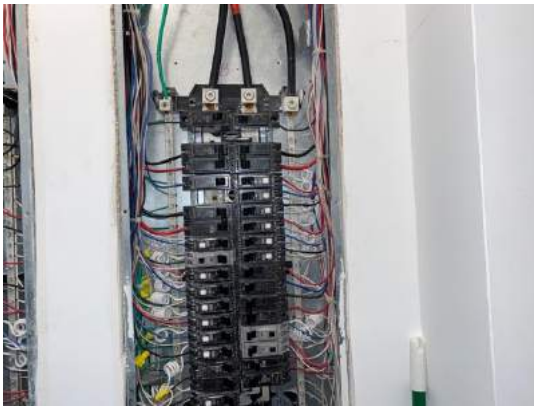
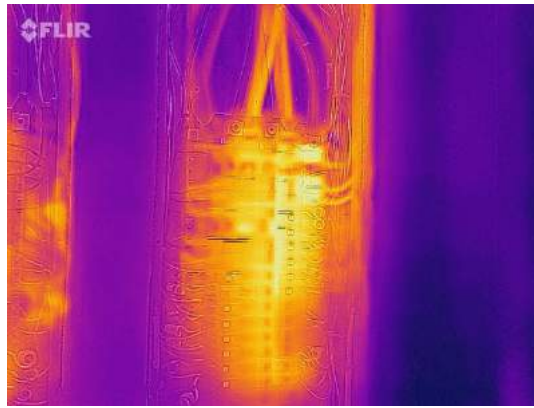
Comment 48

Main distribution panel B (200 AMPs) located within laundry room.

- Distribution panel, circuit breakers, and branch wiring appear in good & working condition at the time of inspection.

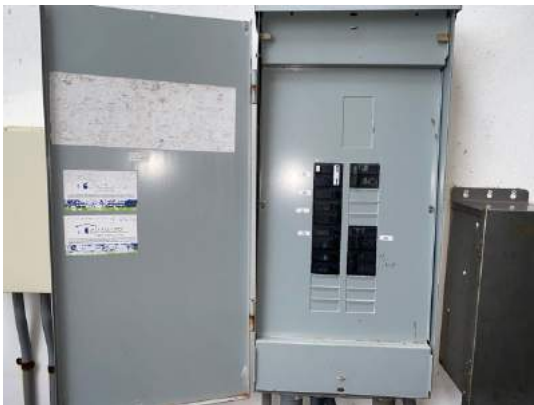
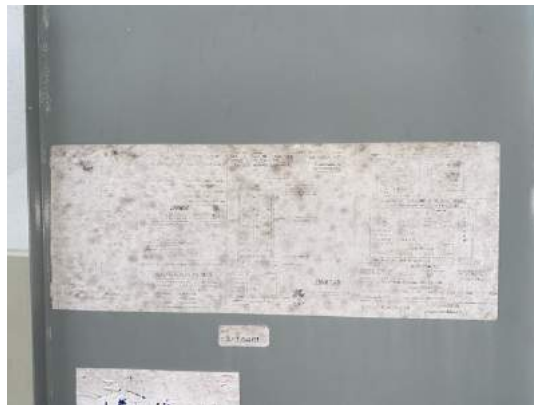
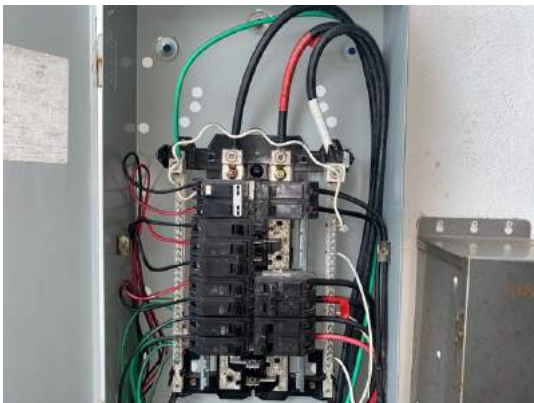
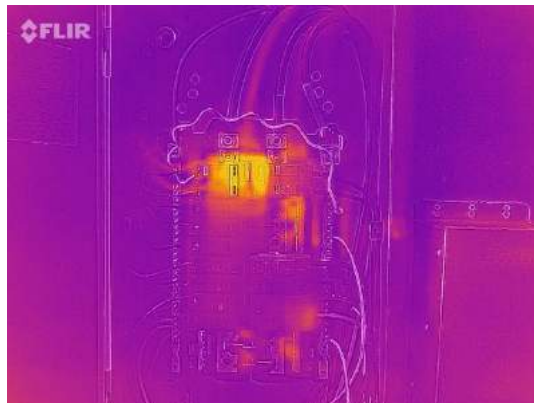
Comment 49
Information

Main distribution panel P (150 AMPs) located along exterior wall.

- Distribution panel, circuit breakers, and branch wiring appear in good & working condition at the time of inspection.

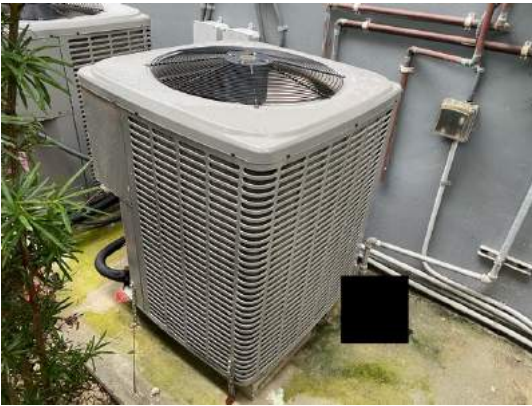
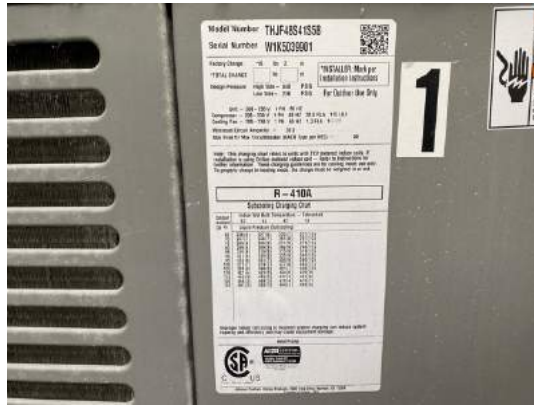
Comment 51
Information

HVAC system exterior compressor unit.

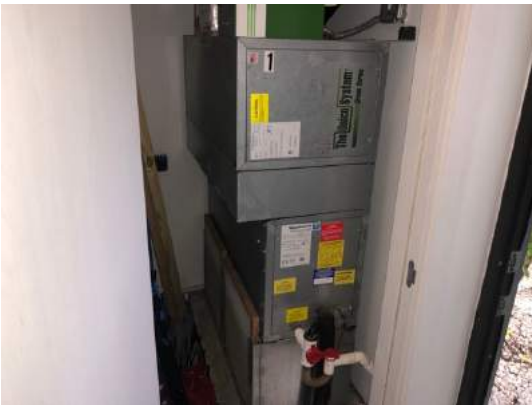
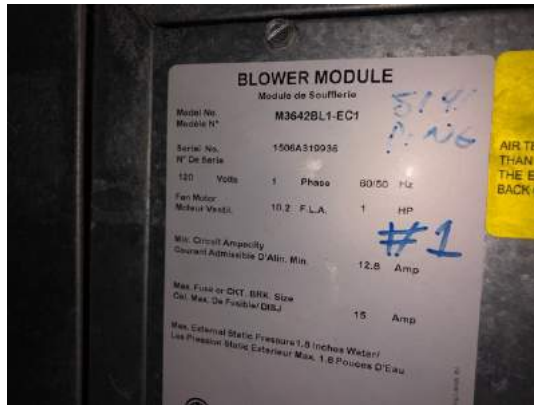
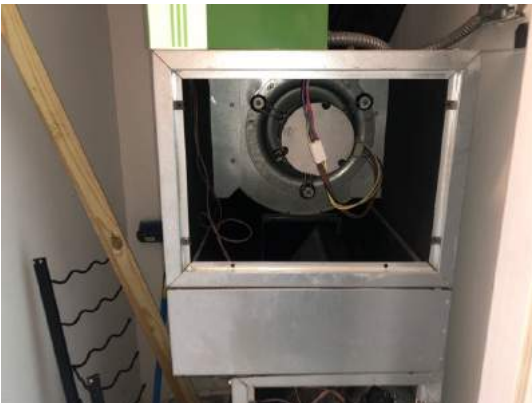
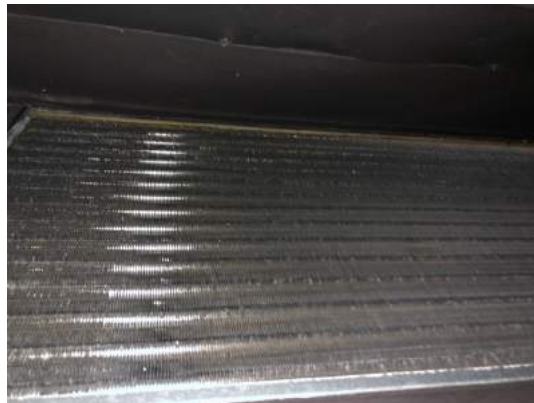
Comment 52
Information

HVAC system air handler unit.

- HVAC system in good & working condition at the time of inspection.
- A/C radiator & coils appear in good condition at the time of inspection.

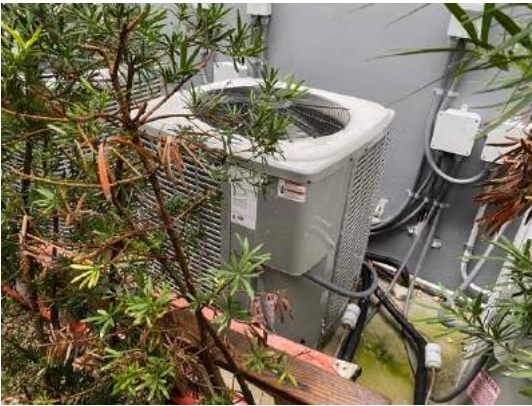
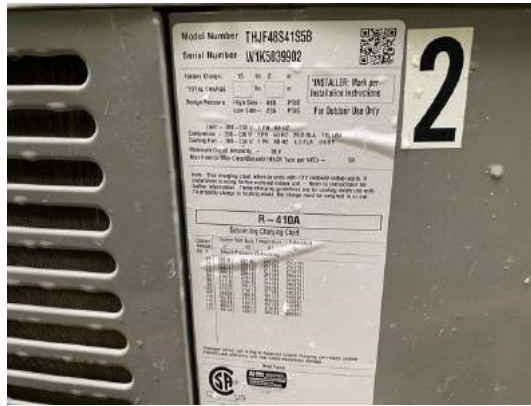
Comment 53
Information

HVAC system exterior compressor unit.

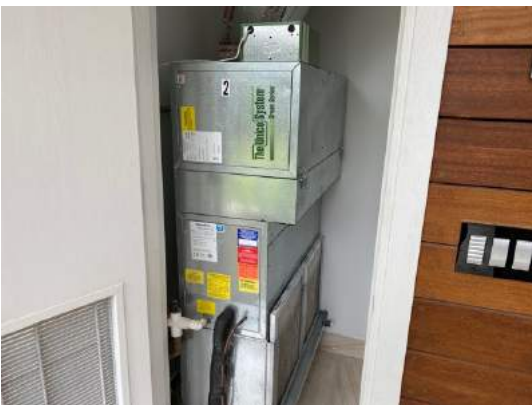
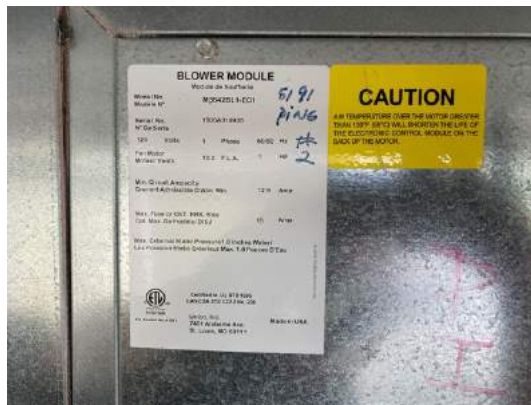
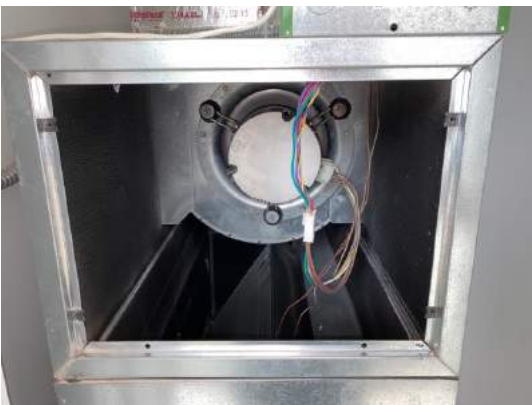
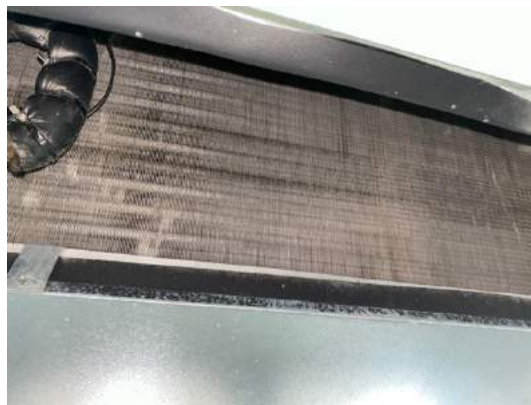
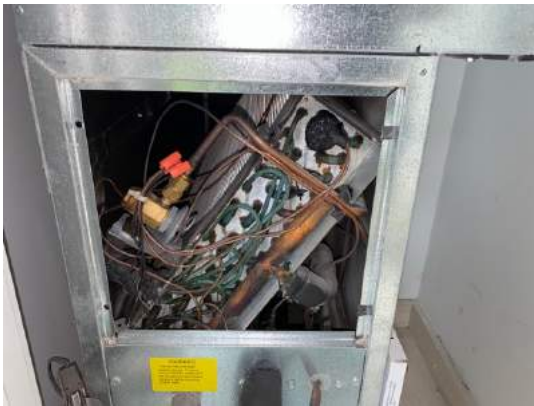
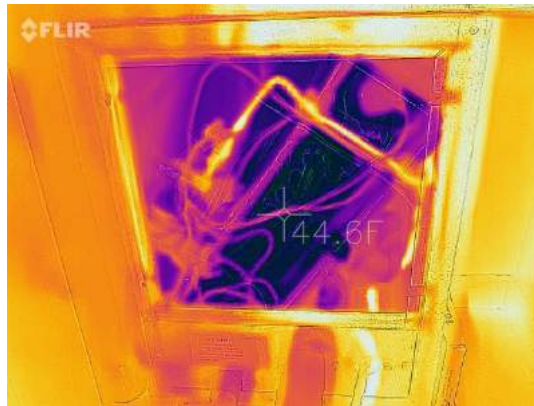
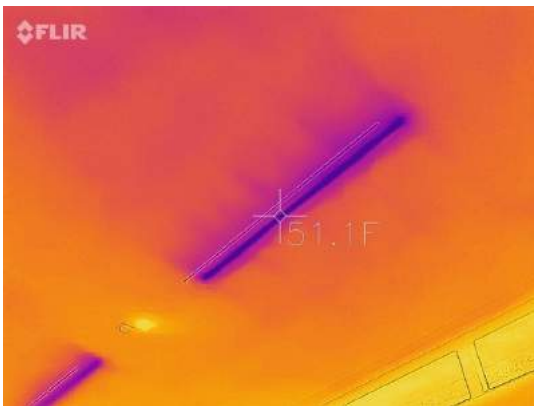
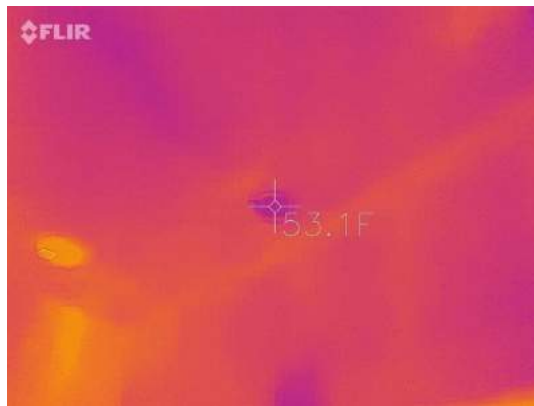
HVAC system air handler unit.

- HVAC system in good & working condition at the time of inspection.
- A/C radiator & coils appear in good condition at the time of inspection.

HVAC systems over 10 years old should be checked, cleaned and serviced yearly by a licensed HVAC technician.

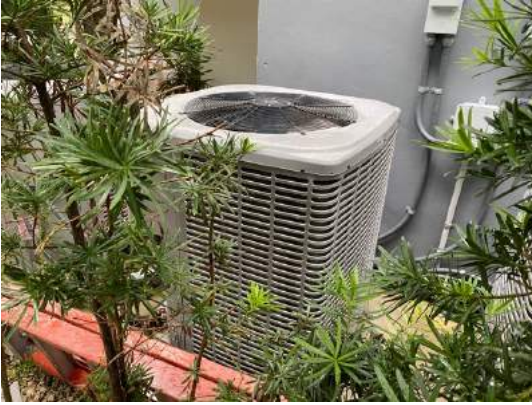
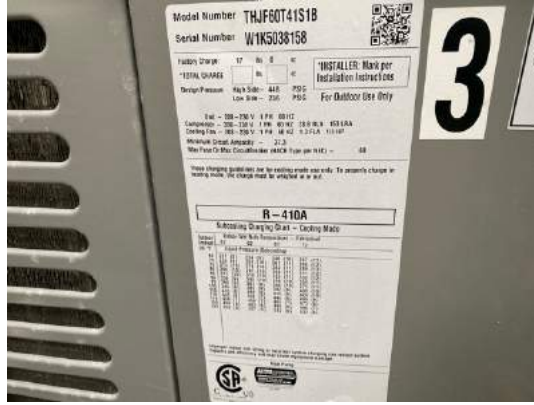
Comment 55
Information

HVAC system exterior compressor unit.
