Home Inspection Report

5191 Pinetree Dr
Miami Beach, FL 33141

Inspected By: Tracy Woodard

Home Pro Miami
(786) 558-5286
www.homepromiami.com
info@homepromiami.com

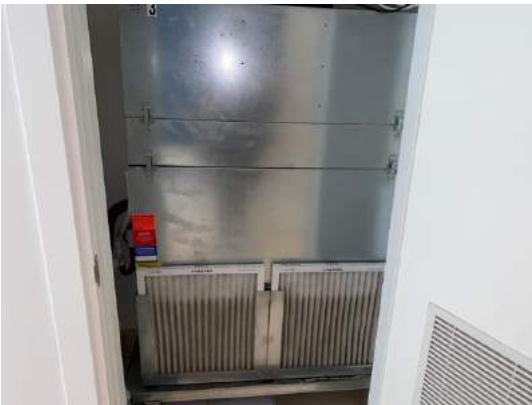
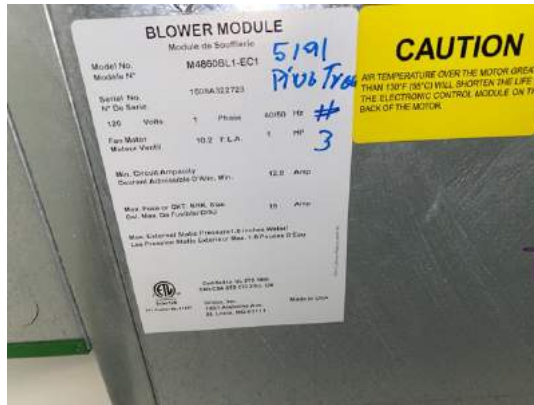
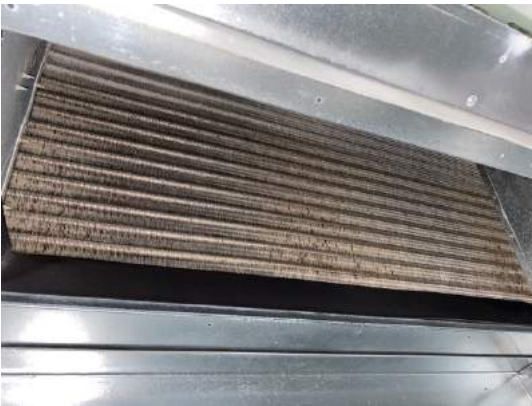
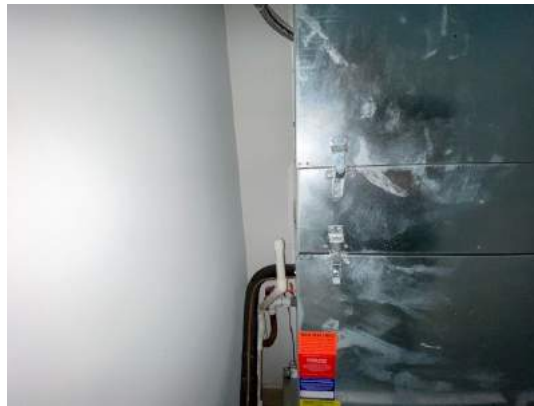
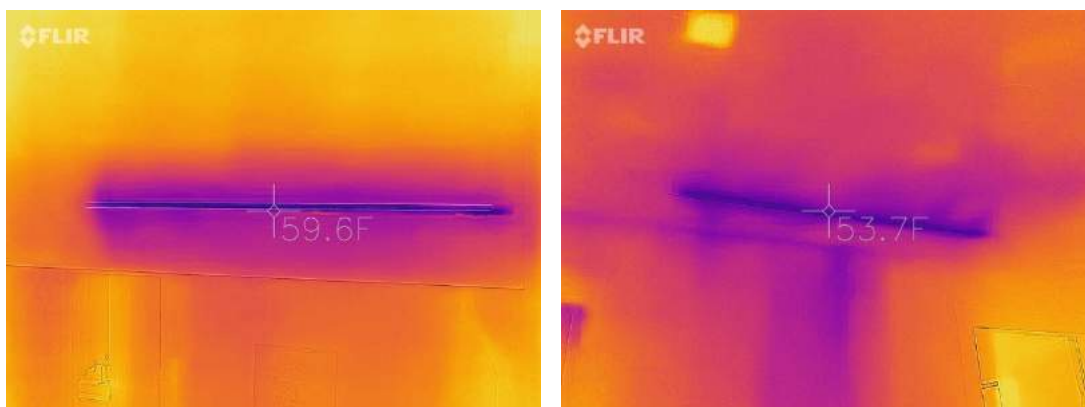
Comment 56
Information

HVAC system air handler unit.

- HVAC system in good & working condition at the time of inspection.
- A/C radiator & coils appear in good condition at the time of inspection.

HVAC systems over 10 years old should be checked, cleaned and serviced yearly by a licensed HVAC technician.

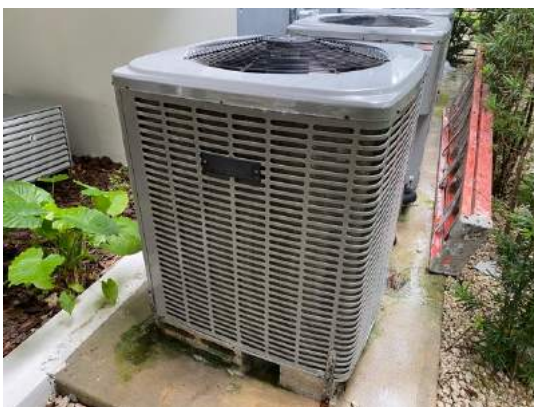
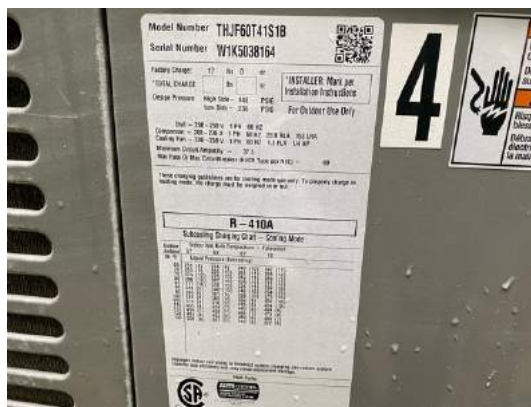
**Comment 57
Information**

HVAC system exterior compressor unit.

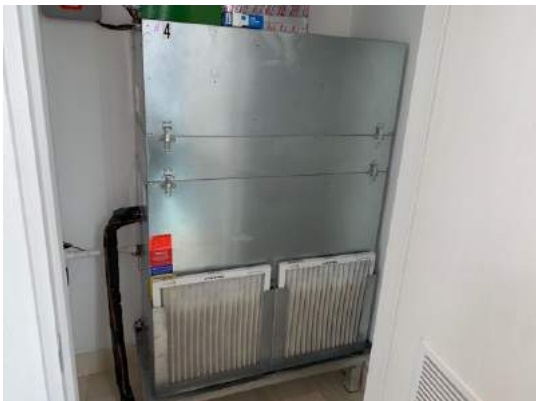
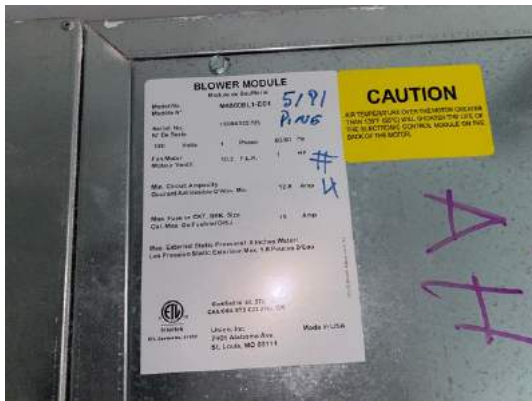
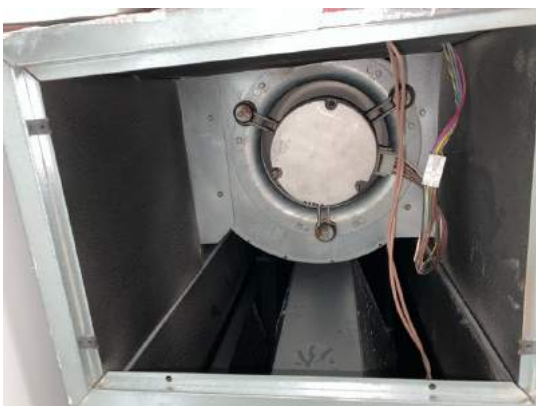
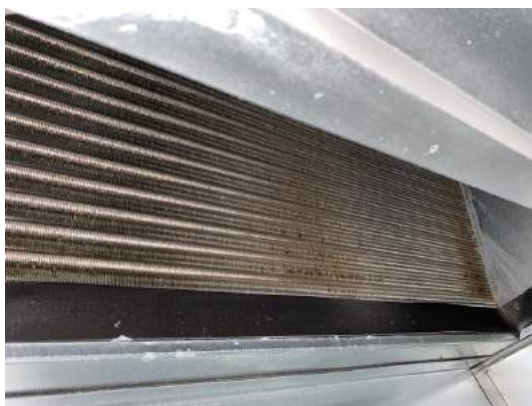
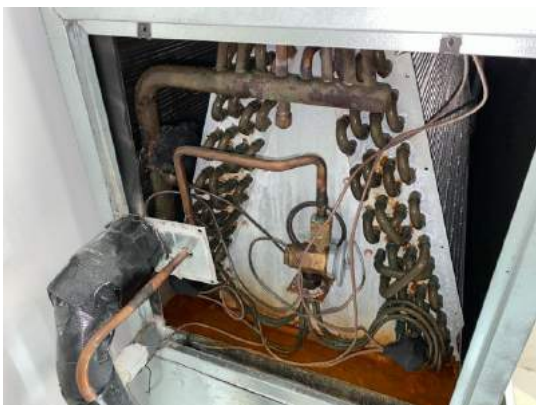
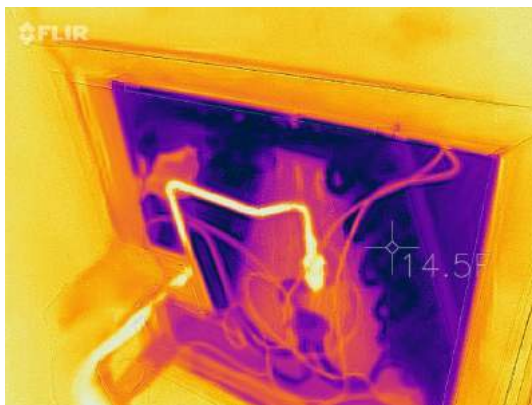
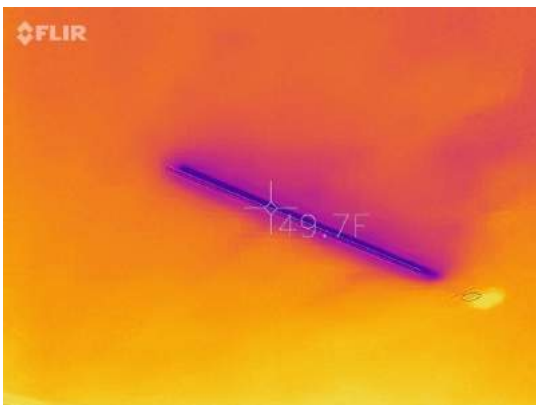
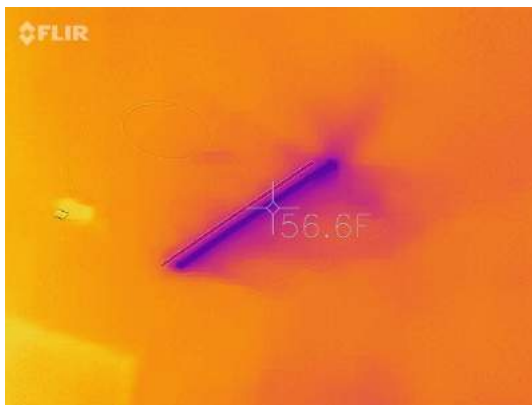
**Comment 58
Information**

HVAC system air handler unit.

- HVAC system in good & working condition at the time of inspection.

- A/C radiator & coils appear in good condition at the time of inspection.

HVAC systems over 10 years old should be checked, cleaned and serviced yearly by a licensed HVAC technician.

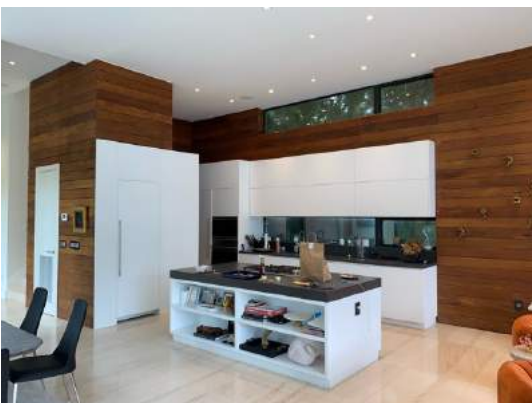
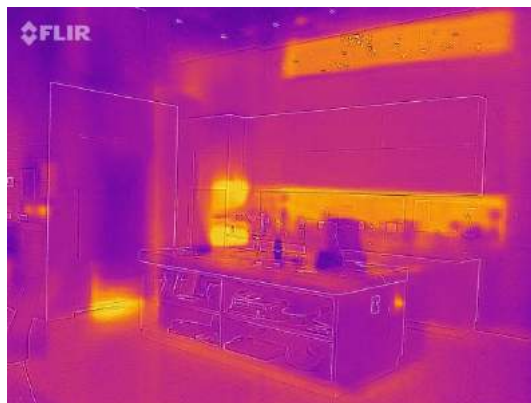
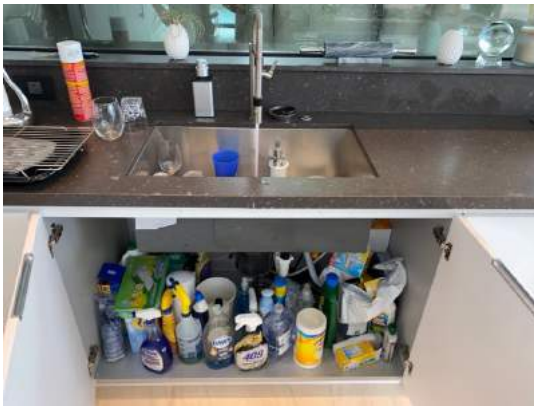
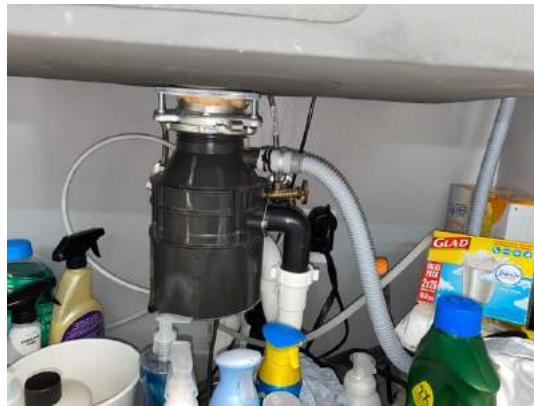
Comment 59 Information

Kitchen Photos.

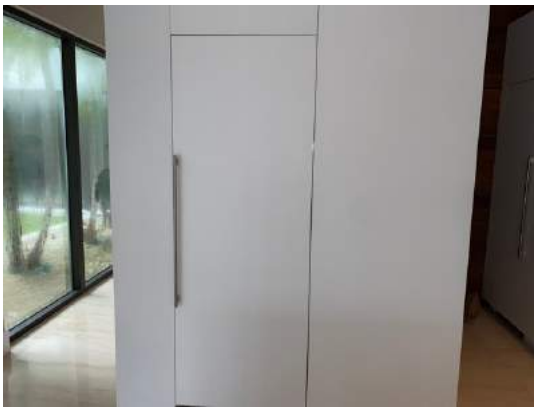
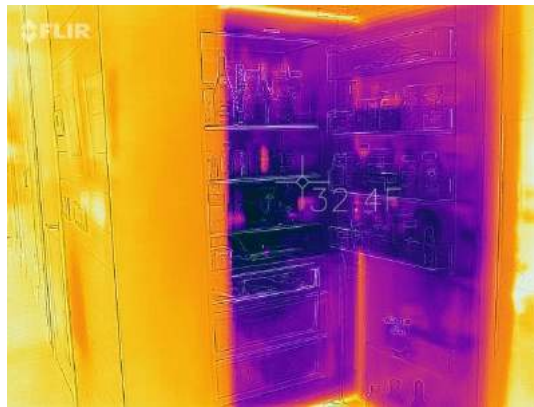
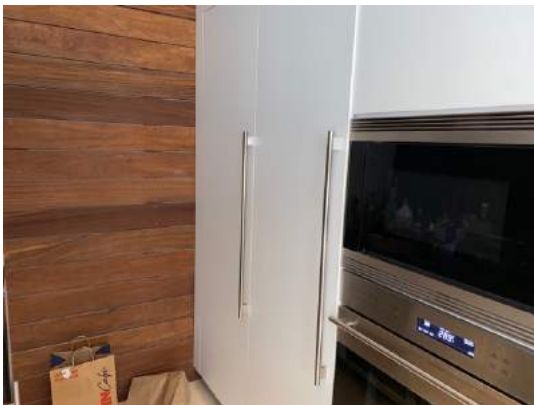
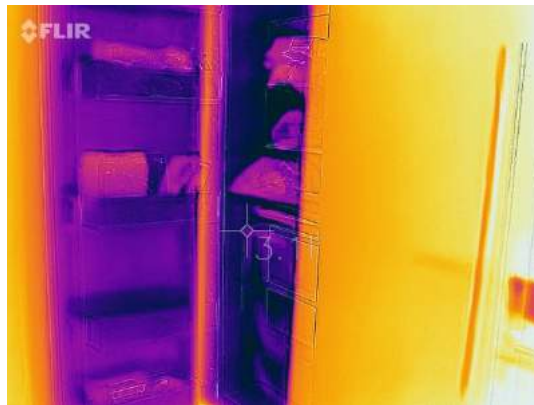
Refrigerator/freezer functioning properly.

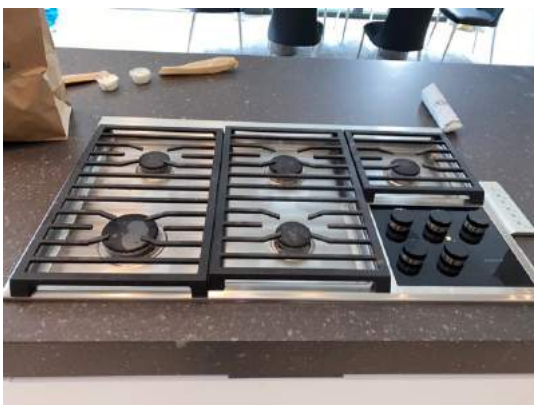
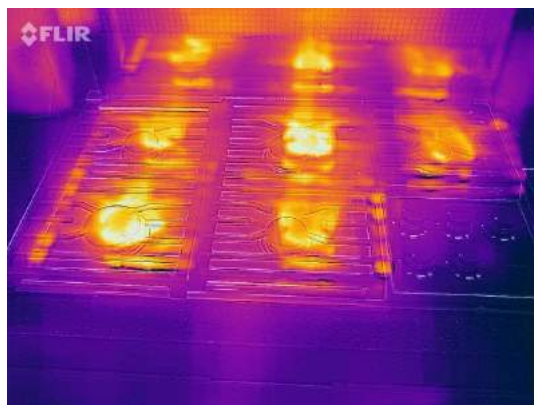
Comment 61

Gas cooktop functioning properly.

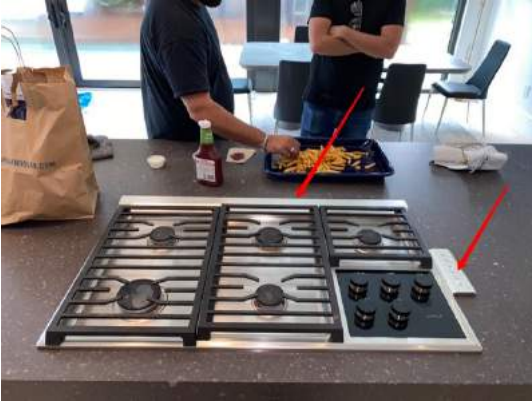
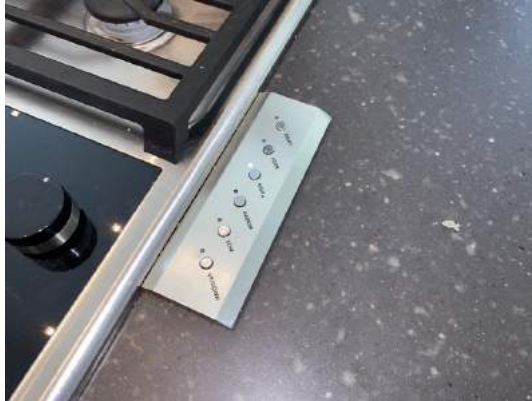
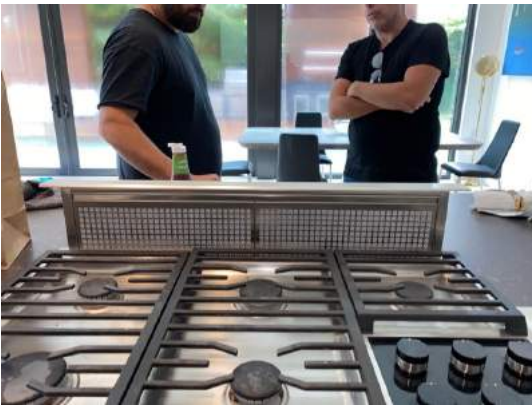
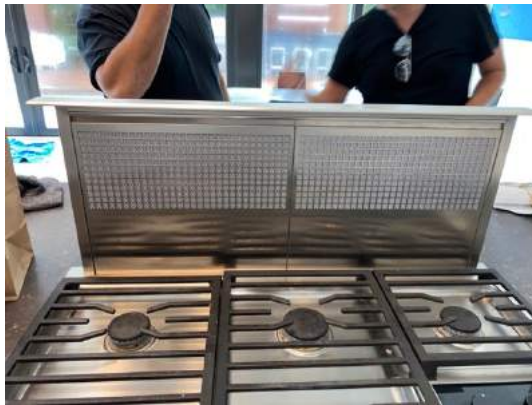
Comment 62
Information

Retractable range hood over cooktop functioning properly at the time of inspection.

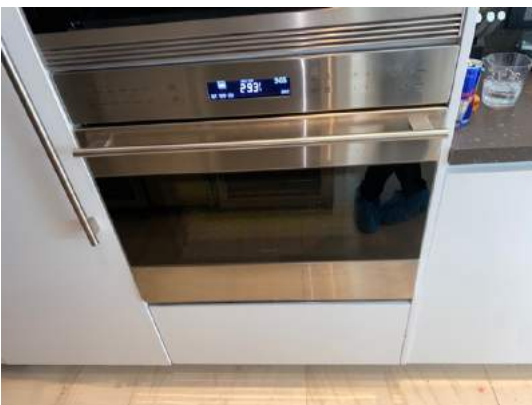
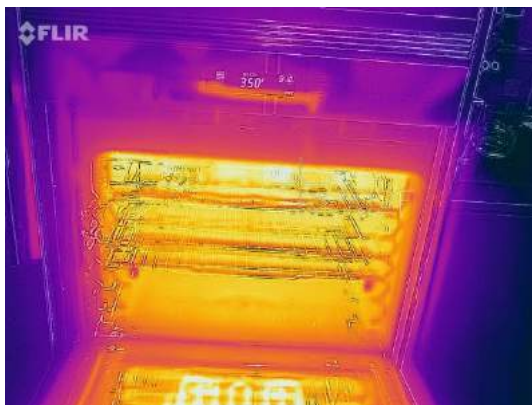
Comment 63
Information

Built-in oven functioning properly.

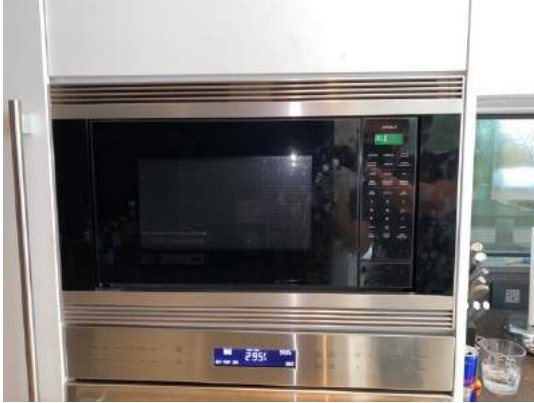
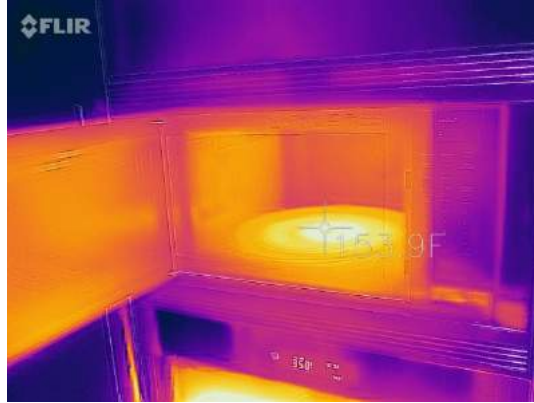
Comment 64
Information

Microwave functioning properly at the time of inspection.

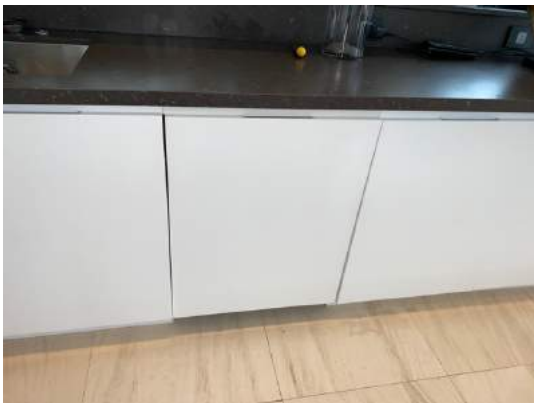
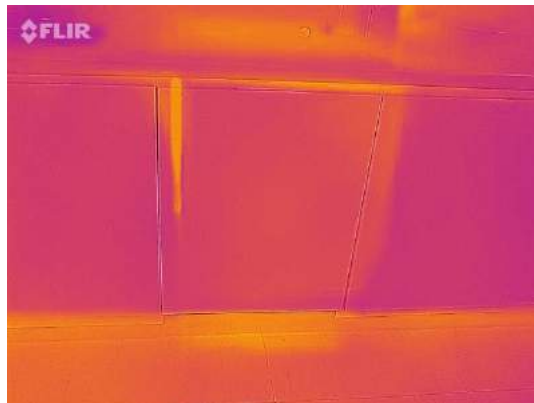
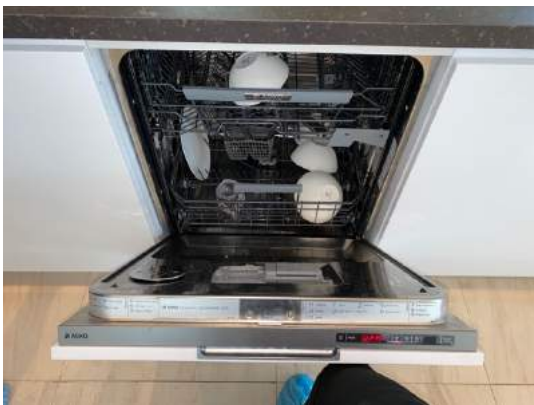
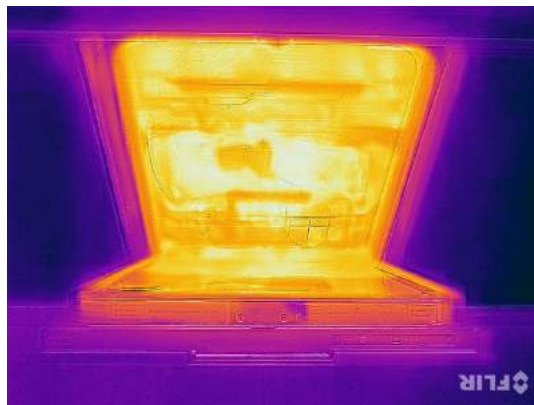
Comment 65
Information

Dishwasher functioning properly.

- No indications of leaking from or around dishwasher at the time of inspection.

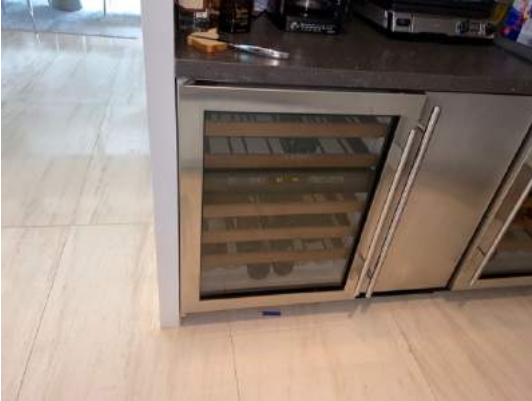
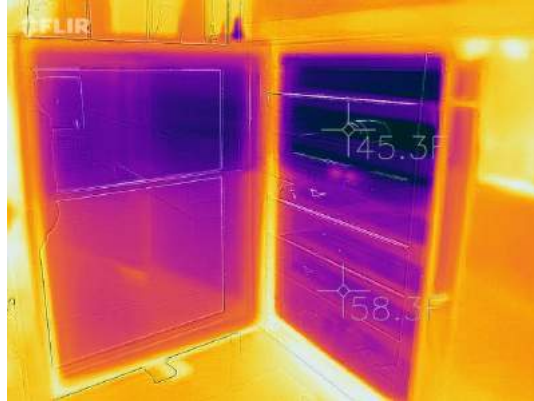
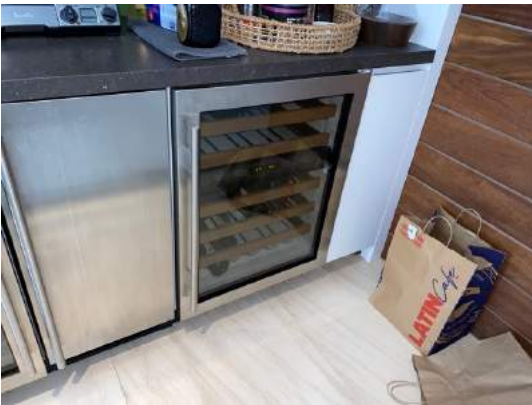
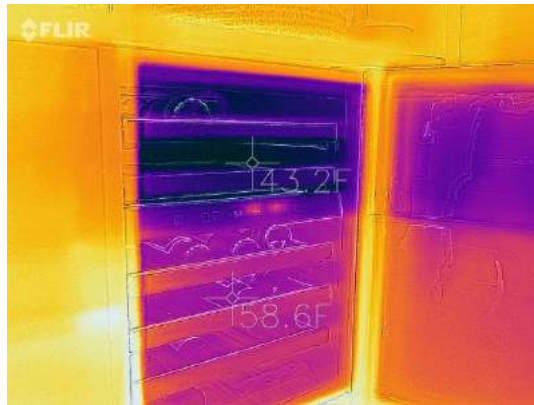
Comment 66
Information

Mini wine refrigerator functioning properly.

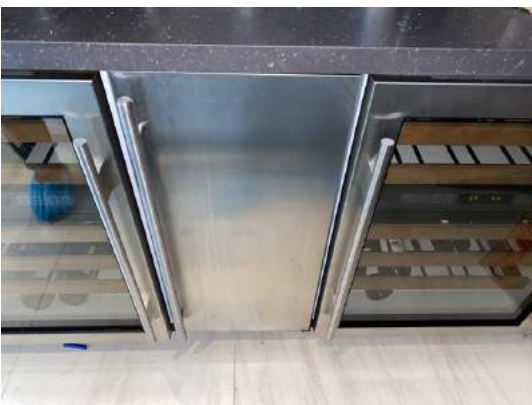
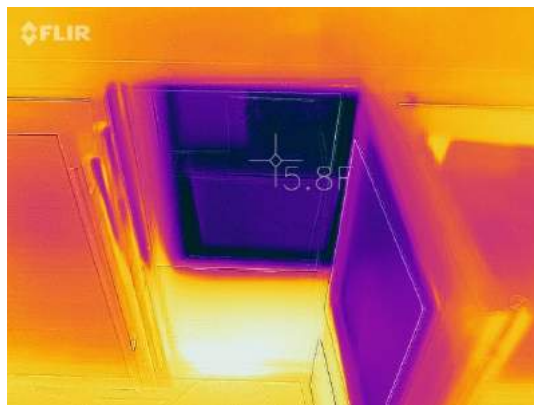
Comment 67
Information

Ice Maker functioning properly.

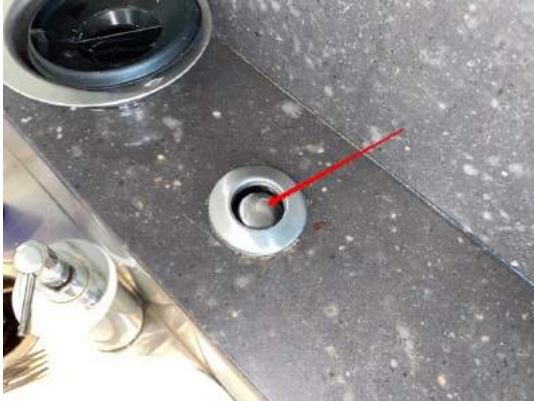
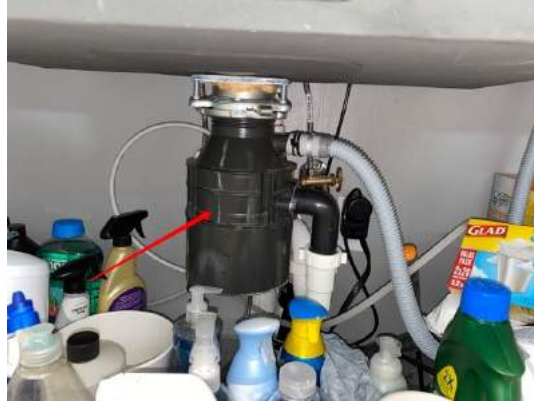
Comment 68
Deficiency

Sink top mounted air switch for garbage disposal is currently broken, and garbage disposal is not functional at the time of inspection.

Replace sink top mounted air switch. (Estimate: \$50 - \$100)

If garbage disposal continues not to function, replace garbage disposal. (Estimate: \$250 - \$500)

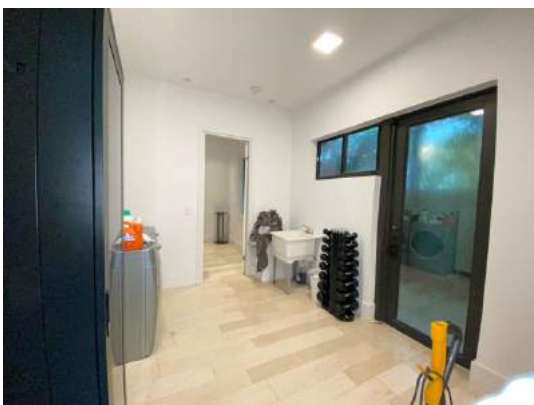
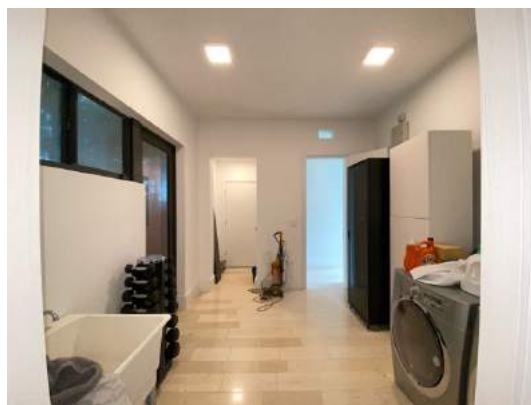
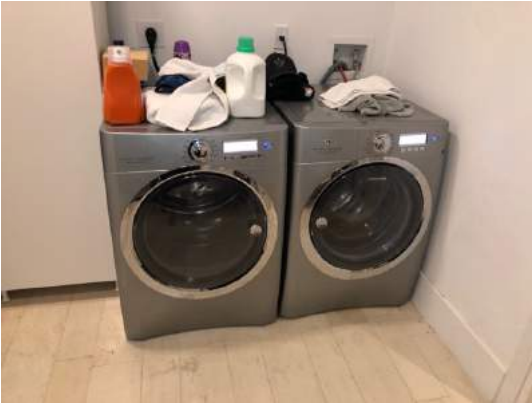
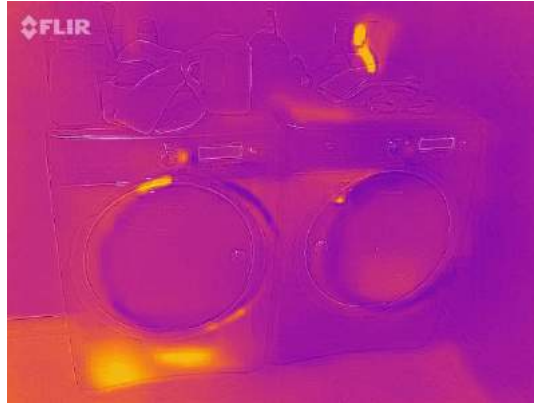
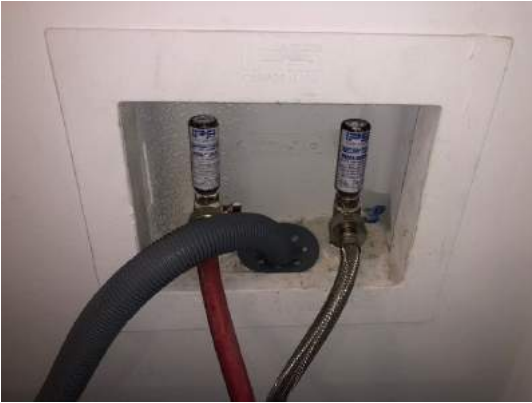
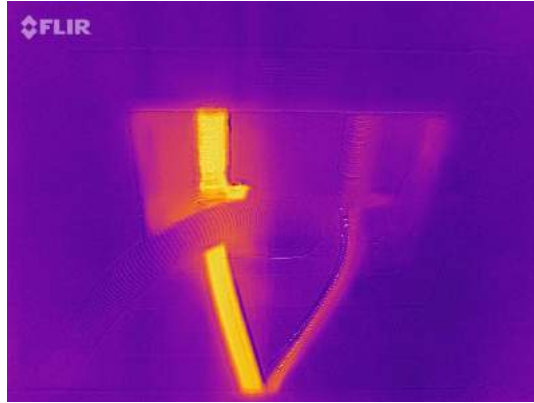
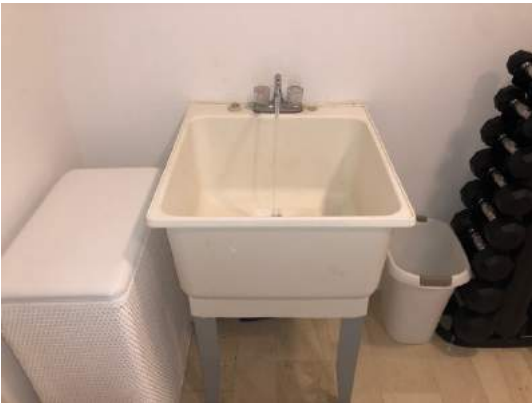
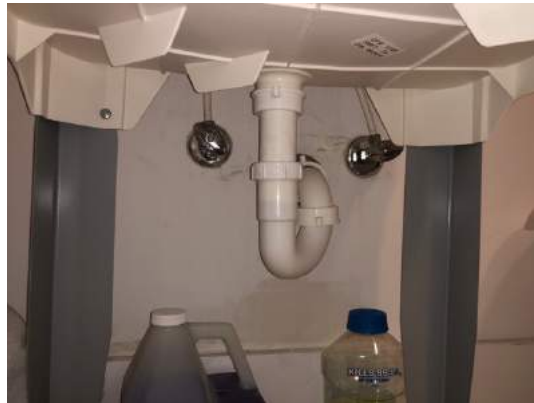
Laundry Room Photos.

- Washer & dryer functioning properly at the time of inspection.
- No indications of water damage or leaking at the time of inspection.

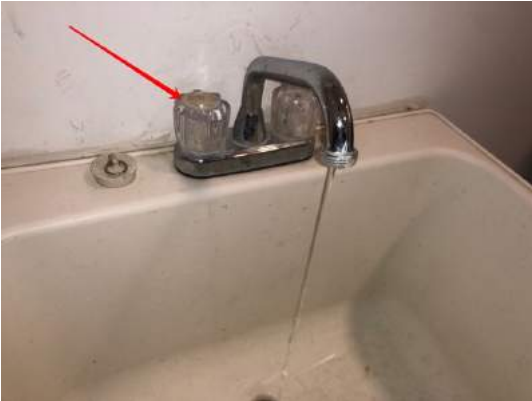
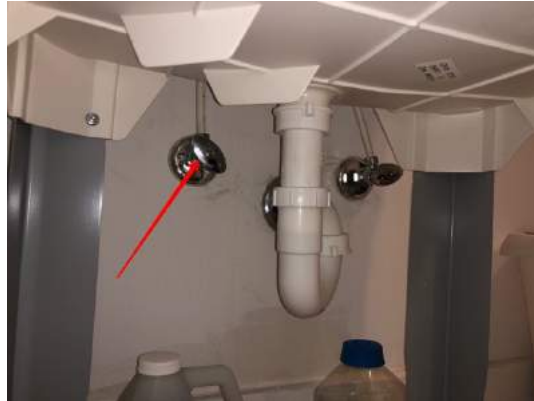
Comment 70

Utility sink faucet fixture hot water valve handle is currently broken , and does not properly close/shut-off hot water.

- Hot water supply turn-stop valve below sink shut-off following inspection to prevent water from continuously flowing.

Recommend replacing utility sink faucet fixture. (Estimate: \$100 - \$250)

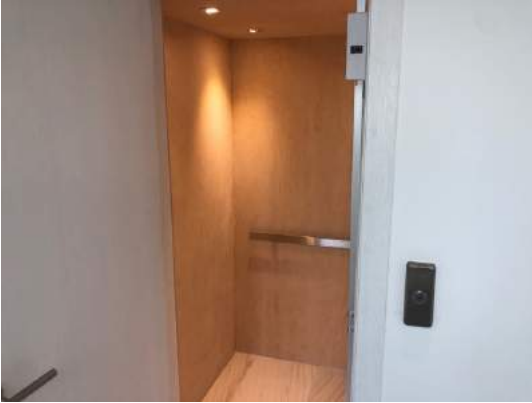
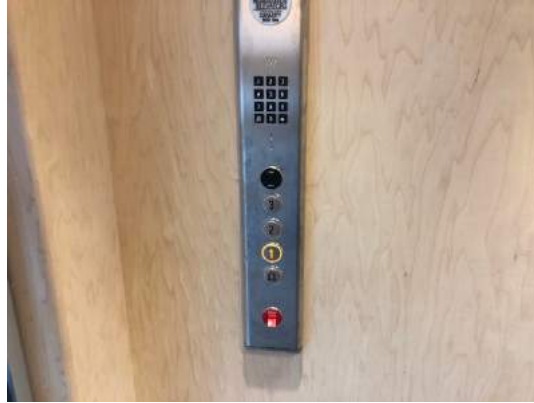
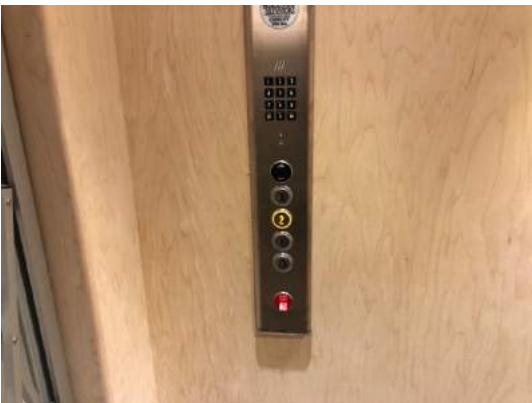
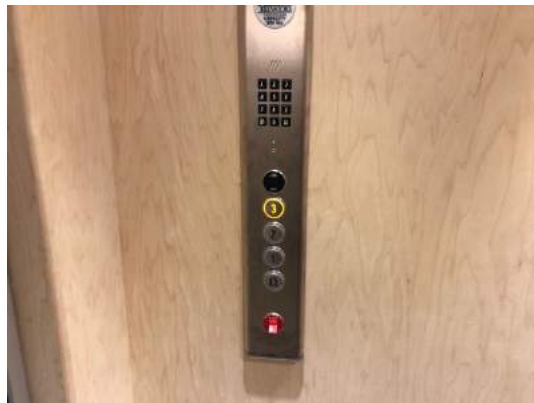
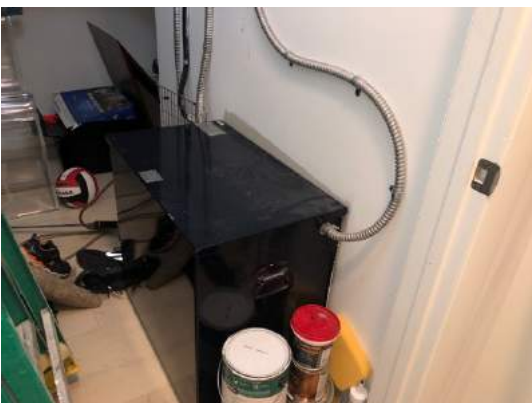
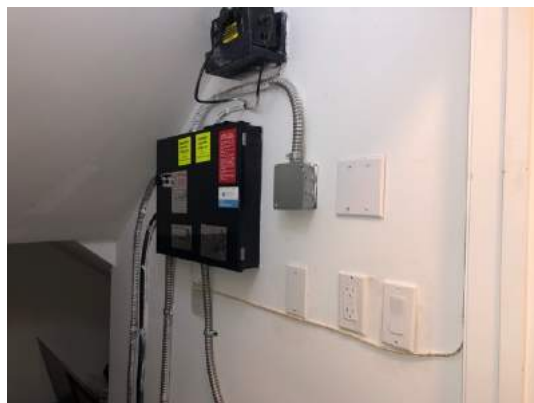
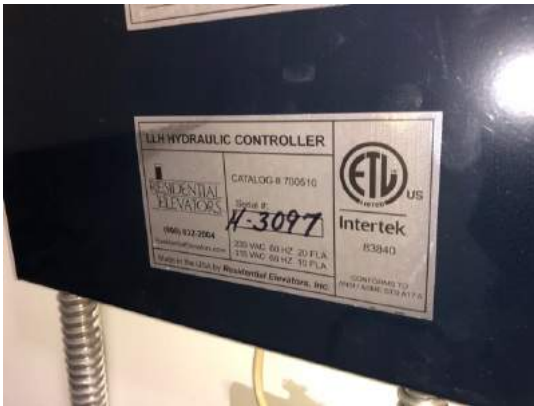
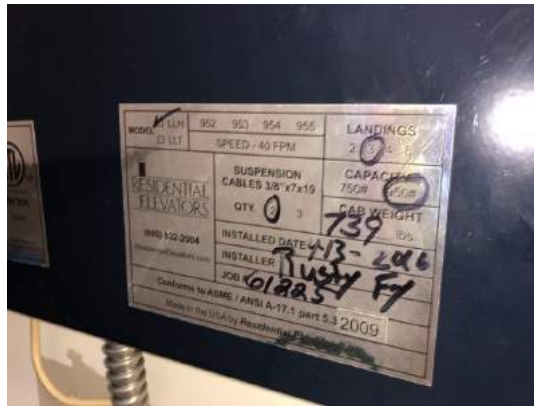
Comment 71
Information

Elevator functioning properly at the time of inspection.

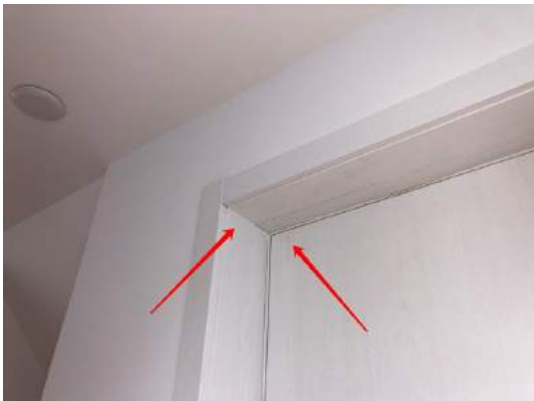
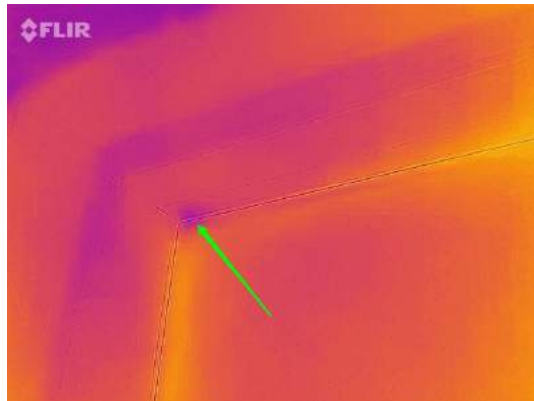
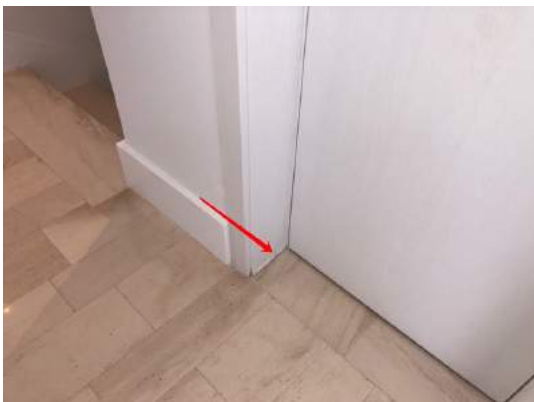
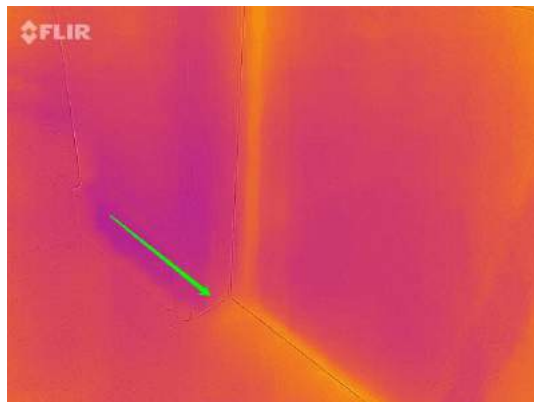
Comment 72

Apparent water damage to 3rd level elevator door trim.

- Active moisture intrusion detected from rooftop over elevator doorway within elevator shaft.

Recommend repairing/re-sealing rooftop above elevator doorway to prevent further moisture intrusion & water damage. (Estimate: \$500 - \$1,000)

Repair/replace water damaged trim around 3rd level elevator doorway. (Estimate: \$200 - \$500)

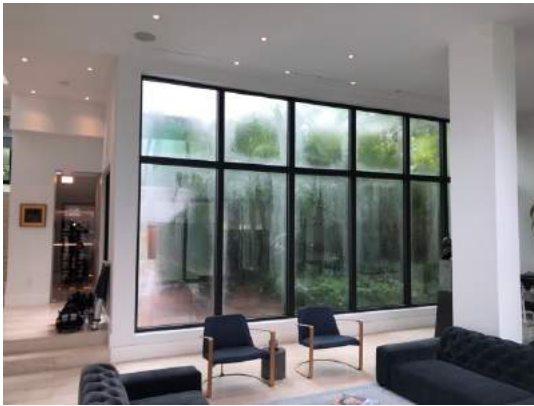
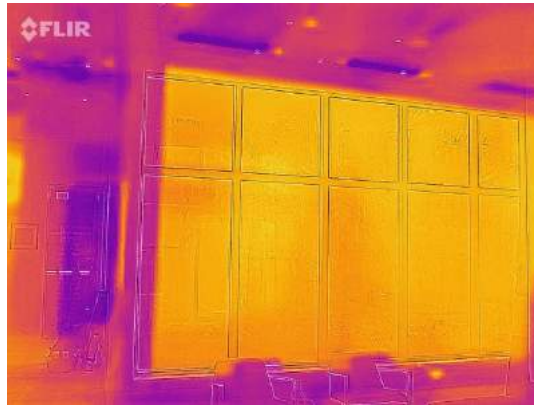
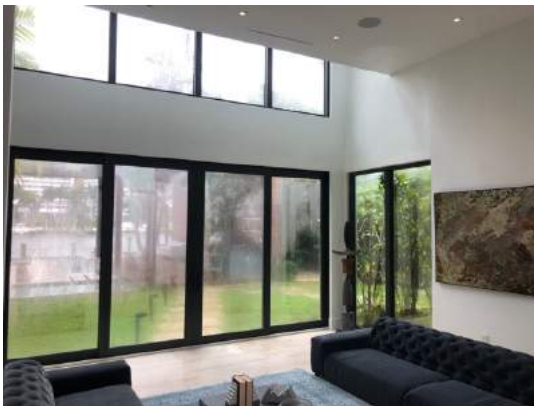
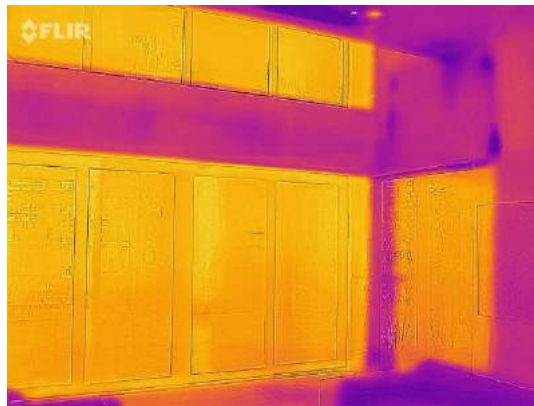
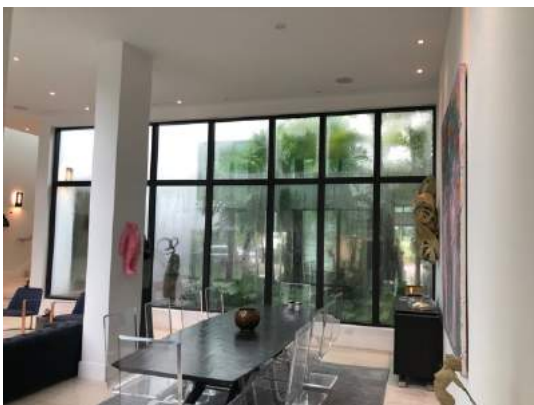
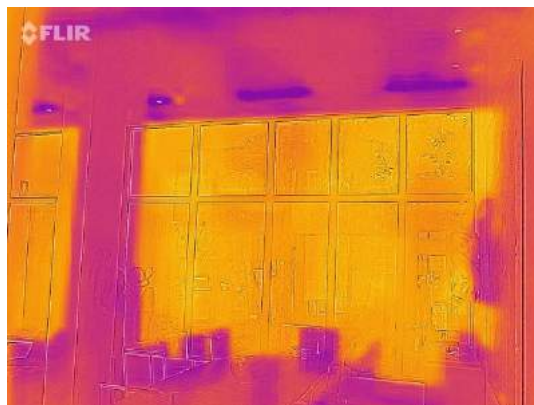
Comment 73
Information

Living Room / Dining Area.

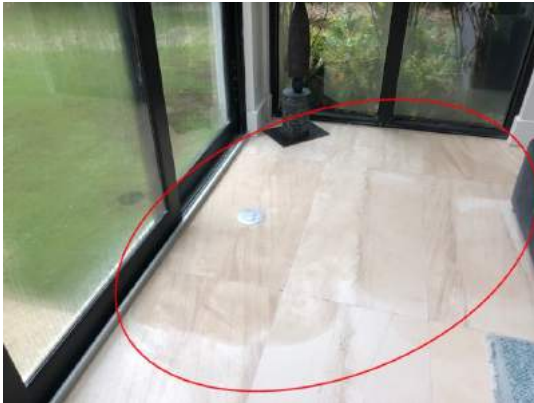
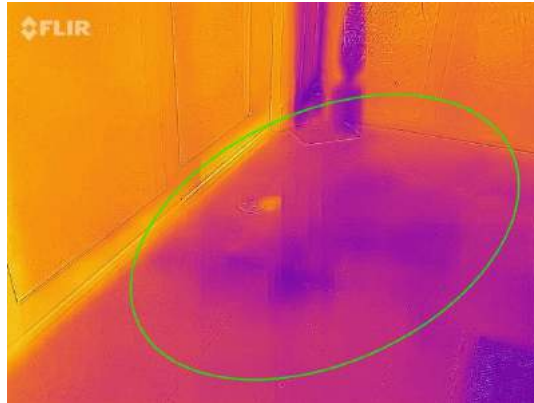
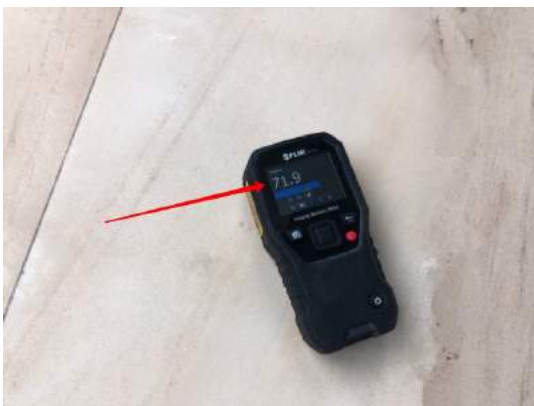
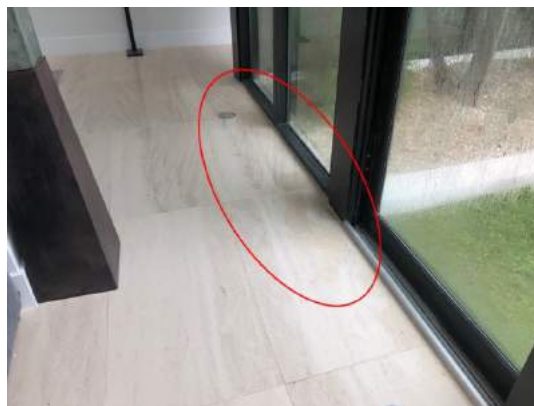
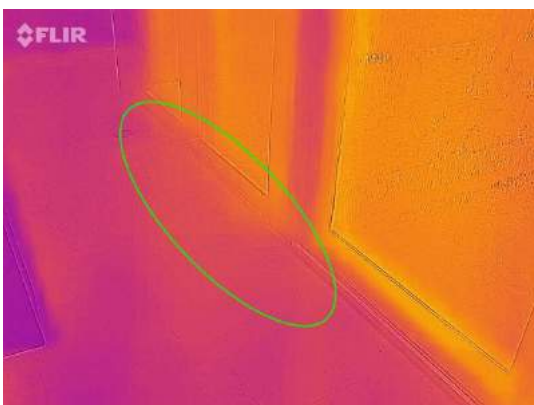
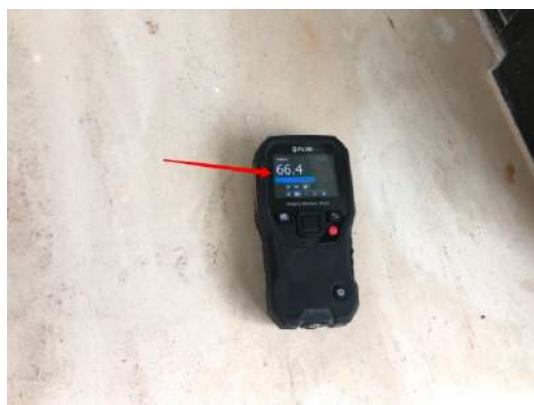
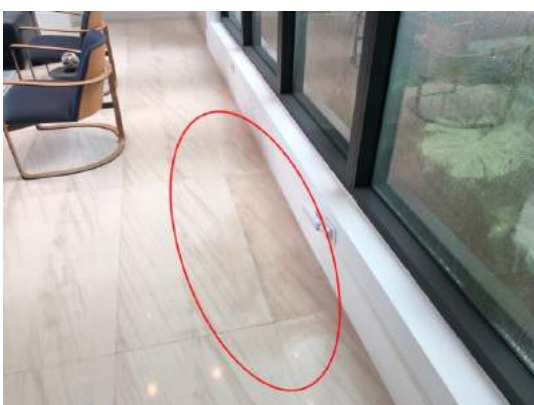
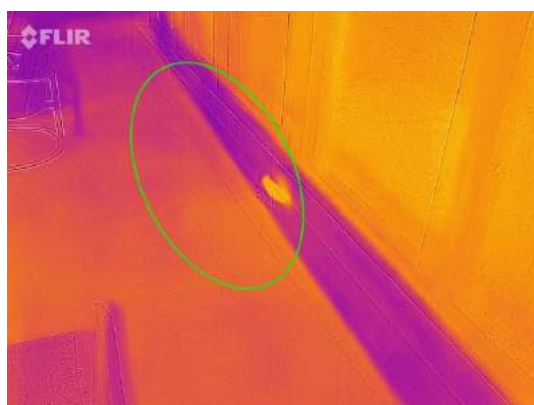
Comment 74
Deficiency

Apparent discoloration along tile flooring within living room/dining room area around sliding glass doors & windows.

- Indications of current moisture intrusion/saturation at the time of inspection.
- Estimate water damage & discoloration to tile flooring due to active moisture intrusion from around base of sliding glass door & window framing.

Recommend further evaluation of exterior windows doors by a licensed professional, and properly re-seal around door/window framing to prevent further moisture intrusion. (Estimate: \$500 - \$1,000)

Recommend re-finishing or replacing tile flooring where necessary. (Estimate: \$2,000 - \$5,000)

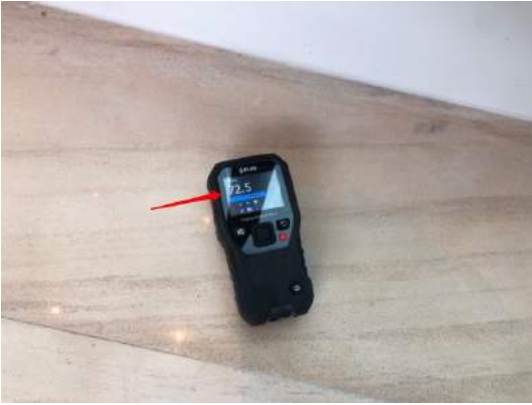
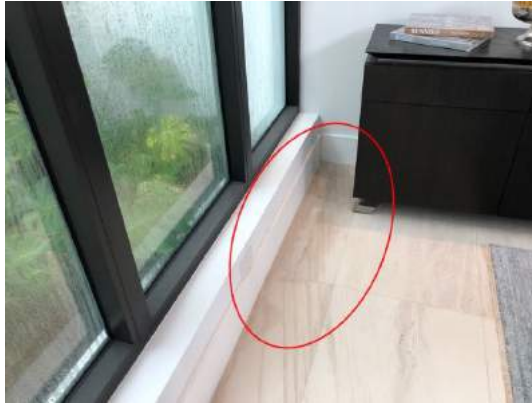
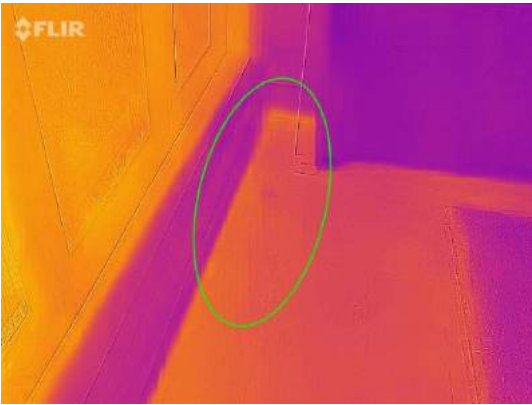
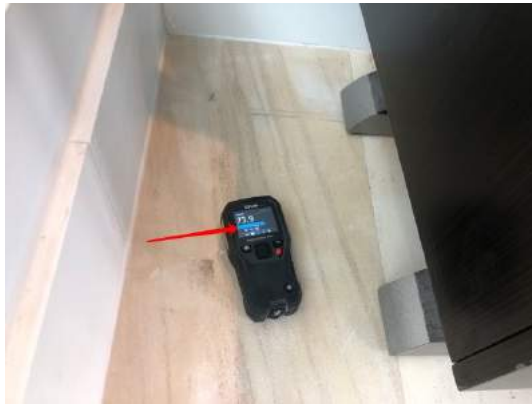
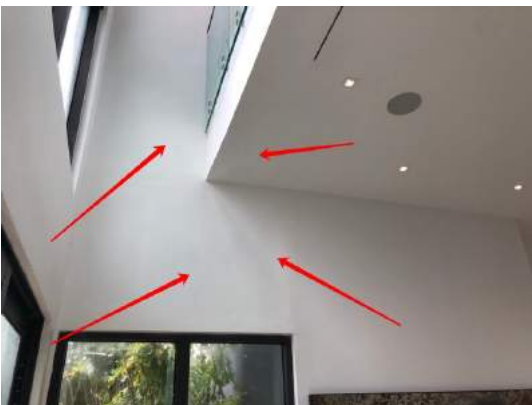
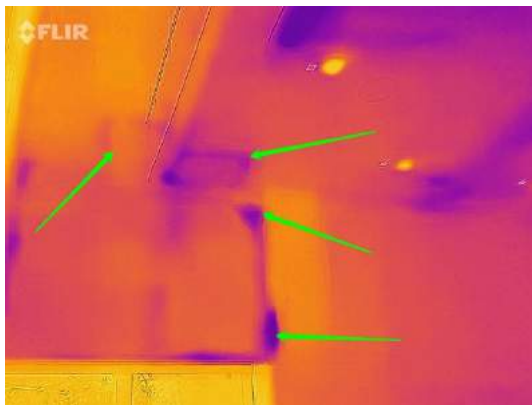
Comment 75
Deficiency

Apparent previous repairs to living room wall & ceiling.

- Active moisture intrusion still detected at the time of inspection.
- Estimate moisture intrusion coming from leaking sliding glass door framing directly above in 3rd level common area.

Recommend re-sealing sliding glass door framing above to prevent further moisture intrusion & water damage.

Recommend excavating water damaged drywall, properly replacing & re-finishing wall & ceiling drywall within living room. (Estimate: \$500 - \$1,000)

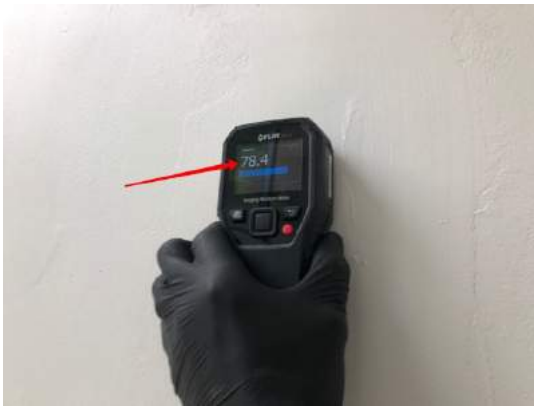
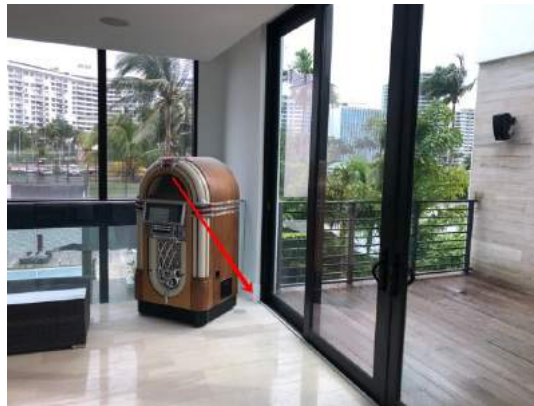
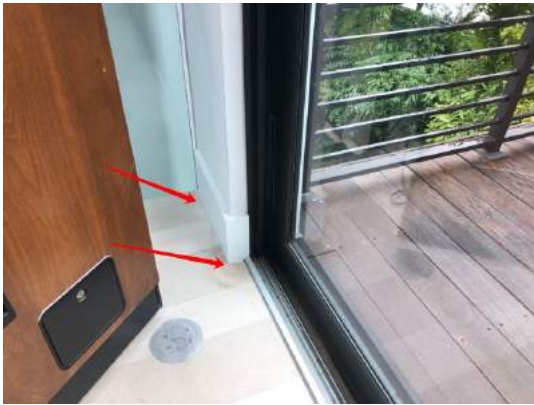
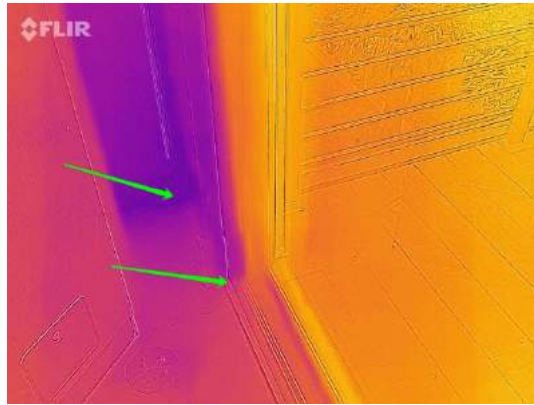
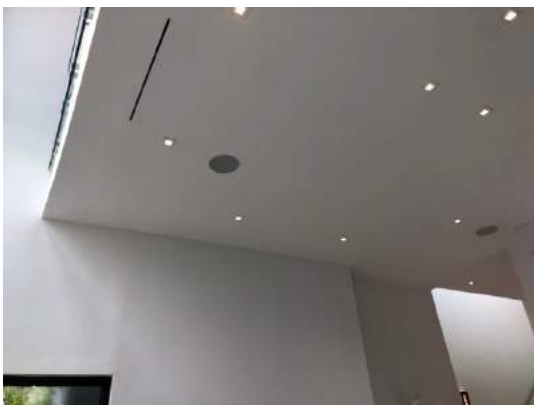
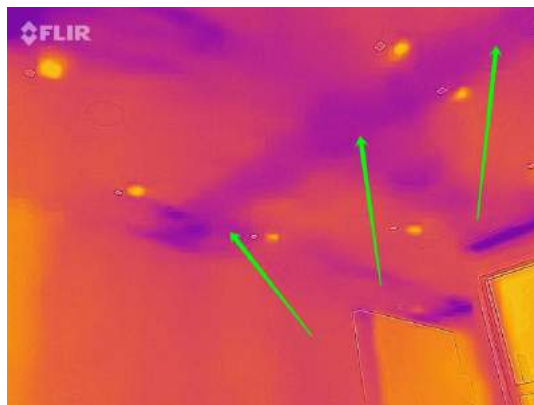
Comment 76
Information

Concern for moisture intrusion from thermal imaging.

- No active moisture intrusion detected. Estimate thermal imaging detecting temperature differential from Ducting running over ceiling.

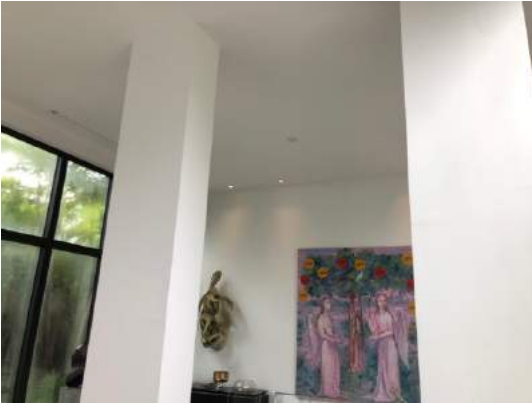
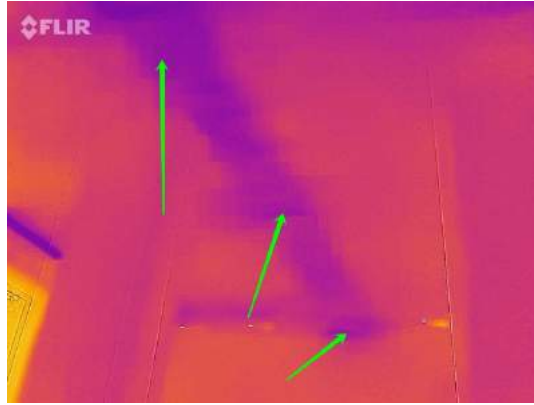
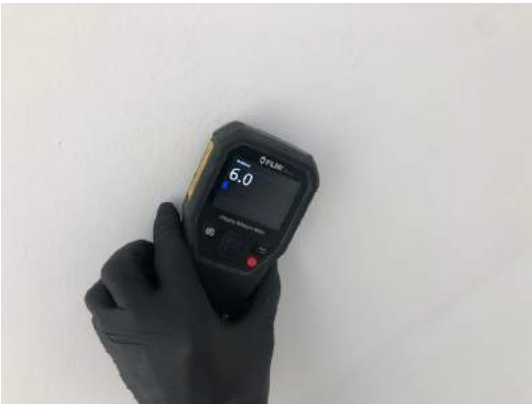
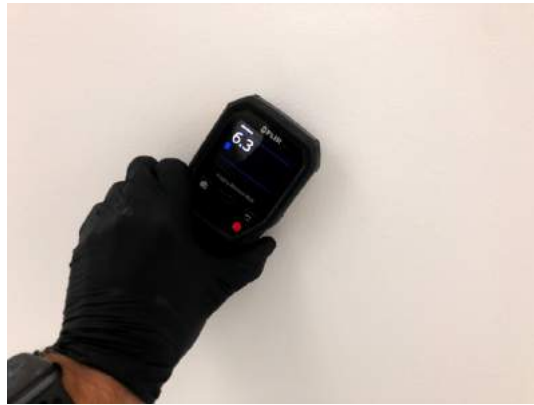
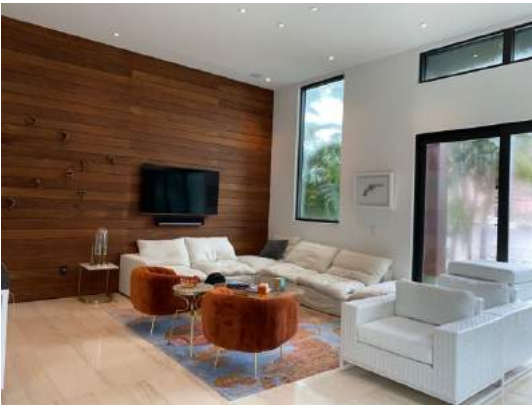
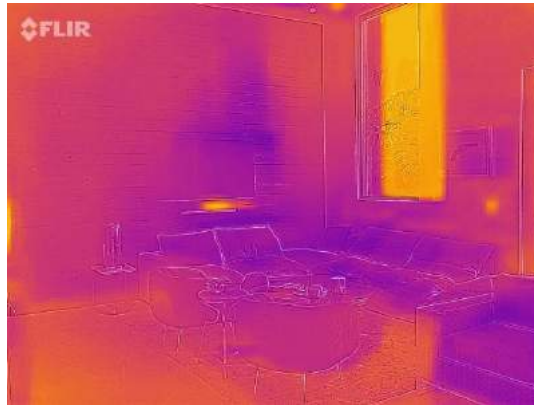
**Comment 77
Information**

Family Room.
