Home Inspection Report

5191 Pinetree Dr
Miami Beach, FL 33141

Inspected By: Tracy Woodard

Home Pro Miami
(786) 558-5286
www.homepromiami.com
info@homepromiami.com

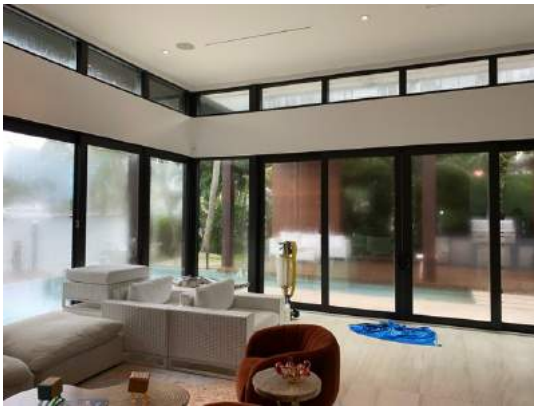
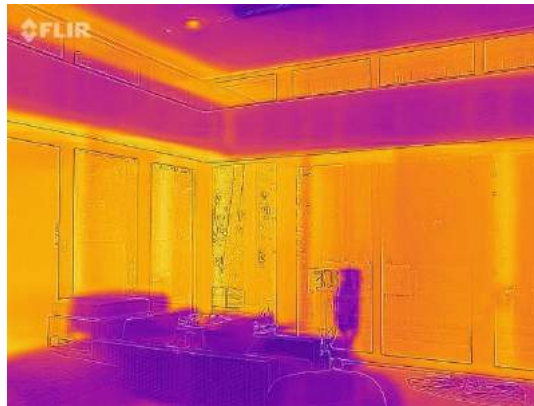
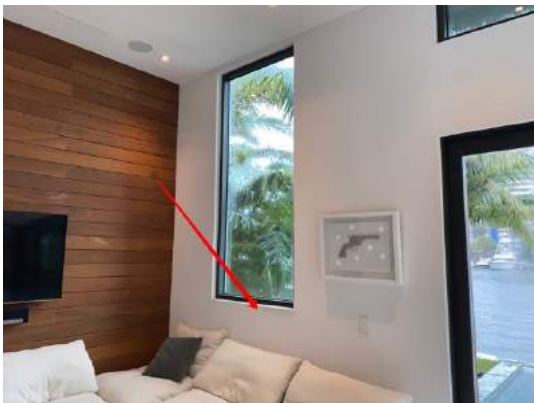
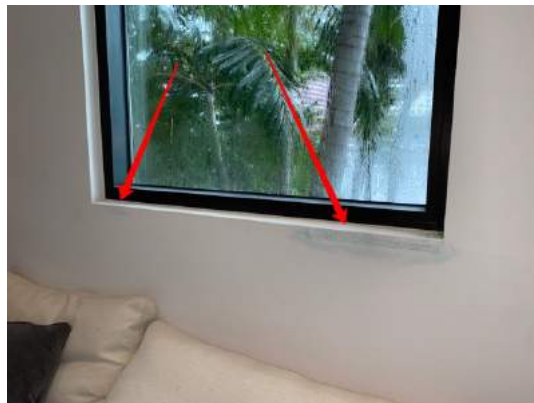
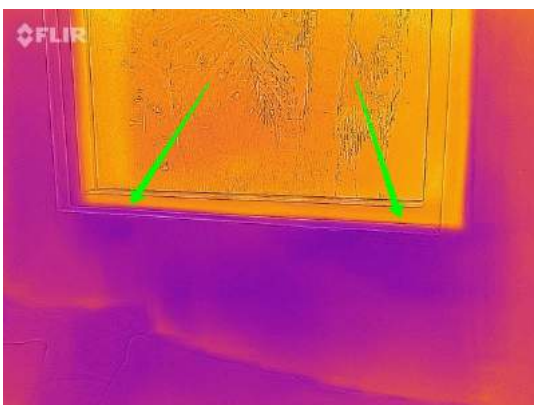
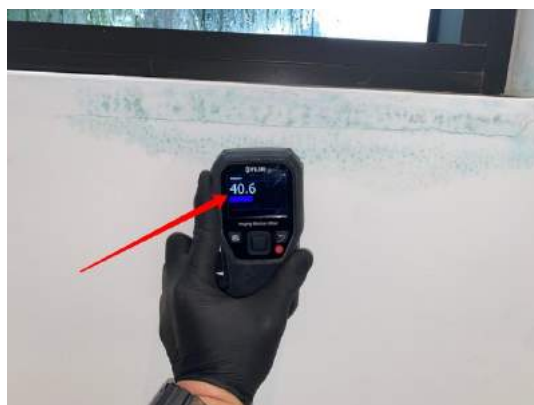
Comment 78

Apparent moisture intrusion from base of window framing within family room.

Recommend re-sealing around exterior window framing to prevent further moisture intrusion. (Estimate: \$200 - \$500)

Recommend repairing or replacing water damage drywall around base of window. (Estimate: \$150 - \$250)

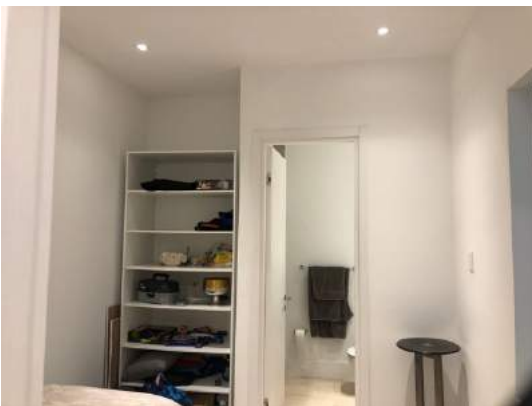
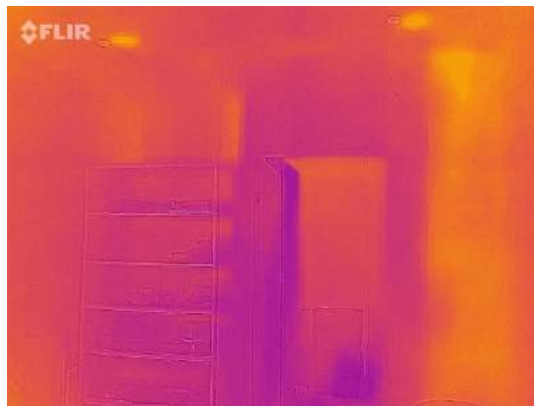
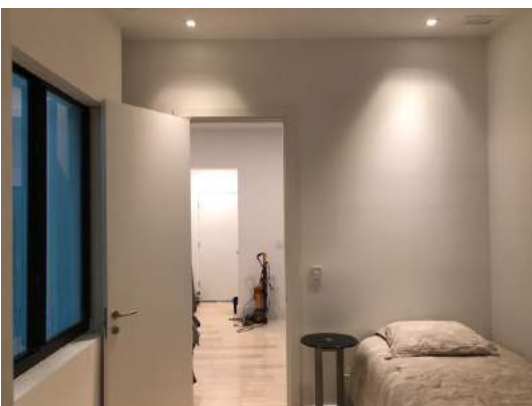
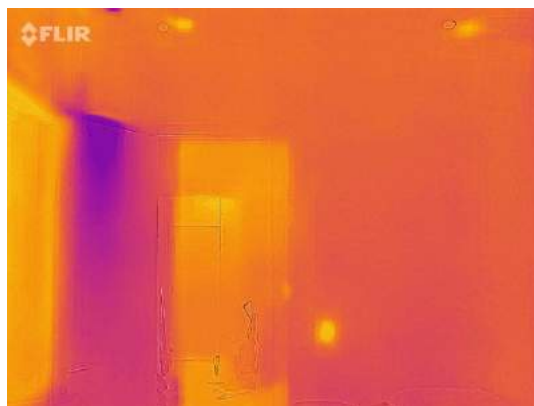
Comment 79
Information

Downstairs Bedroom / Maids Quarters.

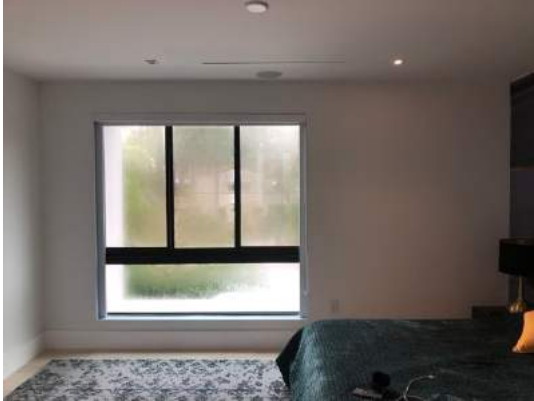
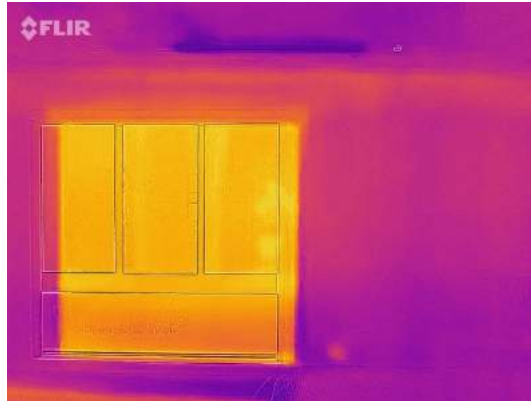
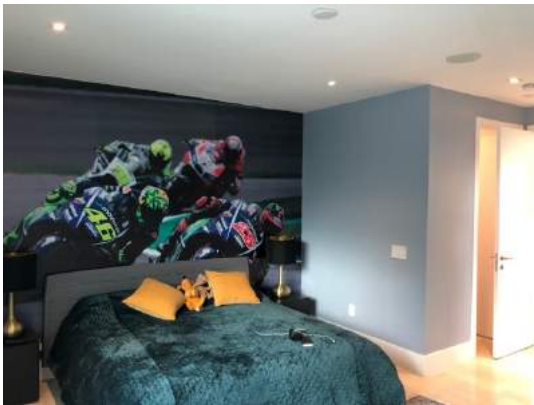
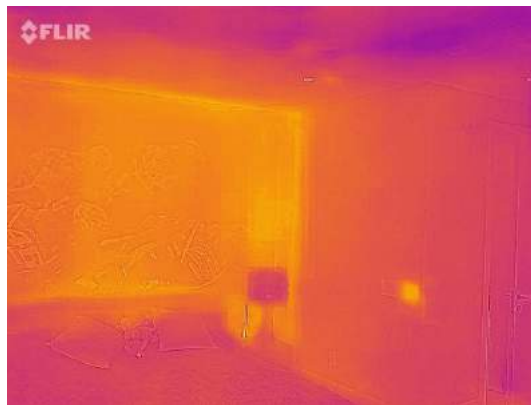
Comment 80
Information

2nd Level Bedroom #1.

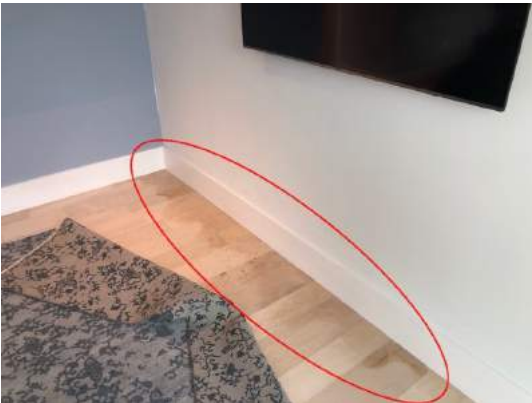
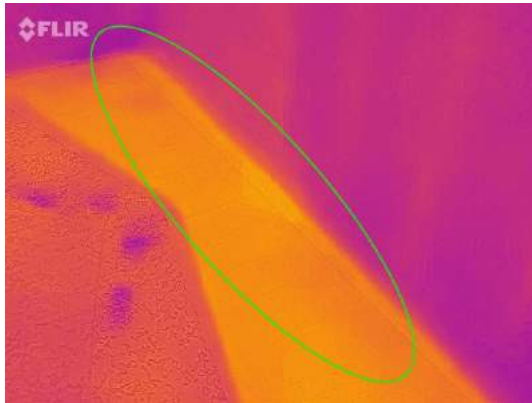
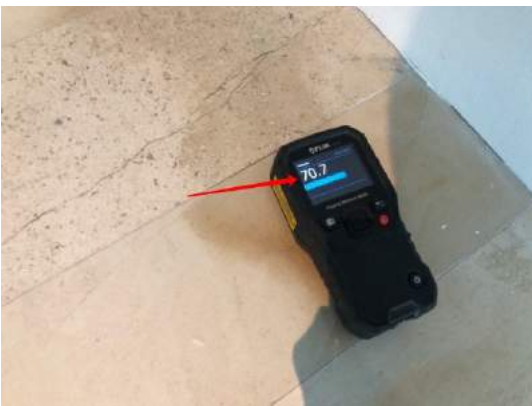
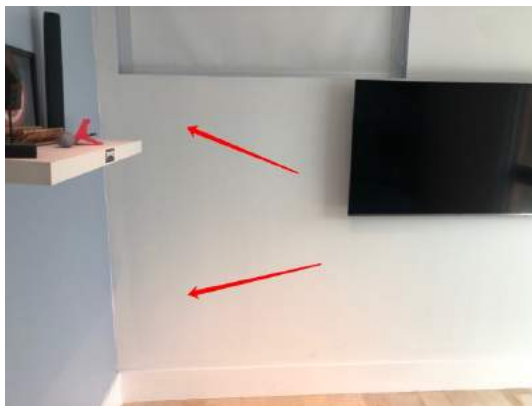
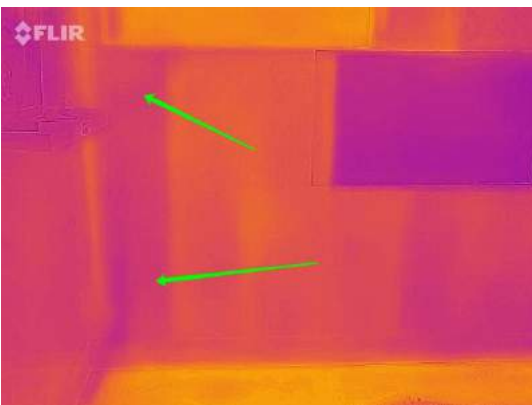
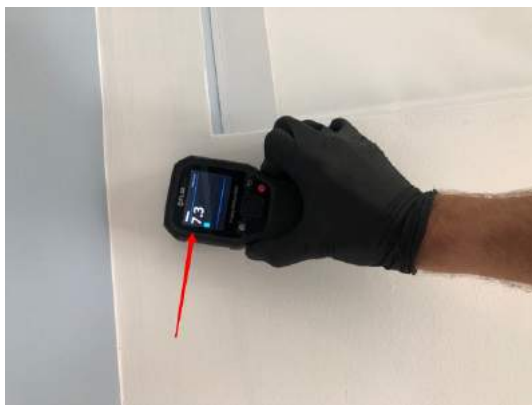
Comment 81
Deficiency

Apparent discoloration along tile flooring within 2nd level bedroom #1 below bedroom window.

- Indications of current moisture intrusion/saturation at the time of inspection.
- Estimate water damage & discoloration to tile flooring due to active moisture intrusion from around base of bedroom window framing and running down CBS wall behind drywall to flooring slab where water is affecting flooring.

Recommend further evaluation of exterior window by a licensed professional, and properly re-seal around window framing to prevent further moisture intrusion & water damage. (Estimate: \$500 - \$1,000)

Recommend re-finishing or replacing tile flooring where necessary. (Estimate: \$1,000 - \$2,500)

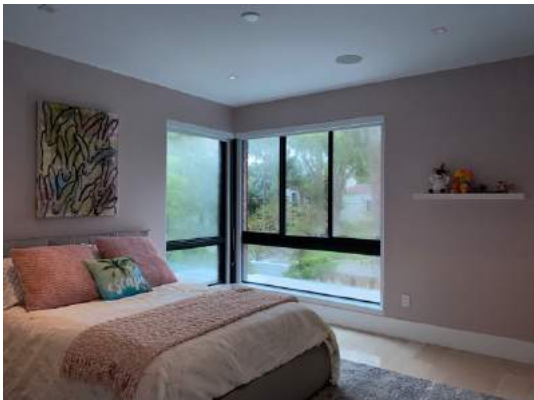
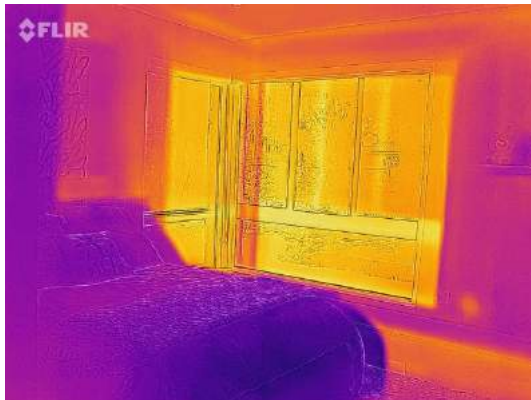
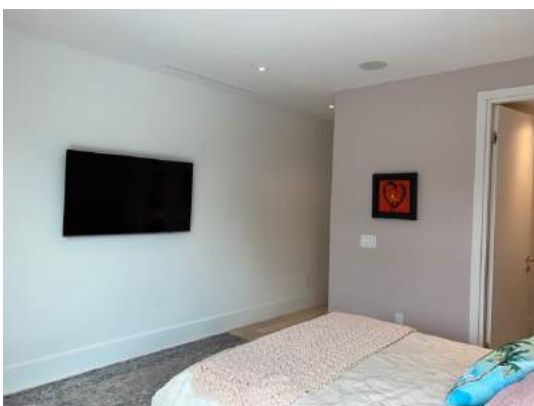
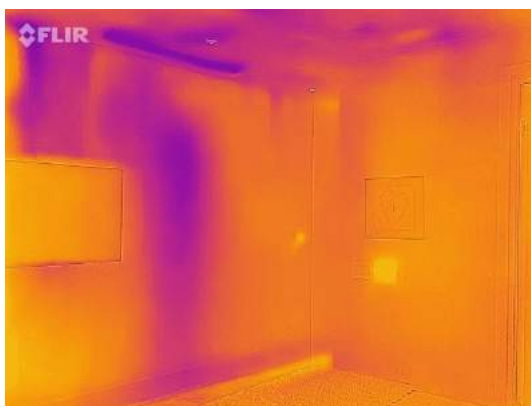
Comment 82
Information

2nd Level Bedroom #2.

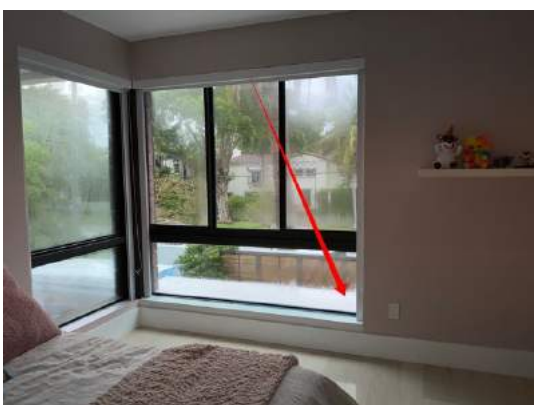
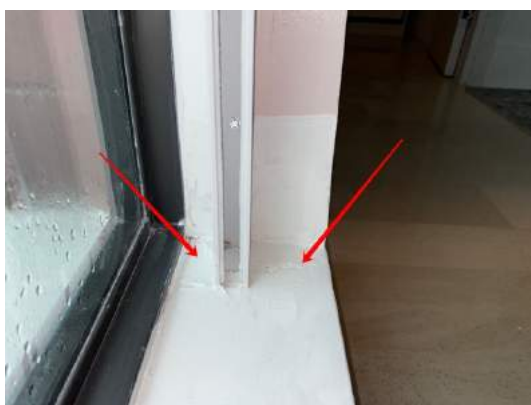
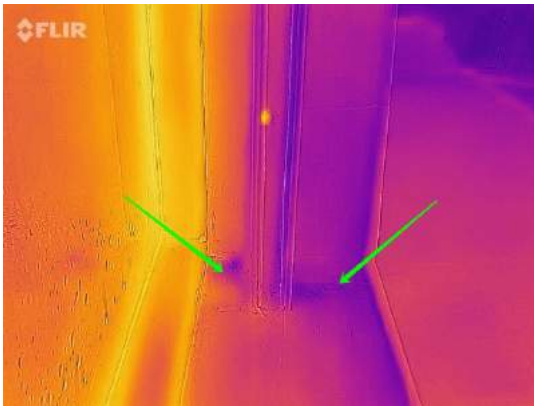
Comment 83
Deficiency

Apparent moisture intrusion from base of window framing within 2nd level bedroom #2.

Recommend re-sealing around exterior window framing to prevent further moisture intrusion. (Estimate: \$200 - \$500)

Recommend repairing or replacing water damage drywall around base of window. (Estimate: \$150 - \$250)

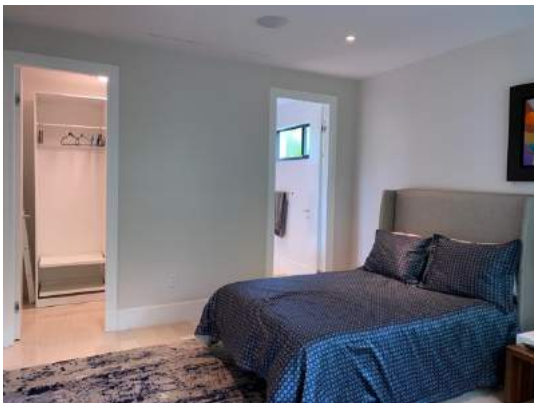
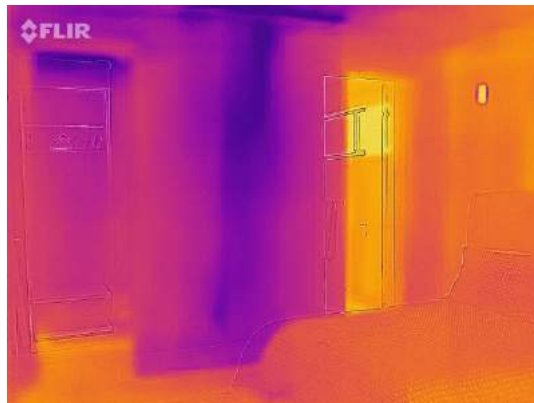
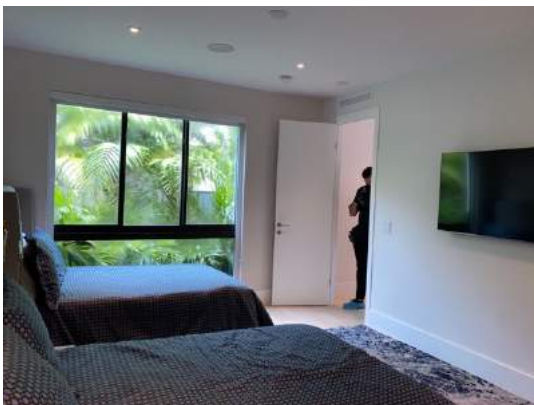
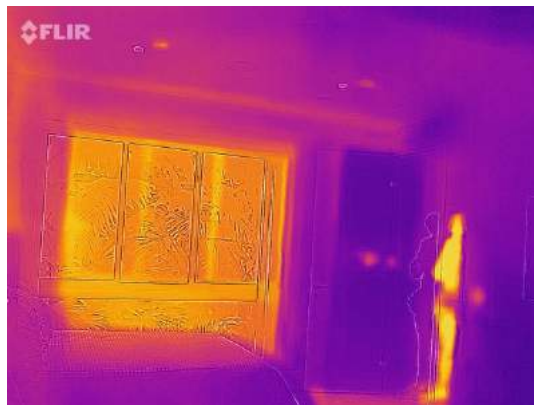
Comment 84
Information

2nd Level Bedroom #3.

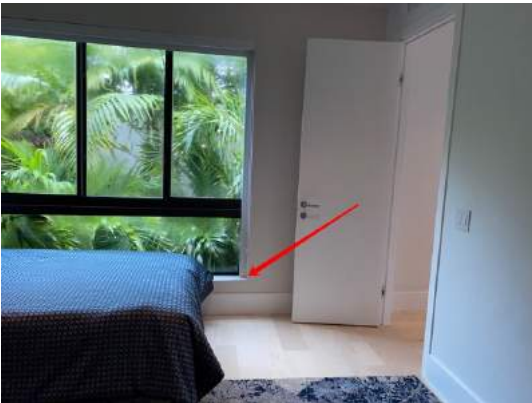
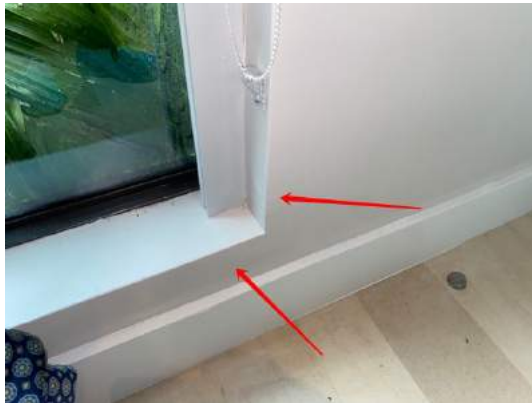
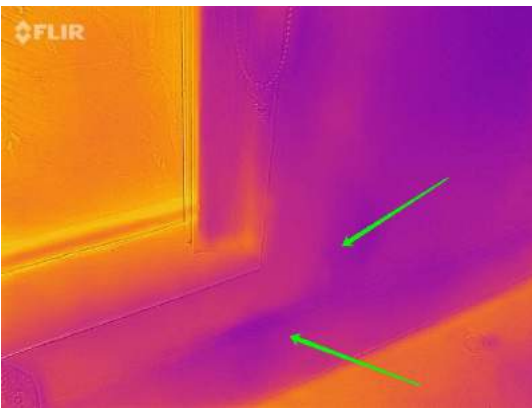
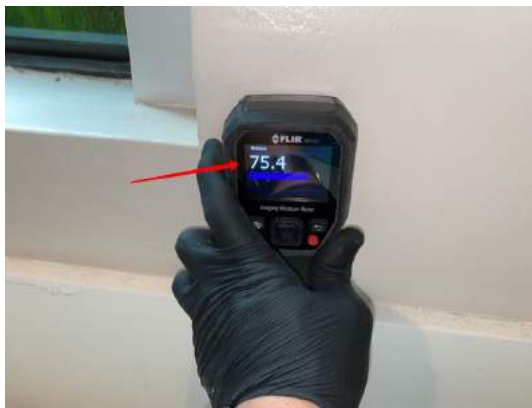
Comment 85
Deficiency

Apparent moisture intrusion from base of window framing within 2nd level bedroom #3.

Recommend re-sealing around exterior window framing to prevent further moisture intrusion. (Estimate: \$200 - \$500)

Recommend repairing or replacing water damage drywall around base of window. (Estimate: \$150 - \$250)

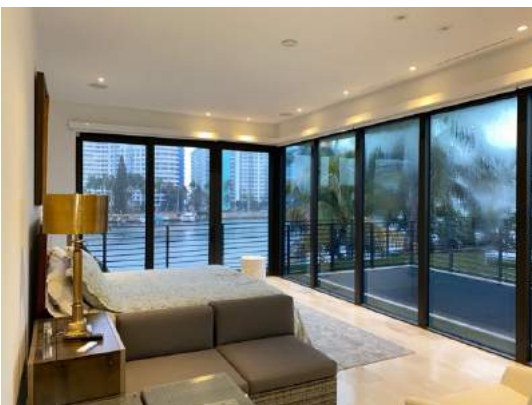
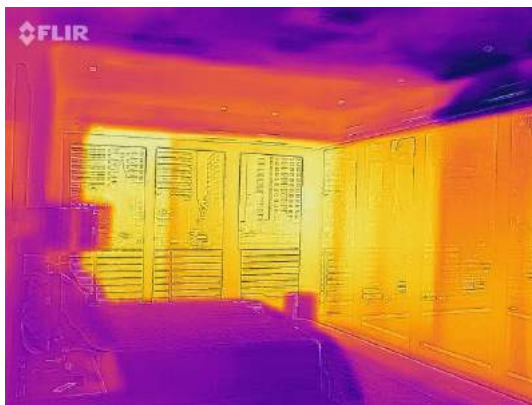
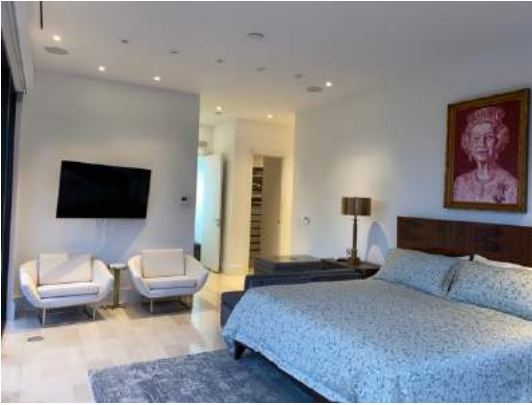
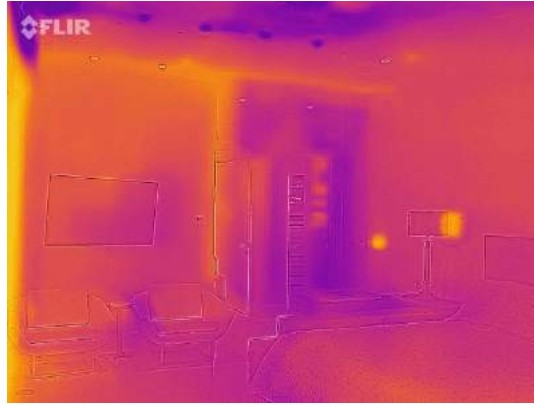
Comment 86
Information

3rd Floor Master Bedroom.

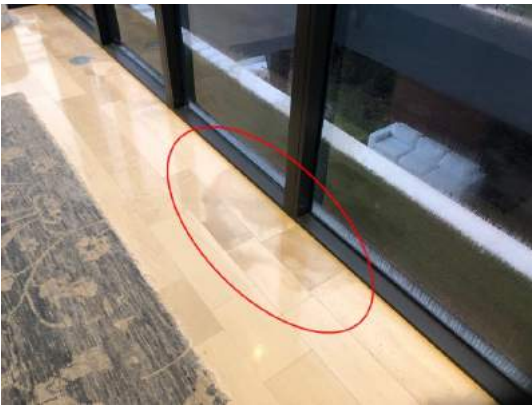
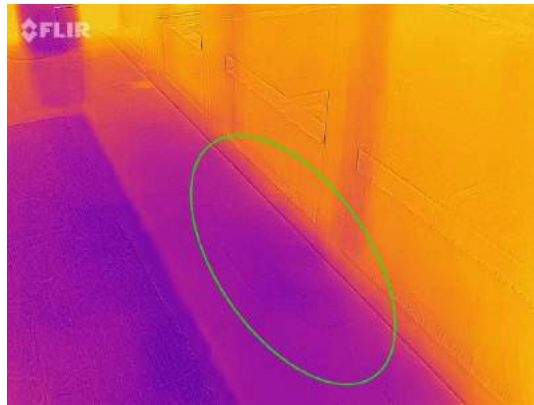
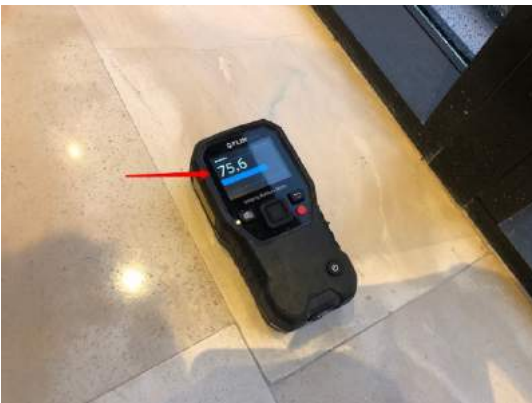
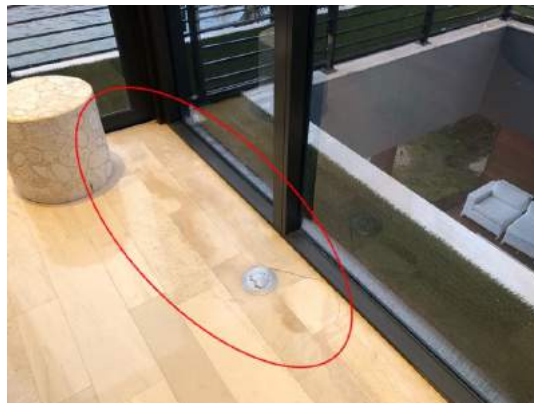
Comment 87

- Indications of current moisture intrusion/saturation at the time of inspection.
- Estimate water damage & discoloration to tile flooring due to active moisture intrusion from around base of window & door framing.

Recommend further evaluation of exterior windows & doors by a licensed professional, and properly re-seal around window & door framing to prevent further moisture intrusion & water damage. (Estimate: \$500 - \$1,000)

Recommend re-finishing or replacing tile flooring where necessary. (Estimate: \$1,000 - \$2,500)

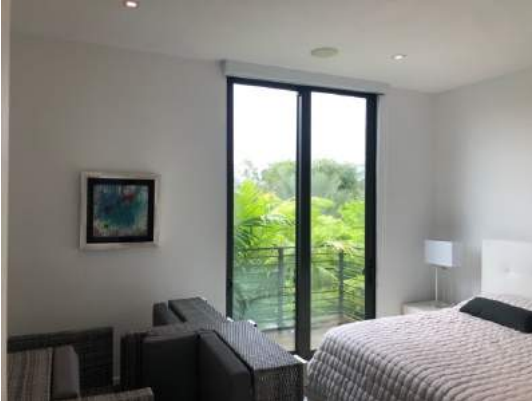
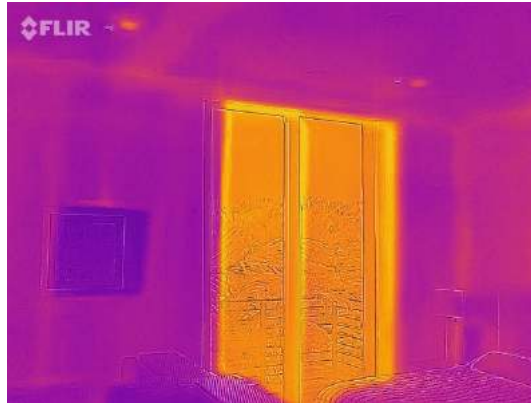
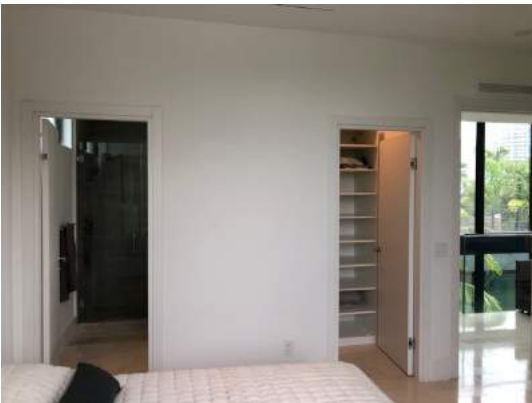
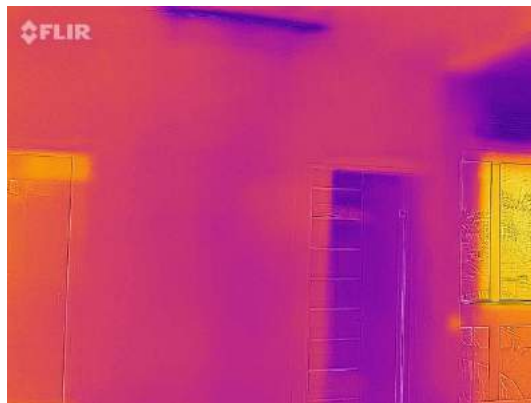
Comment 88
Information

3rd Level Bedroom #2.

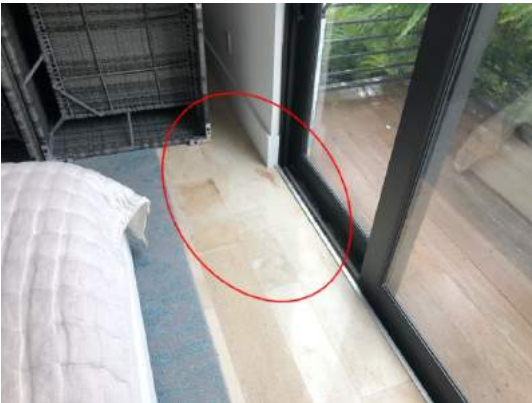
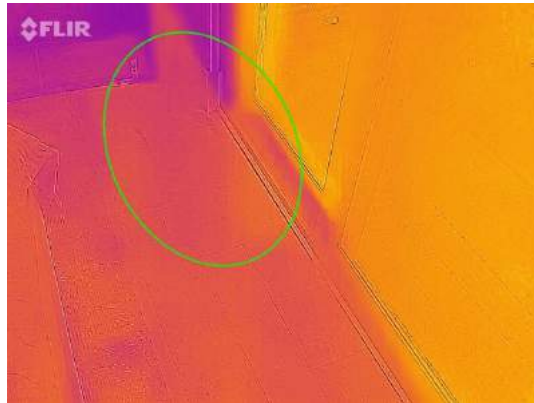
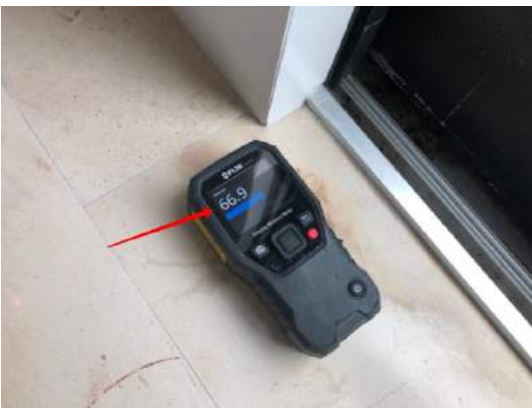
Comment 89
Deficiency

Apparent discoloration along tile flooring within 3rd level bedroom #2 below sliding-glass door.

- Indications of current moisture intrusion/saturation at the time of inspection.
- Estimate water damage & discoloration to tile flooring due to active moisture intrusion from around base of sliding-glass door framing.

Recommend further evaluation of exterior window by a licensed professional, and properly re-seal around sliding-glass door faming to prevent further moisture intrusion & water damage. (Estimate: \$500 - \$1,000)

Recommend re-finishing or replacing tile flooring where necessary. (Estimate: \$500 - \$1,500)

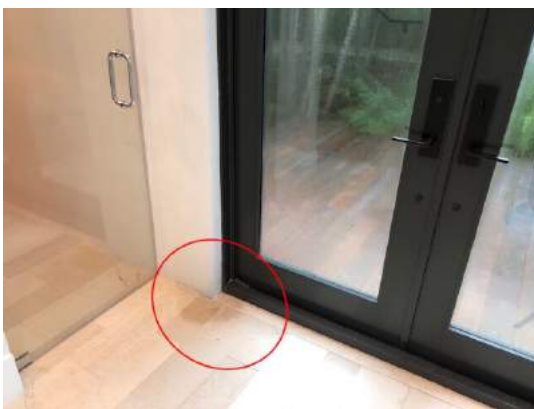
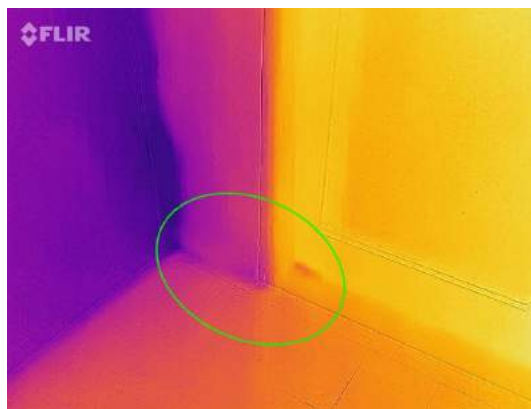
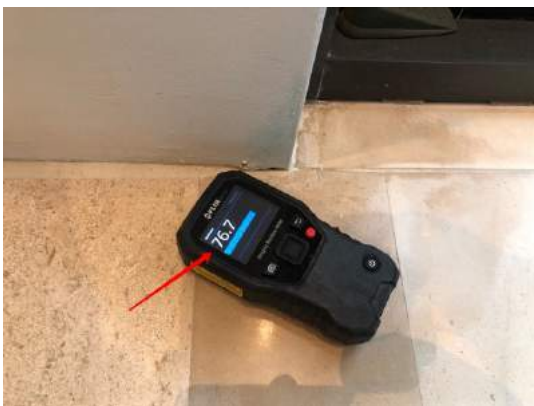
- Indications of current moisture intrusion/saturation at the time of inspection.

- Estimate water damage & discoloration to tile flooring due to active moisture intrusion from around base of door framing.

Recommend further evaluation of exterior door by a licensed professional, and properly re-seal around door framing to prevent further moisture intrusion & water damage. (Estimate: \$250 - \$500)

Recommend re-finishing or replacing tile flooring where necessary. (Estimate: \$500 - \$1,000)

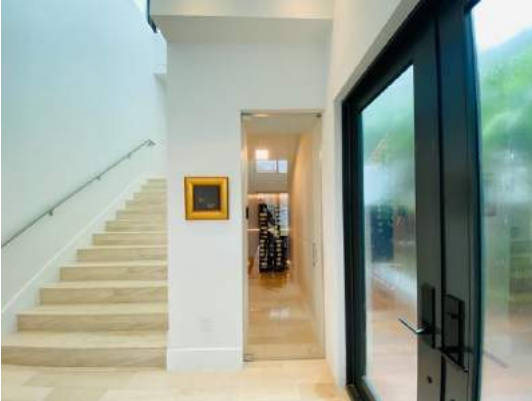
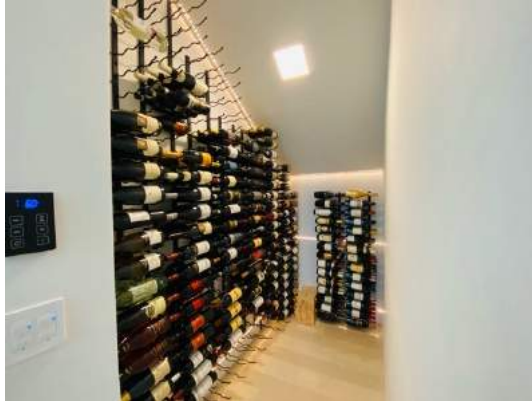
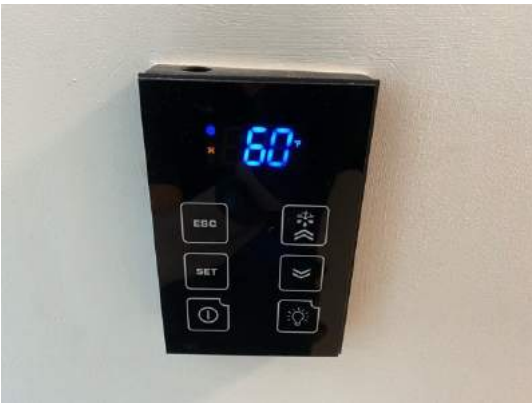
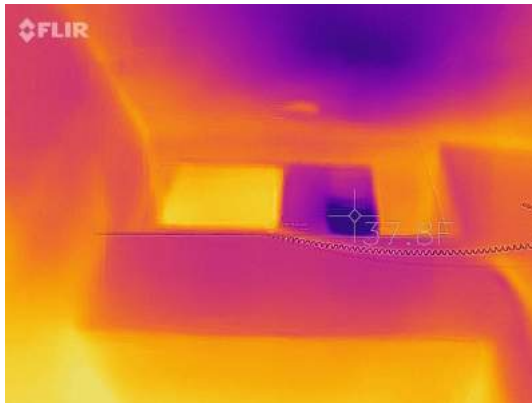
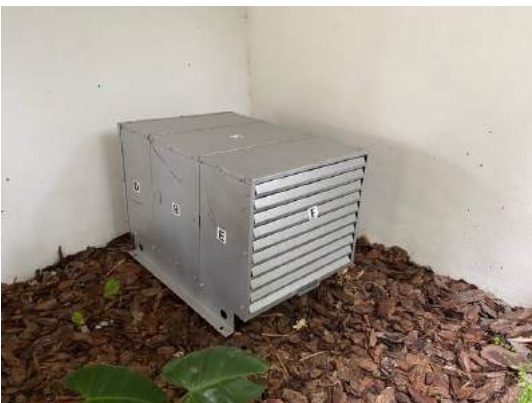
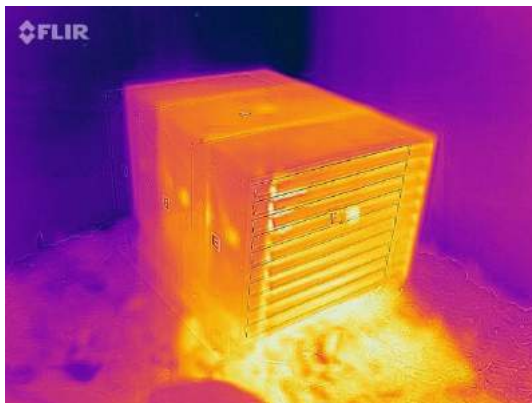
Comment 91
Information

Wine cooler within front entrance hallway functioning properly at the time of inspection.

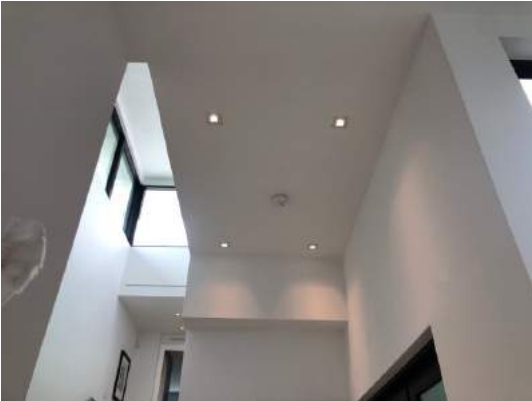
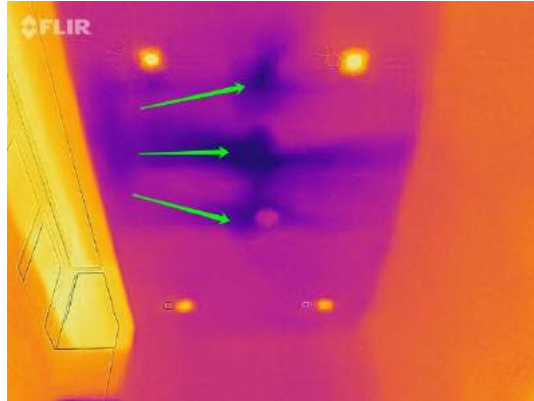
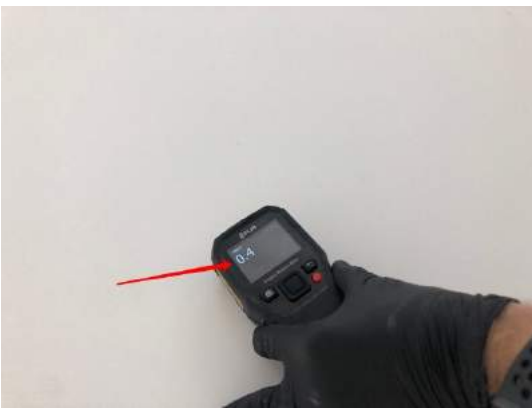
Comment 92
Information

Concern for moisture intrusion from thermal imaging along ceiling over front entrance foyer.

- No active moisture intrusion detected.

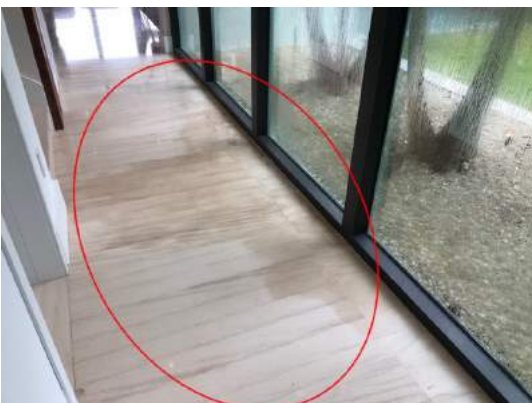
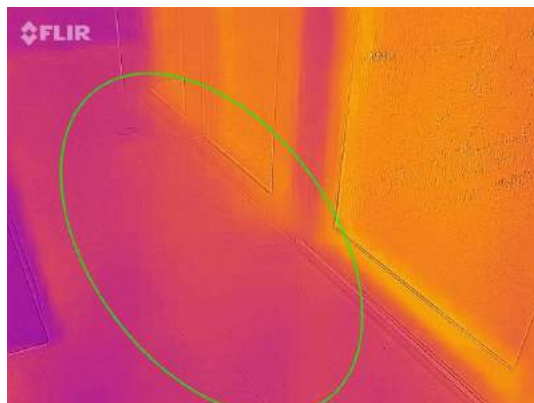
Comment 93
Deficiency

Apparent discoloration along tile flooring within downstairs kitchen hallway adjacent to hallway windows.

- Indications of current moisture intrusion/saturation at the time of inspection.
- Estimate water damage & discoloration to tile flooring due to active moisture intrusion from around base of window framing.

Recommend further evaluation of exterior windows & doors by a licensed professional, and properly re-seal around window & door framing to prevent further moisture intrusion & water damage. (Estimate: \$500 - \$1,000)

Recommend re-finishing or replacing tile flooring where necessary. (Estimate: \$1,000 - \$2,500)

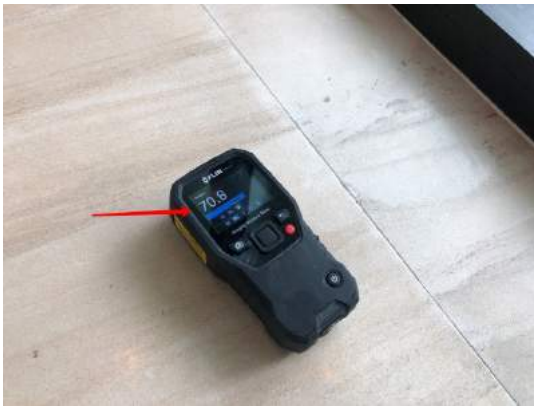
Comment 94

Loose handrail cap to glass staircase railing.

Properly secure cap to glass staircase railing. (Estimate: \$100 - \$200)

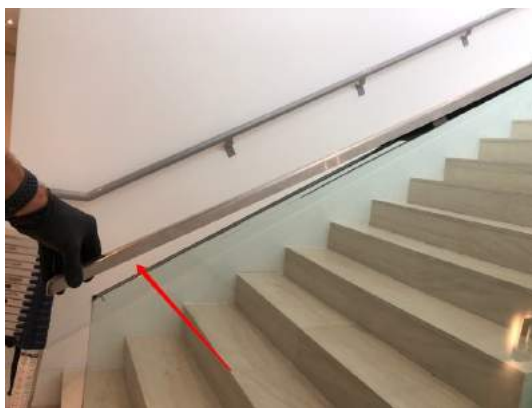
Comment 95

Apparent moisture intrusion from base of window framing over stairwell.

Recommend re-sealing around exterior window framing to prevent further moisture intrusion. (Estimate: \$200 - \$500)

Recommend repairing or replacing water damage drywall around base of window. (Estimate: \$150 - \$250)

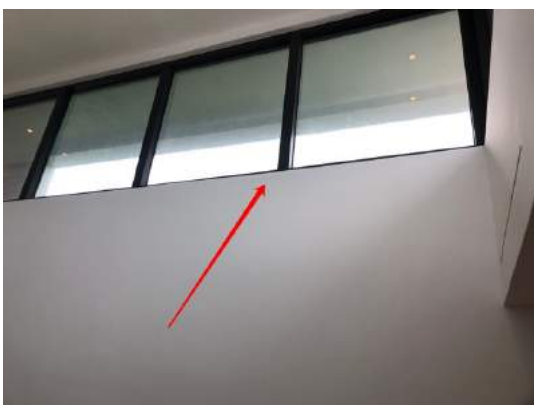
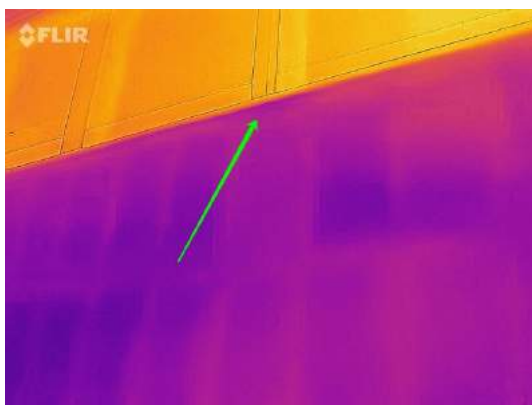
Comment 96

- Indications of current moisture intrusion/saturation at the time of inspection.
- Estimate water damage & discoloration to tile flooring due to active moisture intrusion from around base of window framing.

Recommend further evaluation of exterior windows & doors by a licensed professional, and properly re-seal around window & door faming to prevent further moisture intrusion & water damage. (Estimate: \$500 - \$1,000)

Recommend re-finishing or replacing tile flooring where necessary. (Estimate: \$1,000 - \$1,500)

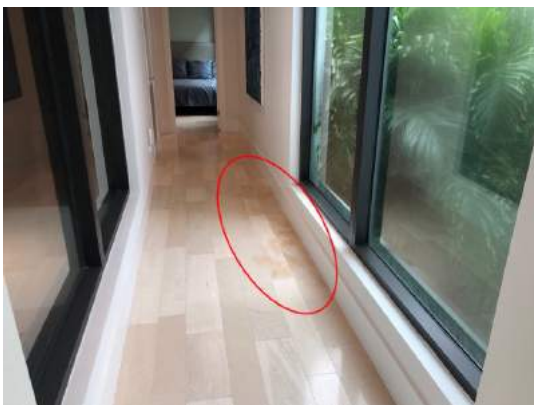
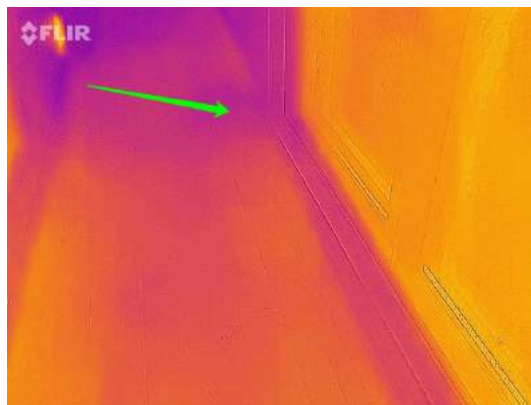
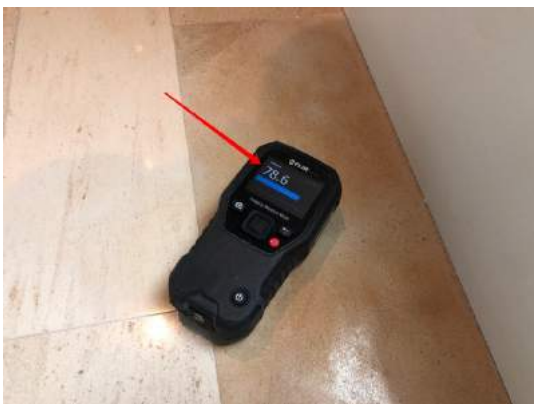
Comment 97
Information

Third Level Common Area.

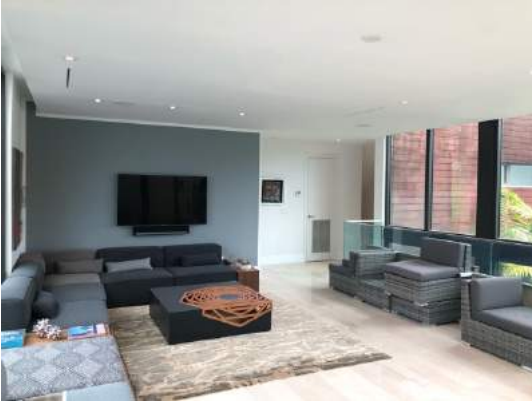
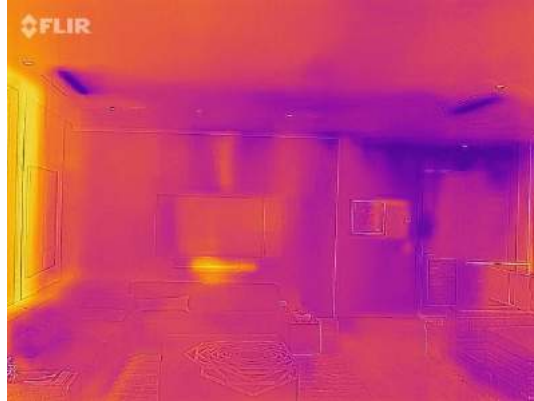
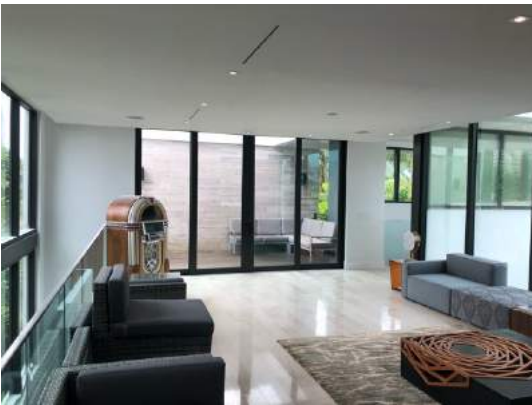
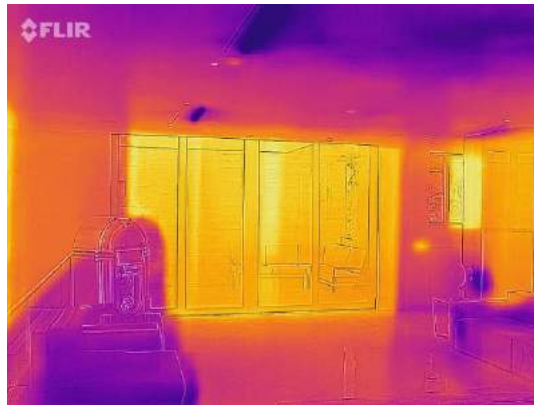
Comment 98
Deficiency

Repairs over 3rd leve common area.

- No active moisture intrusion detected at the time of inspection.

Refinish ceiling drywall. (Estimate: \$100 - \$250)

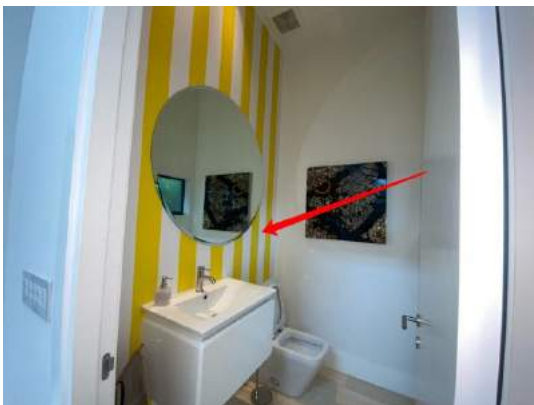
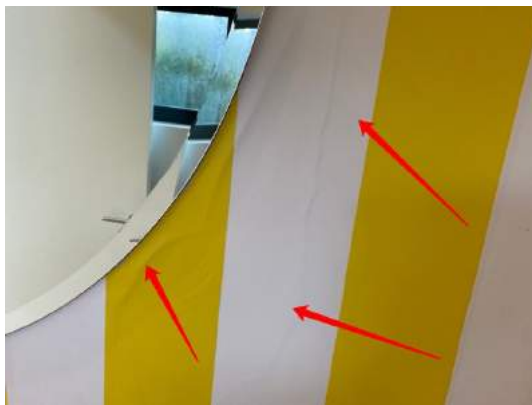
Comment 106

Apparent deformation of drywall behind wall paper within bathroom.

- No indications of moisture intrusion or active water damage at the time of inspection.

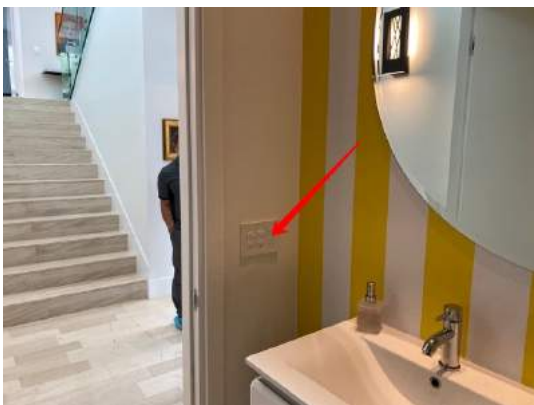
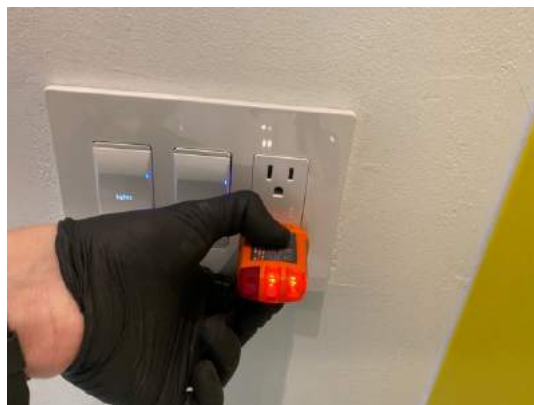
Comment 107
Deficiency

Bathroom outlet functioning properly at the time of inspection, but does not appear to be a proper GFCI outlet or on a GFCI circuit.

Recommend installing GFCI outlet or circuit within bathroom. (Estimate: \$50 - \$100)

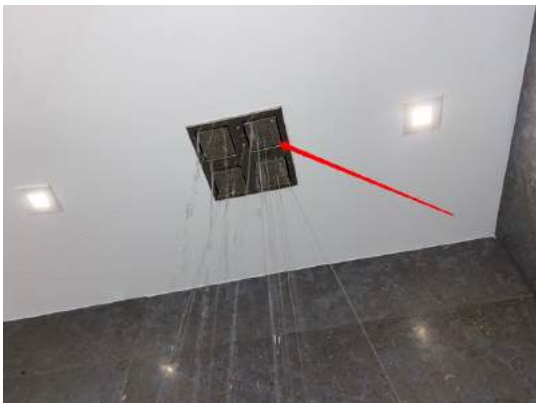
Comment 109

Rain-shower shower head not functioning properly & spraying water everywhere.

Recommend repairing or replacing rain-shower shower head. (Estimate: \$50 - \$250)

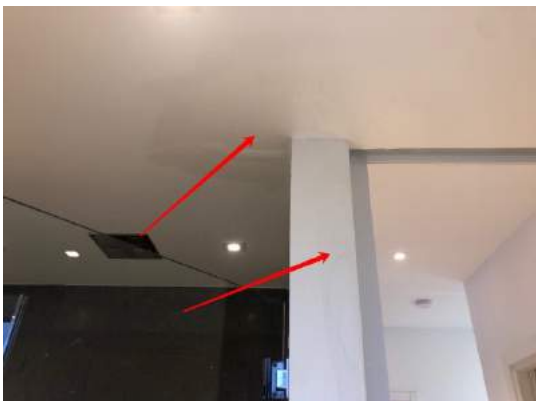
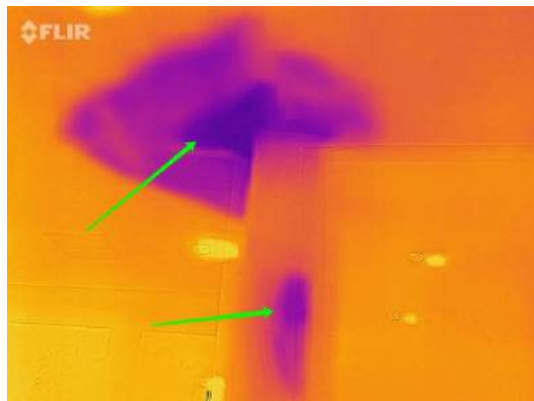
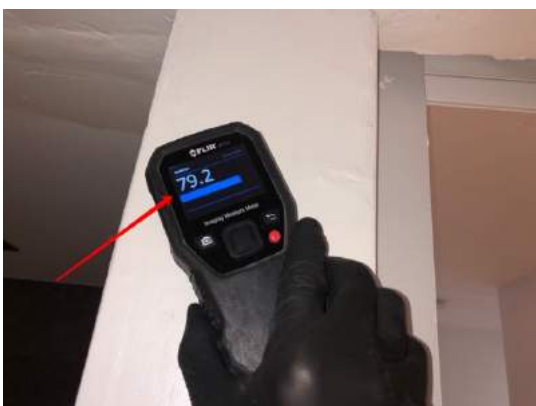
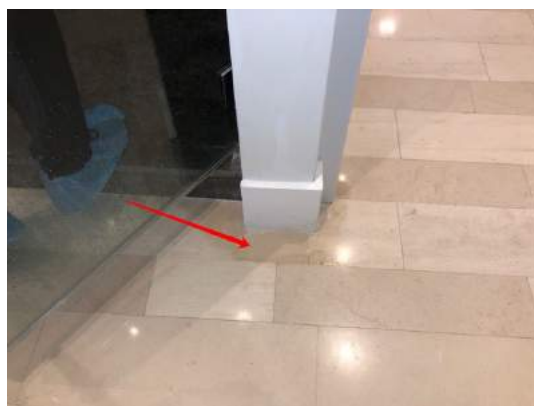
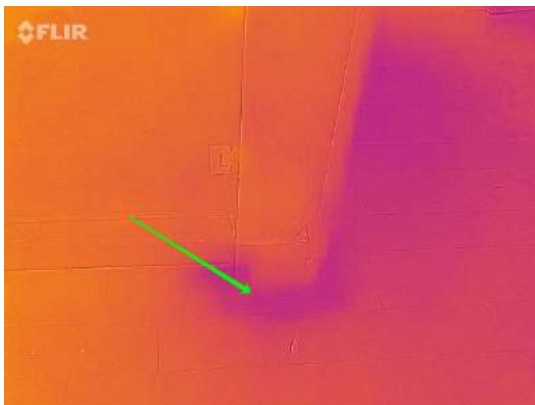
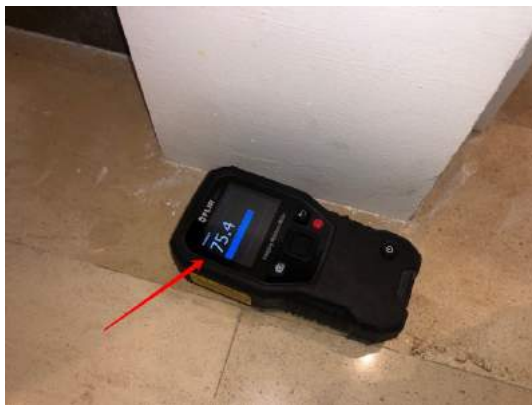
Comment 110
Deficiency

Indications of active leaking & water damage from roof over 3rd level master bathroom.

Recommend further evaluation of source of moisture intrusion from a licensed professional and repair accordingly to prevent further moisture intrusion & water damage. (Detailed quotation required)

Recommend repairing or replacing water damage drywall over hallway. (Estimate: \$500 - \$1,000)

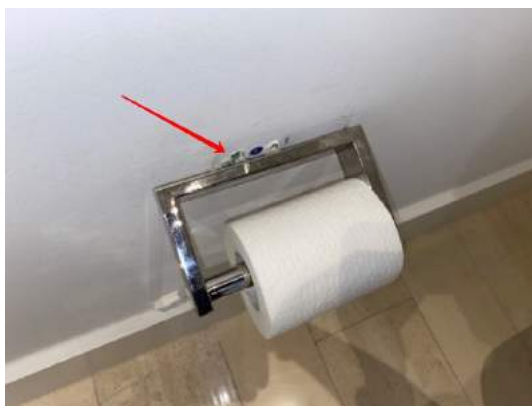
Comment 111

Toilet paper mount currently loose from wall.

Repair/re-secure toilet paper mount on wall. (Estimate: \$25 - \$50)

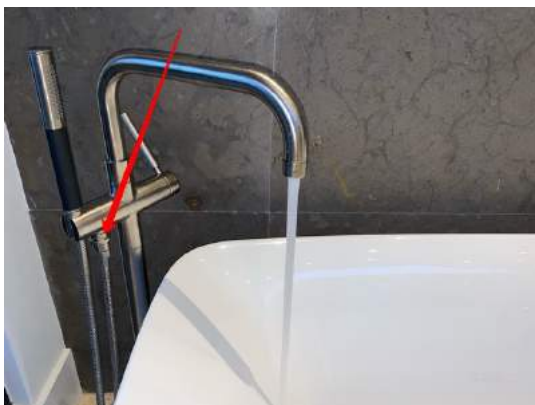
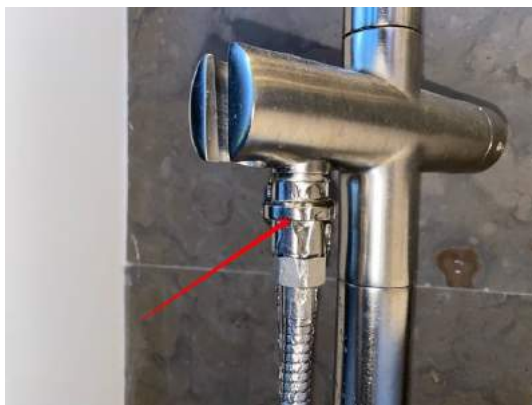
Comment 112

Hand-held faucet release valve leaking for free-standing tub fixture.

Repair or replace tub faucet fixture. (Estimate: \$100 - \$250)

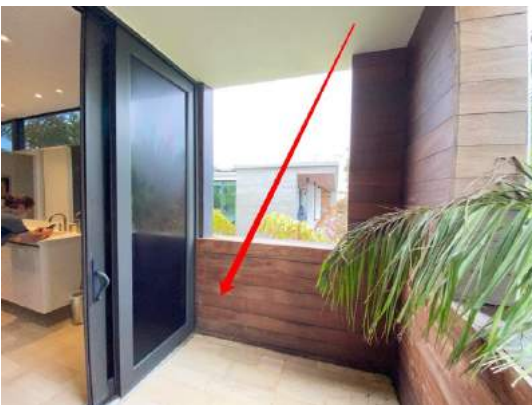
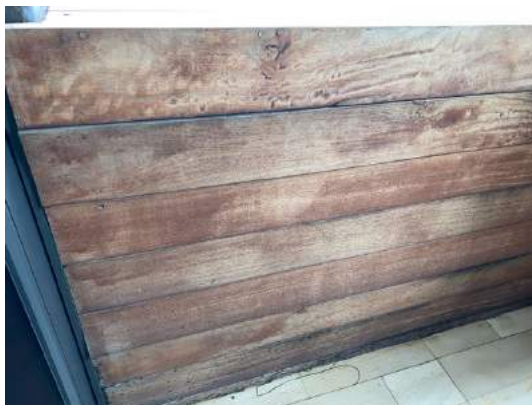
Comment 114
Deficiency

Apparent water damaged & buckling to wood paneling around exterior stand-up shower fixture.
Replace damaged wood paneling around shower fixture. (Estimate: \$200 - \$500)

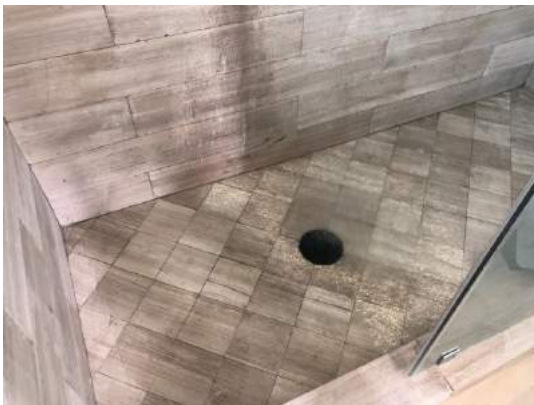
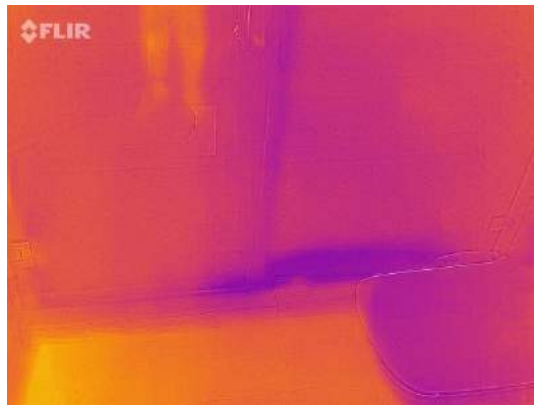
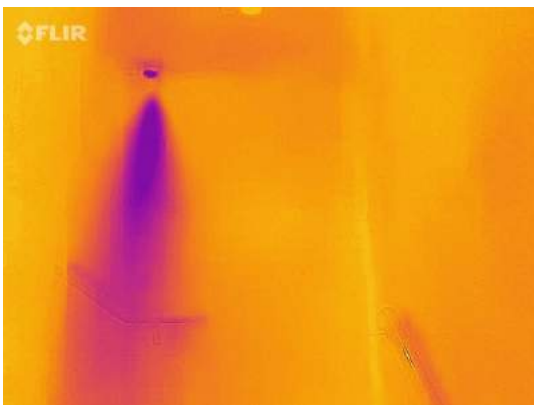
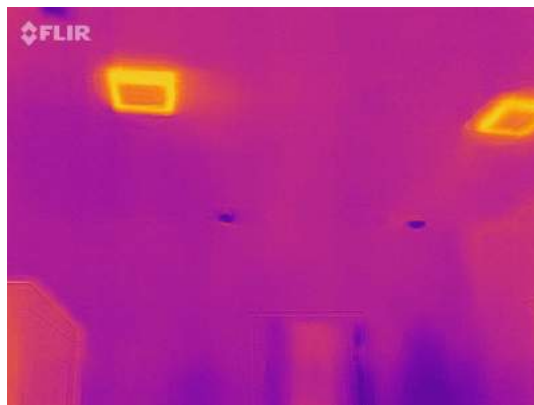
Shower pan tested.

- No indications of leaking from shower pan at the time of inspection.

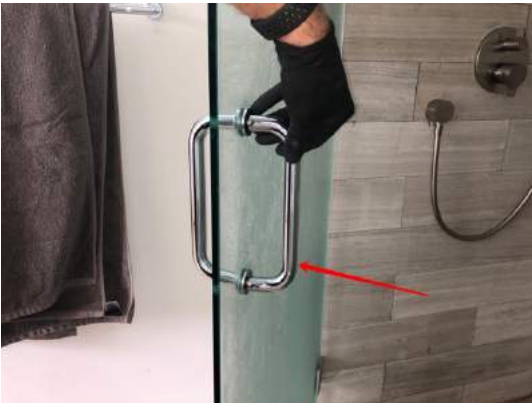
Comment 118
Deficiency

Frameless glass shower door handle is currently loose.

Re-secure shower door handle.

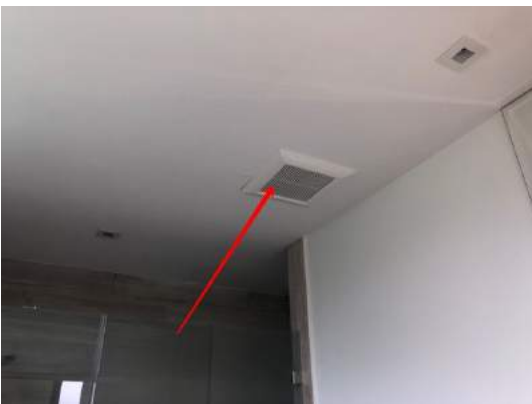
Comment 119

- No indications of current moisture intrusion or water damage detected along bathroom ceilings at the time of inspection.

Recommend repairing or replacing mechanical ventilation exhaust fan in bathroom to promote proper ventilation and reduce elevated humidity levels in confined spaces. (Estimate: \$200 - \$500)
