Home Inspection Report

5191 Pinetree Dr
Miami Beach, FL 33141

Inspected By: Tracy Woodard

Home Pro Miami
(786) 558-5286
www.homepromiami.com
info@homepromiami.com

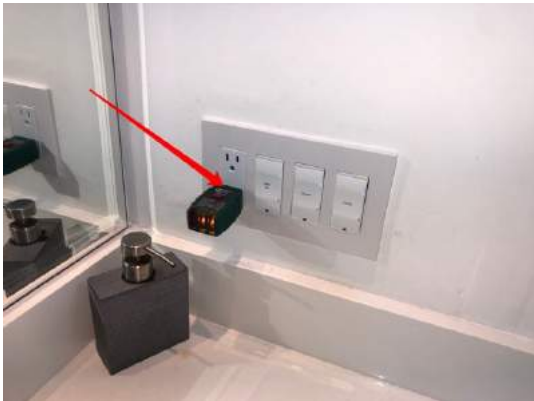
Comment 120

Bathroom outlet functioning properly at the time of inspection, but does not appear to be a proper GFCI outlet or on a GFCI circuit.

Recommend installing GFCI outlet or circuit within bathroom. (Estimate: \$50 - \$100)

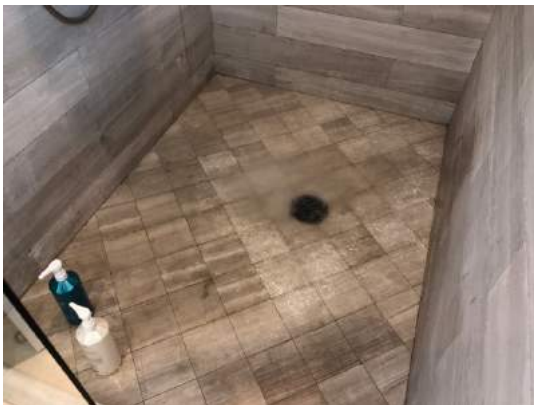
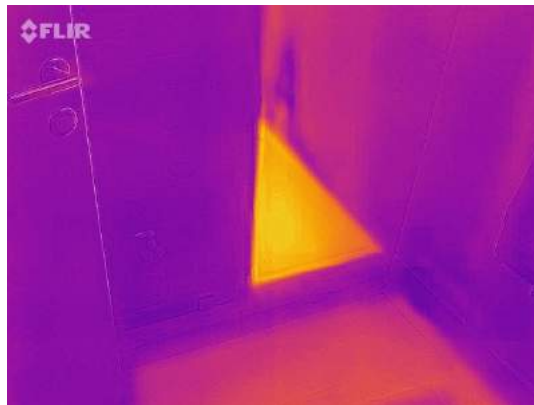
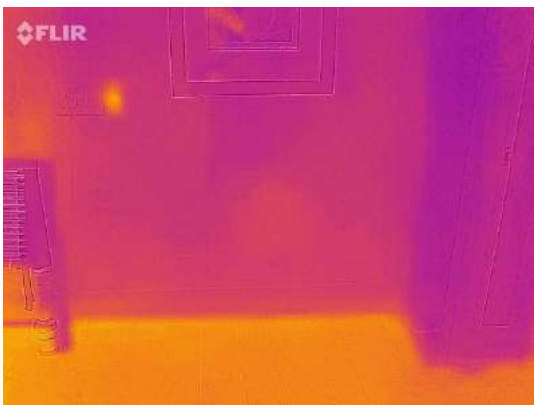
Comment 122

Shower pan tested.

- No indications of leaking from shower pan at the time of inspection.

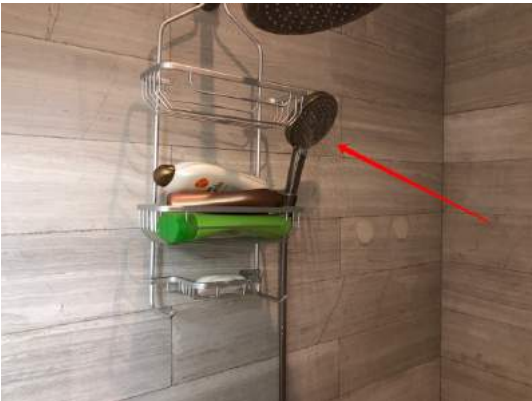
Comment 123

Low pressure from hand-held shower fixture.

Recommend further evaluation by a licensed plumbing contractor & repair or replace accordingly. (Estimate: \$100 - \$200)

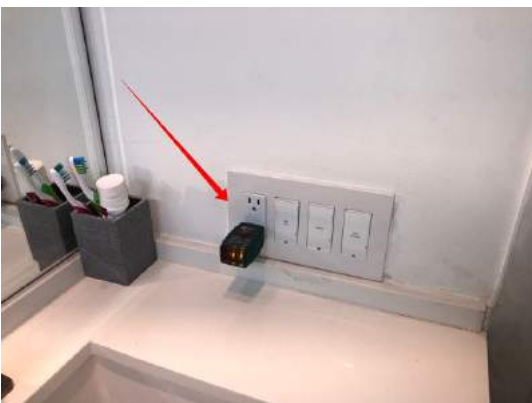
Comment 124
Deficiency

Bathroom outlet functioning properly at the time of inspection, but does not appear to be a proper GFCI outlet or on a GFCI circuit.

Recommend installing GFCI outlet or circuit within bathroom. (Estimate: \$50 - \$100)

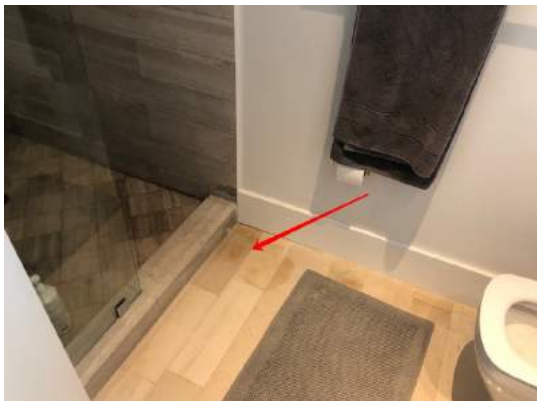
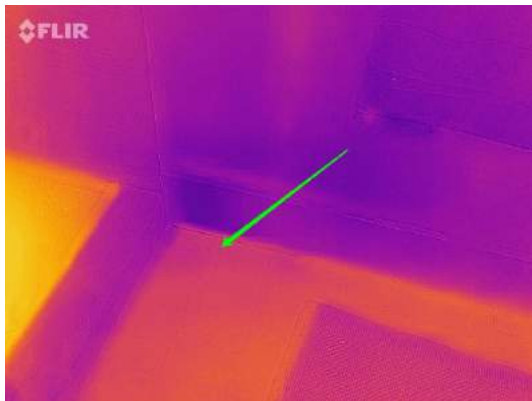
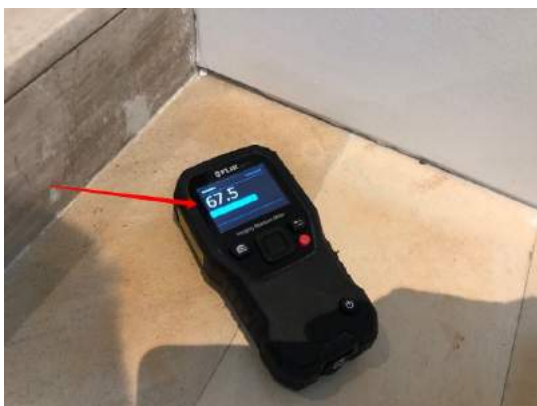
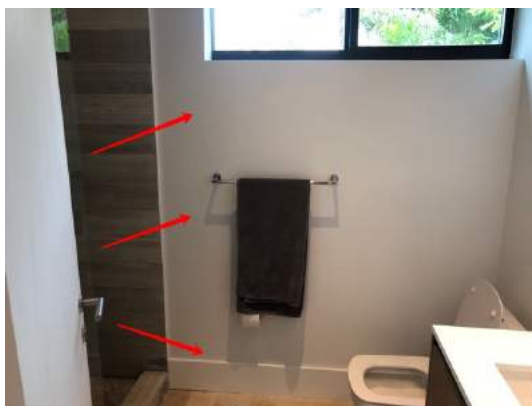
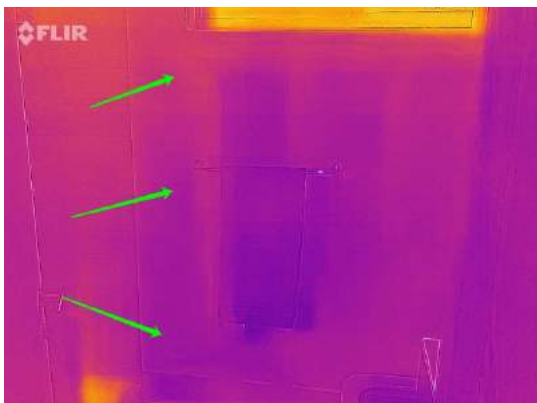
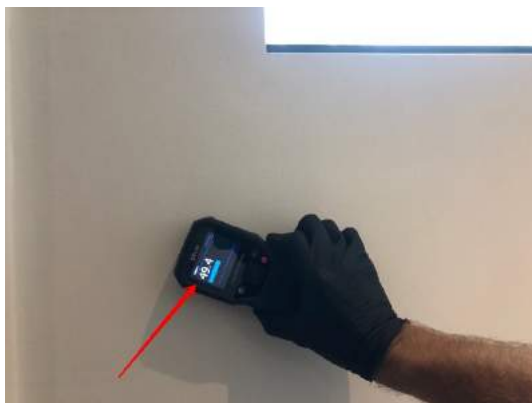
Comment 125
Deficiency

Apparent discoloration along tile flooring within bathroom adjacent to shower fixture below bathroom window.

- Indications of current moisture intrusion/saturation at the time of inspection.
- No indication of leaking from shower pan at the time of inspection.
- Estimate water damage & discoloration to tile flooring due to active moisture intrusion from around base of bathroom window framing and running down CBS wall behind drywall to flooring slab where water is affecting flooring.

Recommend further evaluation of exterior window by a licensed professional, and properly re-seal around window framing to prevent further moisture intrusion & water damage. (Estimate: \$500 - \$1,000)

Recommend re-finishing or replacing tile flooring where necessary. (Estimate: \$250 - \$500)

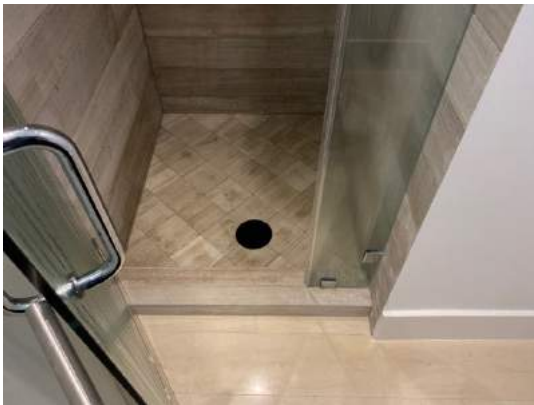
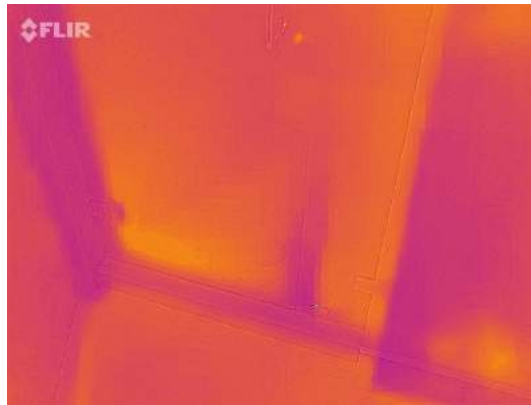
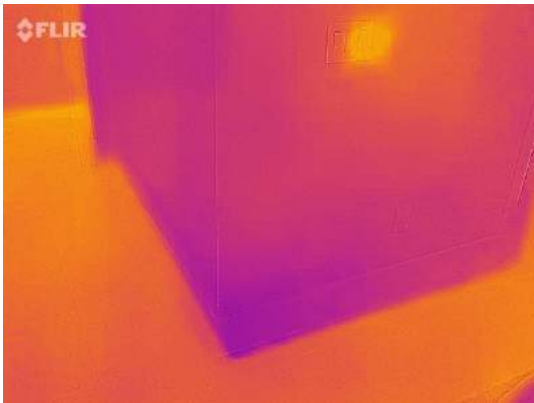
Comment 127

Shower pan tested.

- No indications of leaking from shower pan at the time of inspection.

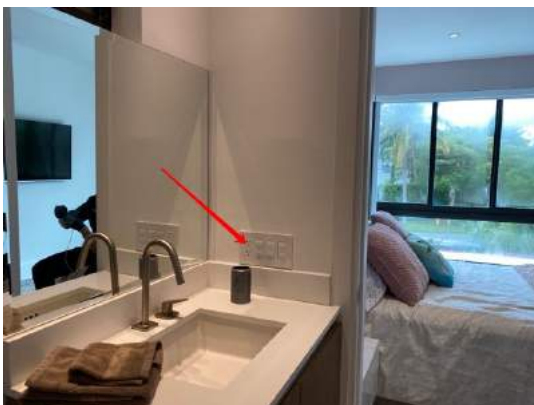
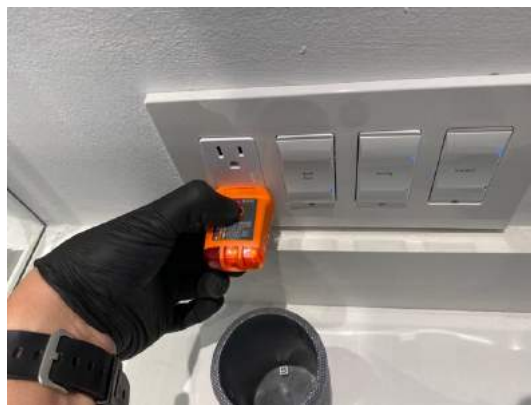
Bathroom outlet functioning properly at the time of inspection, but does not appear to be a proper GFCI outlet or on a GFCI circuit.

Recommend installing GFCI outlet or circuit within bathroom. (Estimate: \$50 - \$100)

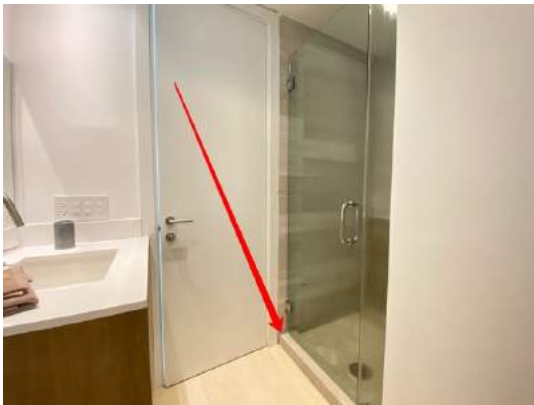
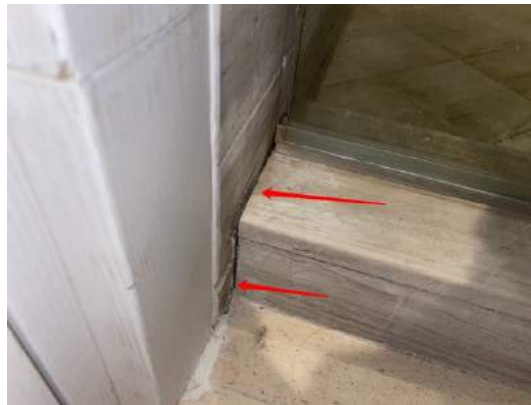
Comment 129

Apparent deterioration to grouting around shower wall & lip.

Recommend re-grouting shower tiling around lip & shower wall. (Estimate: \$100 - \$200)

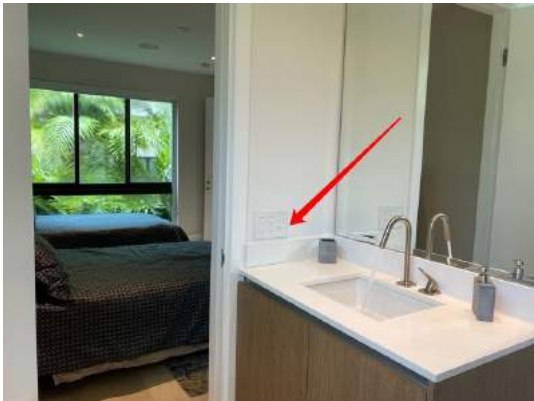
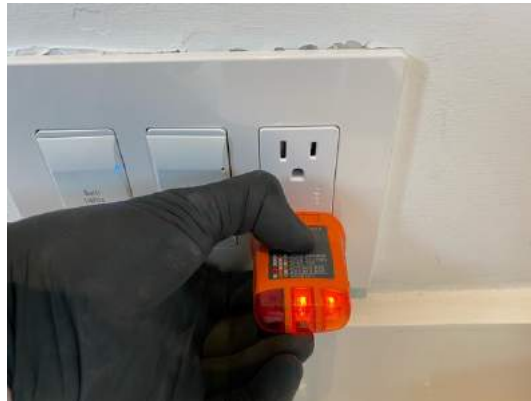
Comment 132
Deficiency

Bathroom outlet functioning properly at the time of inspection, but does not appear to be a proper GFCI outlet or on a GFCI circuit.

Recommend installing GFCI outlet or circuit within bathroom. (Estimate: \$50 - \$100)

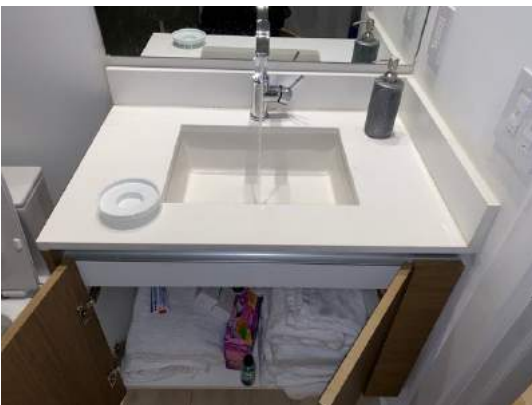
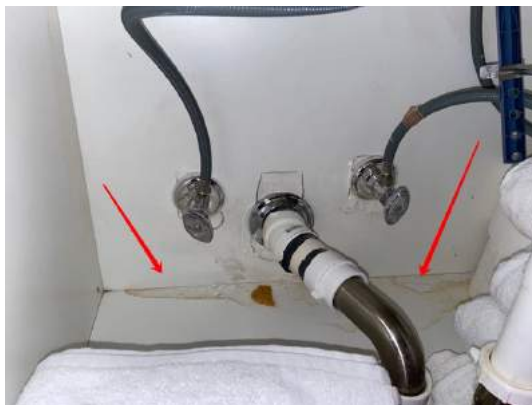
Comment 135
Deficiency

Indications of previous water damage below vanity.

- No indications of active water damage at the time of inspection. Estimate previous leaking from sink has been repaired.

Repair base of vanity and wall below vanity. (Estimate: \$100 - \$250)

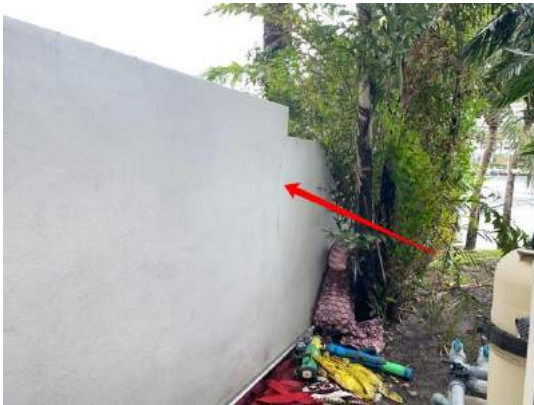
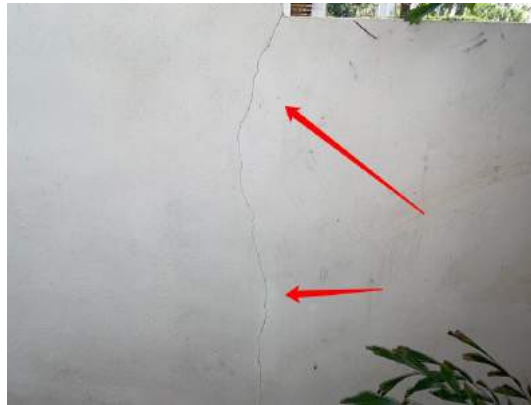
Apparent settlement cracking along structural wall on north side of property.

- Cracking does not appear to be structurally splitting at the time of inspection.

Recommend repairing/re-finishing stucco siding along wall to conceal settlement cracking. (Estimate: \$250 - \$500)

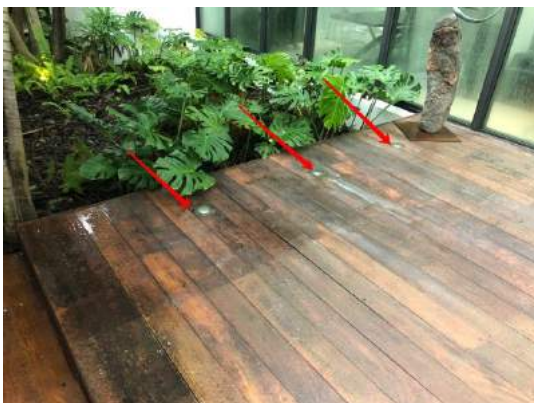
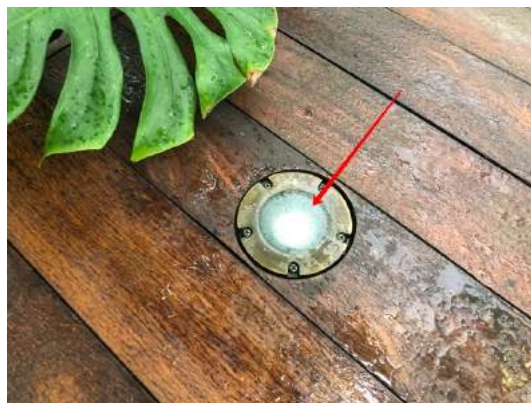
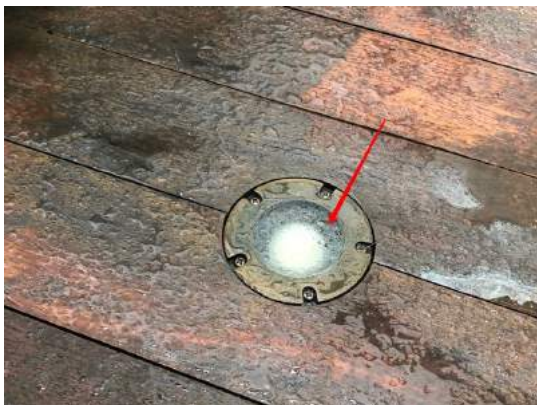
Comment 8

Exterior lighting fixtures built into decking around front entry walkway appear to have moisture intrusion within outlet housing.

Recommend further evaluation of lighting fixtures by a licensed professional contractor, and repair/re-seal or replace exterior lighting fixtures accordingly. (Estimate: \$500 - \$1,000)

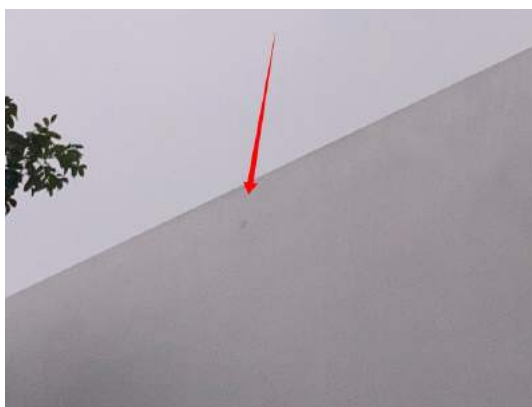
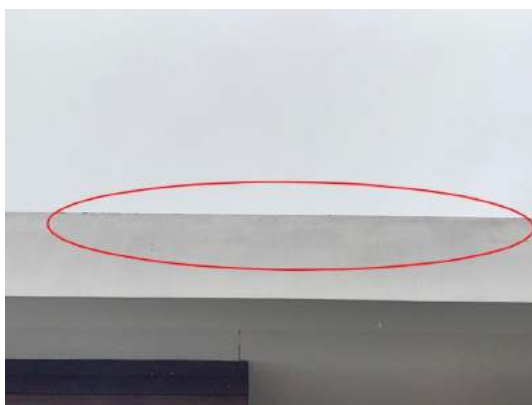
Comment 9

Apparent water damage & deterioration to exterior paint & waterproofing around exterior of property.

- Indications of moisture intrusion below paint & waterproofing.

Recommend having a licensed professional re-finish & re-paint/waterproof exterior stucco siding around exterior of property. (Estimate: \$5,000 - \$10,000)

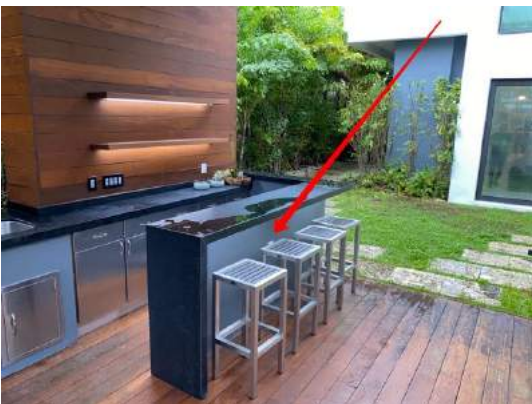
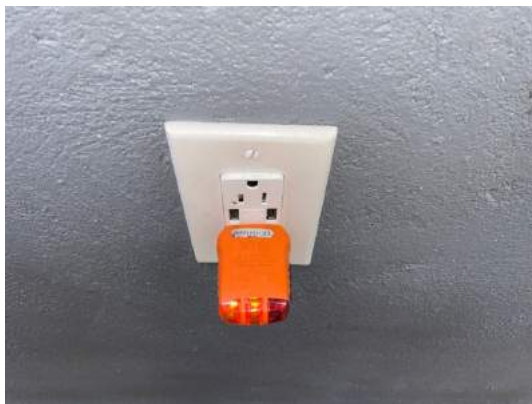
Comment 16

Exterior GFCI outlet along summer kitchen wall functioning properly, but does not appear to be on a proper GFCI circuit and does not trip when electrical surge is detected.

Recommend replacing exterior outlet with GFCI outlet. (Estimate: \$50 - \$100)

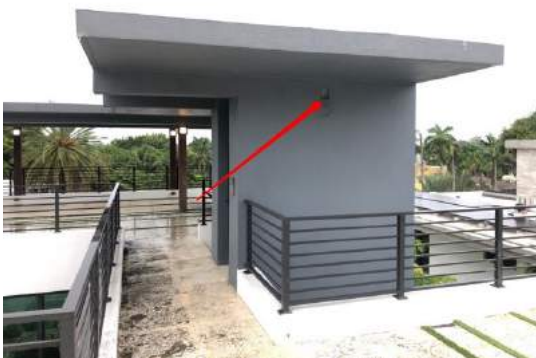
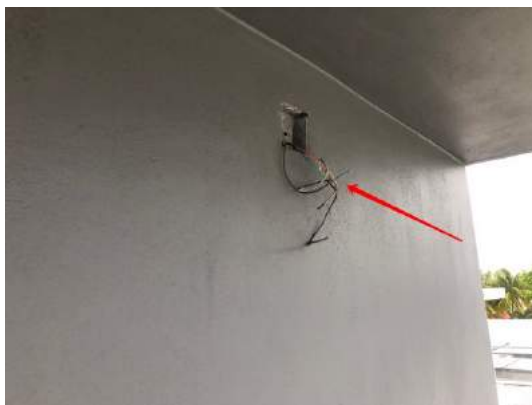
Comment 19

Missing light fixture along rooftop terrace exterior wall.

- Missing fixtures exposing live wiring.

Recommend replacing missing exterior lighting fixture. (Estimate: \$200 - \$400)

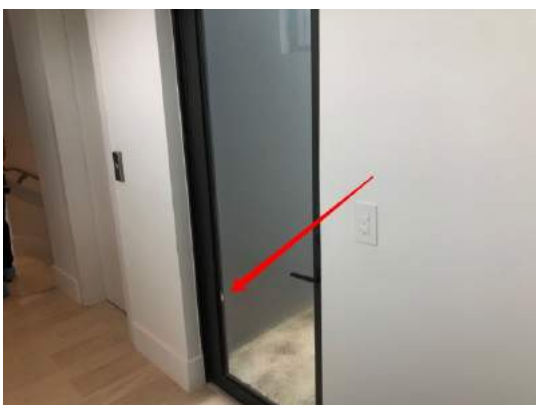
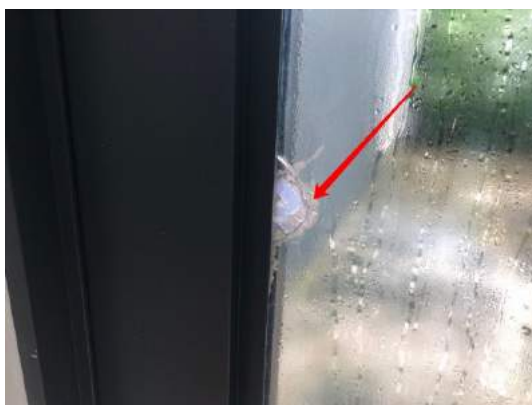
Comment 20

Damaged glazing to 3rd level hallway exterior door to rooftop terrace.

Replace window pane within door or replace door. (Estimate: \$1,000 - \$3,000)

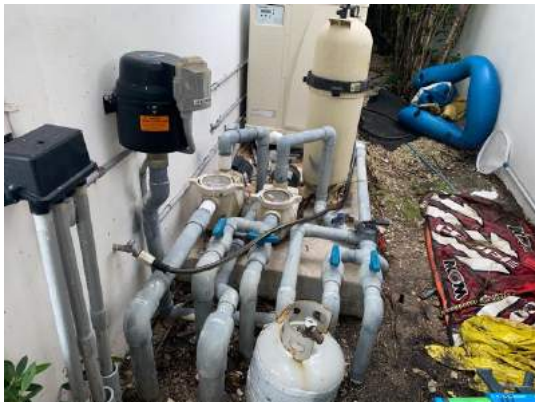
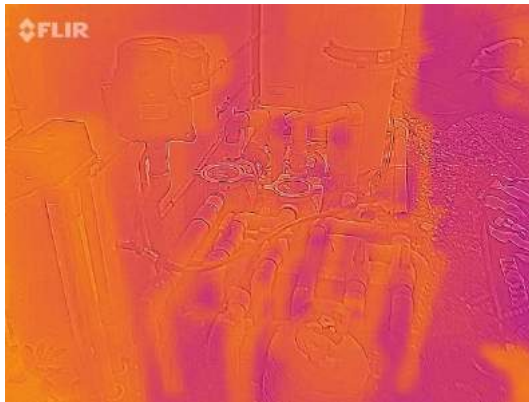
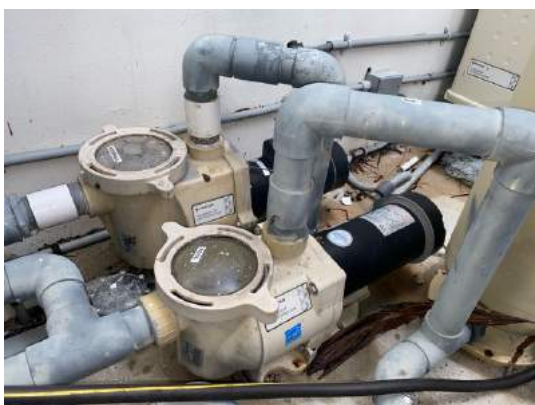
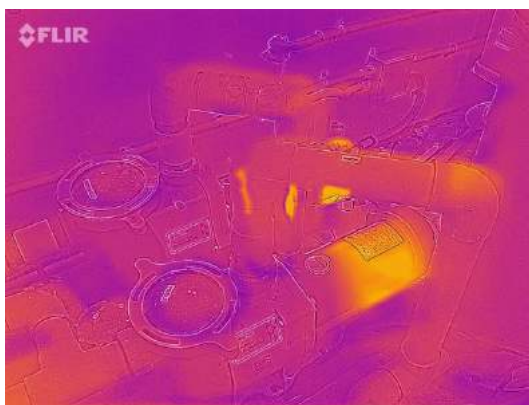
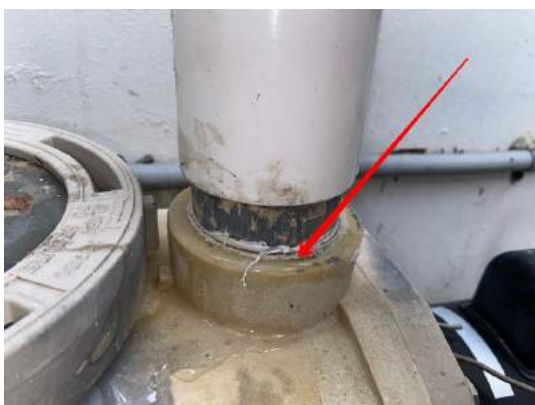
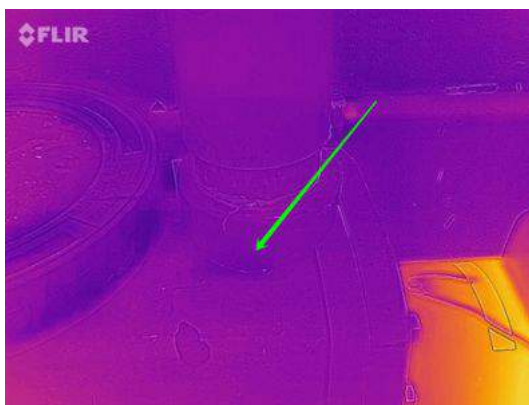
Comment 22

- Leaking pipe connection to pump at the time of inspection.

Recommend further evaluation by a licensed professional & repair accordingly. (Estimate: \$100 - \$250)

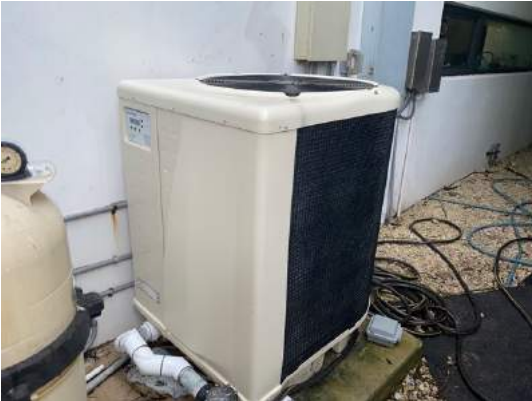
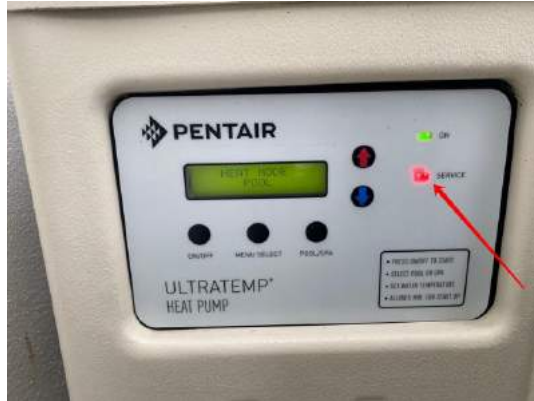
Comment 23

- Not tested.
- Service indicator on at the time of inspection.

Recommend further evaluation by a licensed professional and service accordingly. (Detailed quotation required)

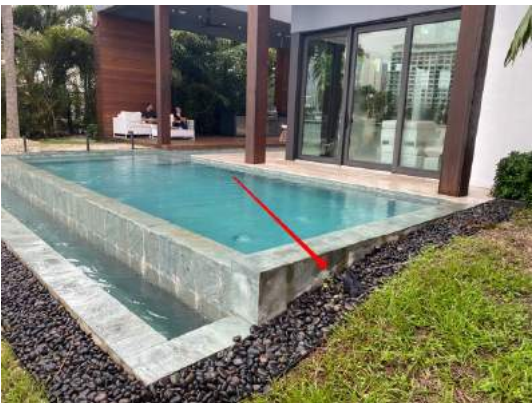
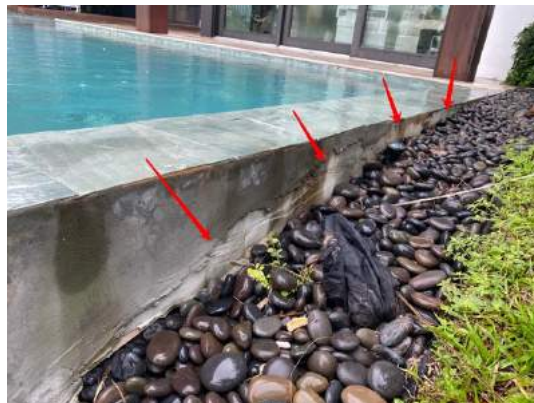
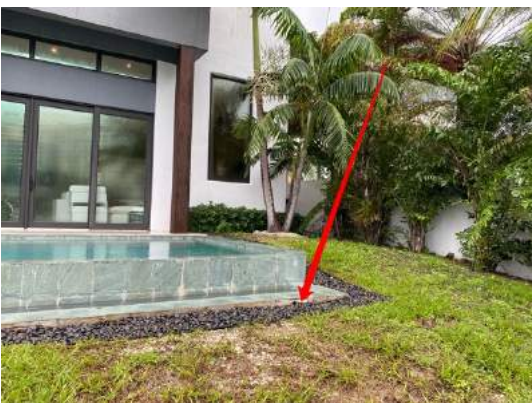
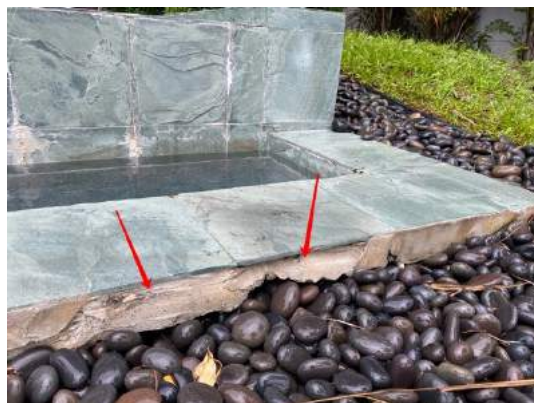
Comment 24

Unfinished stucco siding along outer barrier of pool.

Recommend re-finishing exterior stucco siding around exterior barrier walls of pool. (Estimate: \$500 - \$1,000)

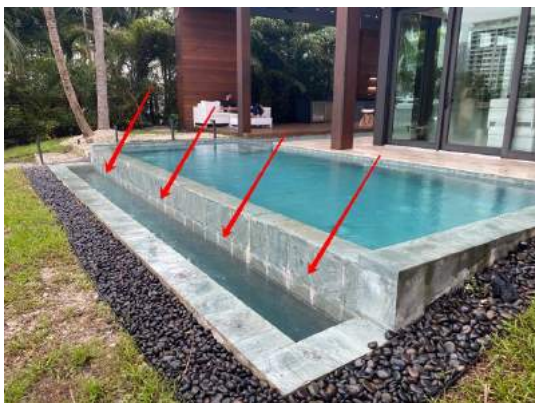
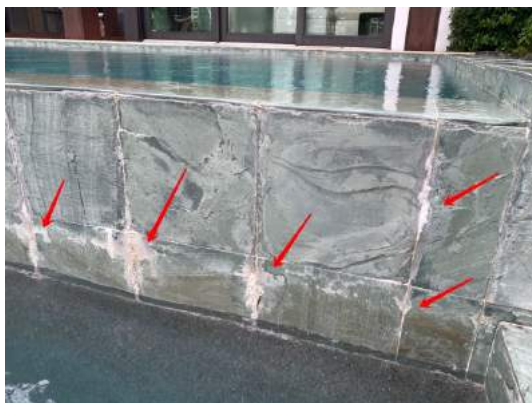
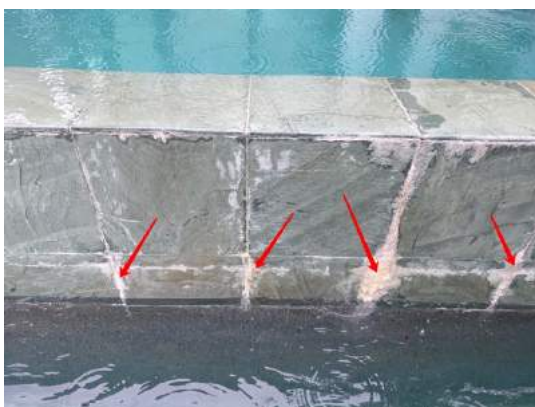
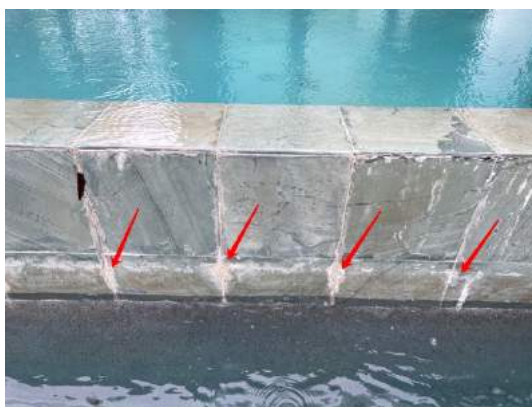
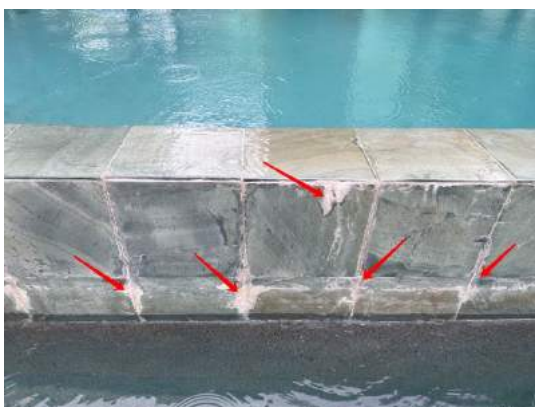
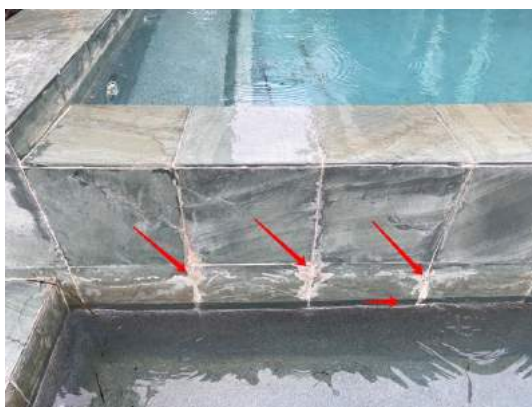
Comment 25

- Estimate minor moisture intrusion below tiles due to minor deterioration to tile grouting causing masonry bonding below tile to cause the crystalline deposit (efflorescence) visible from the surface of the tile.

Recommend repairing & re-sealing grouting along tiled waterfall wall to prevent further excessive efflorescence deposits. (Estimate: \$1,000 - \$1,500)

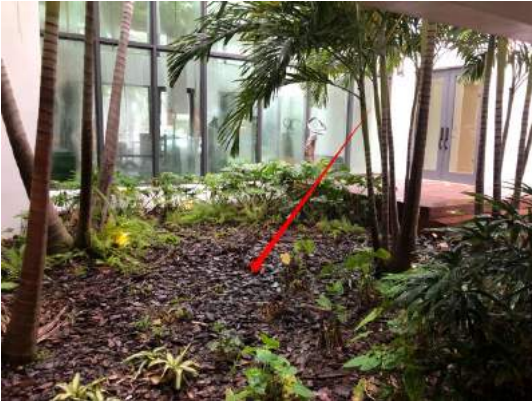
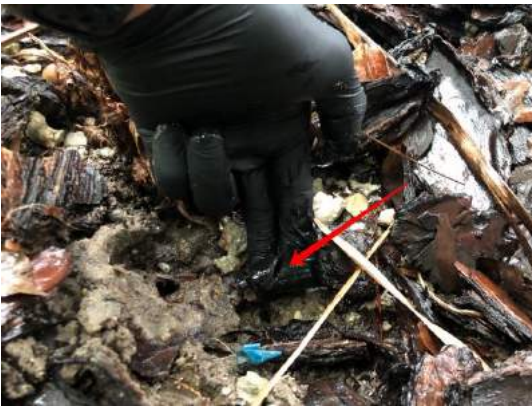
Comment 27
Irrigation System

Cut irrigation line within planter in front of home.

Repair or replace cut irrigation line. (Estimate: \$150 - \$300)

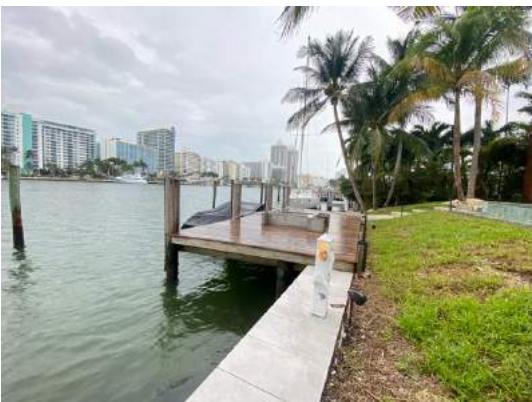
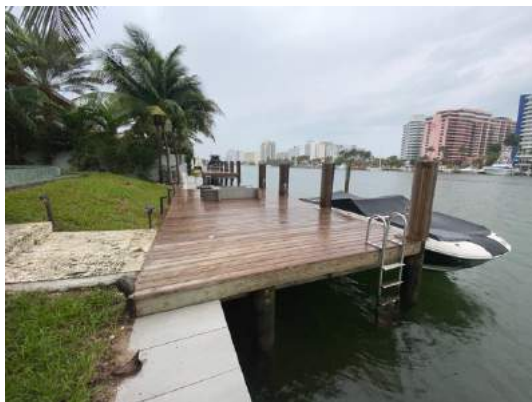
Comment 28
Dock/Seawall

Dock located within back side of property.

- Dock appears to be in fair condition at time of inspection.
- Minor cracking apparent along concrete seawall/bulkhead, but cracking does not appear to be structurally splitting from surface above water.
- Top of bulkhead has been tiled over and may be concealing cracking or damage.

As we can only check for visual deficiencies above water level, we recommend further evaluation of dock & seawall by a licensed structural engineer or seawall contractor for proper structural evaluation of seawall.

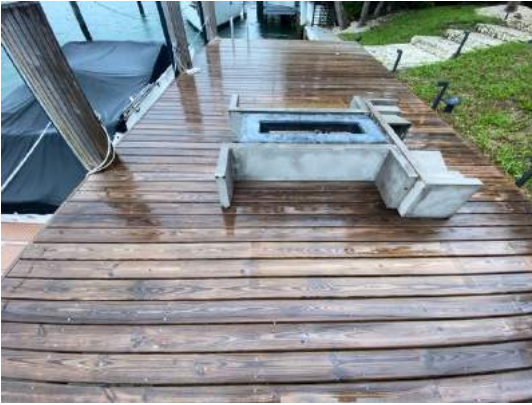
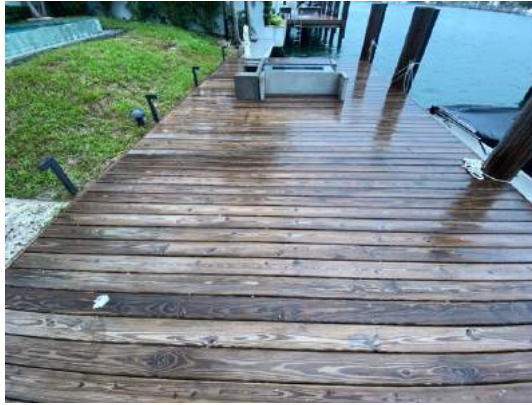
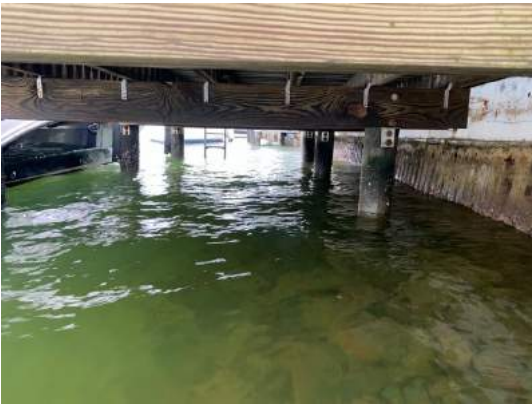
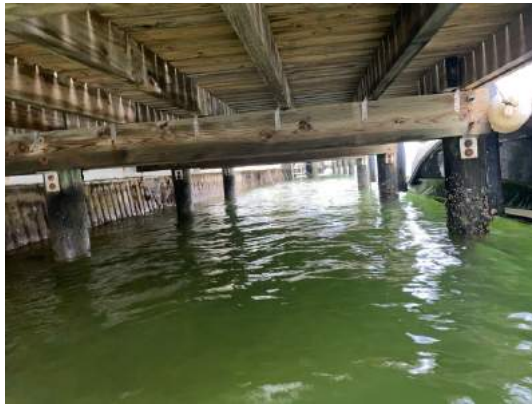
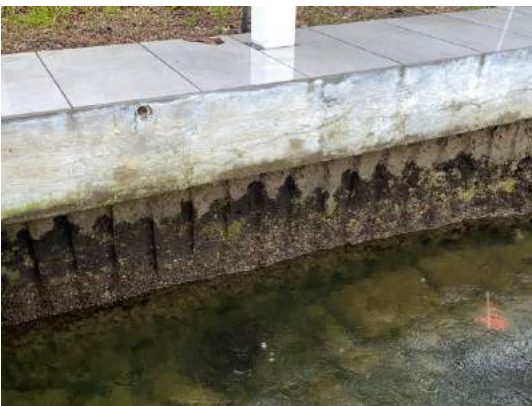
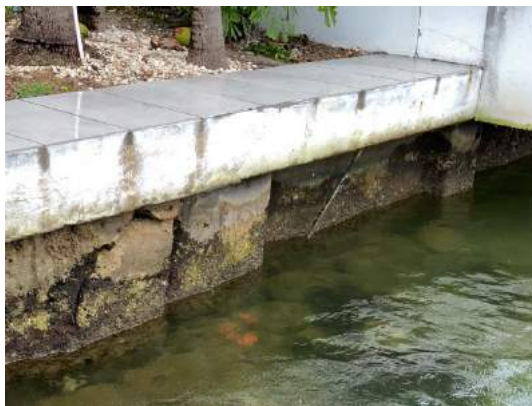
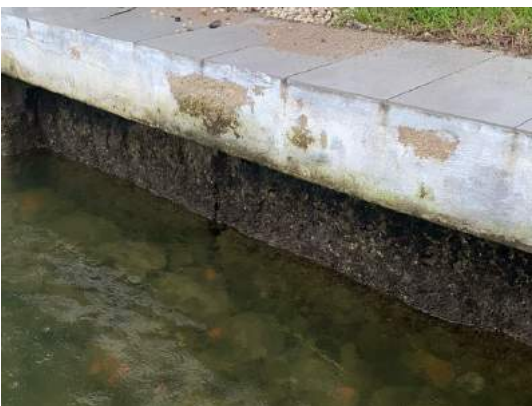
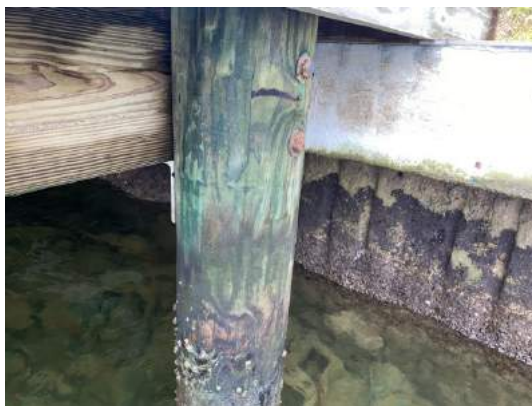
Comment 29
Dock/Seawall

Exterior GFCI outlet in back of property along dock/seawall not functioning at the time of inspection.

Recommend replacing faulty exterior GFCI outlet. (Estimate: \$50 - \$100)

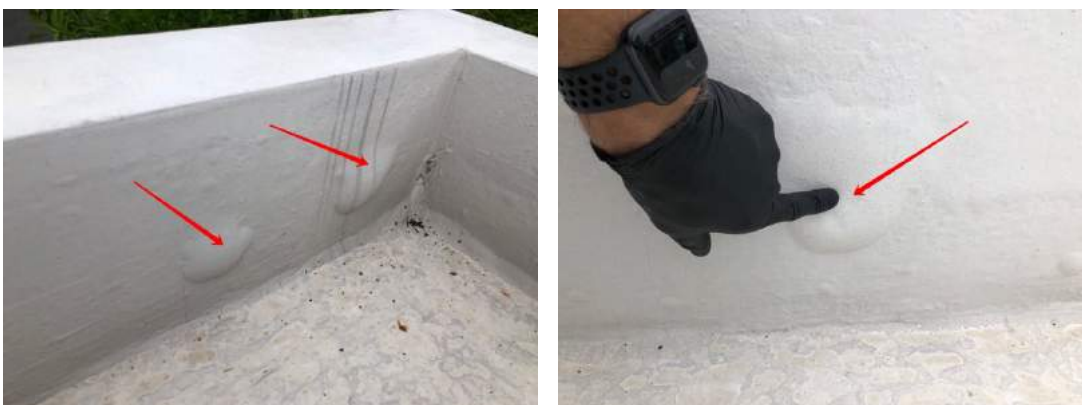
- Bubbling is an indication of moisture intrusion below liquid roof sealant around parapet wall which has expanded with heat.
- Paintbrush left along top of parapet wall from application of liquid roof sealant is currently sealed to crown of wall & oxidizing along wall.

Recommend repairing liquid roofing sealant to prevent possible leaking & water damage. (Estimate: \$1,000 - \$2,500)

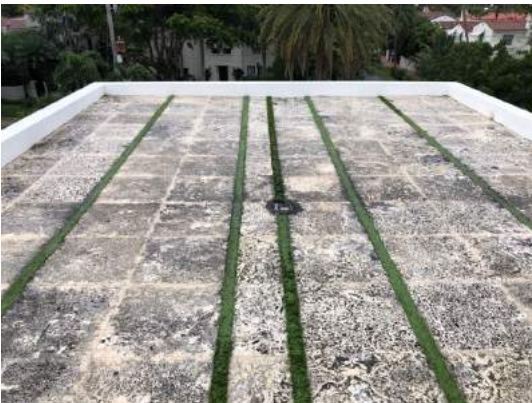
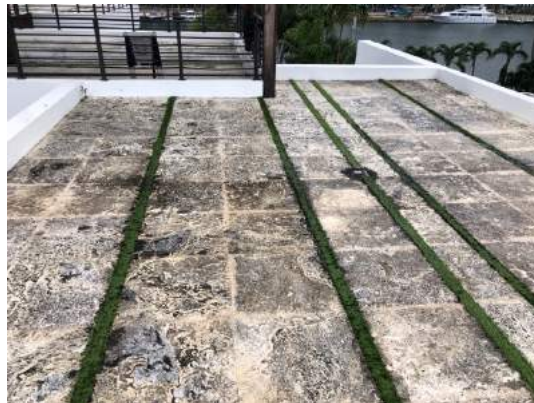
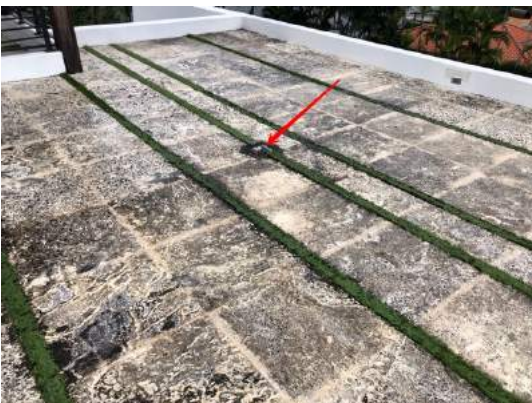
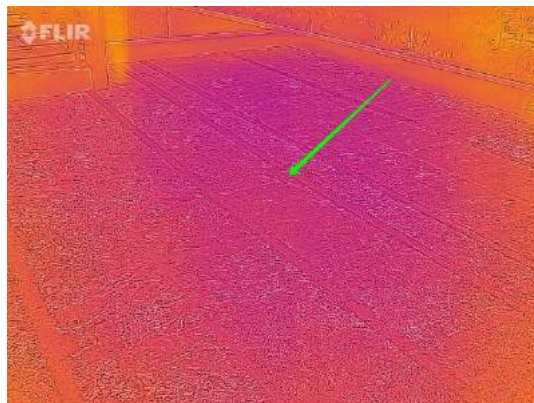
Comment 38

- Roof appears to be properly graded for adequate drainage to roof drain.
- Apparent patch repair to parapet wall round scupper drain. Patch currently peeling away from parapet wall.

Recommend properly repairing parapet wall to prevent potential moisture from roof. (Estimate: \$250 - \$500)

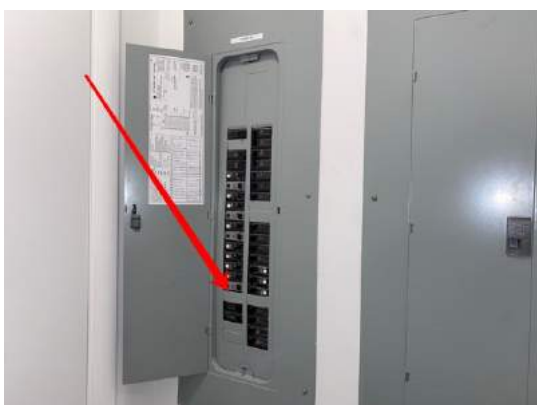
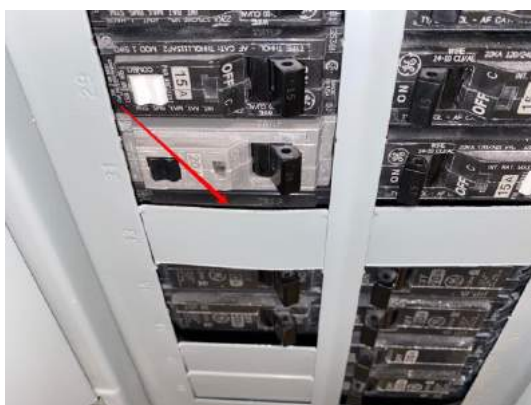
Circuit breaker currently concealed behind dead front cover.

Adjust/modify dead front cover to properly provide opening for all installed circuit breakers.

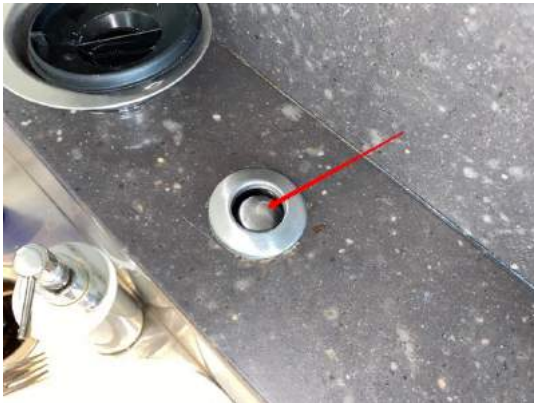
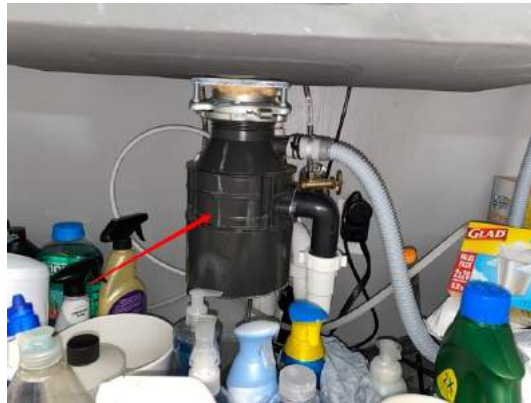
Comment 68

Sink top mounted air switch for garbage disposal is currently broken, and garbage disposal is not functional at the time of inspection.

Replace sink top mounted air switch. (Estimate: \$50 - \$100)

If garbage disposal continues not to function, replace garbage disposal. (Estimate: \$250 - \$500)

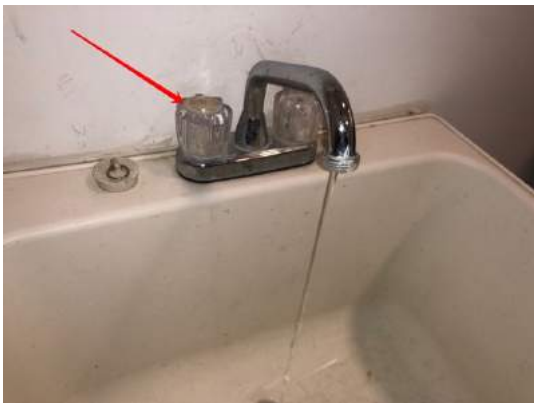
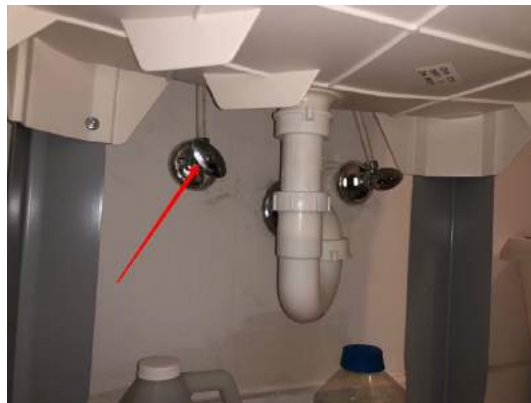
Comment 70
Laundry Room

Utility sink faucet fixture hot water valve handle is currently broken , and does not properly close/shut-off hot water.

- Hot water supply turn-stop valve below sink shut-off following inspection to prevent water from continuously flowing.

Recommend replacing utility sink faucet fixture. (Estimate: \$100 - \$250)

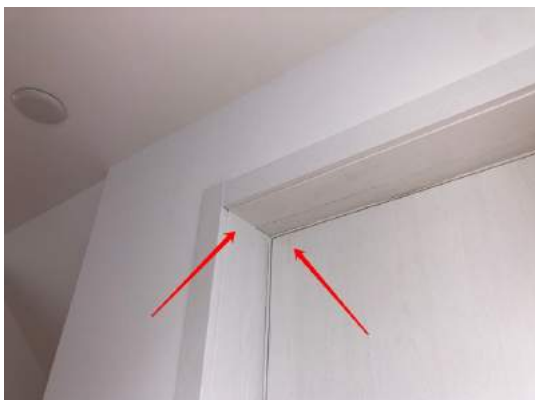
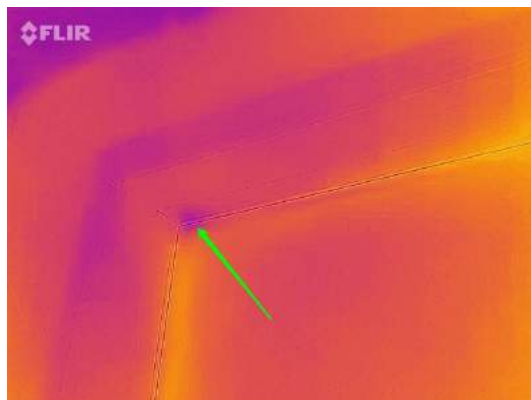
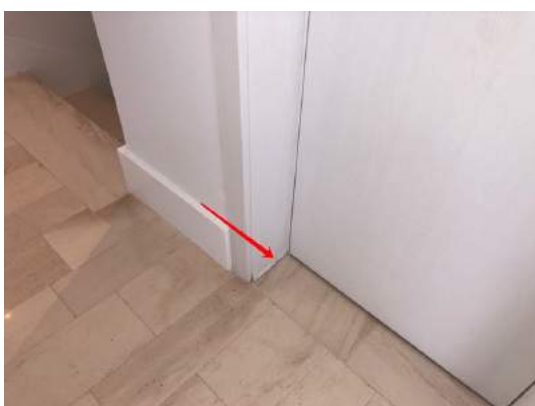
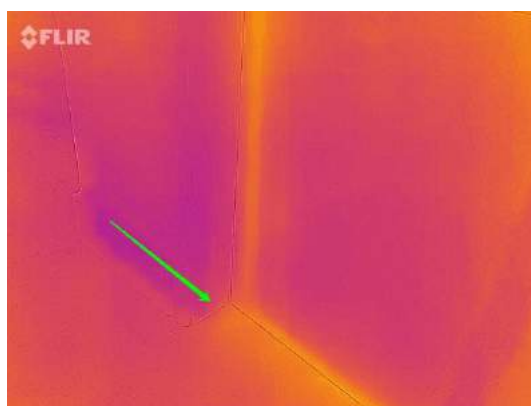
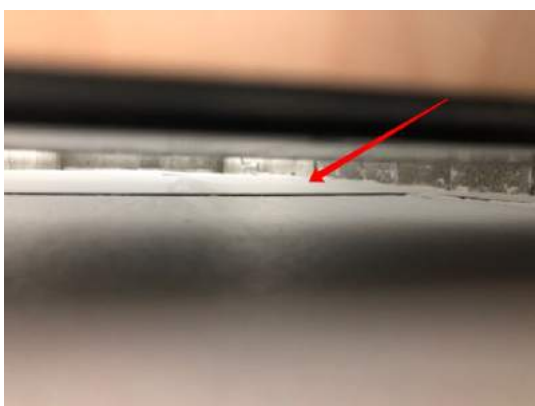
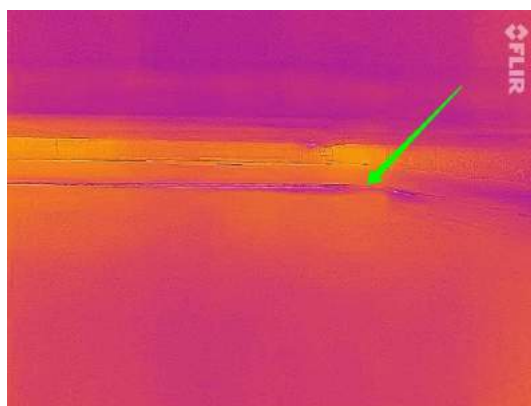
Comment 72
Interior

Apparent water damage to 3rd level elevator door trim.

- Active moisture intrusion detected from rooftop over elevator doorway within elevator shaft.

Recommend repairing/re-sealing rooftop above elevator doorway to prevent further moisture intrusion & water damage. (Estimate: \$500 - \$1,000)

Repair/replace water damaged trim around 3rd level elevator doorway. (Estimate: \$200 - \$500)

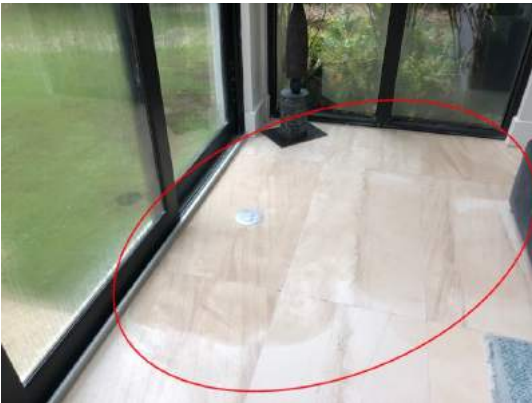
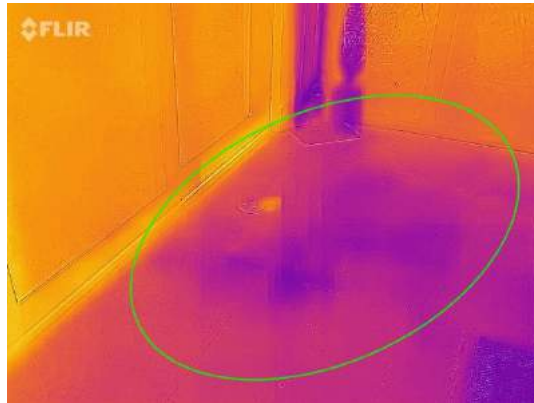
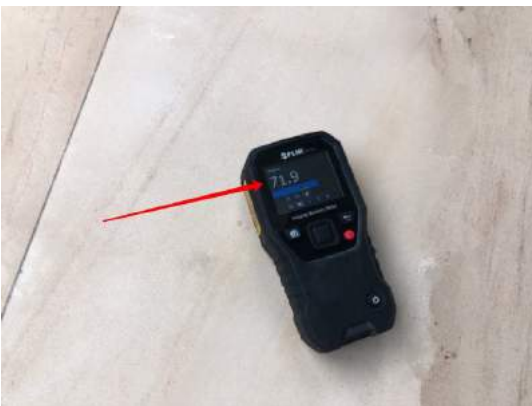
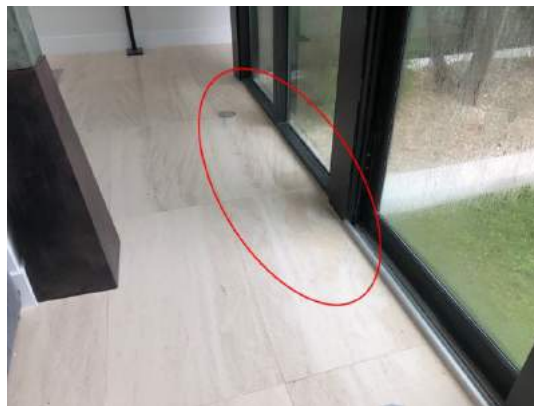
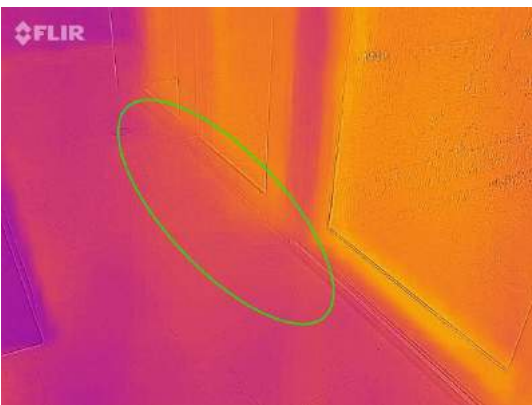
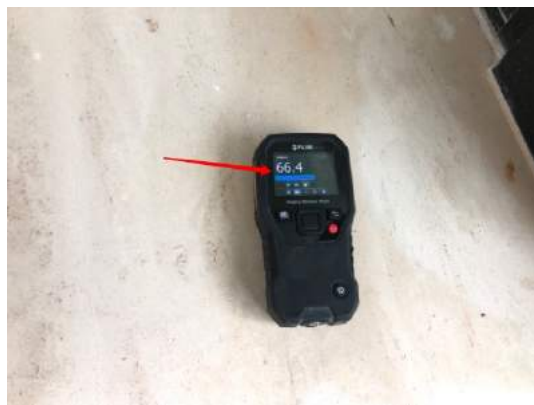
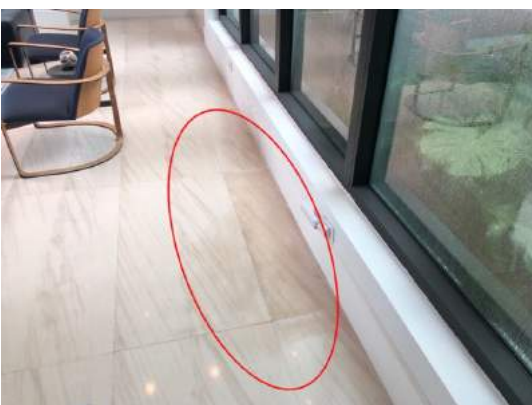
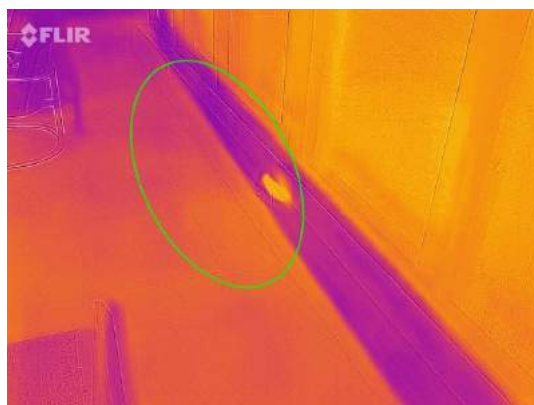
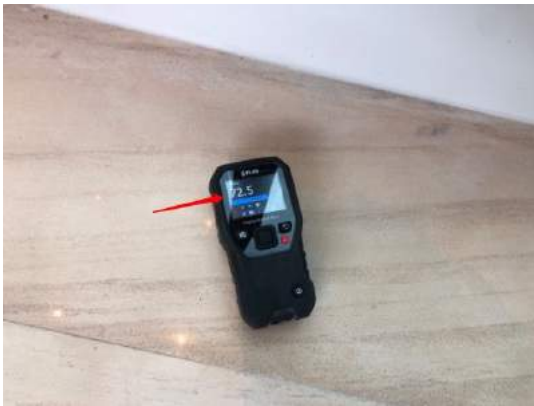
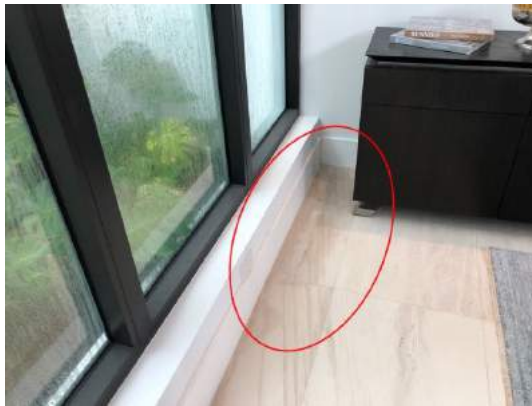
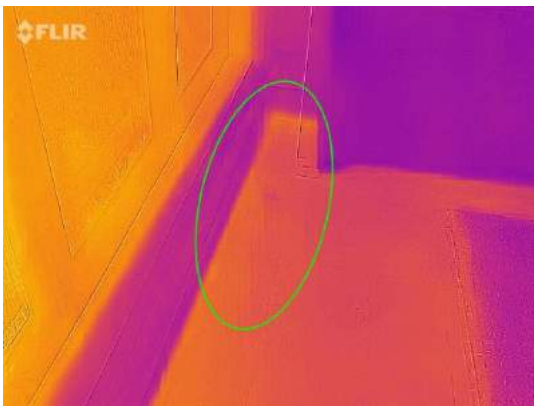
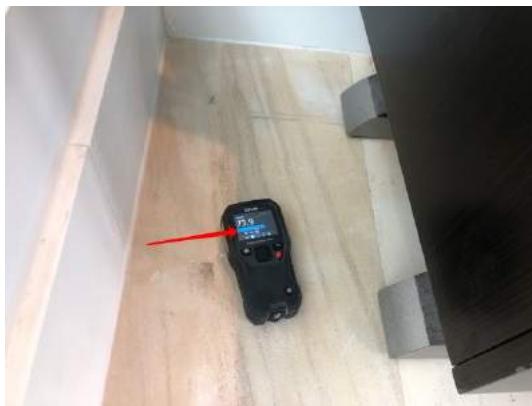
Comment 74

- Indications of current moisture intrusion/saturation at the time of inspection.
- Estimate water damage & discoloration to tile flooring due to active moisture intrusion from around base of sliding glass door & window framing.

Recommend further evaluation of exterior windows doors by a licensed professional, and properly re-seal around door/window faming to prevent further moisture intrusion. (Estimate: \$500 - \$1,000)

Recommend re-finishing or replacing tile flooring where necessary. (Estimate: \$2,000 - \$5,000)
