Home Inspection Report

5191 Pinetree Dr
Miami Beach, FL 33141

Inspected By: Tracy Woodard

Home Pro Miami
(786) 558-5286
www.homepromiami.com
info@homepromiami.com

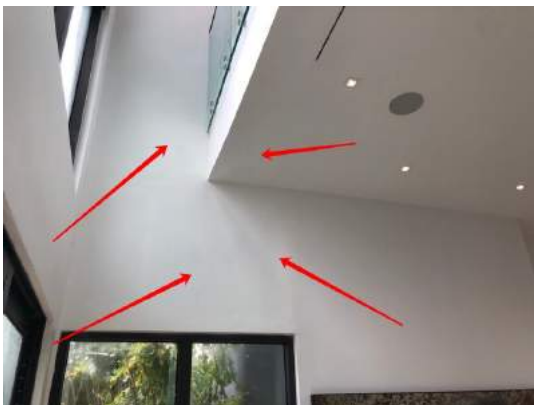
Comment 75
Interior: Living Room

Apparent previous repairs to living room wall & ceiling.

- Active moisture intrusion still detected at the time of inspection.
- Estimate moisture intrusion coming from leaking sliding glass door framing directly above in 3rd level common area.

Recommend re-sealing sliding glass door framing above to prevent further moisture intrusion & water damage.

Recommend excavating water damaged drywall, properly replacing & re-finishing wall & ceiling drywall within living room. (Estimate: \$500 - \$1,000)

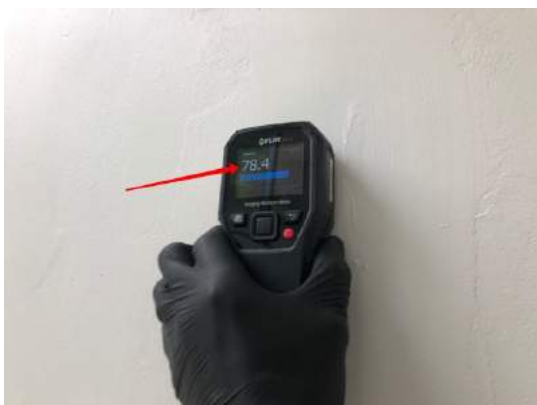
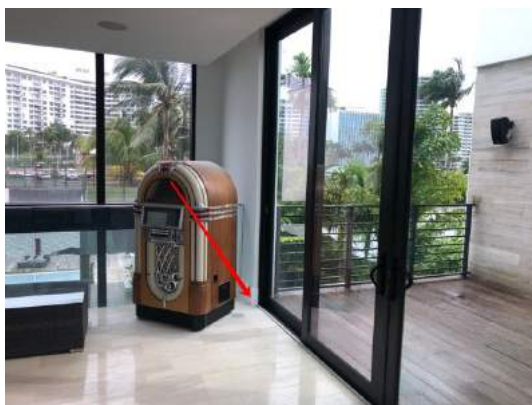
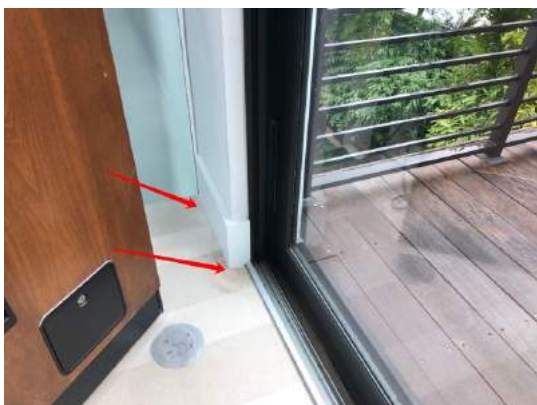
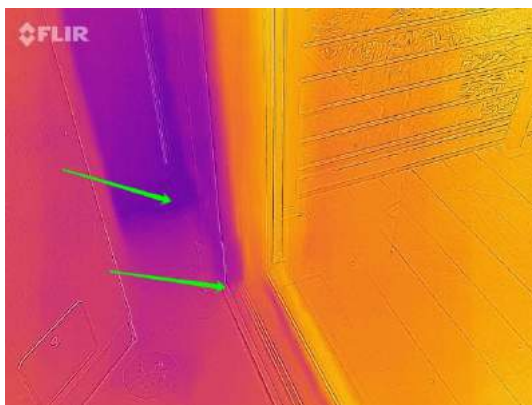
Comment 78

Apparent moisture intrusion from base of window framing within family room.

Recommend re-sealing around exterior window framing to prevent further moisture intrusion. (Estimate: \$200 - \$500)

Recommend repairing or replacing water damage drywall around base of window. (Estimate: \$150 - \$250)

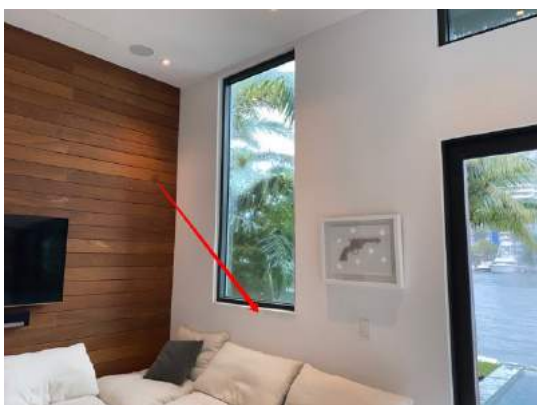
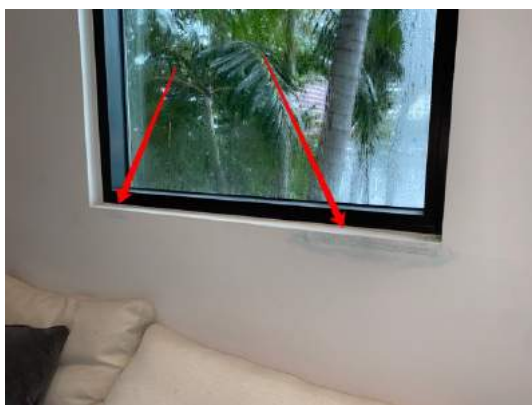
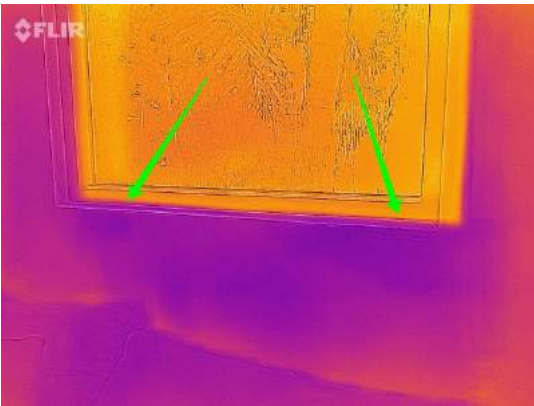
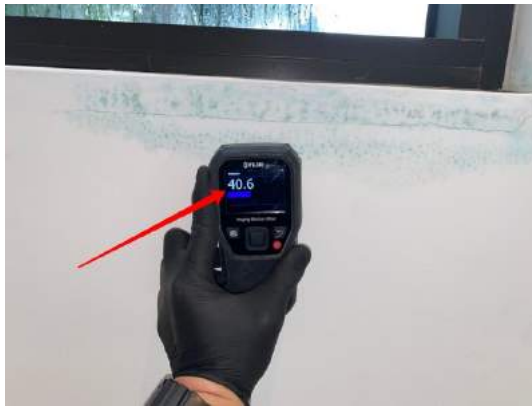
Comment 81

- Indications of current moisture intrusion/saturation at the time of inspection.
- Estimate water damage & discoloration to tile flooring due to active moisture intrusion from around base of bedroom window framing and running down CBS wall behind drywall to flooring slab where water is affecting flooring.

Recommend further evaluation of exterior window by a licensed professional, and properly re-seal around window framing to prevent further moisture intrusion & water damage. (Estimate: \$500 - \$1,000)

Recommend re-finishing or replacing tile flooring where necessary. (Estimate: \$1,000 - \$2,500)

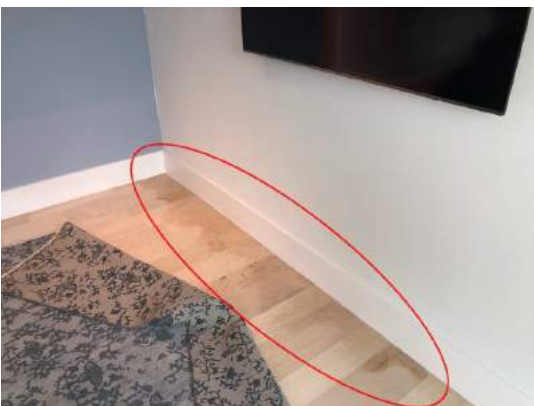
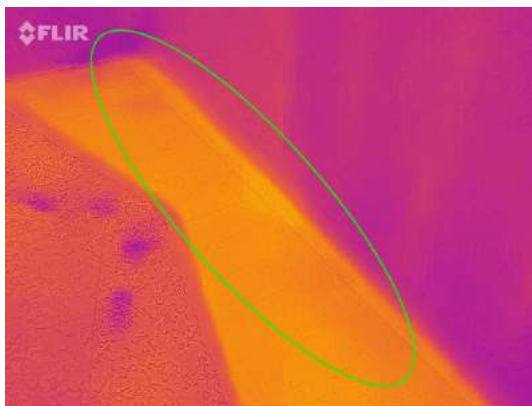
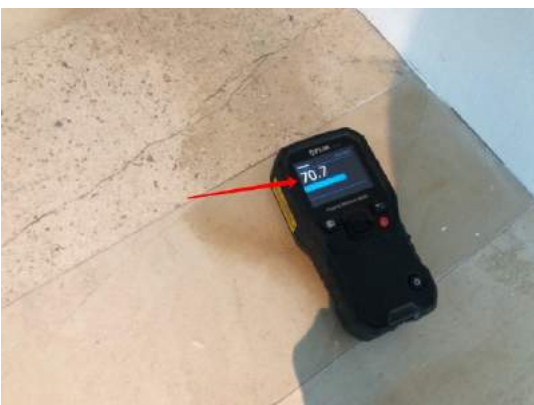
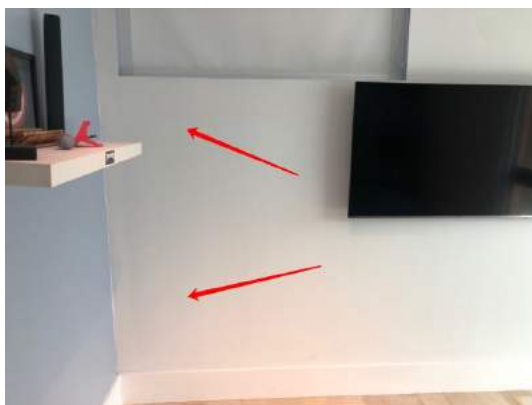
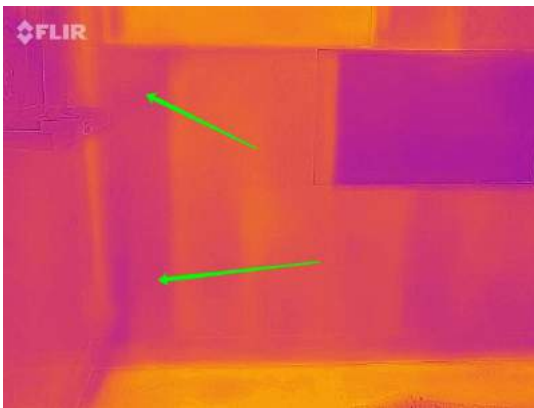
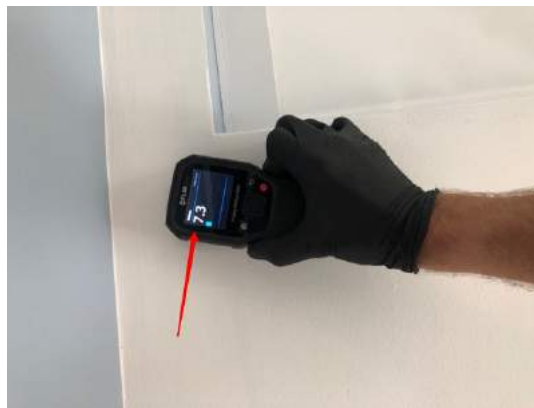
Comment 83

Apparent moisture intrusion from base of window framing within 2nd level bedroom #2.

Recommend re-sealing around exterior window framing to prevent further moisture intrusion. (Estimate: \$200 - \$500)

Recommend repairing or replacing water damage drywall around base of window. (Estimate: \$150 - \$250)

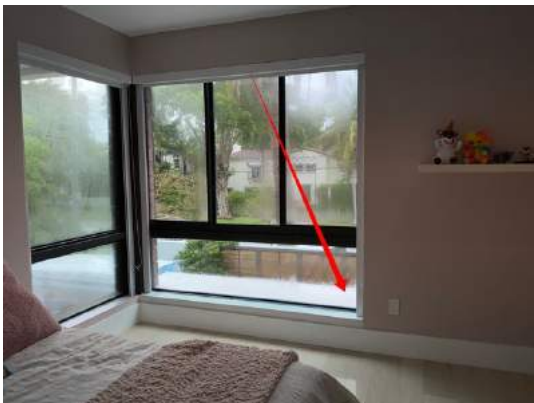
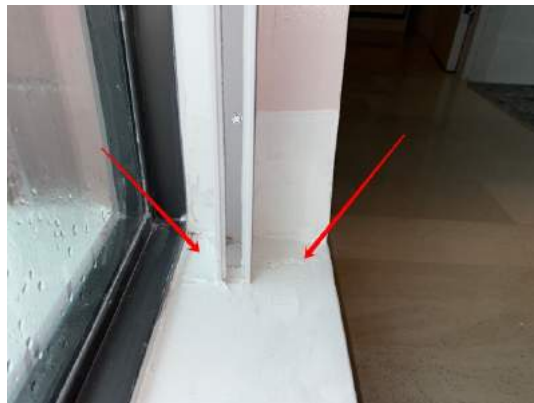
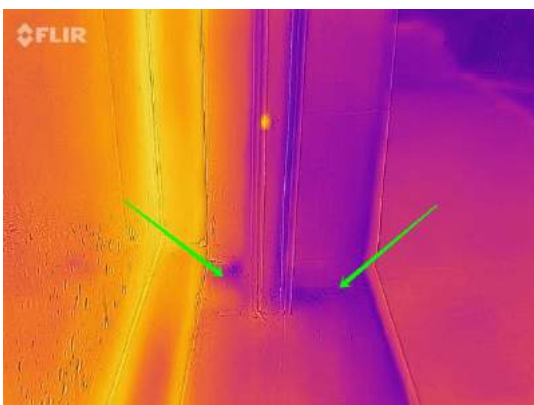
Comment 85

Apparent moisture intrusion from base of window framing within 2nd level bedroom #3.

Recommend re-sealing around exterior window framing to prevent further moisture intrusion. (Estimate: \$200 - \$500)

Recommend repairing or replacing water damage drywall around base of window. (Estimate: \$150 - \$250)

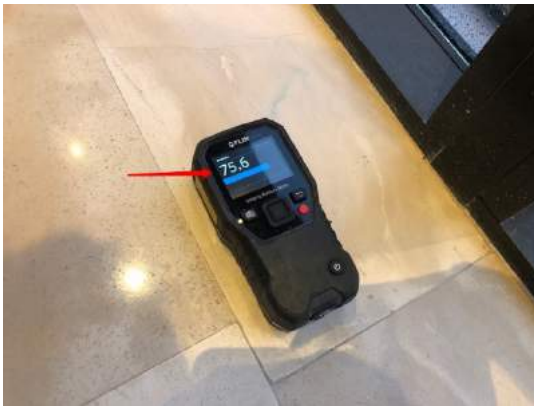
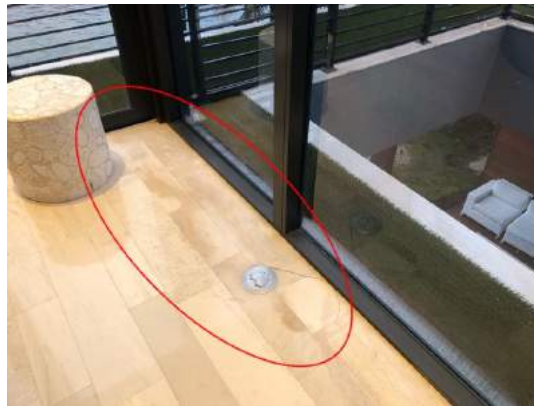
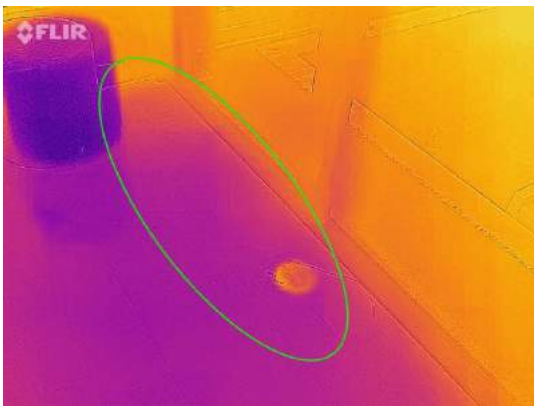
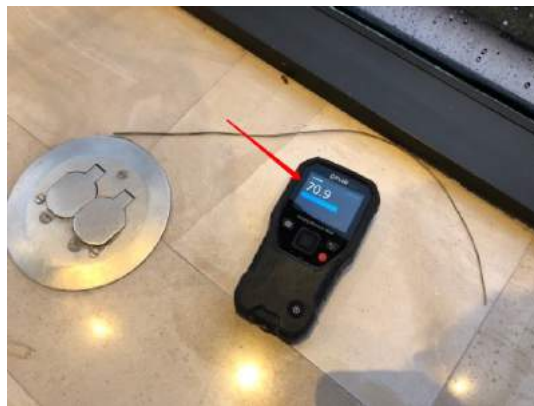
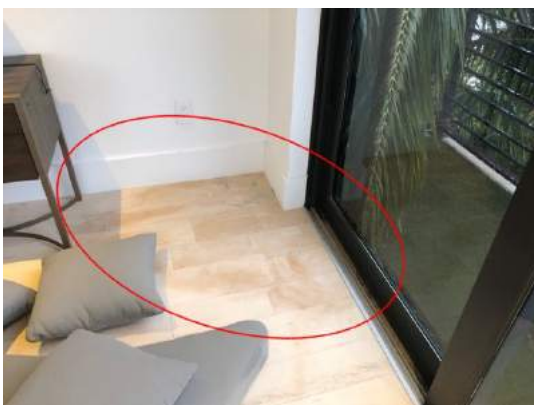
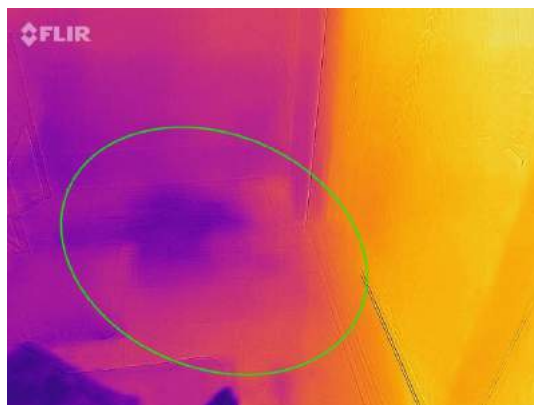
Comment 89

- Indications of current moisture intrusion/saturation at the time of inspection.
- Estimate water damage & discoloration to tile flooring due to active moisture intrusion from around base of sliding-glass door framing.

Recommend further evaluation of exterior window by a licensed professional, and properly re-seal around sliding-glass door faming to prevent further moisture intrusion & water damage. (Estimate: \$500 - \$1,000)

Recommend re-finishing or replacing tile flooring where necessary. (Estimate: \$500 - \$1,500)

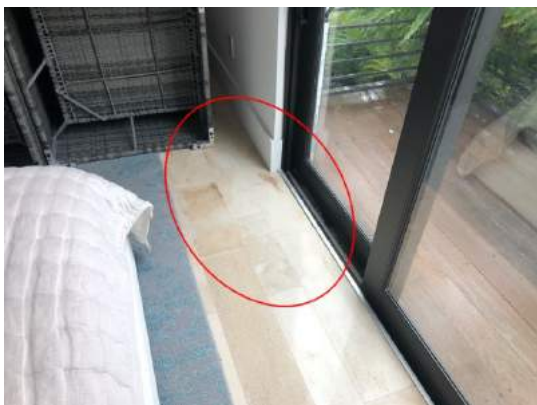
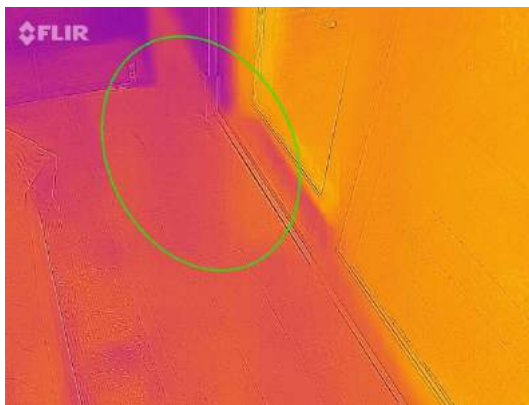
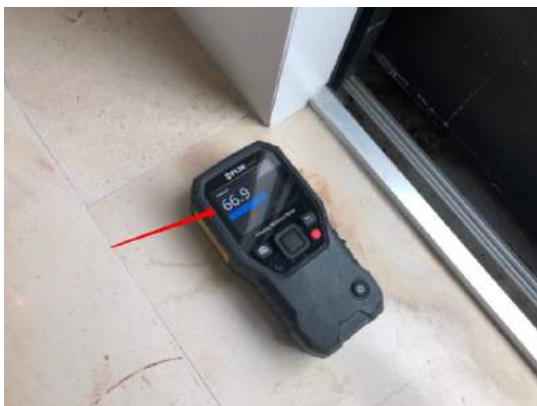
Comment 90

- Indications of current moisture intrusion/saturation at the time of inspection.
- Estimate water damage & discoloration to tile flooring due to active moisture intrusion from around base of door framing.

Recommend further evaluation of exterior door by a licensed professional, and properly re-seal around door faming to prevent further moisture intrusion & water damage. (Estimate: \$250 - \$500)

Recommend re-finishing or replacing tile flooring where necessary. (Estimate: \$500 - \$1,000)

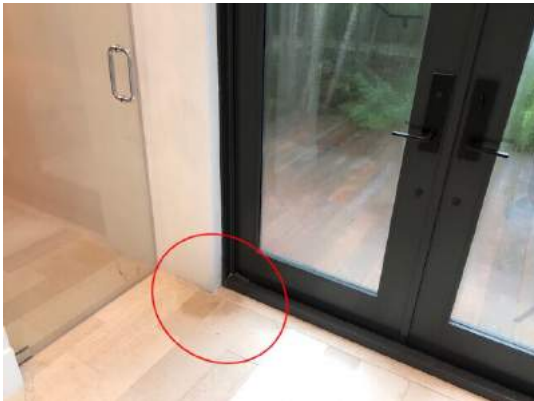
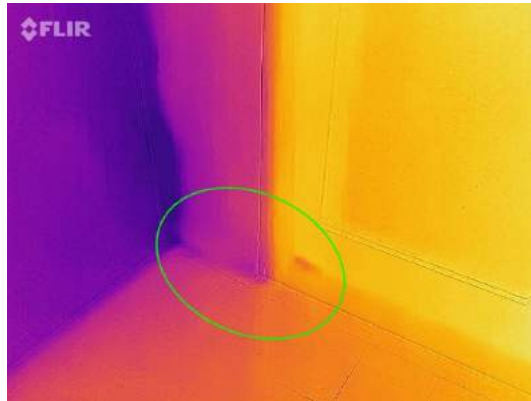
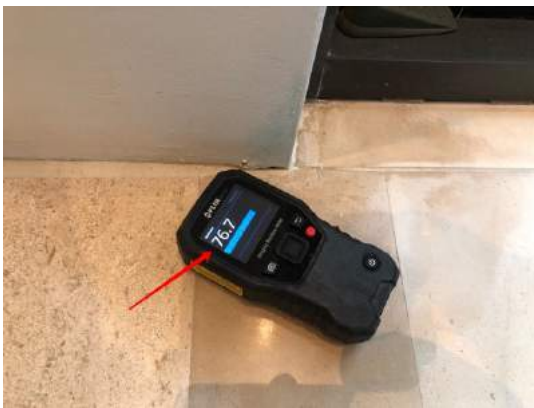
Comment 93

- Indications of current moisture intrusion/saturation at the time of inspection.
- Estimate water damage & discoloration to tile flooring due to active moisture intrusion from around base of window framing.

Recommend further evaluation of exterior windows & doors by a licensed professional, and properly re-seal around window & door faming to prevent further moisture intrusion & water damage. (Estimate: \$500 - \$1,000)

Recommend re-finishing or replacing tile flooring where necessary. (Estimate: \$1,000 - \$2,500)

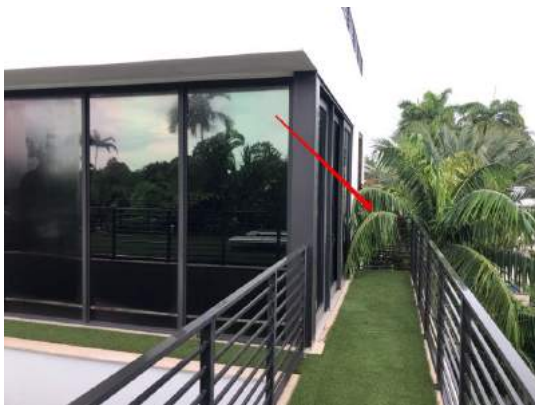
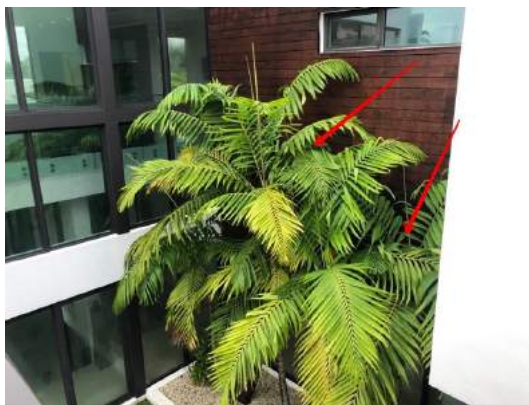
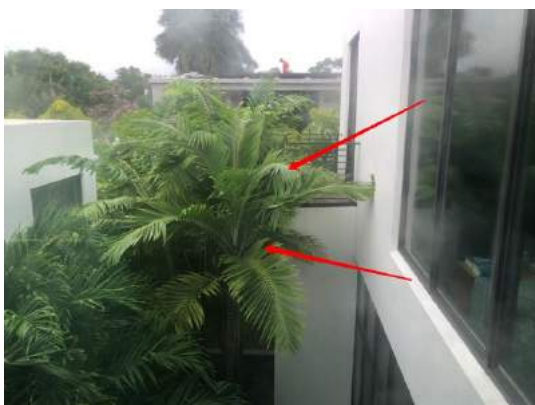
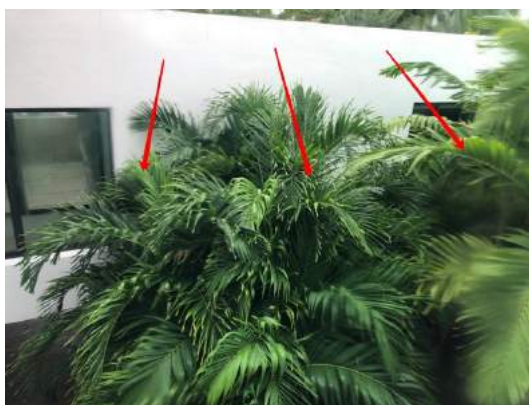
Comment 4

- Debris collecting within roof covering.

Recommend keeping vegetation/trees cut back from side & roof of home as well as properly clear debris from roof to prevent damage to home siding & roof coverings.
